J5451. 26th July, 2024. Page 1.

GEOTECHNICAL INVESTIGATION:

New House and Pool at 14 Bellevue Parade, Curl Curl

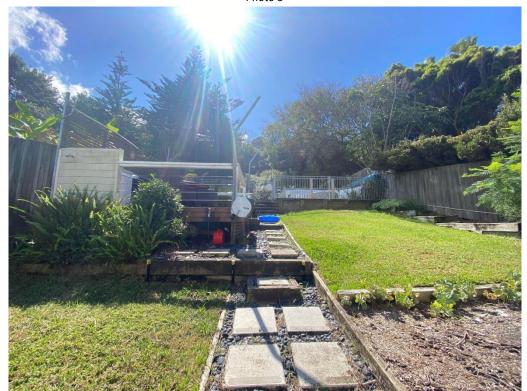
Photo 6

sloping lawn area extends upslope to a stable ~1.0m high timber retaining wall that

supports the fill for a level paved area above (Photo 6). Moderately sloping garden

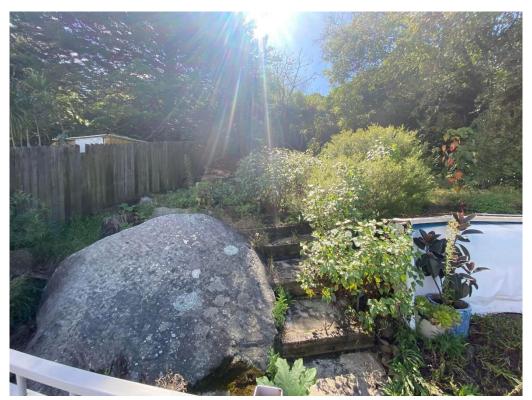
Photo 7

extends above the paved area to a ~3.0m high Sandstone rock face that outcrops and

steps up at the boundary (Photo 7 & 8). This rock face is undercut to ~0.8m but

otherwise shows no significant defects and is considered stable.

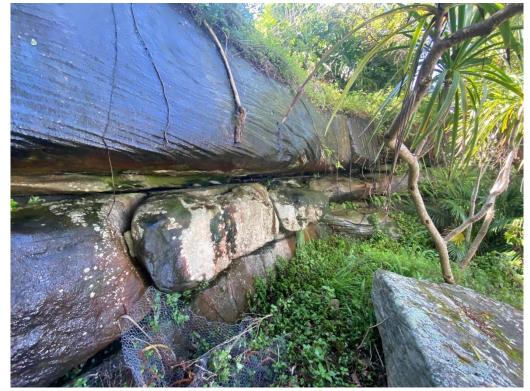
Photo 8

AUGER HOLE 1 (~RL30.0) - AH1 (Photo 8)

No geotechnical hazards were observed beside the property. The moderately graded slope that rises across the property and continues above and below is a potential hazard (Hazard One). The undercut rock face (Photo 8) failing and toppling onto the slope below is a potential hazard (Hazard Two). The vibrations from the proposed excavations are a potential hazard (Hazard Three). The proposed excavations are a potential hazard until retaining structures are in place (Hazard Four). The proposed fill for the lawn area is a potential hazard until retaining walls are in place (Hazard Five).

HAZARDS	Hazard One	Hazard Two		
ТҮРЕ	The moderate slope that rises across the property and continues above and below failing and impacting on the proposed works.	The undercut rock face (Photo 8) failing and causing damage to the property below.		
LIKELIHOOD	'Unlikely' (10 ⁻⁴)	'Rare' (10 ⁻⁵)		
CONSEQUENCES TO PROPERTY	'Medium' (12%)	'Major' (60%)		
RISK TO PROPERTY	'Low' (2 x 10 ⁻⁵)	'Low' (6 x 10 ⁻⁵)		
RISK TO LIFE	8.3 x 10 ⁻⁷ /annum	8.3 x 10 ⁻⁷ /annum		
COMMENTS	This level of risk is 'ACCEPTABLE'.	This level of risk is 'ACCEPTABLE'.
