## **ARBORICULTURAL IMPACT ASSESSMENT REPORT**

**106 Prince Alfred Parade,  
Newport**

**8<sup>th</sup> June 2021**

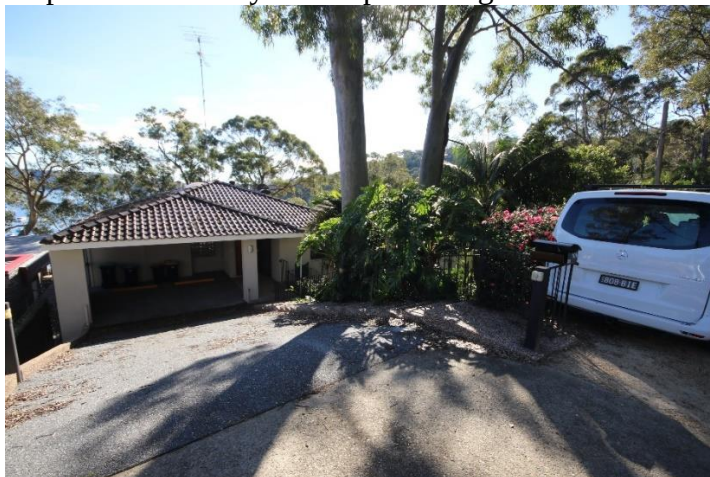
1. Tree 1 & 2 *Corymbia maculata* are showing good condition with an existing suspended driveway and steps leading to the residence – refer plate 1.

Plate 1: Existing driveway and steps within TPZ of trees 1 & 2.

- a. Strip out and demolition of the dwelling will be undertaken with the existing driveway being retained.
- b. Demolish existing driveway & steps. The demolition works shall be undertaken from the garage out towards the street to avoid compaction of the ground around these trees.

- c. Construction of the new driveway on isolated piers. The piers closest to these trees will utilize the existing piers to minimize potential root disturbance – refer Site Survey for existing piers.

Trunk protection shall be installed around Tree 1 & 2 – refer Annexure D.

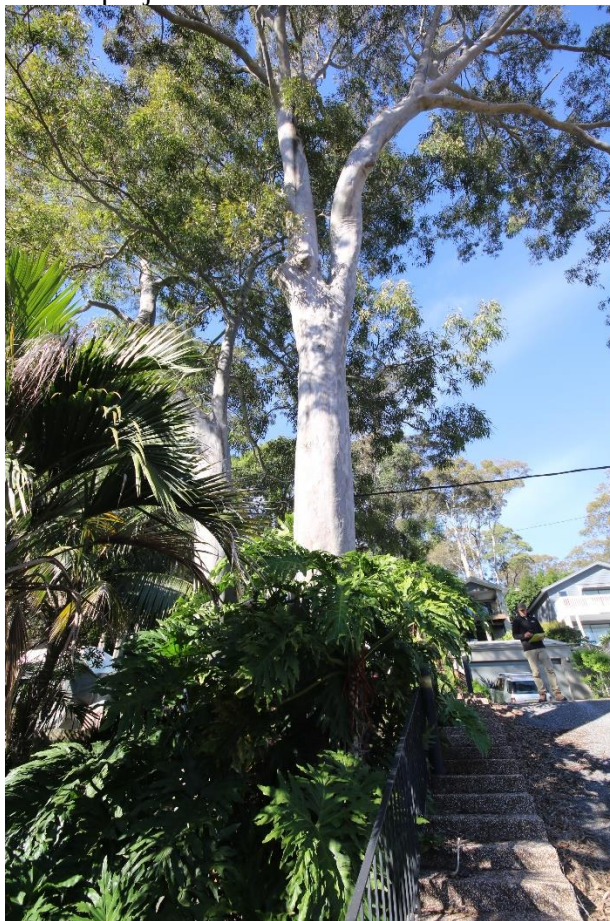
- g. The carport will be constructed over the new driveway with a 500mm clearance from the trunk of Tree 2 – refer plate 2. N.B. No pruning is required.

Plate 2: Trunk of Tree 2.

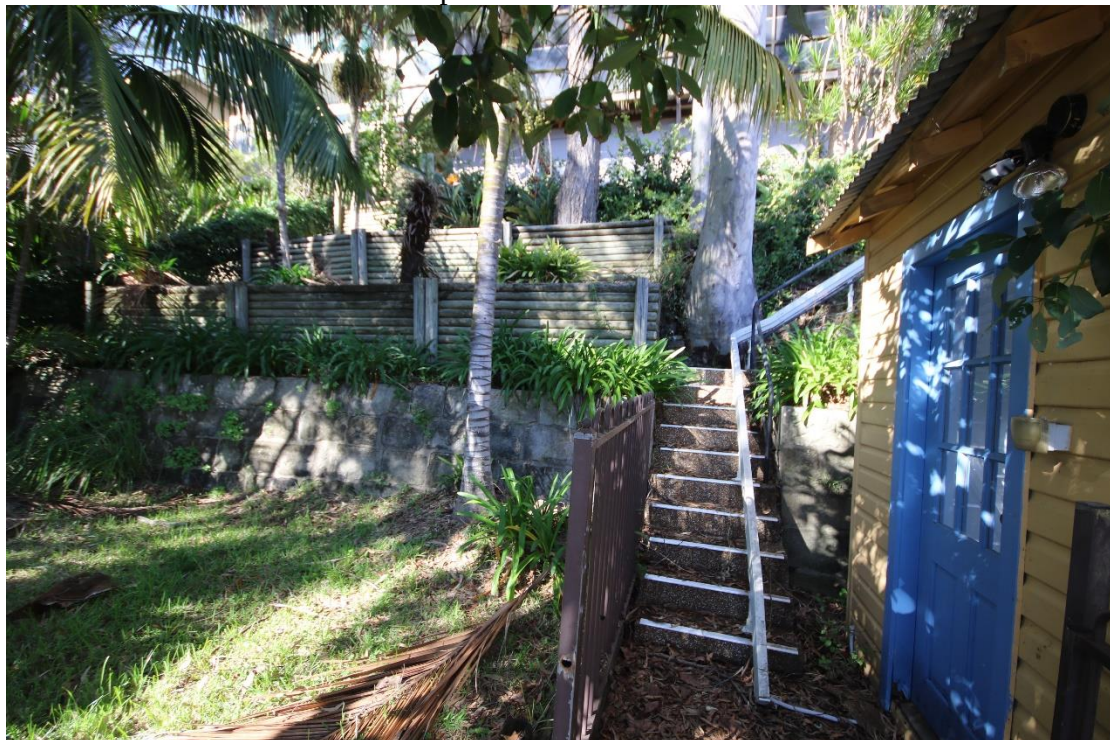
2. Trees 3, 4, 5 *Corymbia maculata* and tree 6 *Eucalyptus paniculata* are showing good condition and are growing in an existing terraced garden beds, using treated pine logs – refer plate 3.

Plate 3: Existing log walls below trees.

It is proposed to care fully replace the treated pine logs with gravity-based blocks that will not require a concrete footing, thus avoiding potential root disturbance.

All of these trees will be retained and protected during the development works with the walls being under the direct supervision of the project arborist.
