| Address of site | <u>179 PLATEAU ROAD BILGOLA PLATEAU</u> |

**RISK ANALYSIS & MANAGEMENT  
FOR  
PROPOSED ALTERATIONS, ADDITIONS AND SECONDARY  
DWELLING  
AT  
179 PLATEAU ROAD BILGOLA PLATEAU**

MQ 30164

25<sup>th</sup> October, 2016

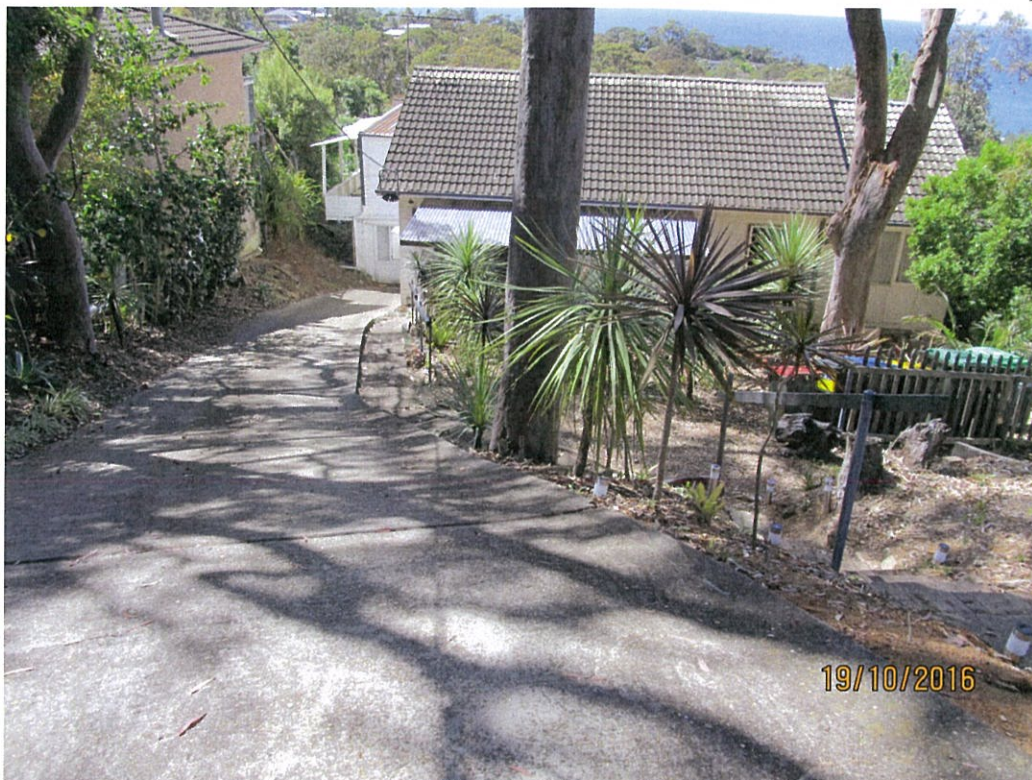
Photo 1

3.3 From the road frontage a short concrete vehicle crossing provides access to a long moderately sloping driveway which terminates in a single vehicle hardstand (Photo 1). Pedestrian access to the residence is via a paved moderately sloping footpath which terminates at the front of the residence (Photo 2). A largely open, terraced garden is located at the front of the block. These terraces are supported by stable non engineered mortared sandstone, brick and masonry structures (Photos 3 & 4). A paved patio area is located in a cut at the front of the house. The cut is supported by a stable well-constructed timber wall (Photo 5). Pedestrian access to the rear of the property is via an access corridor on the southern boundary of the block (Photo 6). A series of terraces are located at the rear of the house (Photo 7). The upper most terrace is supported by a partially dilapidated masonry block wall which shows signs of movement (Photos 8 & 9). At the time of inspection it appeared stable however we recommend that the wall be periodically monitored for further movement or instability. Should further movement be detected, we recommend a structural engineer or licenced builder be consulted to discuss potential remediation works. A small paved patio area is located on the middle terrace which is supported by stable timber soldier pile walls (Photo 10). A small timber deck is located on the lower most terrace which is supported by stable timber piers and a timber soldier pile wall (Photo 7).

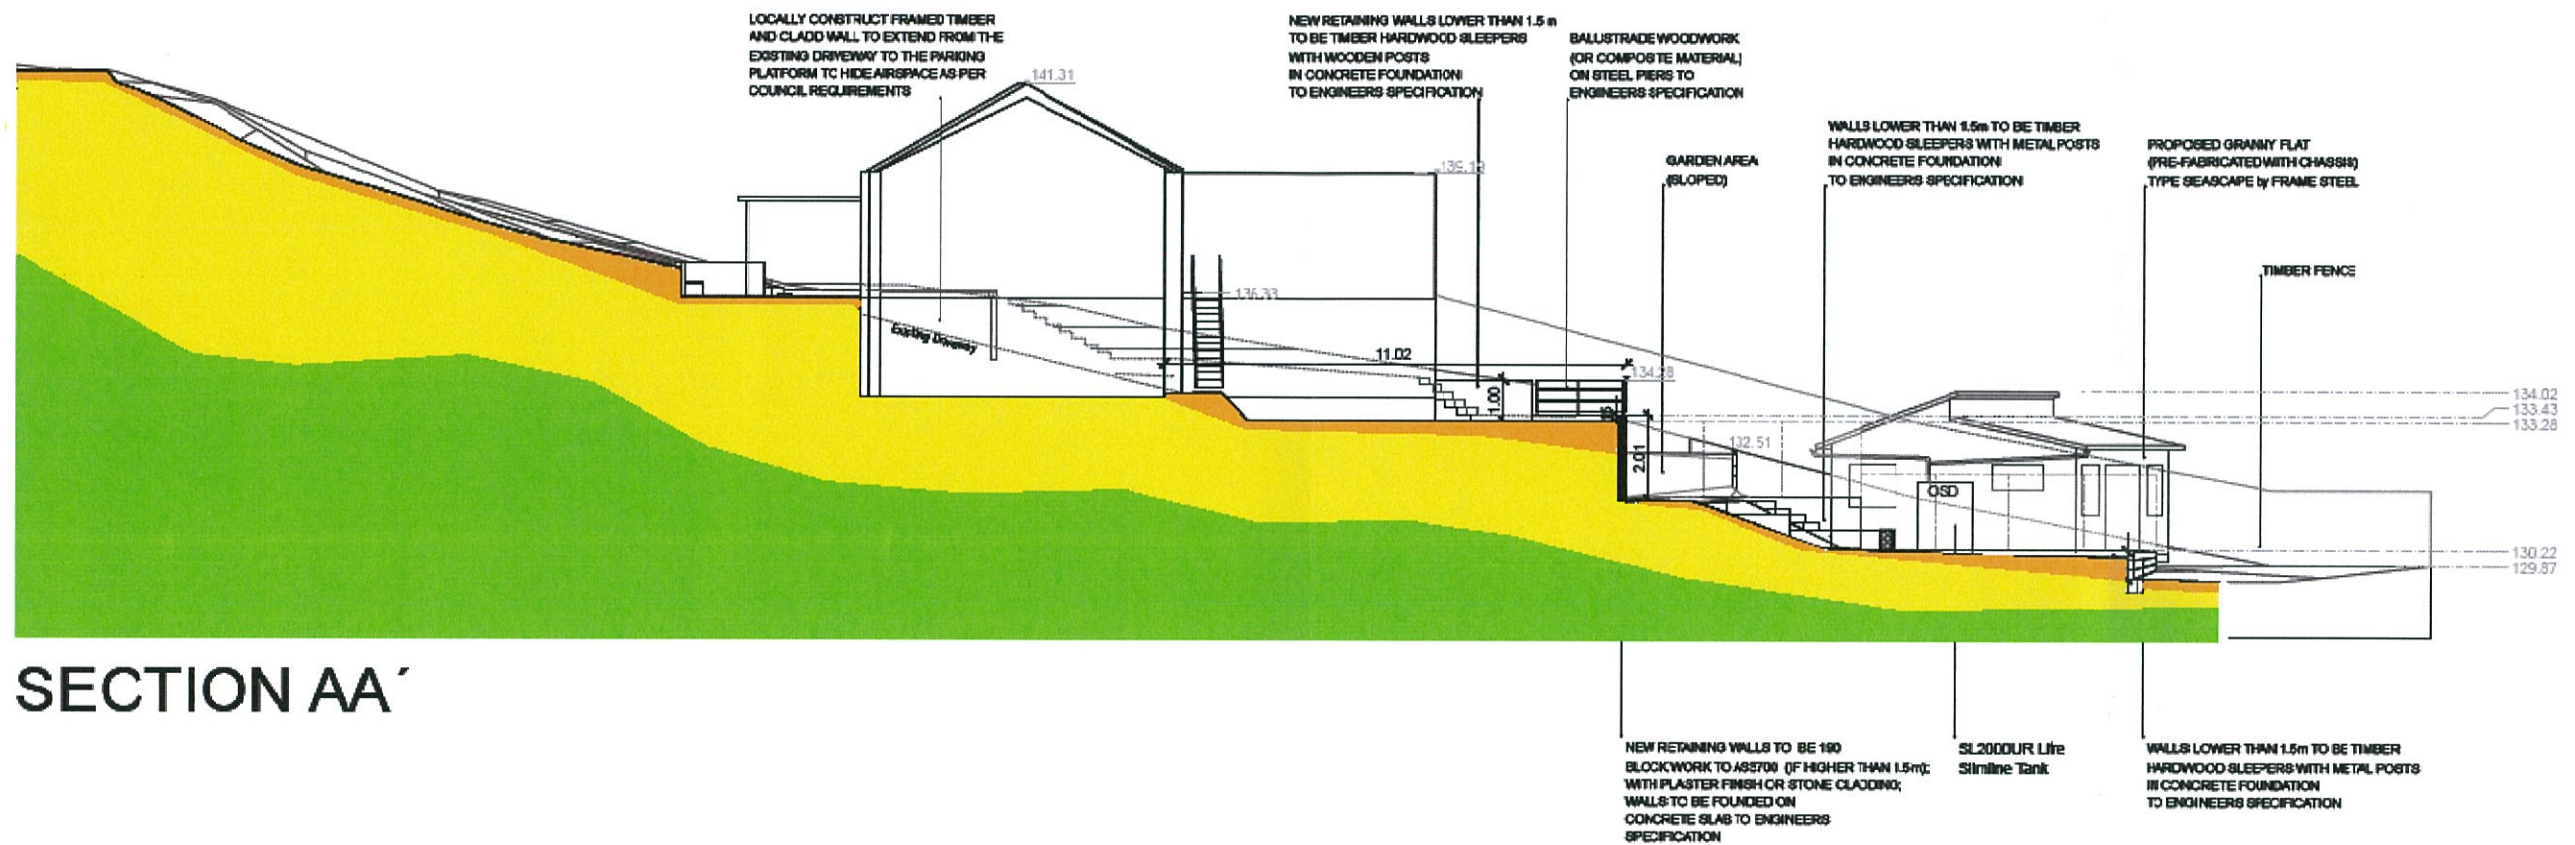
SECTION AA'

**4.2** The slope materials are colluvial at the surface and residual at depth. They consist of sandy loams over sandy clays that merge into the weathered zone of the underlying rocks at depths expected to be in the range of 1.3 to 2.8 metres.
