Project name	Project number	Project date
3 Fazzolari avenue_ mona vale 2025_07_17		17/07/2025

Section No.	US MH	DS MH	Date of inspection	Address/Location	Material	Inspected Length [m]	Pipe Asset ID
1	SPP56061	SPP56047	17/07/2025	3 Fazzolari avenue	Concrete reinforced	53.71	SPI50195

Section Inspection - 17/07/2025 - SPI50195

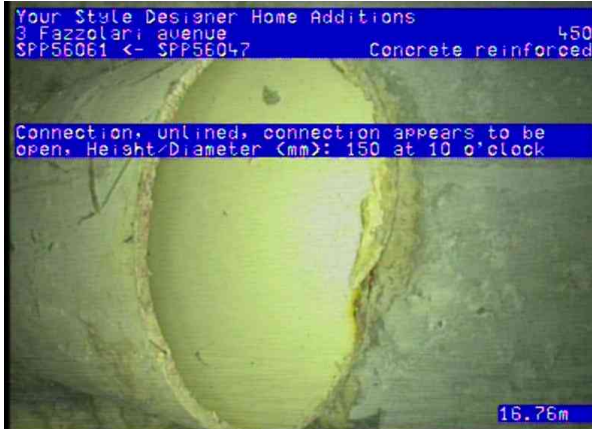
16.76	CNOU	Connection, unlined, connection appears to be open, Height/Diameter (mm): 150 at 10 o'clock	00:05:48	SPI50195_c4b506c8-7b9a-4194

SPI50195_c4b506c8-7b9a-4194-82fb-1adf6b650383_20250717_074417_076.jpg, 00:05:48, 16.76
Connection, unlined, connection appears to be open, Height/Diameter (mm): 150 at 10 o'clock

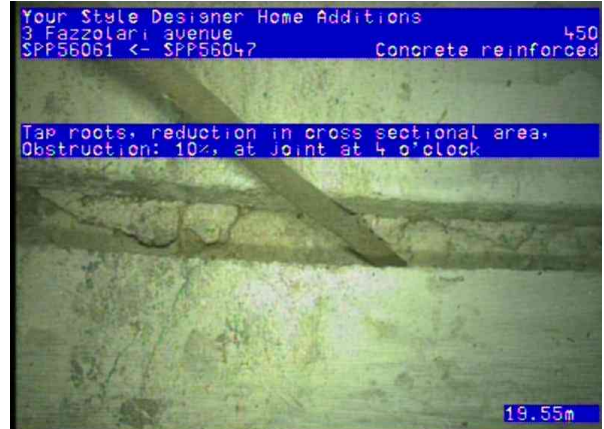
19.55	RT	Tap roots, reduction in cross sectional area, Obstruction: 10%, at joint at 4 o'clock	00:06:56	SPI50195_8f4c3fff-8801-47bd-8	
	21.09	CNOU	Connection, unlined, connection appears to be open, Height/Diameter (mm): 150 at 3 o'clock	00:07:33	SPI50195_c25cf139-651f-40a0-9

SPI50195_8f4c3fff-8801-47bd-8c30-f33521e3bfe9_20250717_074531_593.jpg, 00:06:56, 19.55
Tap roots, reduction in cross sectional area, Obstruction: 10%, at joint at 4 o'clock

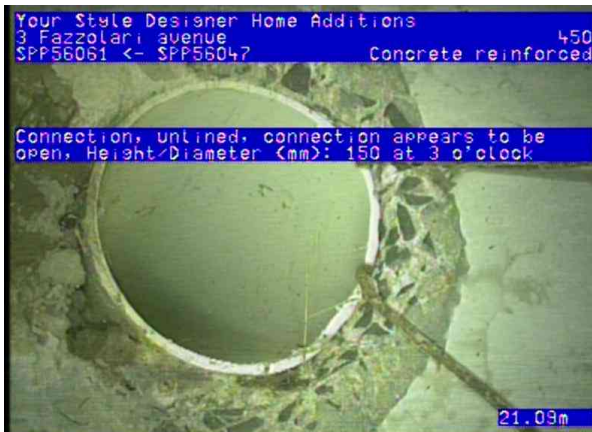
SPI50195_c25cf139-651f-40a0-9c57-ffc22386b16_20250717_074618_146.jpg, 00:07:33, 21.09
Connection, unlined, connection appears to be open, Height/Diameter (mm): 150 at 3 o'clock

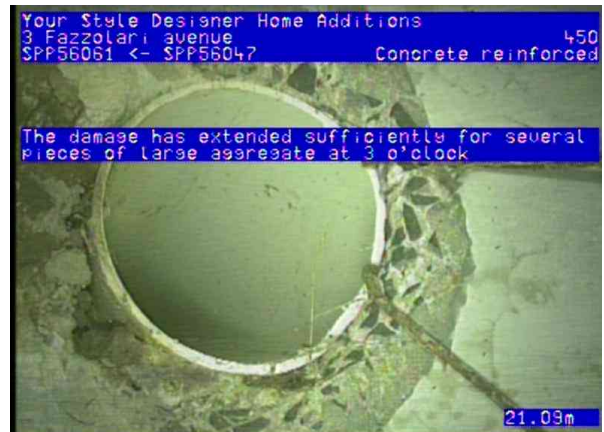
21.09	SCAM	The damage has extended sufficiently for several pieces of large aggregate at 3 o'clock	00:07:38	SPI50195_c70b843b-77fa-43cd-	3
	22.73	CNOU	Connection, unlined, connection appears to be open, Height/Diameter (mm): 150 at 10 o'clock	00:08:33	SPI50195_65d6a7c9-8581-4621

SPI50195_c70b843b-77fa-43cd-9401-9ed1842afa41_20250717_074627_748.jpg, 00:07:38, 21.09
The damage has extended sufficiently for several pieces of large aggregate at 3 o'clock

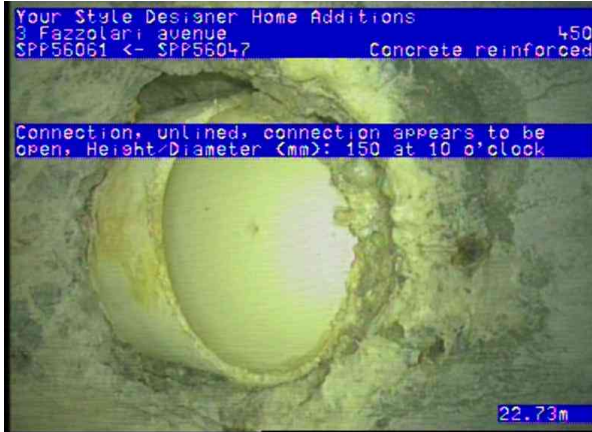
SPI50195_65d6a7c9-8581-4621-866b-a4aafc08ee69_20250717_074728_528.jpg, 00:08:33, 22.73
Connection, unlined, connection appears to be open, Height/Diameter (mm): 150 at 10 o'clock

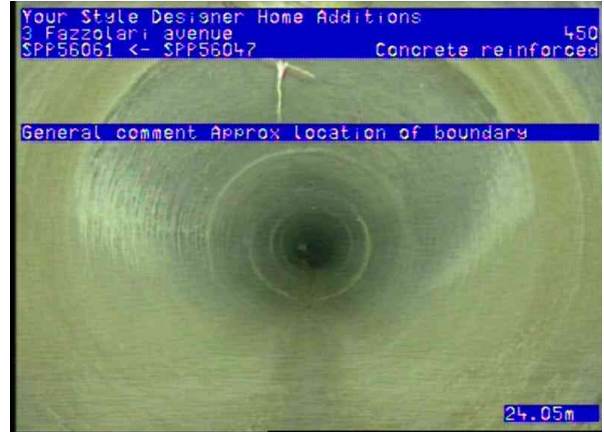
24.05	GC	General comment / Approx location of boundary	00:08:58	SPI50195_beee9a99-f10a-408c-	
	24.74	CNOU	Connection, unlined, connection appears to be open, Height/Diameter (mm): 150 at 12 o'clock	00:09:33	SPI50195_a12b57b7-9d0c-472e

SPI50195_beee9a99-f10a-408c-acf3-afc77d3260c9_20250717_074817_159.jpg, 00:08:58, 24.05
General comment / Approx location of boundary

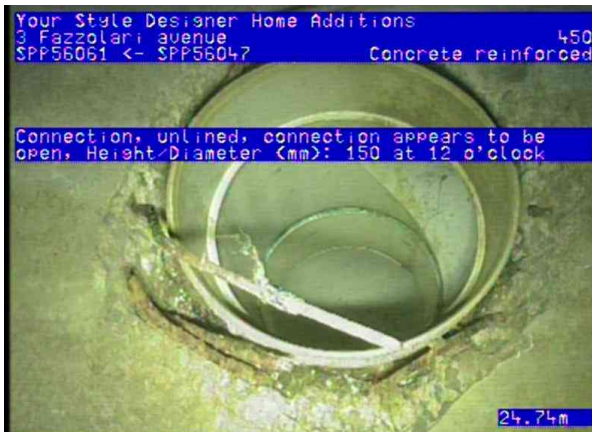
SPI50195_a12b57b7-9d0c-472e-825b-0966ac886c06_20250717_074858_918.jpg, 00:09:33, 24.74
Connection, unlined, connection appears to be open, Height/Diameter (mm): 150 at 12 o'clock

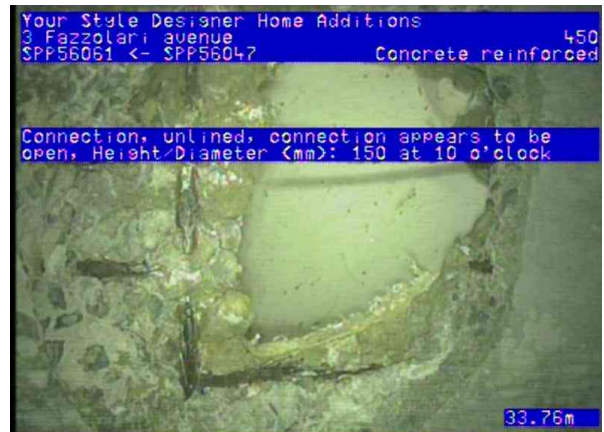
SPI50195_c57dc26f-6edf-4e3e-98ea-b8fa7592980f_20250717_075156_214.jpg, 00:12:24, 33.76
Connection, unlined, connection appears to be open, Height/Diameter (mm): 150 at 10 o'clock

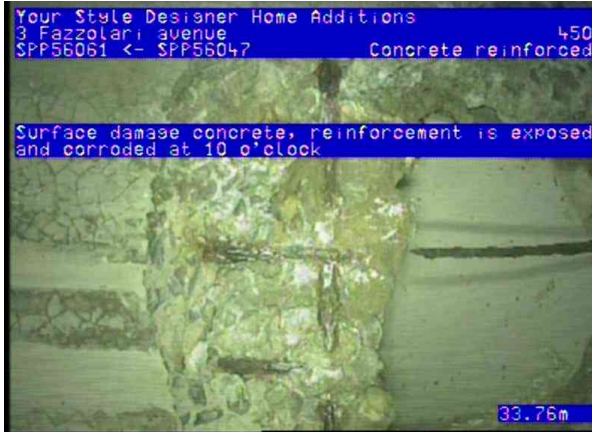
33.76	CNOU	Connection, unlined, connection appears to be open, Height/Diameter (mm): 150 at 10 o'clock	00:12:24	SPI50195_c57dc26f-6edf-4e3e-9	
	33.76	SCRC	Surface damage concrete, reinforcement is exposed and corroded at 10 o'clock	00:12:31	SPI50195_9dd911e3-e750-4b59	3

SPI50195_9dd911e3-e750-4b59-a15a-1e90ae8a19de_20250717_075208_390.jpg, 00:12:31, 33.76
Surface damage concrete, reinforcement is exposed and corroded at 10 o'clock

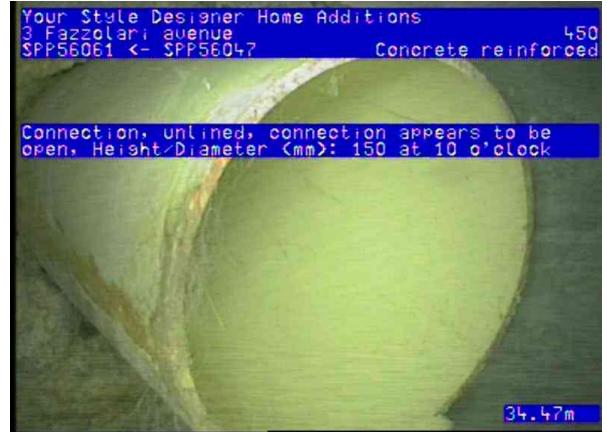
34.47	CNOU	Connection, unlined, connection appears to be open, Height/Diameter (mm): 150 at 10 o'clock	00:13:13	SPI50195_8ea5d1ed-199d-4735	
	41.52	LL	The conduit curves to the left	00:15:15	SPI50195_ee54ead3-a01f-40a8-

SPI50195_8ea5d1ed-199d-4735-98f3-bb28d7dcec5a_20250717_075256_013.jpg, 00:13:13, 34.47
Connection, unlined, connection appears to be open, Height/Diameter (mm): 150 at 10 o'clock

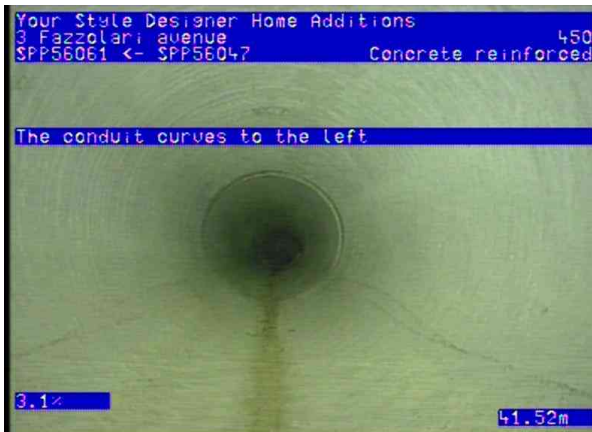
SPI50195_ee54ead3-a01f-40a8-bc6d-e162712ebe54_20250717_075503_204.jpg, 00:15:15, 41.52
The conduit curves to the left

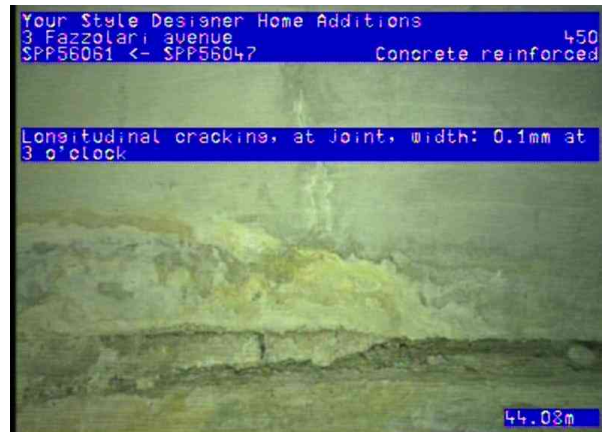
44.08	CL	Longitudinal cracking, at joint, width: 0.1mm at 3 o'clock	00:16:22	SPI50195_6251ddc9-0100-437a	1
	44.08	CL	Longitudinal cracking, at joint, width: 0.1mm at 10 o'clock	00:16:39	SPI50195_2649fa71-106a-47f7-	1

SPI50195_6251ddc9-0100-437a-ad25-351bb763ffa3_20250717_075616_093.jpg, 00:16:22, 44.08
Longitudinal cracking, at joint, width: 0.1mm at 3 o'clock

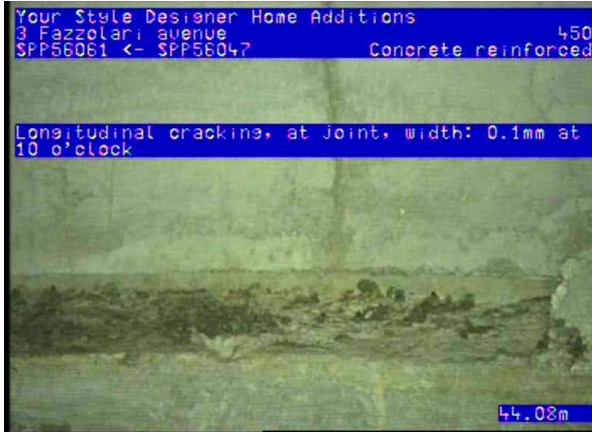
SPI50195_2649fa71-106a-47f7-971c-913f5edb0f2f_20250717_075637_532.jpg, 00:16:39, 44.08
Longitudinal cracking, at joint, width: 0.1mm at 10 o'clock

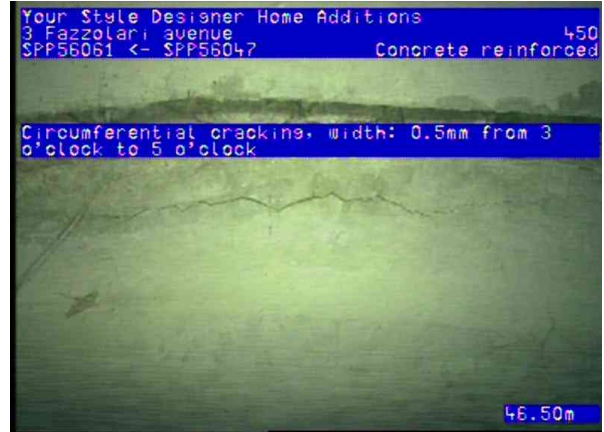
46.50	CC	Circumferential cracking, width: 0.5mm from 3 o'clock to 5 o'clock	00:17:29	SPI50195_95d6b962-df2b-4011-	1

SPI50195_95d6b962-df2b-4011-81a4-0d7730b077f3_20250717_075737_545.jpg, 00:17:29, 46.50
Circumferential cracking, width: 0.5mm from 3 o'clock to 5 o'clock

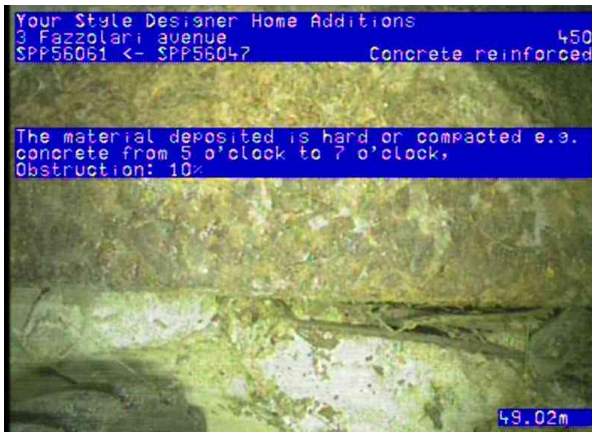
49.02	DEC	The material deposited is hard or compacted e.g. concrete from 5 o'clock to 7 o'clock, Obstruction: 10%	00:18:24	SPI50195_3a4345c3-ecdb-46d9	3
	53.71	FHGJP	Finish node, grated junction pit, Nodename:, SPP56061	00:19:56

SPI50195_3a4345c3-ecdb-46d9-ac8e-912809074003_20250717_075841_976.jpg, 00:18:24, 49.02
The material deposited is hard or compacted e.g. concrete from 5 o'clock to 7 o'clock, Obstruction: 10%
