### **NEW ‘*Amending Development Application*’ Submission**

## ***Construction Impact & Management Statement***

**October 2020**

| <b>Site:</b> | <b>Lot 41 in DP 22361<br/>7 Ruskin Rowe<br/>AVALON BEACH, NSW</b> |

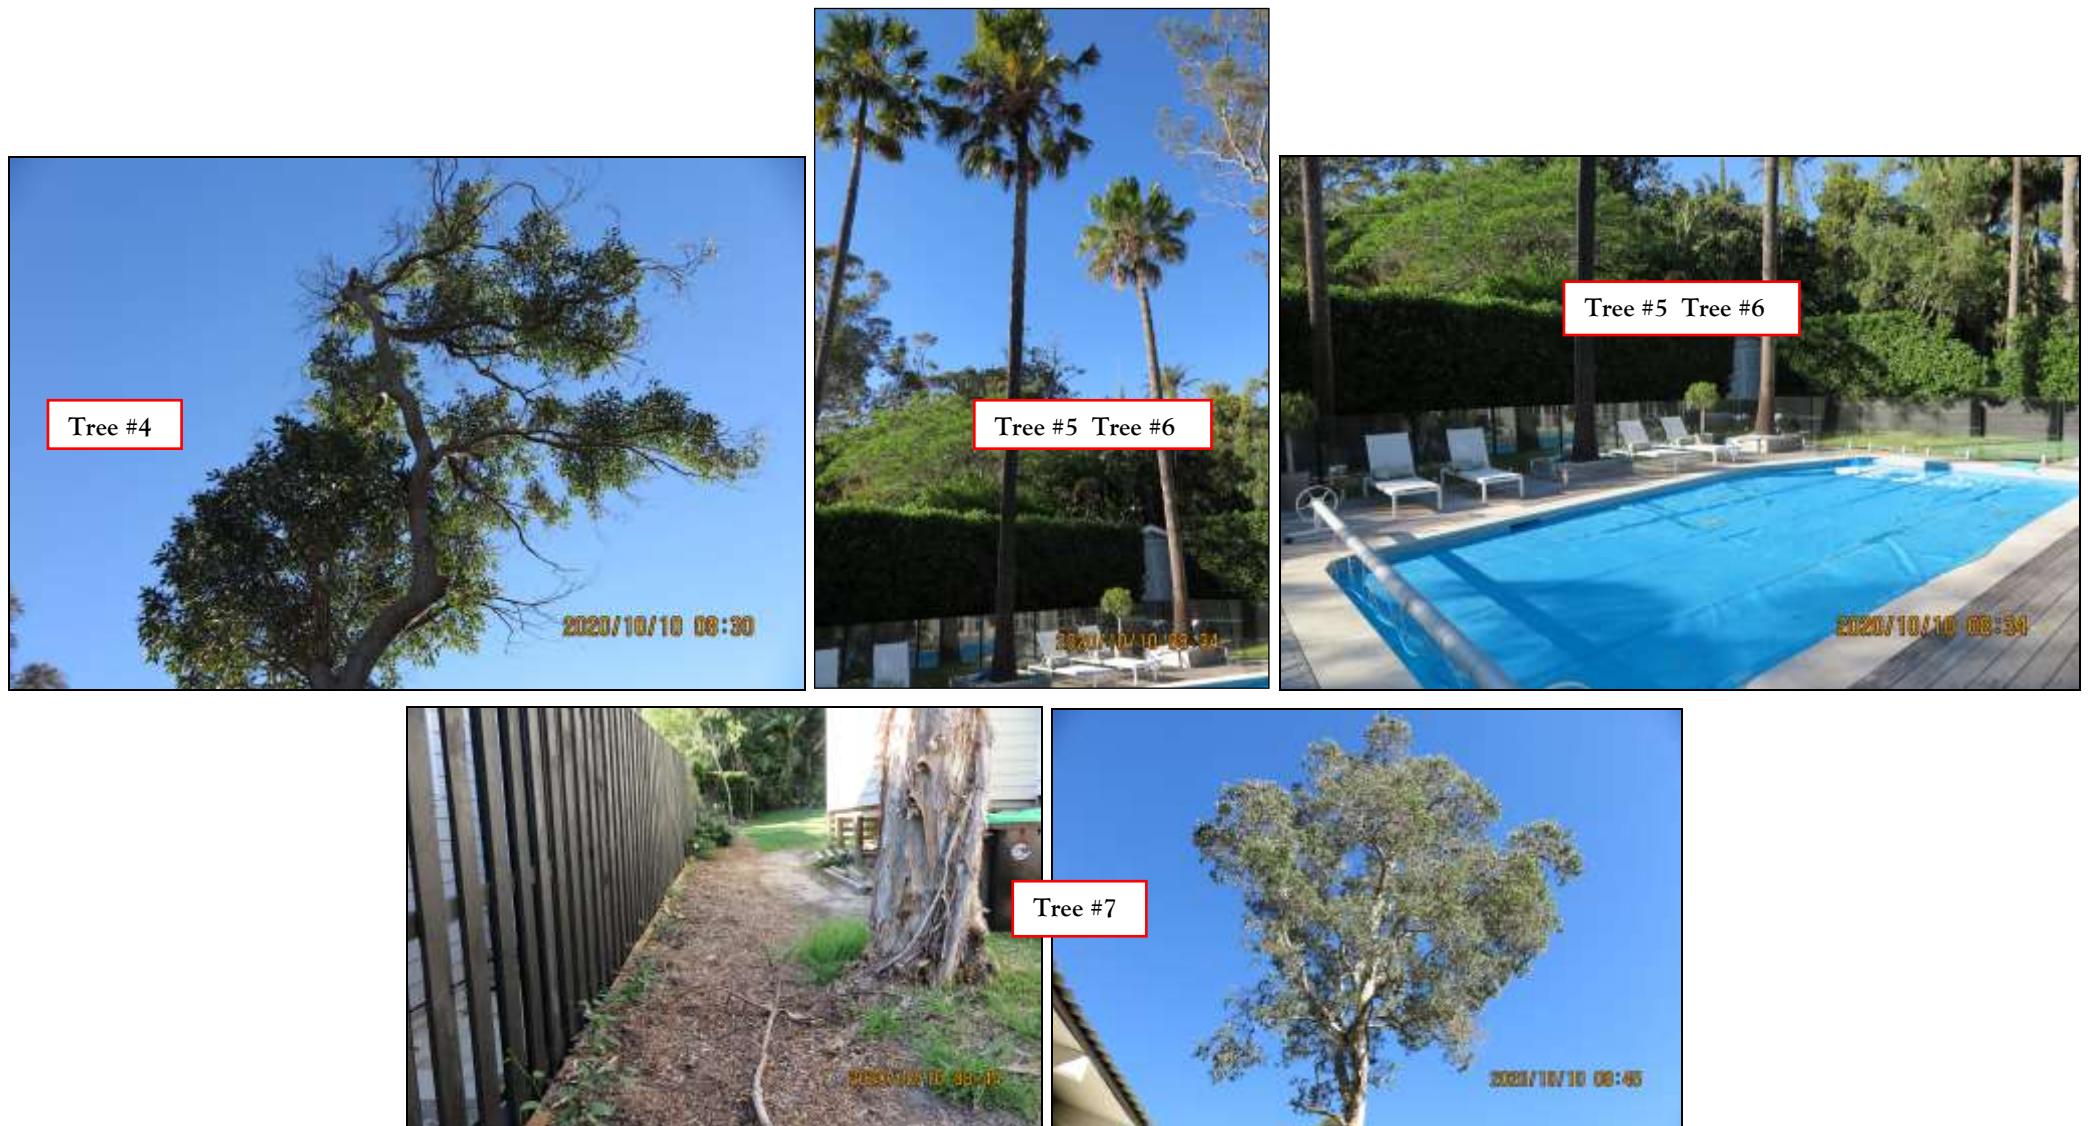
Figure 7; Illustrates tree locations & canopies as viewed from onsite on Saturday, 10 October 2020

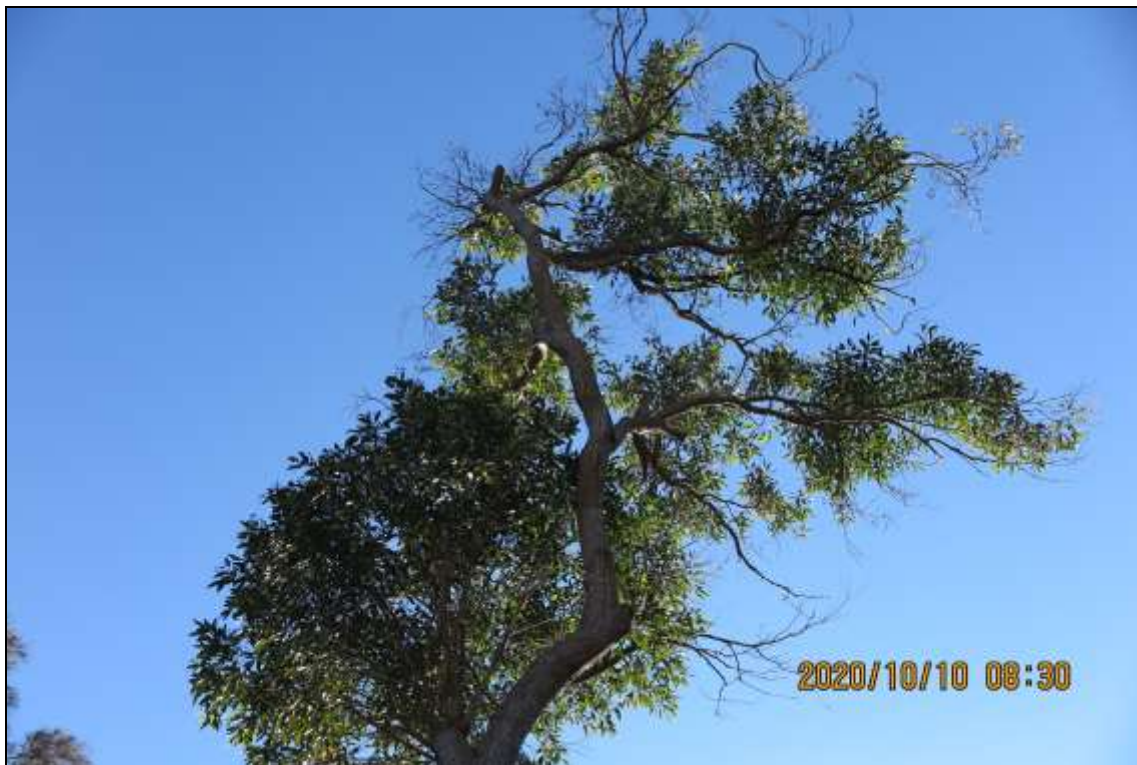
| | Identification | Height (m) | Crown (m) | DBH (m) | TPZ (m) | SRZ (m) | Age | Health/Vigour | Structure | Significance/Retention Values | Comments |
|---|--|---|---|---|---|---|---|---|---|---|---|
| 4 | <i>Eucalyptus paniculata</i><br>Grey Ironbark | <18.00 | <13.50 | 0.57 | 6.84 | 2.81 | Over Mature | Poor & Poor | Atypical | High/Low | Replace:<br>Tree displays advanced 'symptoms of stress' & 'decline'. Canopy is almost totally 'epicormic'. Tree has been previously subjected to significant 'change of environment', hence its poor condition. |

Tree #4 is a NBC Tree Management' provisions protected tree (in fact locally indigenous), but is supported to be replaced on the grounds of declining health & vigour, likely most attributable to previous owners 'change of environment within both its TPZ (Tree Protection Zone) & SRZ (Structural Root Zone) calculated radial distances. Tree #4 is supported to be replaced by at least one (1) same species new tree/s in a more suitable location with the potential of replicating/improving the high level of amenity it previously provided as a healthy/vigorous individual. See below photograph confirming very significant 'branch tip dieback', interpreted to be an indicator or 'live root dysfunction' & nearly 100% 'epicormic shoot' by origin foliage.

Figure 8: Confirms discussed Tree #4 declining health & vigour. Especially note, the number of dead/dying 'branch tips'.

| TREE # & IDENTIFICATION | RETAIN<br>MANAGE<br>PROTECT/<br>REPLACE | MANUAL<br>EXCAVATION<br>(for<br>footings/piers/s<br>ervices) | CANOPY<br>PRUNING | Install TPZ<br>Fencing<br>Install Tree<br>Trunk<br>Guard | Excavation<br>Signoff | CC<br>Signoff | OC<br>Signoff |
|--|---|--|---|--|---|---|---|
| 4<br><i>Eucalyptus<br/>paniculata</i> | Replace | No | No | No | No | No | No |
