15 July 2024  
GG070-24\_GA

**Groundzero Geo Pty Ltd**  
PO Box 593, KOGARAH, NSW 1485

## **Geotechnical Assessment Report** **46A York Terrace, Bilgola Plateau, NSW 2107**

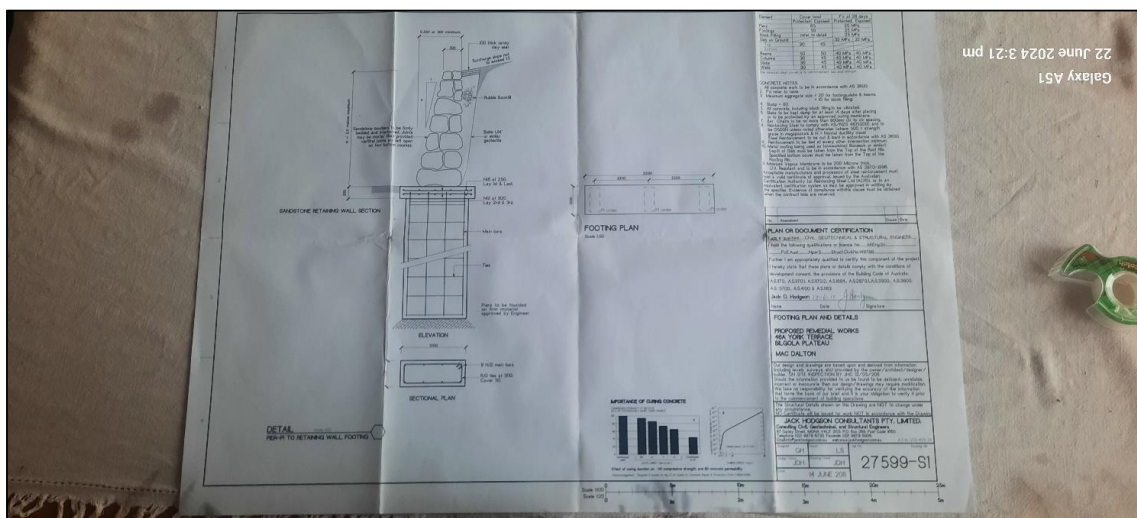
**Plate 1:** A snapshot of Footing Plan and Details, No. 27599-S1.

- A review of the above-mentioned footing plan revealed that the following recommendation was provided for piers supporting the sandstone retaining wall:

**“Piers to be founded on firm material approved by Engineer”.**

- It is to be noted that the piers meant to support a retaining wall, constructed over a very steep slope, were not recommended to be founded and embedded into bedrock of at least Low to Medium strength, to provide sufficient lateral support against sliding over a very steeply dipping slope face.
- Also, no allowable bearing capacity was recommended for “Firm” material.

- **Inspection of Existing Footings** – In view of a recommendation for supporting the sandstone retaining wall stating, "**Piers to be founded on firm material approved by Engineer**", provided on the Footing Plan and Details for Proposed Remedial Works, 46A York terrace, Bilgola Plateau, prepared and certified by Jack Hodgson Consultants Pty Ltd, Consulting Civil, Geotechnical and Structural Engineers, Job No.: 27599, Drawing No.: S1, Dated: 14 June 2011, the pier/column/strip footings supporting the existing building structures on the site are suspected to be founded at shallow depths into colluvium/fill soils, and not into the underlying bedrock for their stability against sliding. Therefore, it is strongly recommended that all the existing pier/column footings supporting the intact raised timber deck (at the upper level) and the Upper and

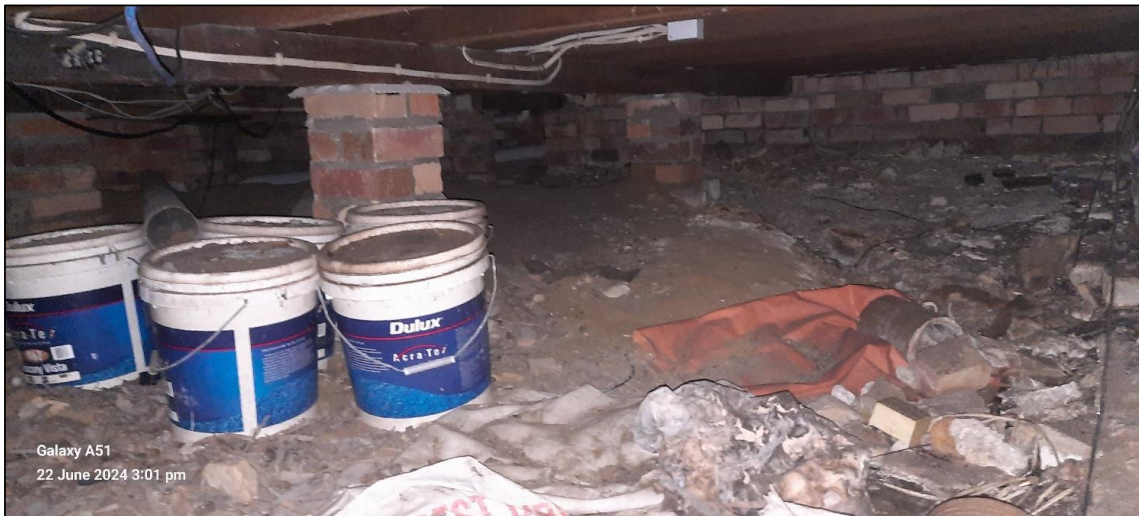
- As observed within the subfloor cavity, the upper floor level is supported by mortared brick strip and column footings, as shown below in **Plate 13**. The founding conditions of those footing could not be observed during this inspection. Also, the subfloor area at the upper floor level did not appear to be well drained.

**Plate 13:** Strip and column footings supporting the upper floor level, looking south.

- The founding conditions of the mortared brick strip and column footings which support the existing building structure at the upper floor level, could not be inspected due to the access issue into the subfloor cavity. Also, the subfloor area at the upper floor level did not appear to be well drained. Although, the footings supporting the upper floor level were founded over a terraced/levelled area excavated into the hill slope (away from the crest of the slope), yet the in-situ ground conditions at the founding level of those footings need to be inspected to verify their bearing capacity and the in-situ nature of the founding strata.

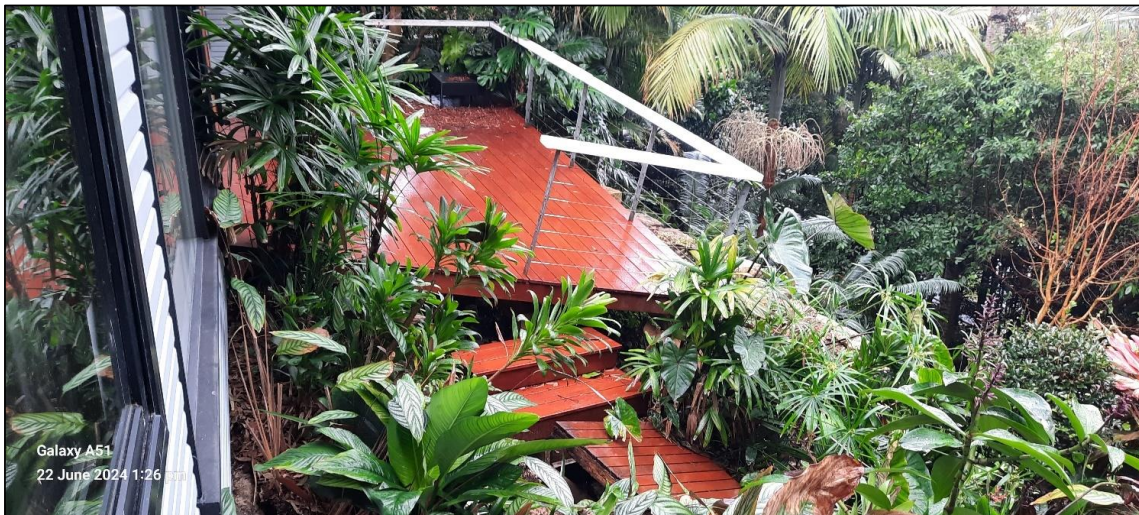
- As observed from inside of the LGF level, the timber deck and the timber pathways located within the densely vegetated, lower half of the site, have been completely damaged by the landslide, as shown below in **Plates 14 and 15**.

**Plate 14:** Timber deck (northern half) and pathway destroyed by landslide, looking north.

- **Removal of Damaged Timber Deck/Pathway** – Since the timber post footings and the concrete piers supporting the raised timber deck, along with the stone retaining wall are completely damaged and the raised timber deck and the associated timber pathways are significantly displaced over the slope, it is recommended that the existing timber deck and pathways should be dismantled and removed to prevent their further sliding downslope.

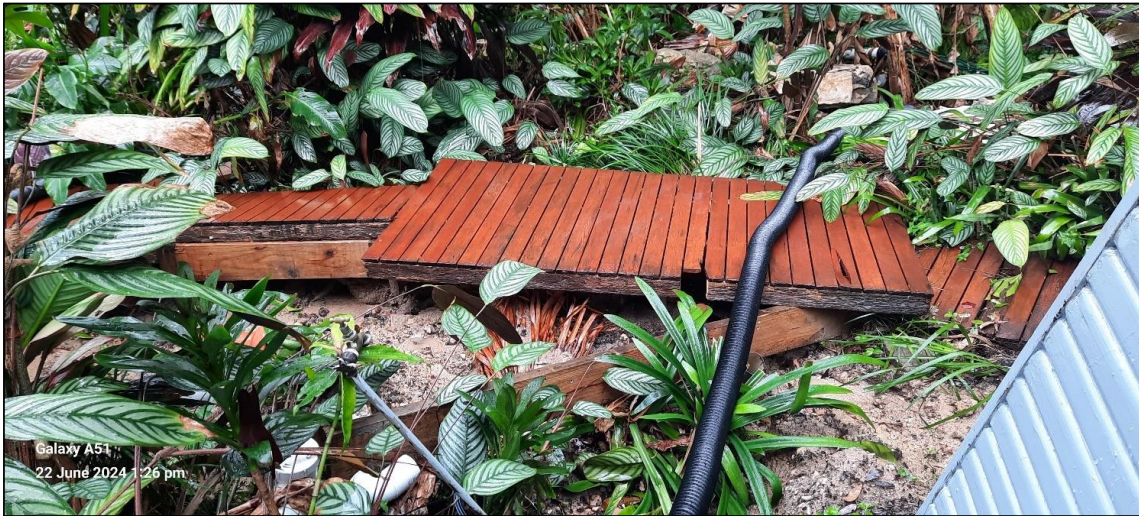
**Plate 15:** Timber pathway (southern half) destroyed by landslide, looking east.

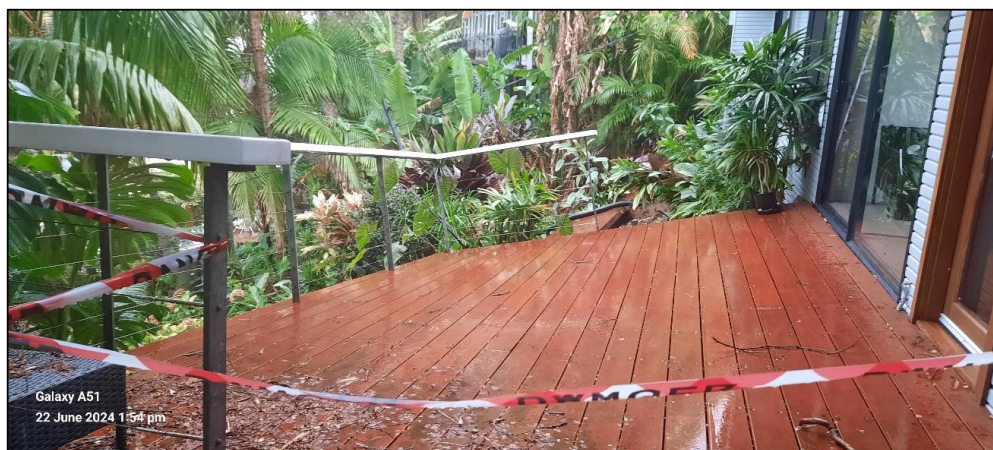
**Plate 19:** Displaced timber deck at LGF level, looking south.

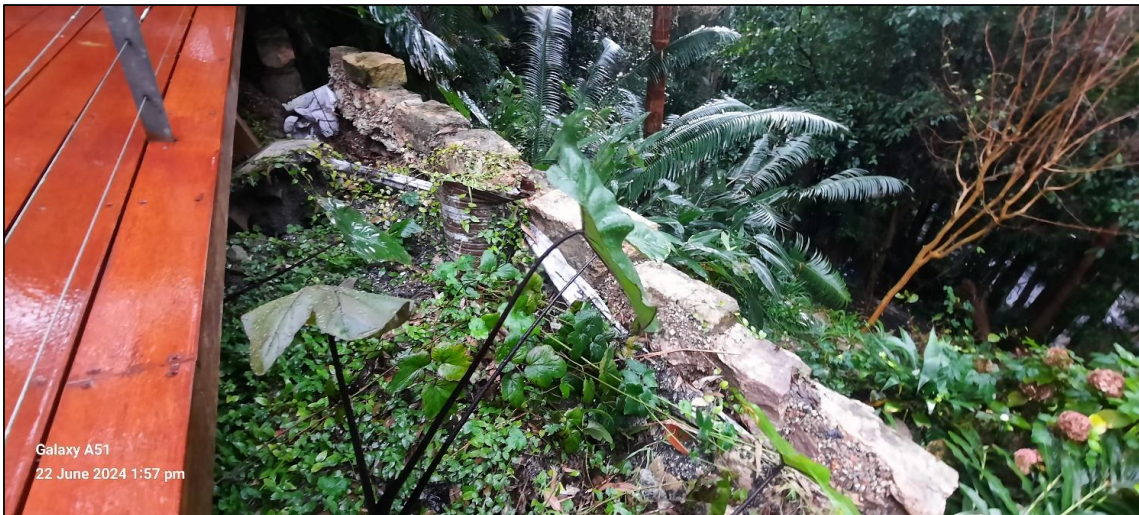
- The mortared stone wall located immediately adjacent to the eastern edge of the timber deck at LGF, retaining the colluvial soils resting over the very steep slope, underneath the deck where timber post footings were supported by the concrete piles founded in colluvial soils, was completely damaged by the landslide, as shown below in **Plates 23 and 24**.

**Plate 23:** Completely failed stone wall, adjacent to eastern edge of timber deck at LGF level, looking north.

- The completely failed mortared stone wall located immediately adjacent to the eastern edge of the timber deck at LGF, that retained the colluvial soils resting over a very steep slope, underneath the deck where timber post footings were supported by the concrete piles founded in colluvium, appeared to be of non-engineered design and constructed without any drainage measures to prevent pore pressure build up within the colluvium being retained by this wall. **If the retaining wall had been designed adequately against sliding and overturning and designed as drained with measures provided for complete and permanent drainage to prevent pore pressure build up behind the wall then this wall would not have failed, therefore the principal cause of retaining wall failure is the defective retaining wall design.**

- It is interpreted that surface water ingress due to uncontrolled surface water flows within the colluvium resting over a very steep slope, caused a significant pore pressure build-up within the colluvial soils (and increase in lateral loads) due to the non-existent drainage measures behind/through the retaining wall which resulted in complete failure of the retaining wall and the raised timber deck at LGF level.

- LS-MS sandstone bedrock is considered suitable for an allowable bearing pressure of 1200kPa.
- **Construction of New Retaining Walls** – The new retaining walls must be designed by a qualified Structural Engineer and are recommended to be steel reinforced concrete wall constructed in accordance with Australian Standard AS 4678-2002 Earth Retaining Structures. The new retaining walls must be founded/doweled into the underlying bedrock for their long-term stability against sliding and overturning and designed as drained and measures are to be taken to provide complete and permanent drainage to prevent pore pressure build up behind the walls.

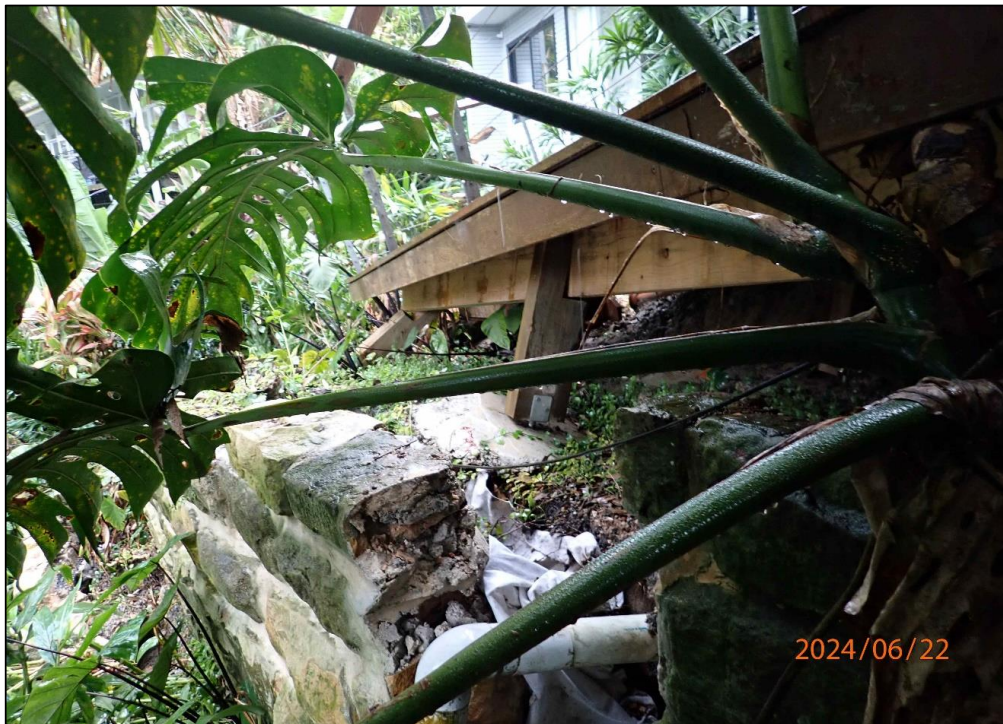
**Plate 24:** Timber post footings supported by concrete piles founded in colluvial soils, looking north.

- **Removal of Colluvium from Eastern Slope** – The damaged timber deck and the colluvial soils along with the damaged concrete pier footings resting over the eastern slope located adjacent to the eastern edge of the LGF level and underneath the damaged timber deck are being impacted by creeping movement within the colluvial soils, which is further aided by persistent surface runoff over the slope. The colluvium resting over the underlying sandstone bedrock could slide down due to uncontrolled stormwater flows over the slope face. Therefore, it needs to be removed as a first step to ensure safety of the workers and any plant and equipment to carry out ground preparation works to implement the required slope stabilisation measures over the eastern slope face.

- It is recommended that all new/replaced pier footings to support the existing site house (Upper and Lower Ground Floor Levels), along with the intact raised timber deck at the upper floor level and the new raised timber deck (at LGF level) must be socketed at least 0.50m into Low Strength (LS) to Medium Strength (MS) sandstone bedrock to provide sufficient lateral support against sliding over a very steeply dipping slope face.

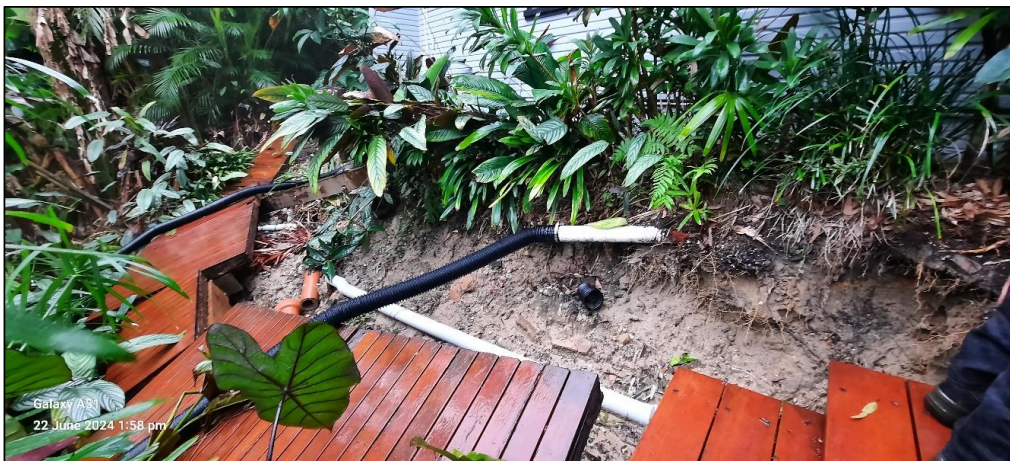
- As per onsite discussion with owner of the property, a localised landslide failure from an unprotected colluvial slope (located immediately adjacent to the eastern edge of LGF level) occurred in the month of April 2024, during a heavy rain event which completely damaged the timber deck at the LGF level and the stone retaining wall, and the sliding debris, uprooted trees and cobbles got piled over the eastern slope face. As observed over the exposed sections of the scarred, very steeply dipping eastern slope face, the cover of colluvial soils appeared to be  $\geq 3.00\text{m}$  thick which was overly saturated due to surface runoff ingress and fully penetrated by vegetation roots, underlain by weathered sandstone bedrock. Some loose boulders and pockets of colluvial soils can be seen perched precariously over the scarred slope which may slide down without any warning during wet weather conditions, as shown below in **Plates 25 and 26**.

**Plate 25:** Landslide extending to the eastern edge of LGF level, looking west.

- Also, the presence of several shallow rooted trees and dense vegetation over the slope face is considered to be a significant factor to cause sliding of the cover of colluvial soils resting over a very steeply dipping slope, after saturation of the colluvium.

- Removal of the topsoil, vegetation, colluvium and scaling of any loose boulders resting over the slope should be carried out to expose the underlying, in-situ sandstone bedrock.

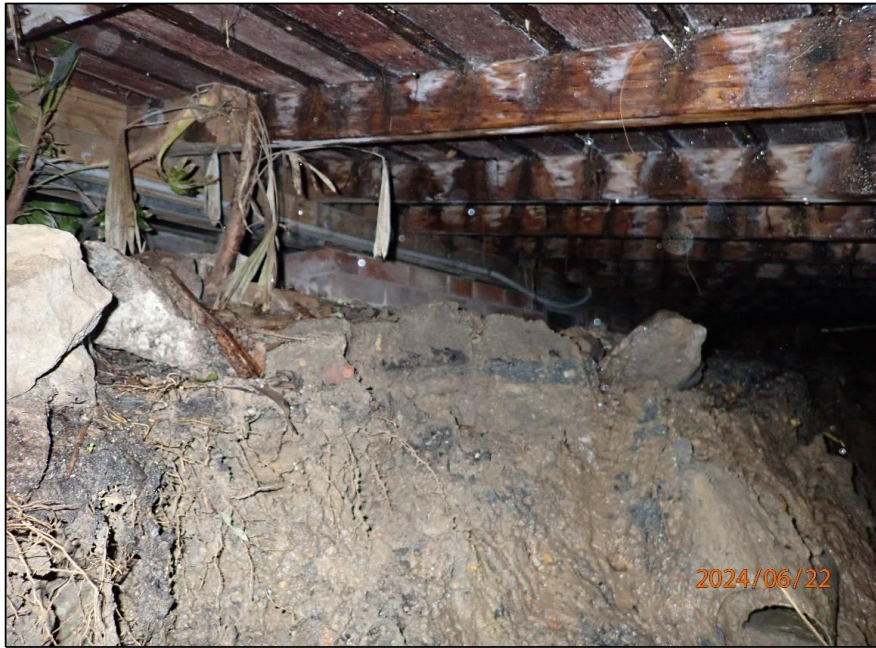
**Plate 26:** Saturated colluvium and boulders exposed underneath timber deck at LGF level, looking north-east.

- The saturated colluvium containing some loose boulders, lying over sections of the very steeply east dipping slope face after a localised landslide causing sliding of the colluvial soils triggered by heavy rain events (which completely damaged the timber deck and stone retaining wall at LGF level), is susceptible to erosion caused by uncontrolled stormwater water flows and at high risk of sliding as it is resting over a very steep slope face, further aided by root growth of vegetation over the slope.

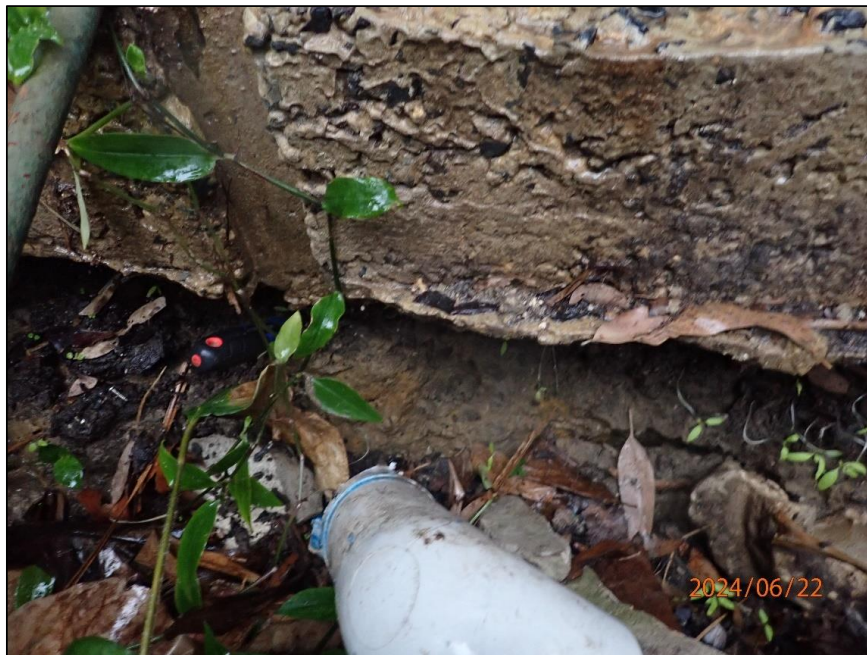
- Since the landslide extended to the eastern edge of the LGF level i.e. the existing building structure was located within the zone of influence of the landslide, therefore the conditions of the existing footings supporting the LGF level were inspected which were discovered to be undermined, founded on colluvium and contained significant cracks extending along mortared brick joint, as shown below in **Plates 27 to 29**.

**Plate 27:** Undermined concrete pad of brick strip footing supporting LGF level, looking north-west.

- **As the landslide extended right up to the eastern edge of the LGF level, meaning that the existing building structure was located within the Zone of Influence of the landslide. Also, the existing footings supporting the building structure at LGF level were found to be undermined, founded on colluvium and contained open cracks extending along mortared brick joints (as shown above in Plates 27 to 29). Therefore, the existing site house is considered 'Unsafe' for occupancy, until the remedial measures recommended below in Section 5, are fully implemented.**

- **Temporary Underpinning of LGF Level** – Temporary steel props are recommended to be installed adjacent to all those brick column and strip wall footings supporting the LGF level building structure which appear to be undermined/founded on colluvium and contained open cracks. These steel props are meant to support the overlying building structures on a temporary basis, until the permanent support measures are installed.

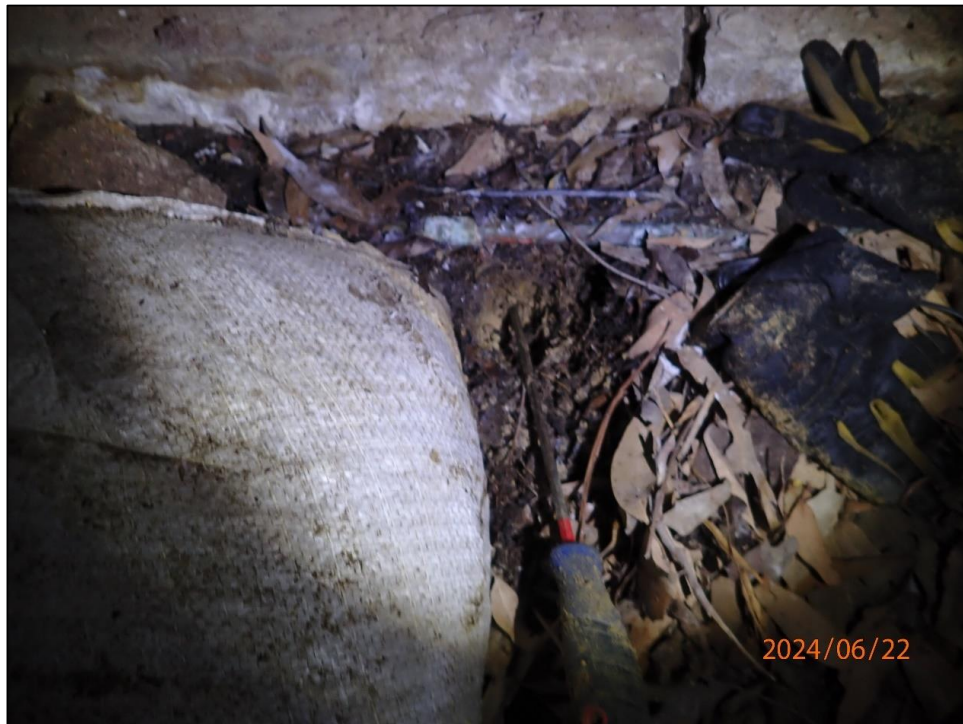
**Plate 28:** Concrete pad of brick strip footing founded on colluvium, looking west.

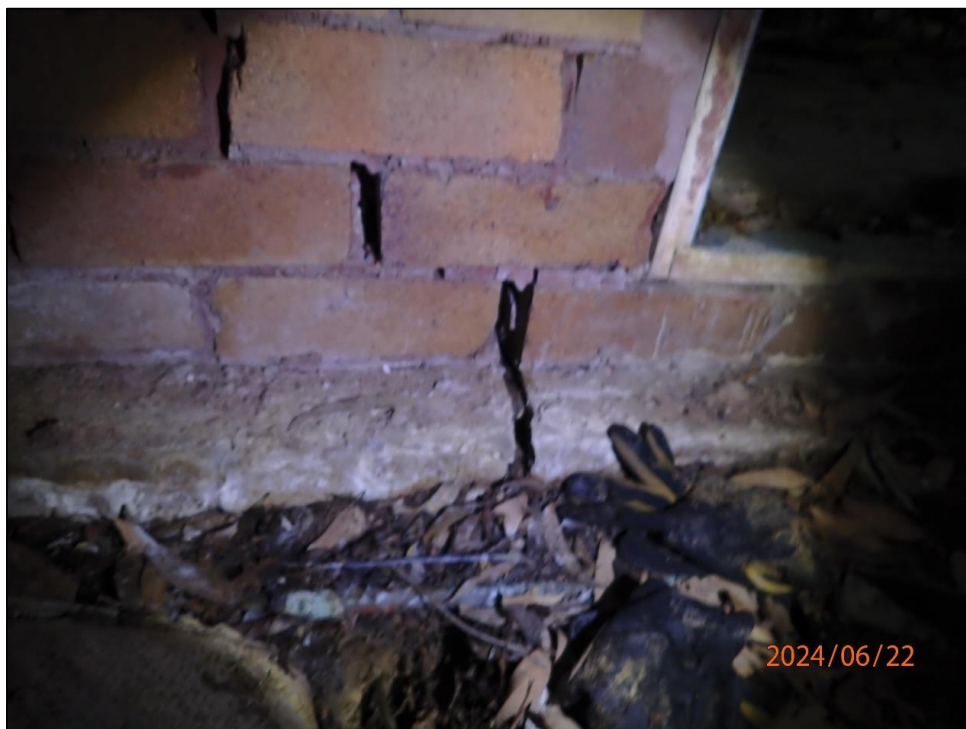
**Plate 29:** Cracks within brick strip footing, looking west

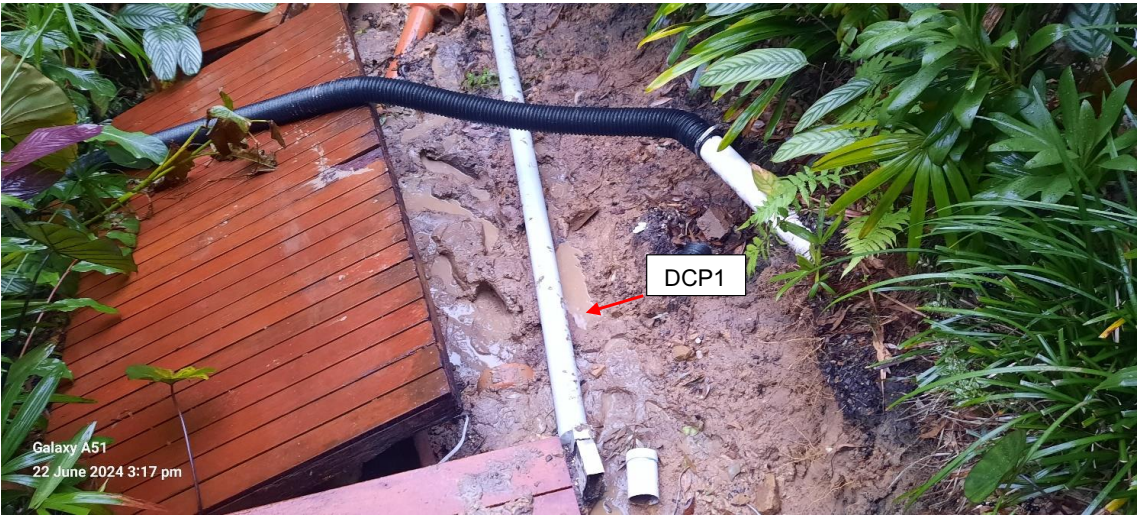
| Test No. | Location | Termination Depth<br>(m, BEGL) | Comments |
|---|---|---|---|
| DCP1 | East of LGF level at mid-slope level | 2.92 | Refusal on interpreted VLS bedrock |

**Plate 30:** DCP1 test location, southern corner of concrete block, looking north-east.

- **Based on DCP testing adjacent to the damaged timber deck and the retaining wall located over the slope at LGF level, the depth to a minimum of Very Low Strength (VLS) sandstone bedrock is inferred to be encountered at a depth of approximately 2.92m (DCP1) below the existing ground surface, adjacent to the eastern edge of the LGF level. This VLS bedrock is expected to grade quickly to Low Strength (LS) to Medium Strength (MS) bedrock which is outcropping within the site area.**
