Report Title: Geotechnical Report 73 Dolphin Crescent, Avalon

Report Date: 3/5/23

## **GEOTECHNICAL INVESTIGATION:**

Alterations and Additions at **73 Dolphin Crescent, Avalon**

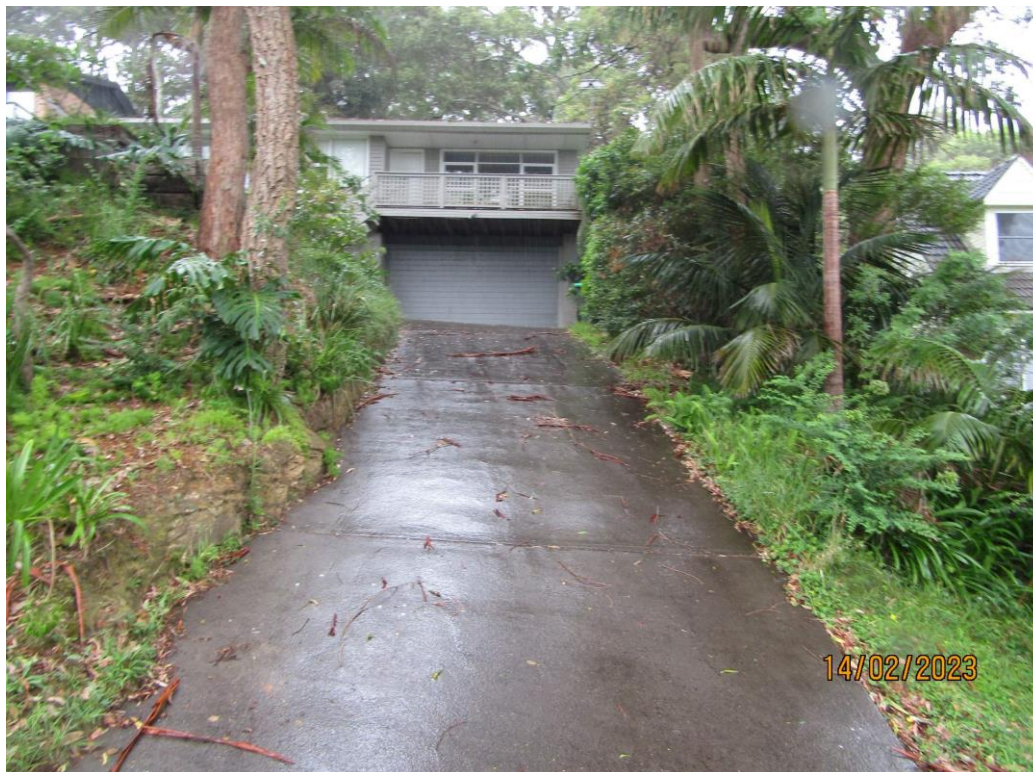
Photo 1

- 2.3** At the road frontage, a concrete driveway runs up the slope to a garage below the house (Photo 1). A stable low unsupported cut and fill provides a level platform for the driveway. Fill provides a level platform for a lawn and garden area on the downhill side of the house (Photo 2). The fill is supported by a timber retaining wall up to ~1.0m high (Photo 3). The timber wall displays some rotting but appears to be currently stable. The single storey brick and timber clad house with garage below is supported on brick walls and piers (Photos 4 & 5). The supporting walls and piers stand

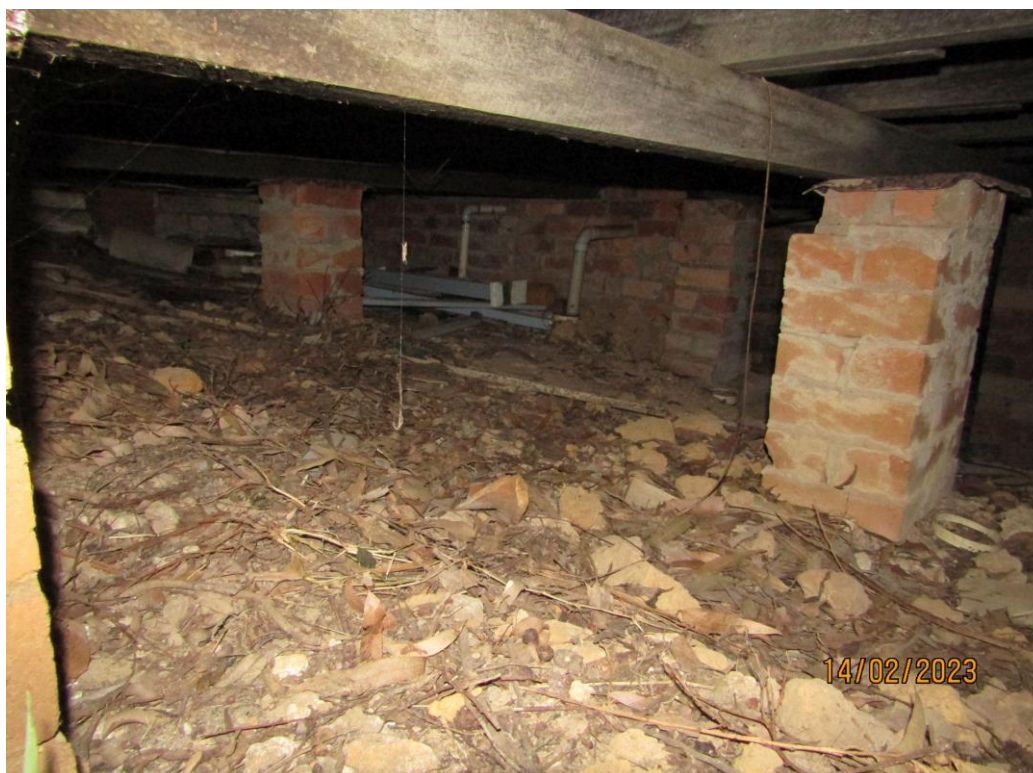
Photo 6

vertical and show no significant signs of movement (Photo 6). A stable concrete block retaining wall up to ~2.0m high along the W common boundary supports fill on the W neighbouring property (Photo 7). A timber deck and paved area extends off the uphill side of the house (Photo 5). Two timber retaining walls ~0.8m high each (maximum combined height of ~1.6m) support a cut for the deck and paved area (Photo 8). The lower and upper walls are tilting at up to ~11° and ~4° downslope respectively. See 'Section 13 Ongoing Maintenance'. A moderately sloping lawn and garden area extends from the uphill side of the retaining walls to the uphill property boundary (Photo 9). Apart from the tilting retaining walls (Photo 8), no signs of slope instability were observed on the property. The adjoining neighbouring properties were observed to be in good order as seen from the street and subject property.

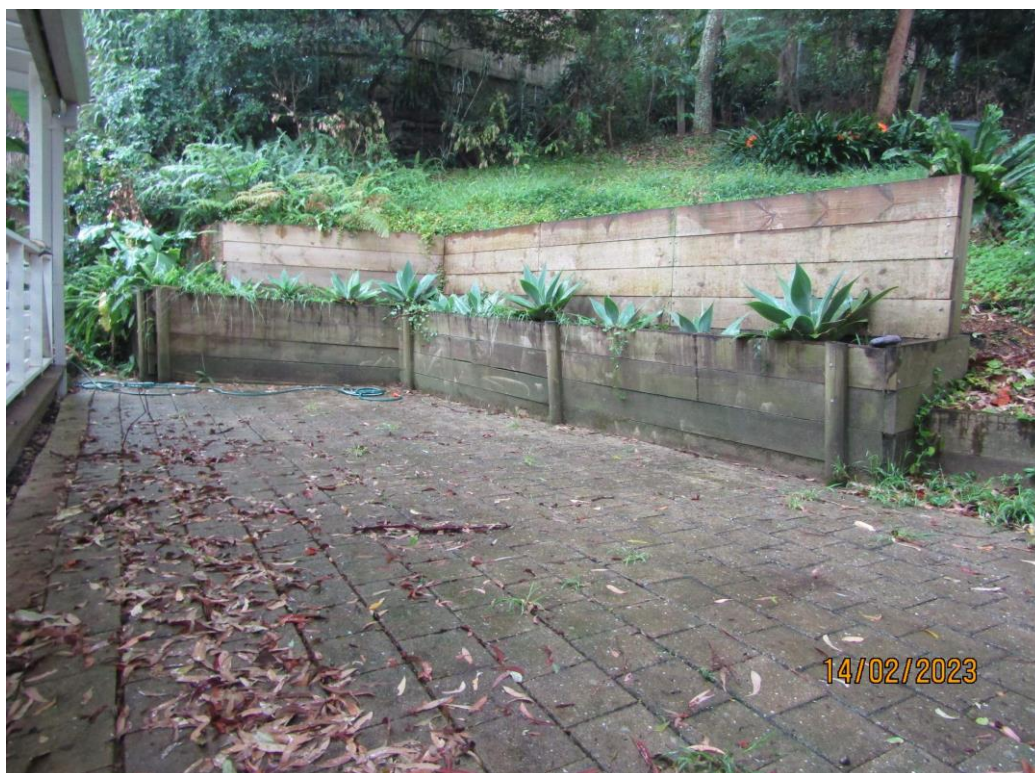
Photo 8

## AUGER HOLE 1 (~RL41.6) – AH1 (Photo 8)

The tilting timber retaining walls (Photo 8) are to be monitored by the owners on an annual basis or after heavy and prolonged rainfall events, whichever occurs first. A photographic record of these inspections is to be kept. Should further movement occur the walls are to be remediated or rebuilt so that they meet current engineering standards. We can carry out these inspections upon request.

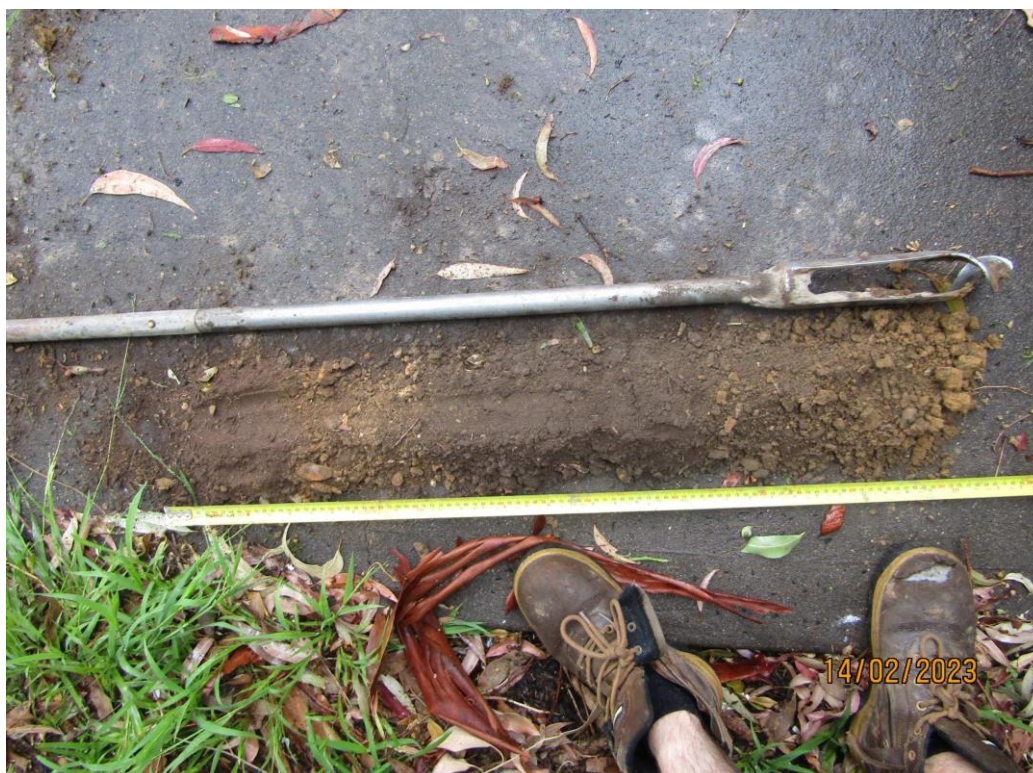
| Depth (m) | Material Encountered |
|---|---|
| 0.0 to 0.4 | <b>FILL</b> , soil and clay, dark brown, orange, dry, fine to course grained. |
| 0.4 to 0.8 | <b>TOPSOIL</b> , sandy soil, dark brown, dry to moist, fine to medium grained with fine trace organic matter. |
| 0.8 to 0.9 | <b>CLAY</b> , light orange brown, stiff, moist. |

End of Test @ 0.9m in stiff clay. No water table encountered.

Photo 10: AH1 – Downhole is from left to right.

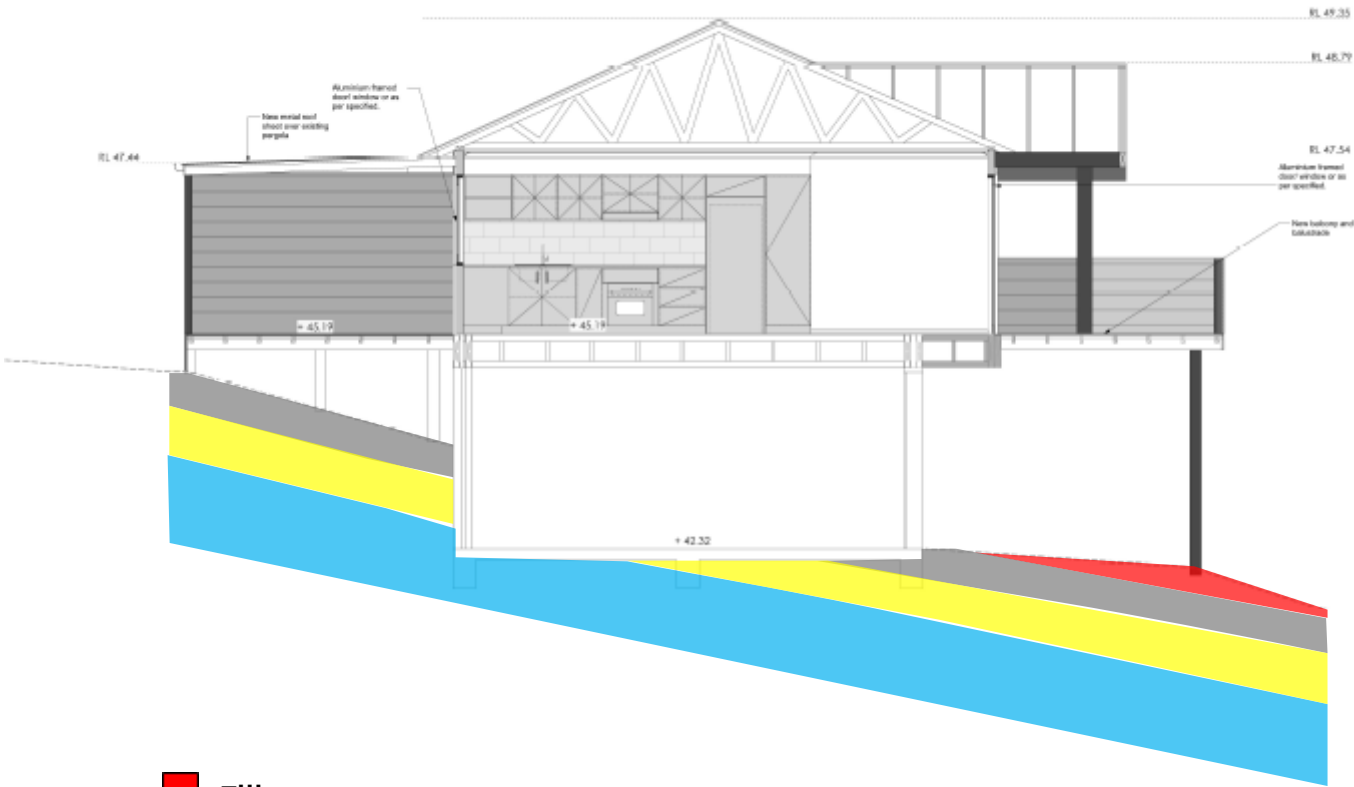
TYPE SECTION – Diagrammatical Interpretation of expected Ground Materials

The slope materials are colluvial at the near surface and residual at depth. In the test locations, the ground materials consist of fill and a thin sandy topsoil over firm to stiff clays. Fill to a maximum depth of ~1.5m provides level platforms for lawn and garden areas across the property. In the test locations, the clays merge into the weathered zone of the under lying rocks at depths of between ~0.7m to ~1.8m below the current surface, being deeper in the filled areas (DCP3 & 4). The weathered zone of the underlying rock is interpreted as Extremely Low to Low Strength Rock. It is to be noted that this material is a soft rock and can appear as a mottled stiff clay when it is cut up by excavation equipment. See Type Section attached for a diagrammatical representation of the expected ground materials.

- Fill
- Topsoil
- Clay – Firm to Stiff
- Narrabeen Group Rocks – Extremely Low to Low Strength Rock - after being cut up by excavation equipment can resemble a stiff to hard clay.
