**Determination of a Final Occupation Certificate Application**

**Final Occupation Certificate No: 2009/3215**

Address: 22 Chiltern Road, Ingleside

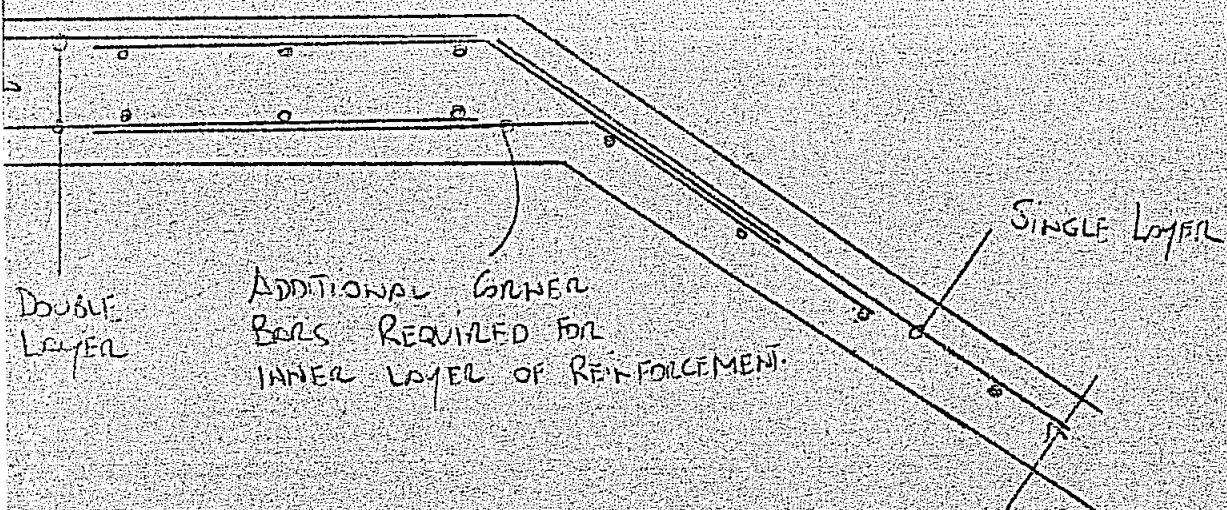
DRAWING REFERENCE NO S02, S03, S11, S14

Pool corner reinforcement needs to be rectified as follows.

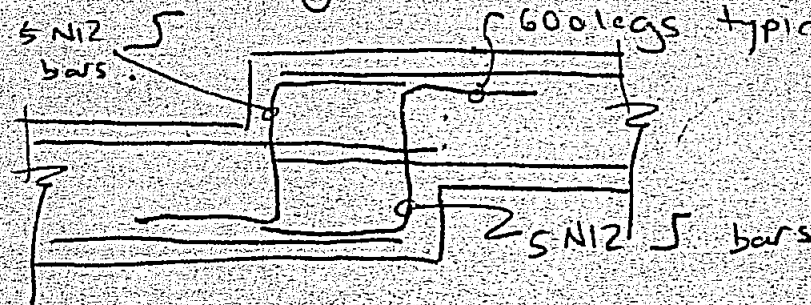
FOOTING PREPARATION HAS BEEN INSPECTED. BUILDOR TO ADDRESS THE FOLLOWING:

- i) At step in footing, provide "Z" lap bars as per:

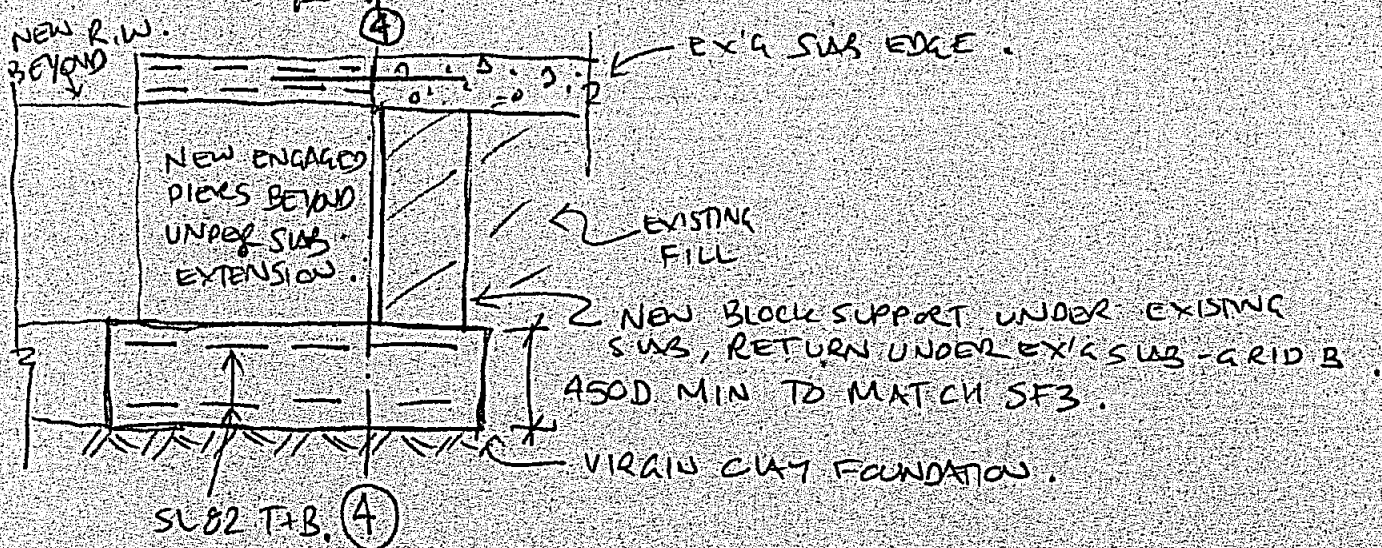
1v) ALONG GRID 4, between grids A & B, clean out existing fill, a minimum of 300 mm under existing slab & pour mass concrete pad footing to support underpinning walls as per:

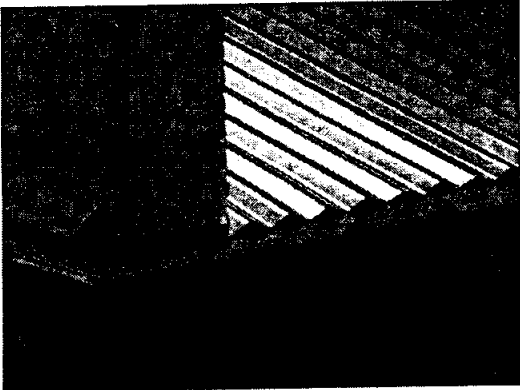
Photo 1: Metal gutter guards

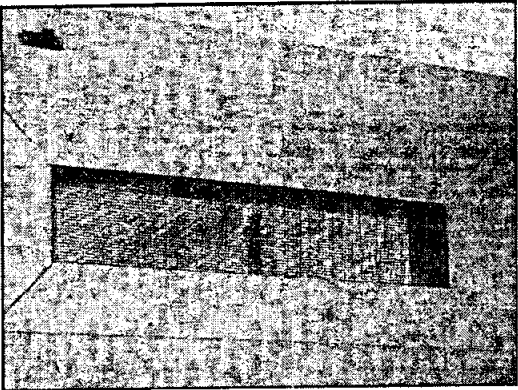
Photo 2: Metal mesh screen over vent

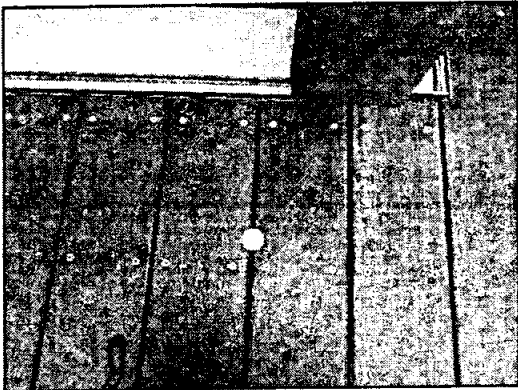
Photo 4: Timber decking min 5 mm gap

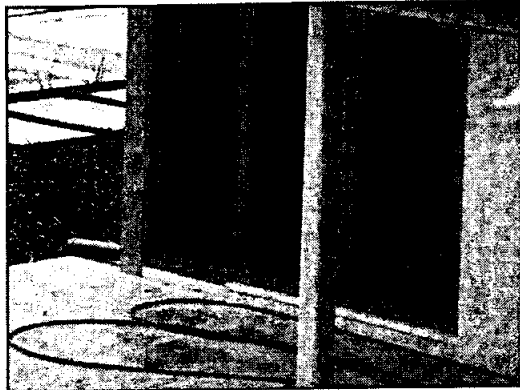
Photo 5: Doors with metal mesh screens

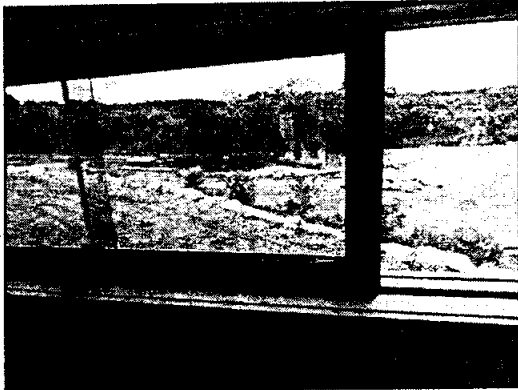
Photo 6: Window with metal mesh screen
