REPORT ON GEOTECHNICAL INVESTIGATION

PROPOSED ALTERATIONS AND ADDITIONS

6 -7 KARA CRESCENT, BAYVIEW, NSW

Project No.: 2023-081

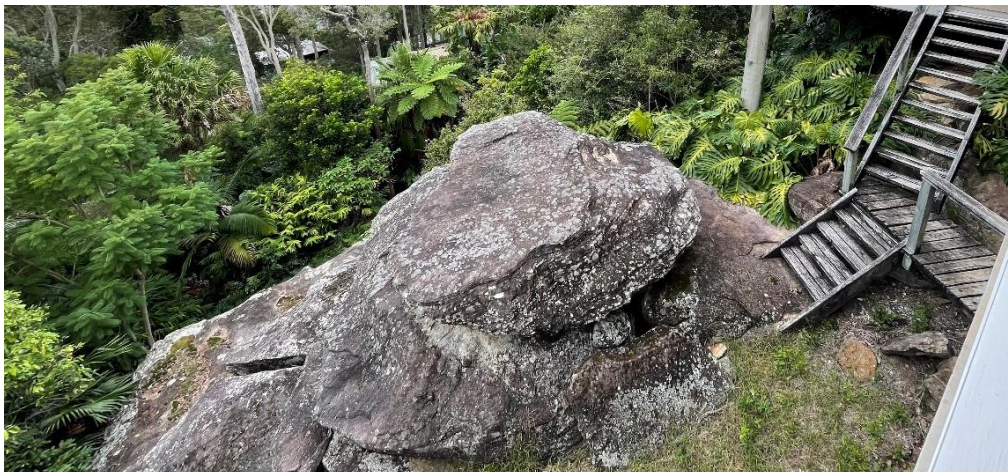
To the south and east of the existing dwelling and adjacent pool area, the topography transitions to a steep to extreme south east dipping slope and contains a large sandstone outcrop featuring both bedrock and detached boulders. Near the base of this outcrop, a significant overhang was observed where the rock was undercut up to 2.00m. The rock mass did not appear to feature any significant subvertical joint sets within the overhang and the overhang was considered relatively stable. Photographs 2 – Photograph 4 below provide views of this exposed rock.

Photograph 2: View of the sandstone outcrop, looking broadly south-east from the dwelling

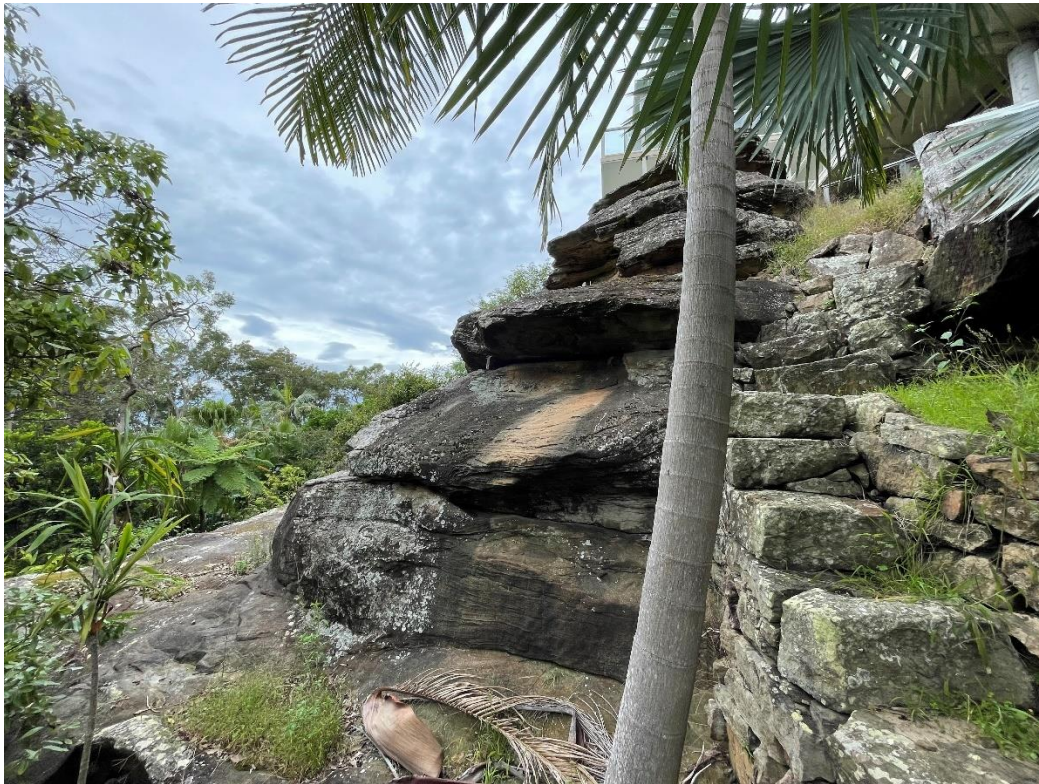
Photograph 3: View of the sandstone outcrop, looking broadly south

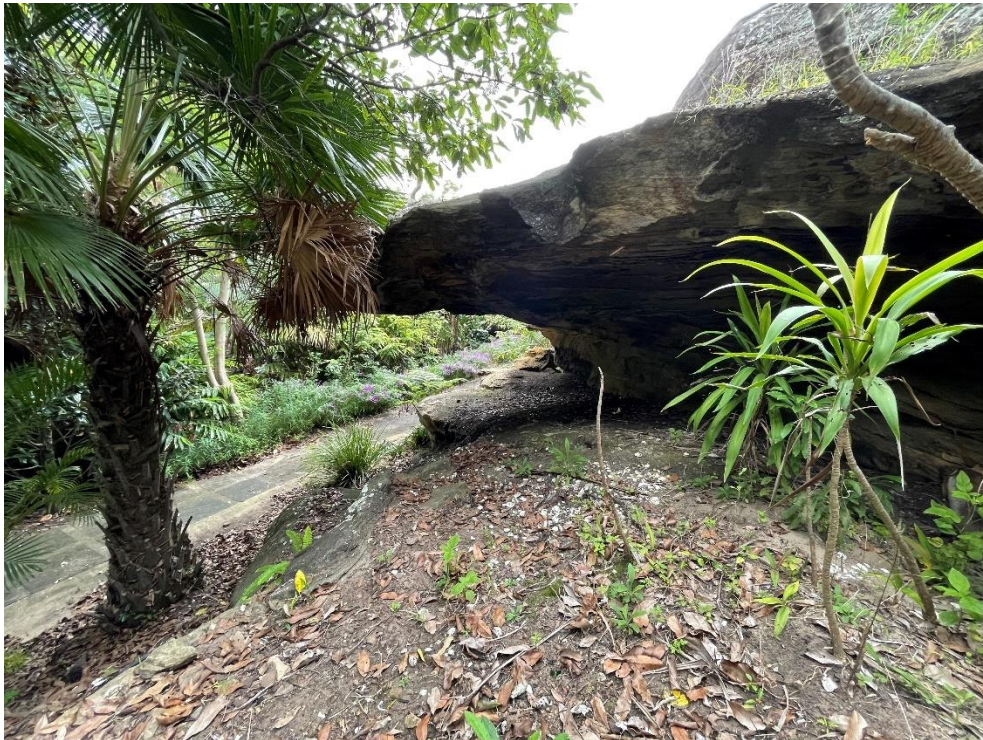
Photograph 4: View of the undercut portion of the sandstone outcrop adjacent to the eastern site boundary

Cliff overhang stability calculations as per Young & Young 1992 were utilized, based on visible bedrock conditions, to assess the stability of the overhang adjacent to the southern site boundary and returned a factor of safety in excess of 3, it was therefore not considered as a hazard.

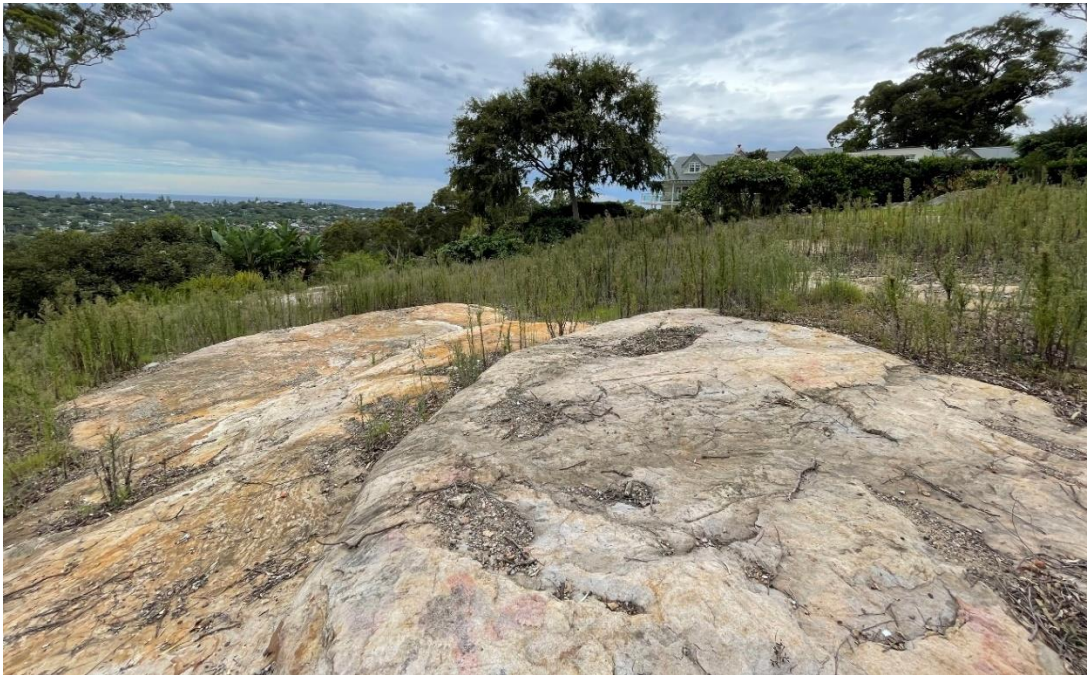
No. 6 Kara Crescent is currently a vacant site, understood to have previously contained a residential dwelling. Sandstone was observed outcropping both as bedrock and detached boulders in multiple locations within the property. Where exposed, all outcropping bedrock was preliminarily assessed as at least low strength and all boulders were considered stable. Photograph 5 below provides a view of some of the exposed bedrock within No. 6 Kara Crescent.

Photograph 5: View of the sandstone bedrock outcrop within No. 6, looking broadly south from the northern corner of site
