## Paul Mabbott's Tree Service

**Client: David from HUMEL Architects**

Property: Old Darby & Joan site

Inspection Date: 15 July 2013

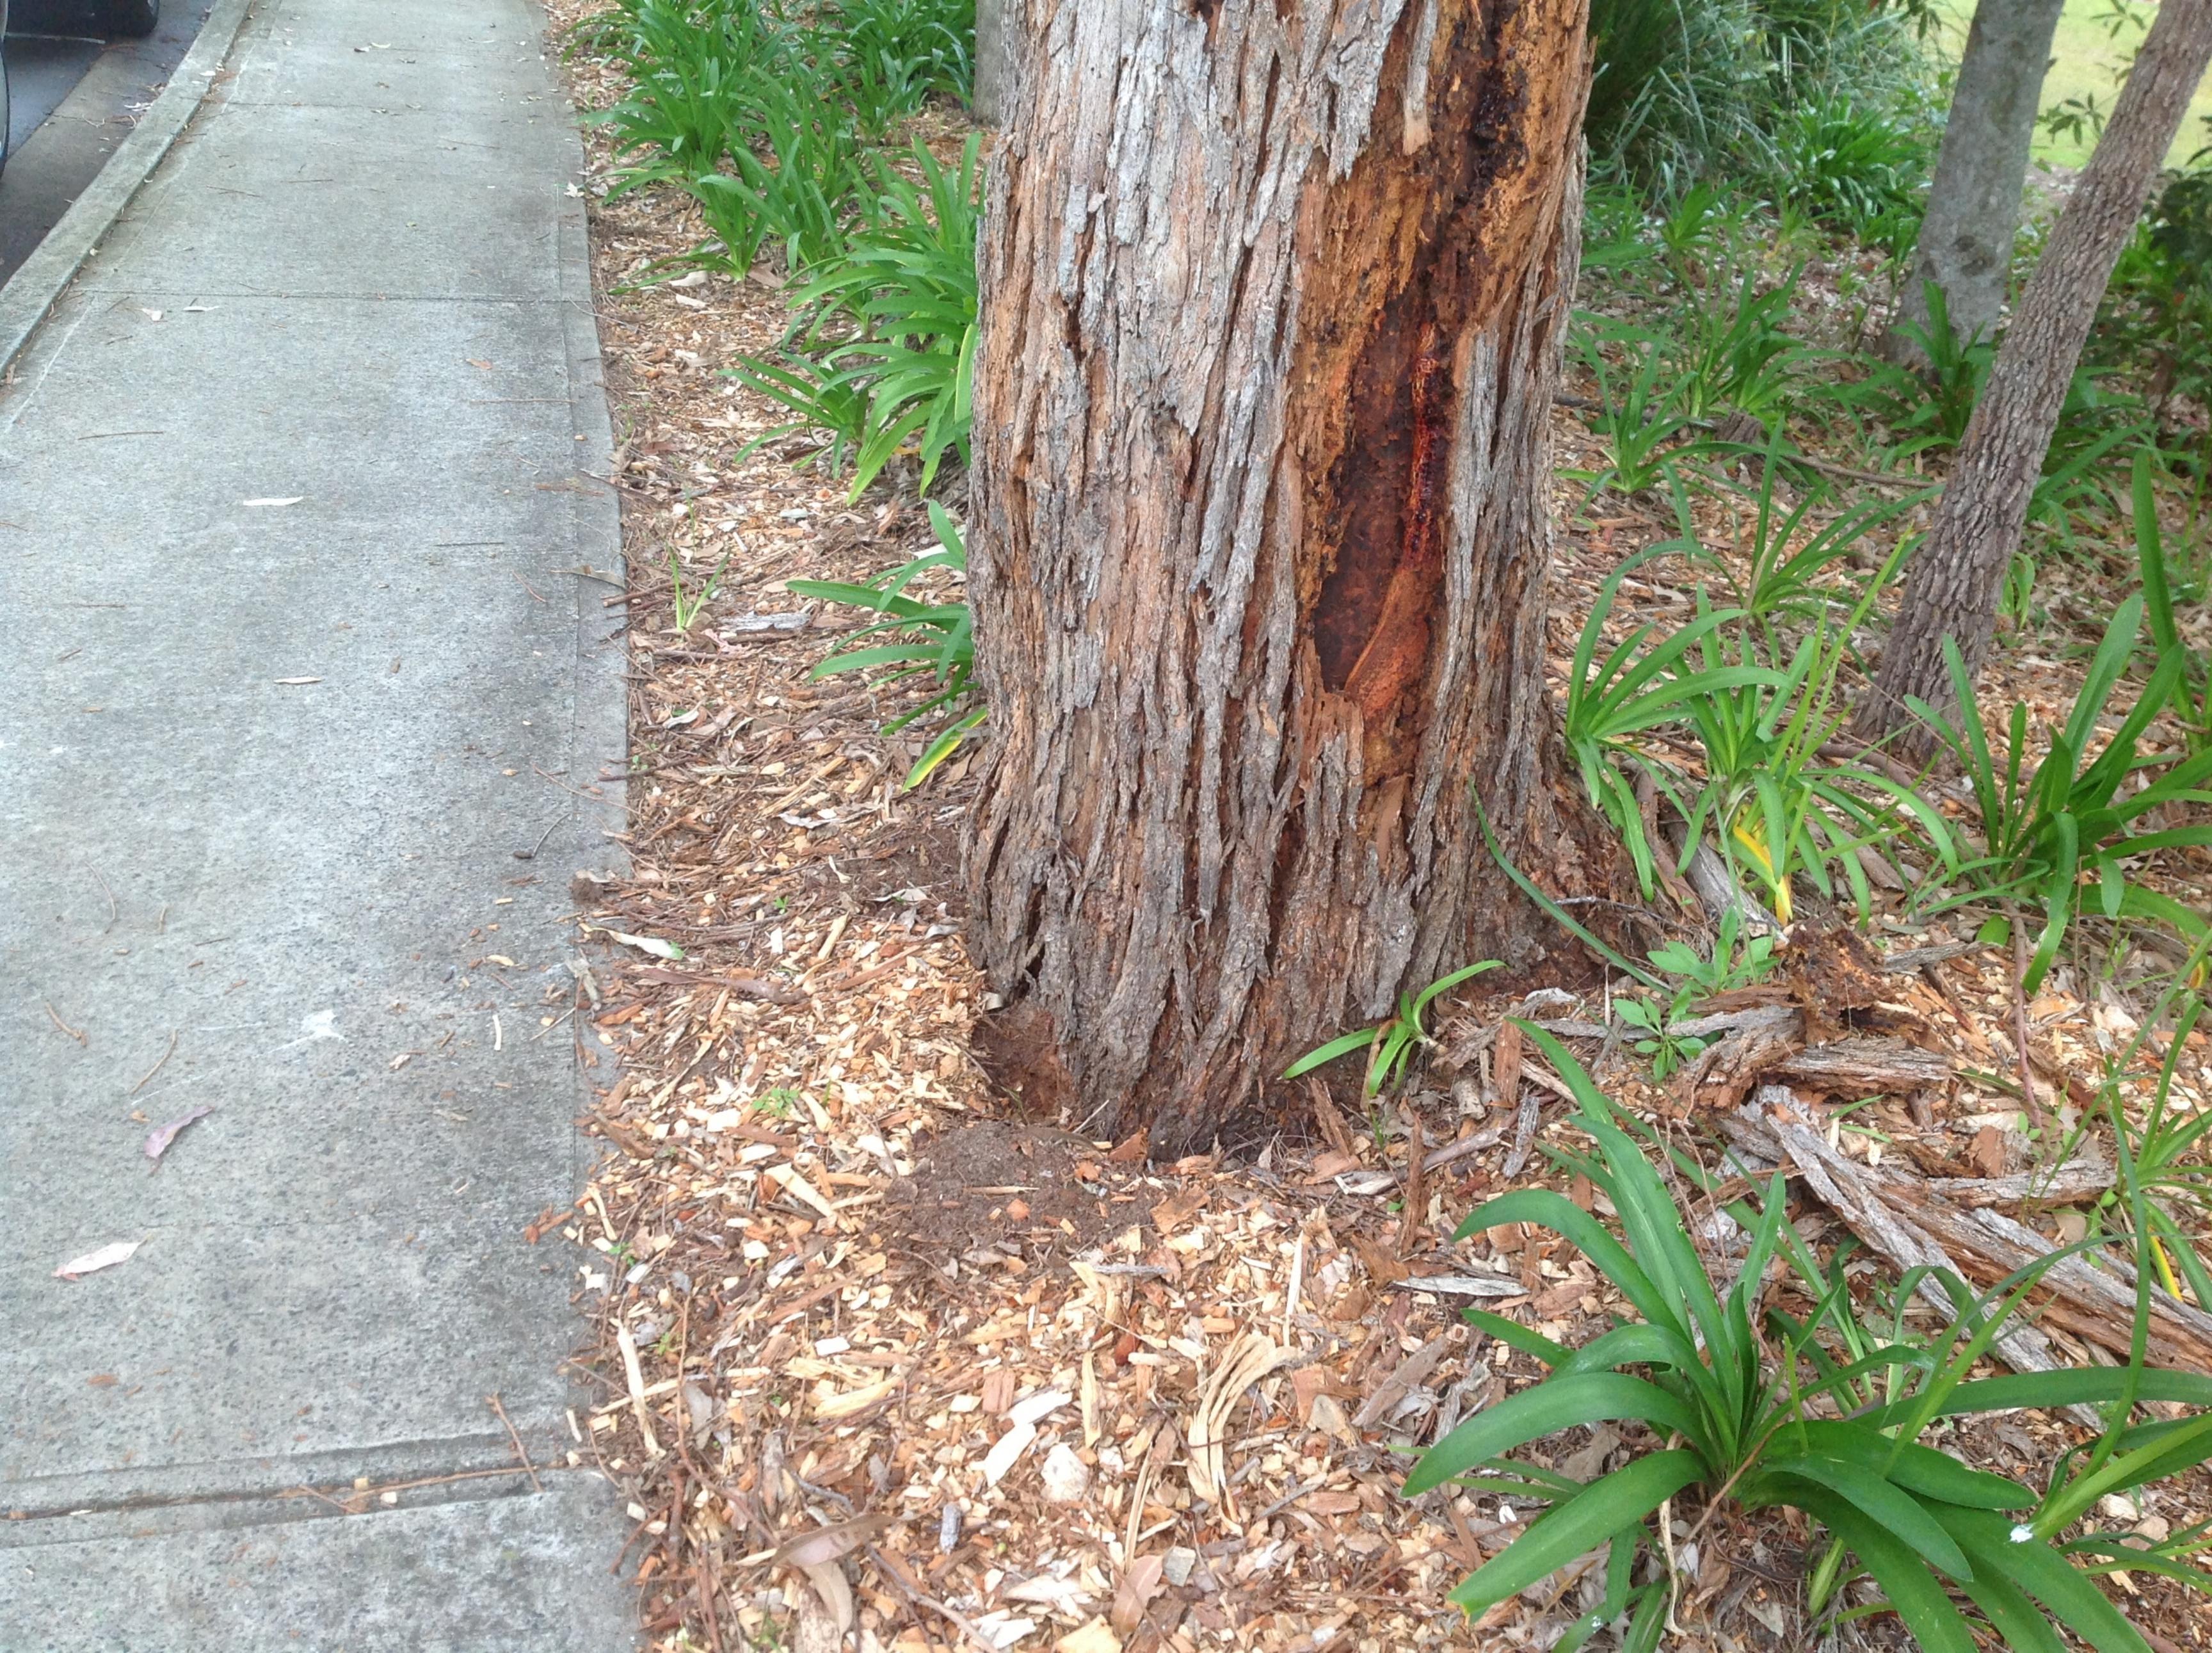
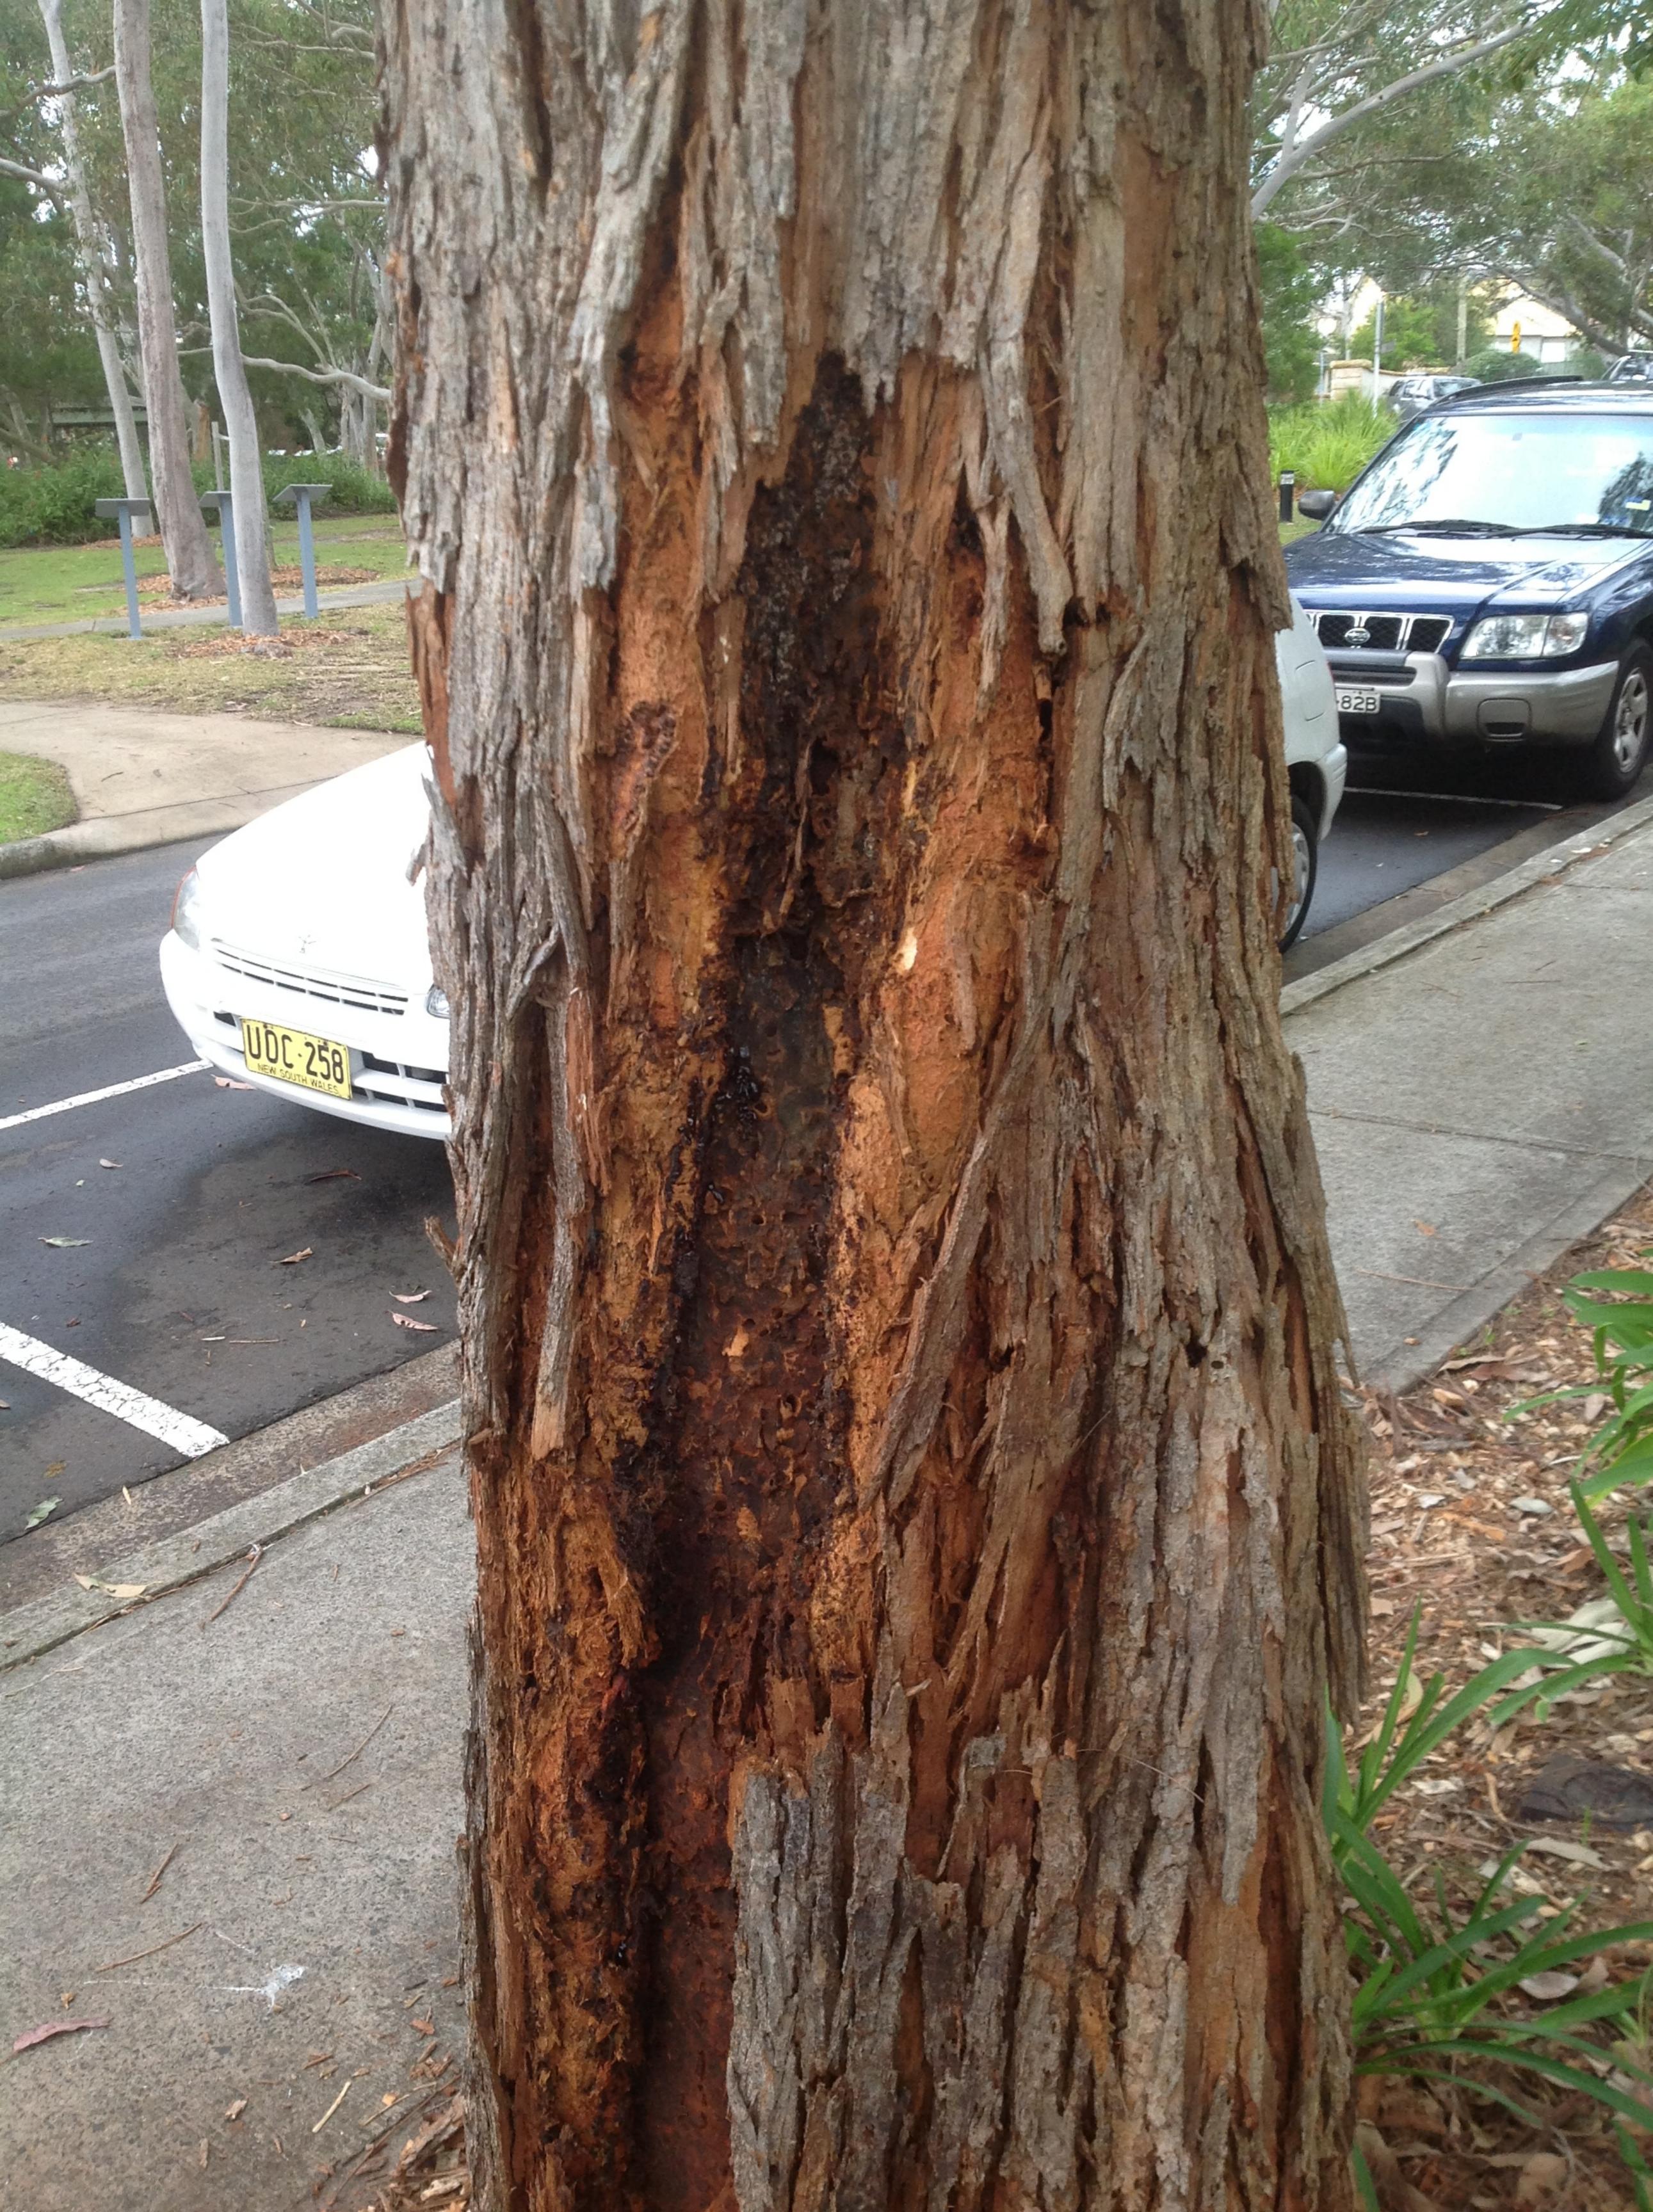
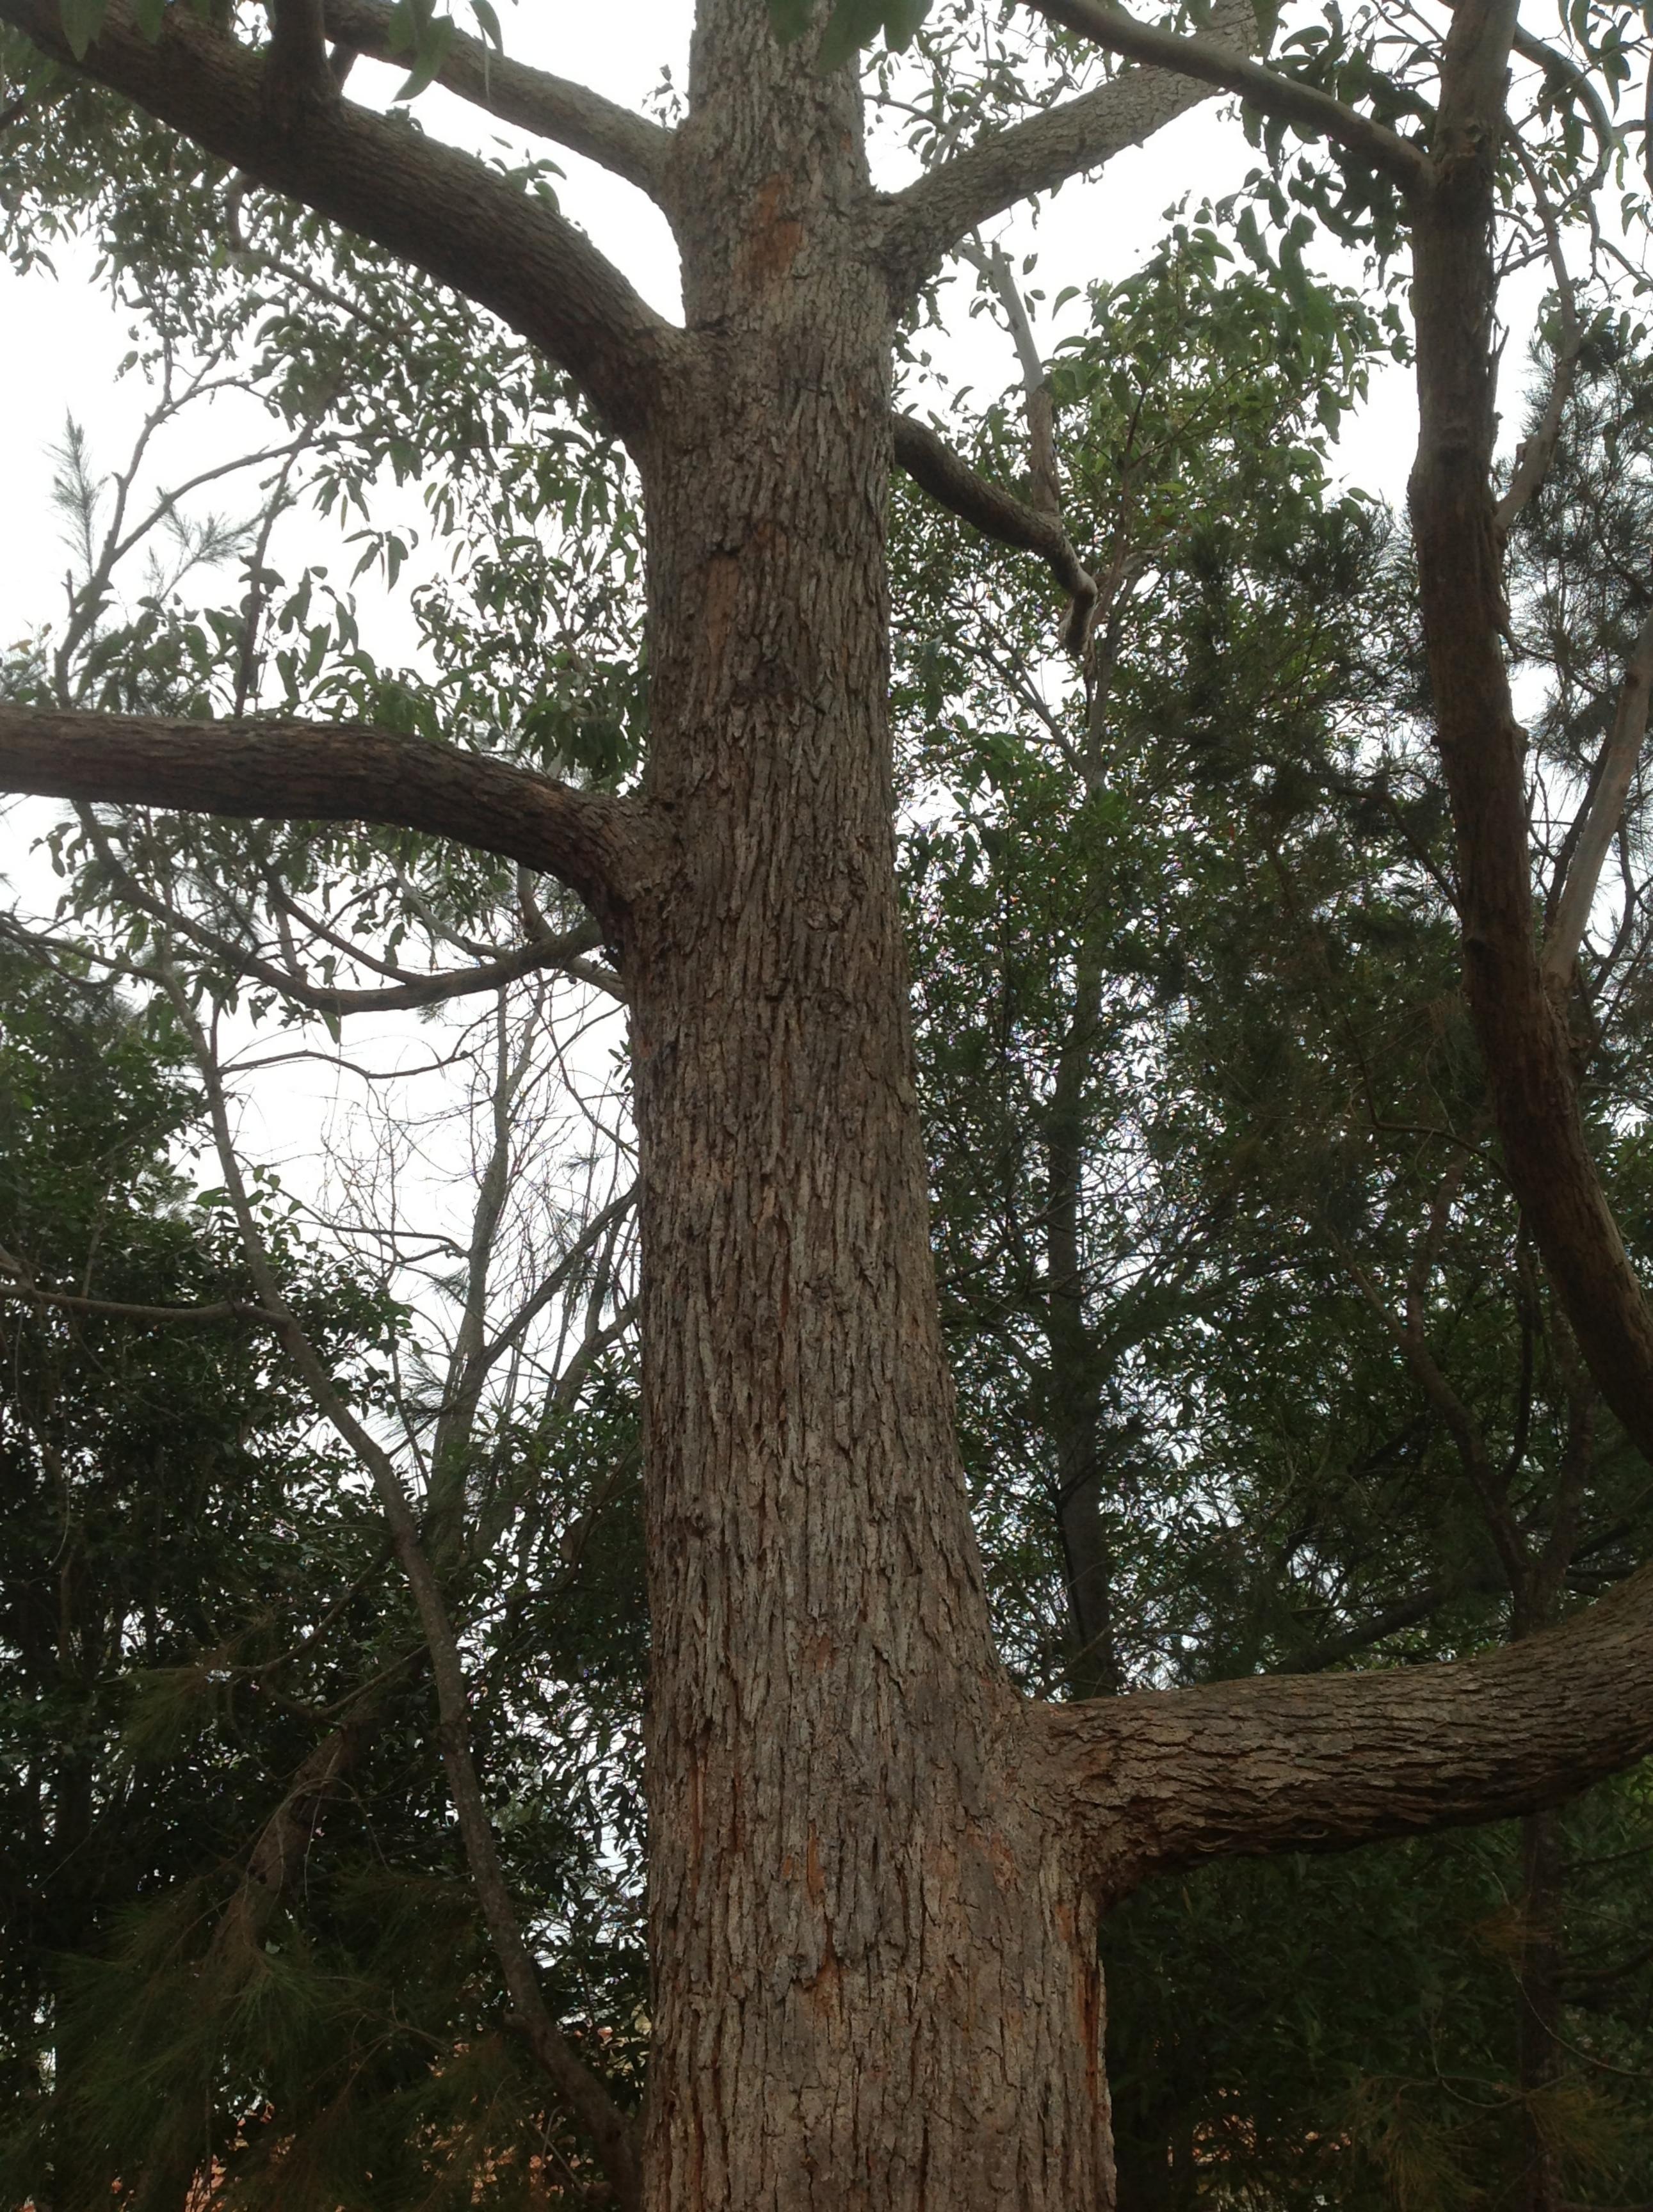
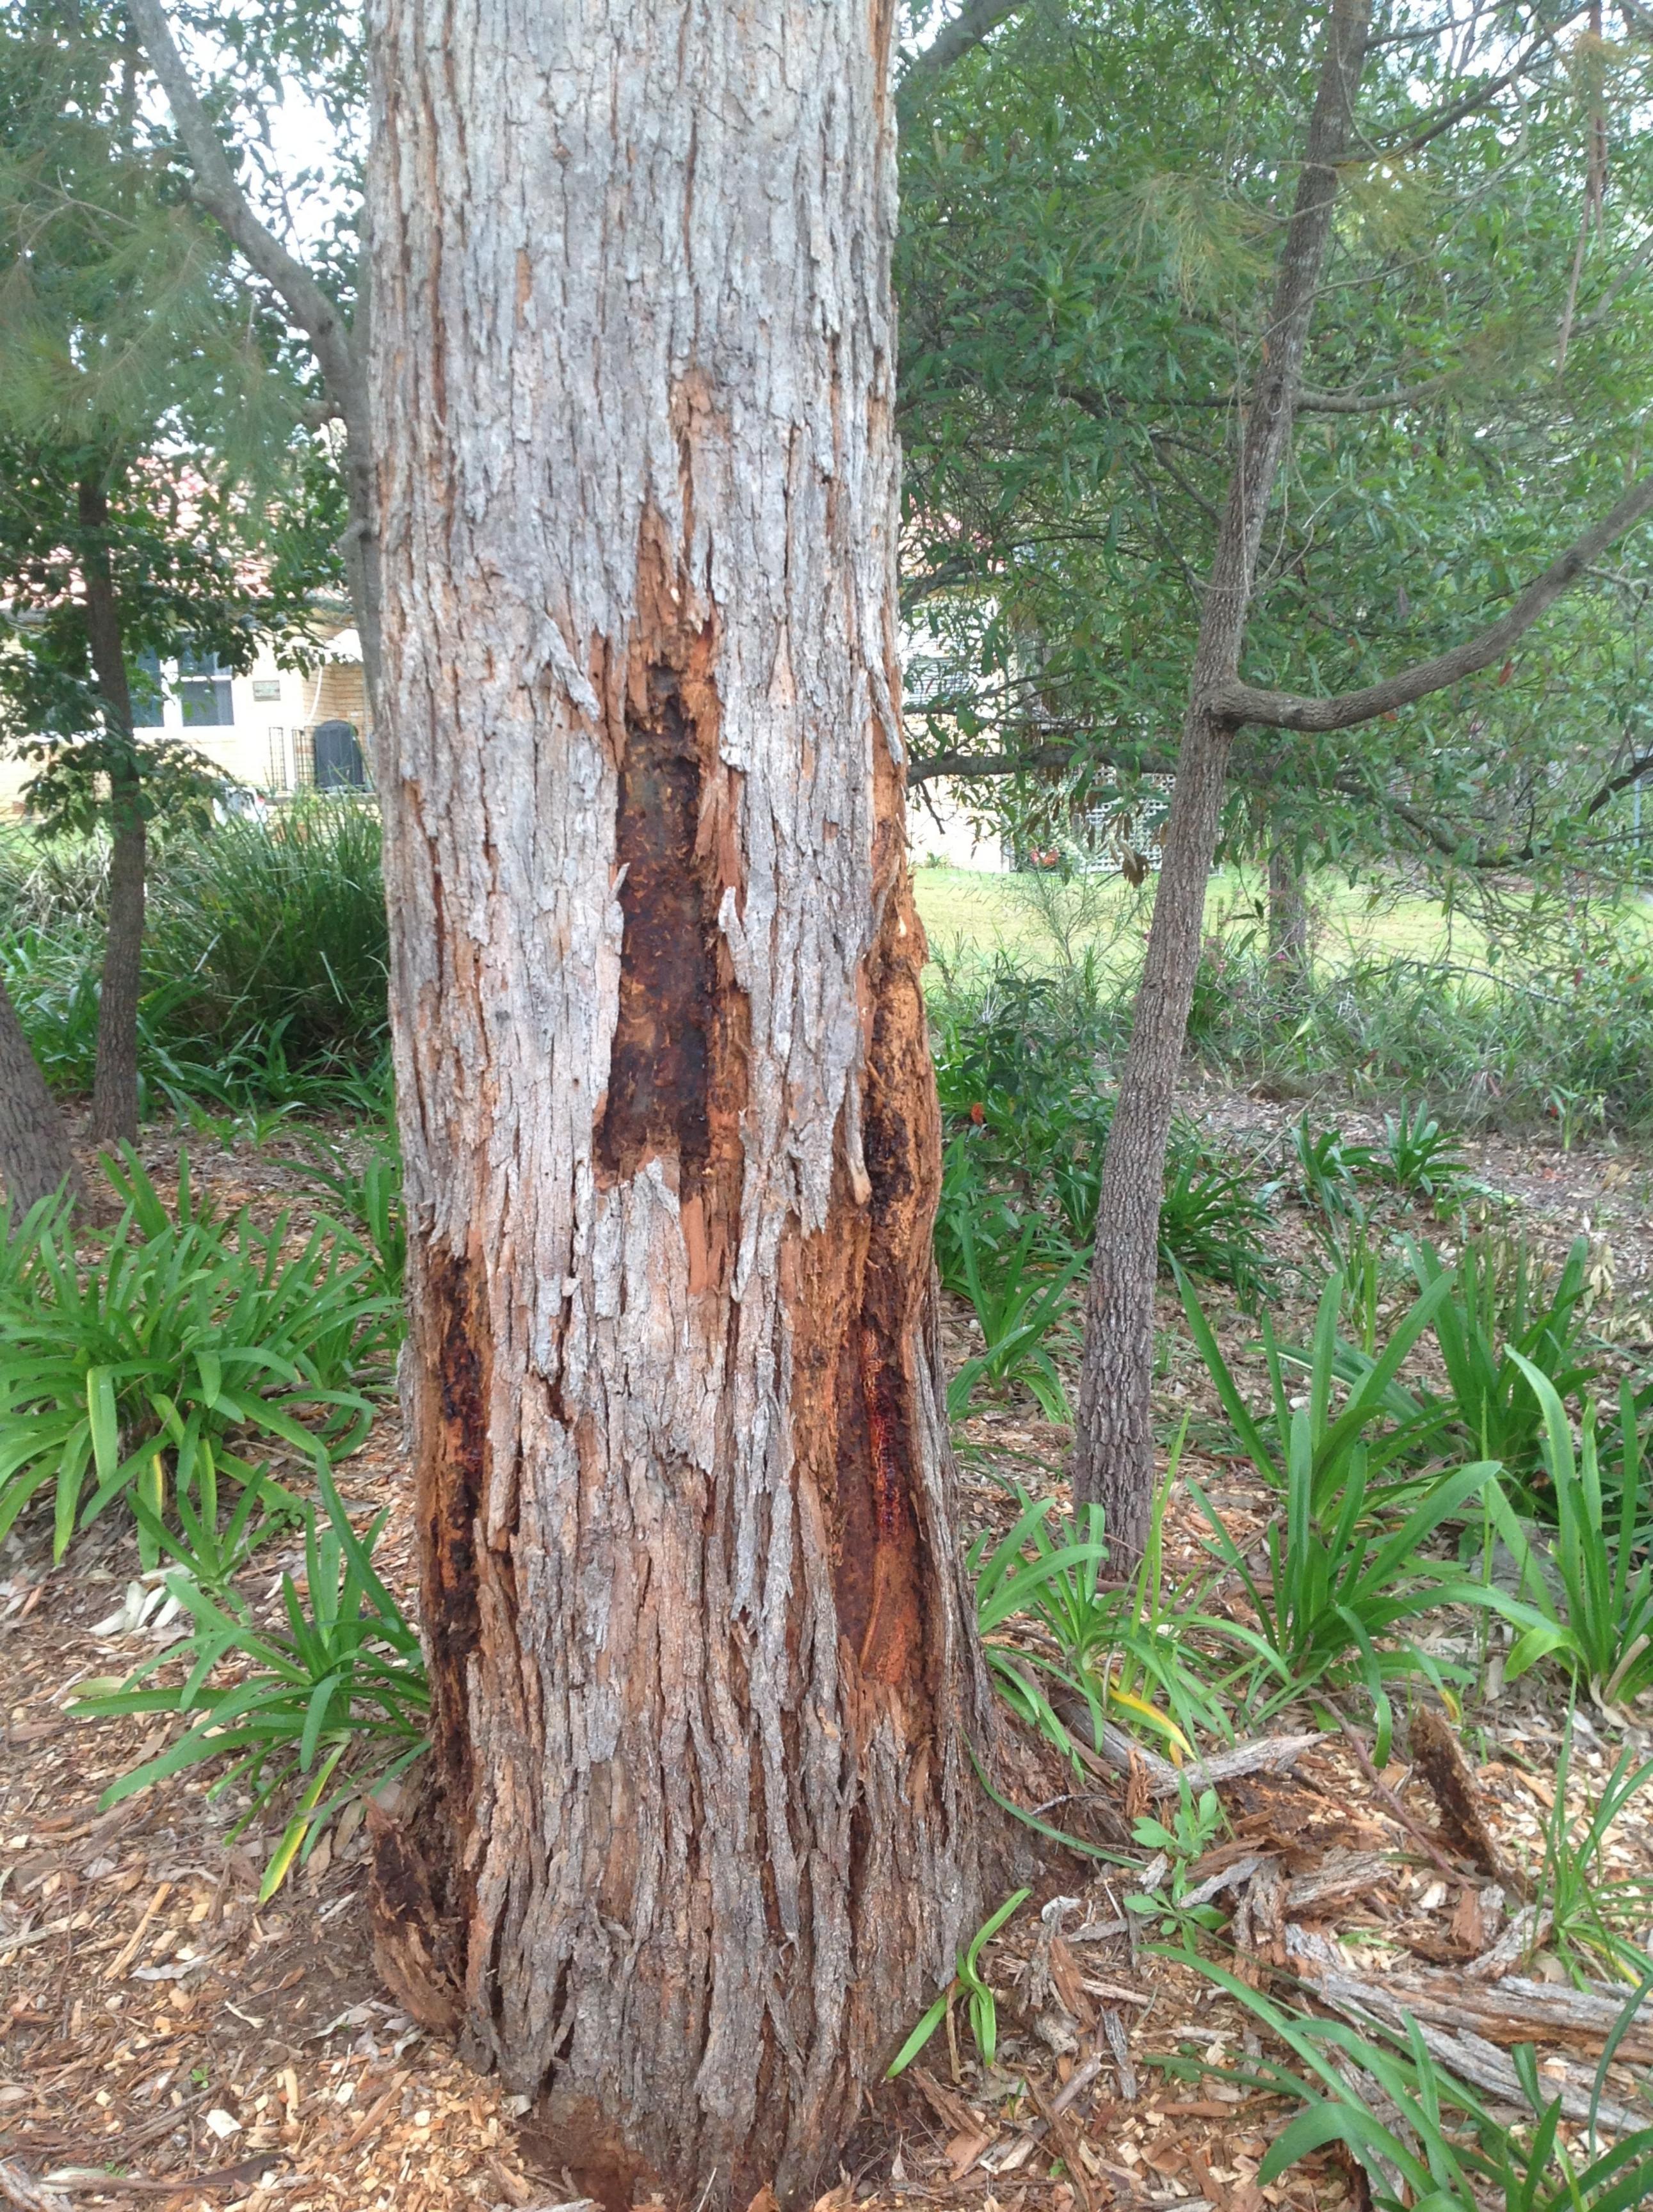
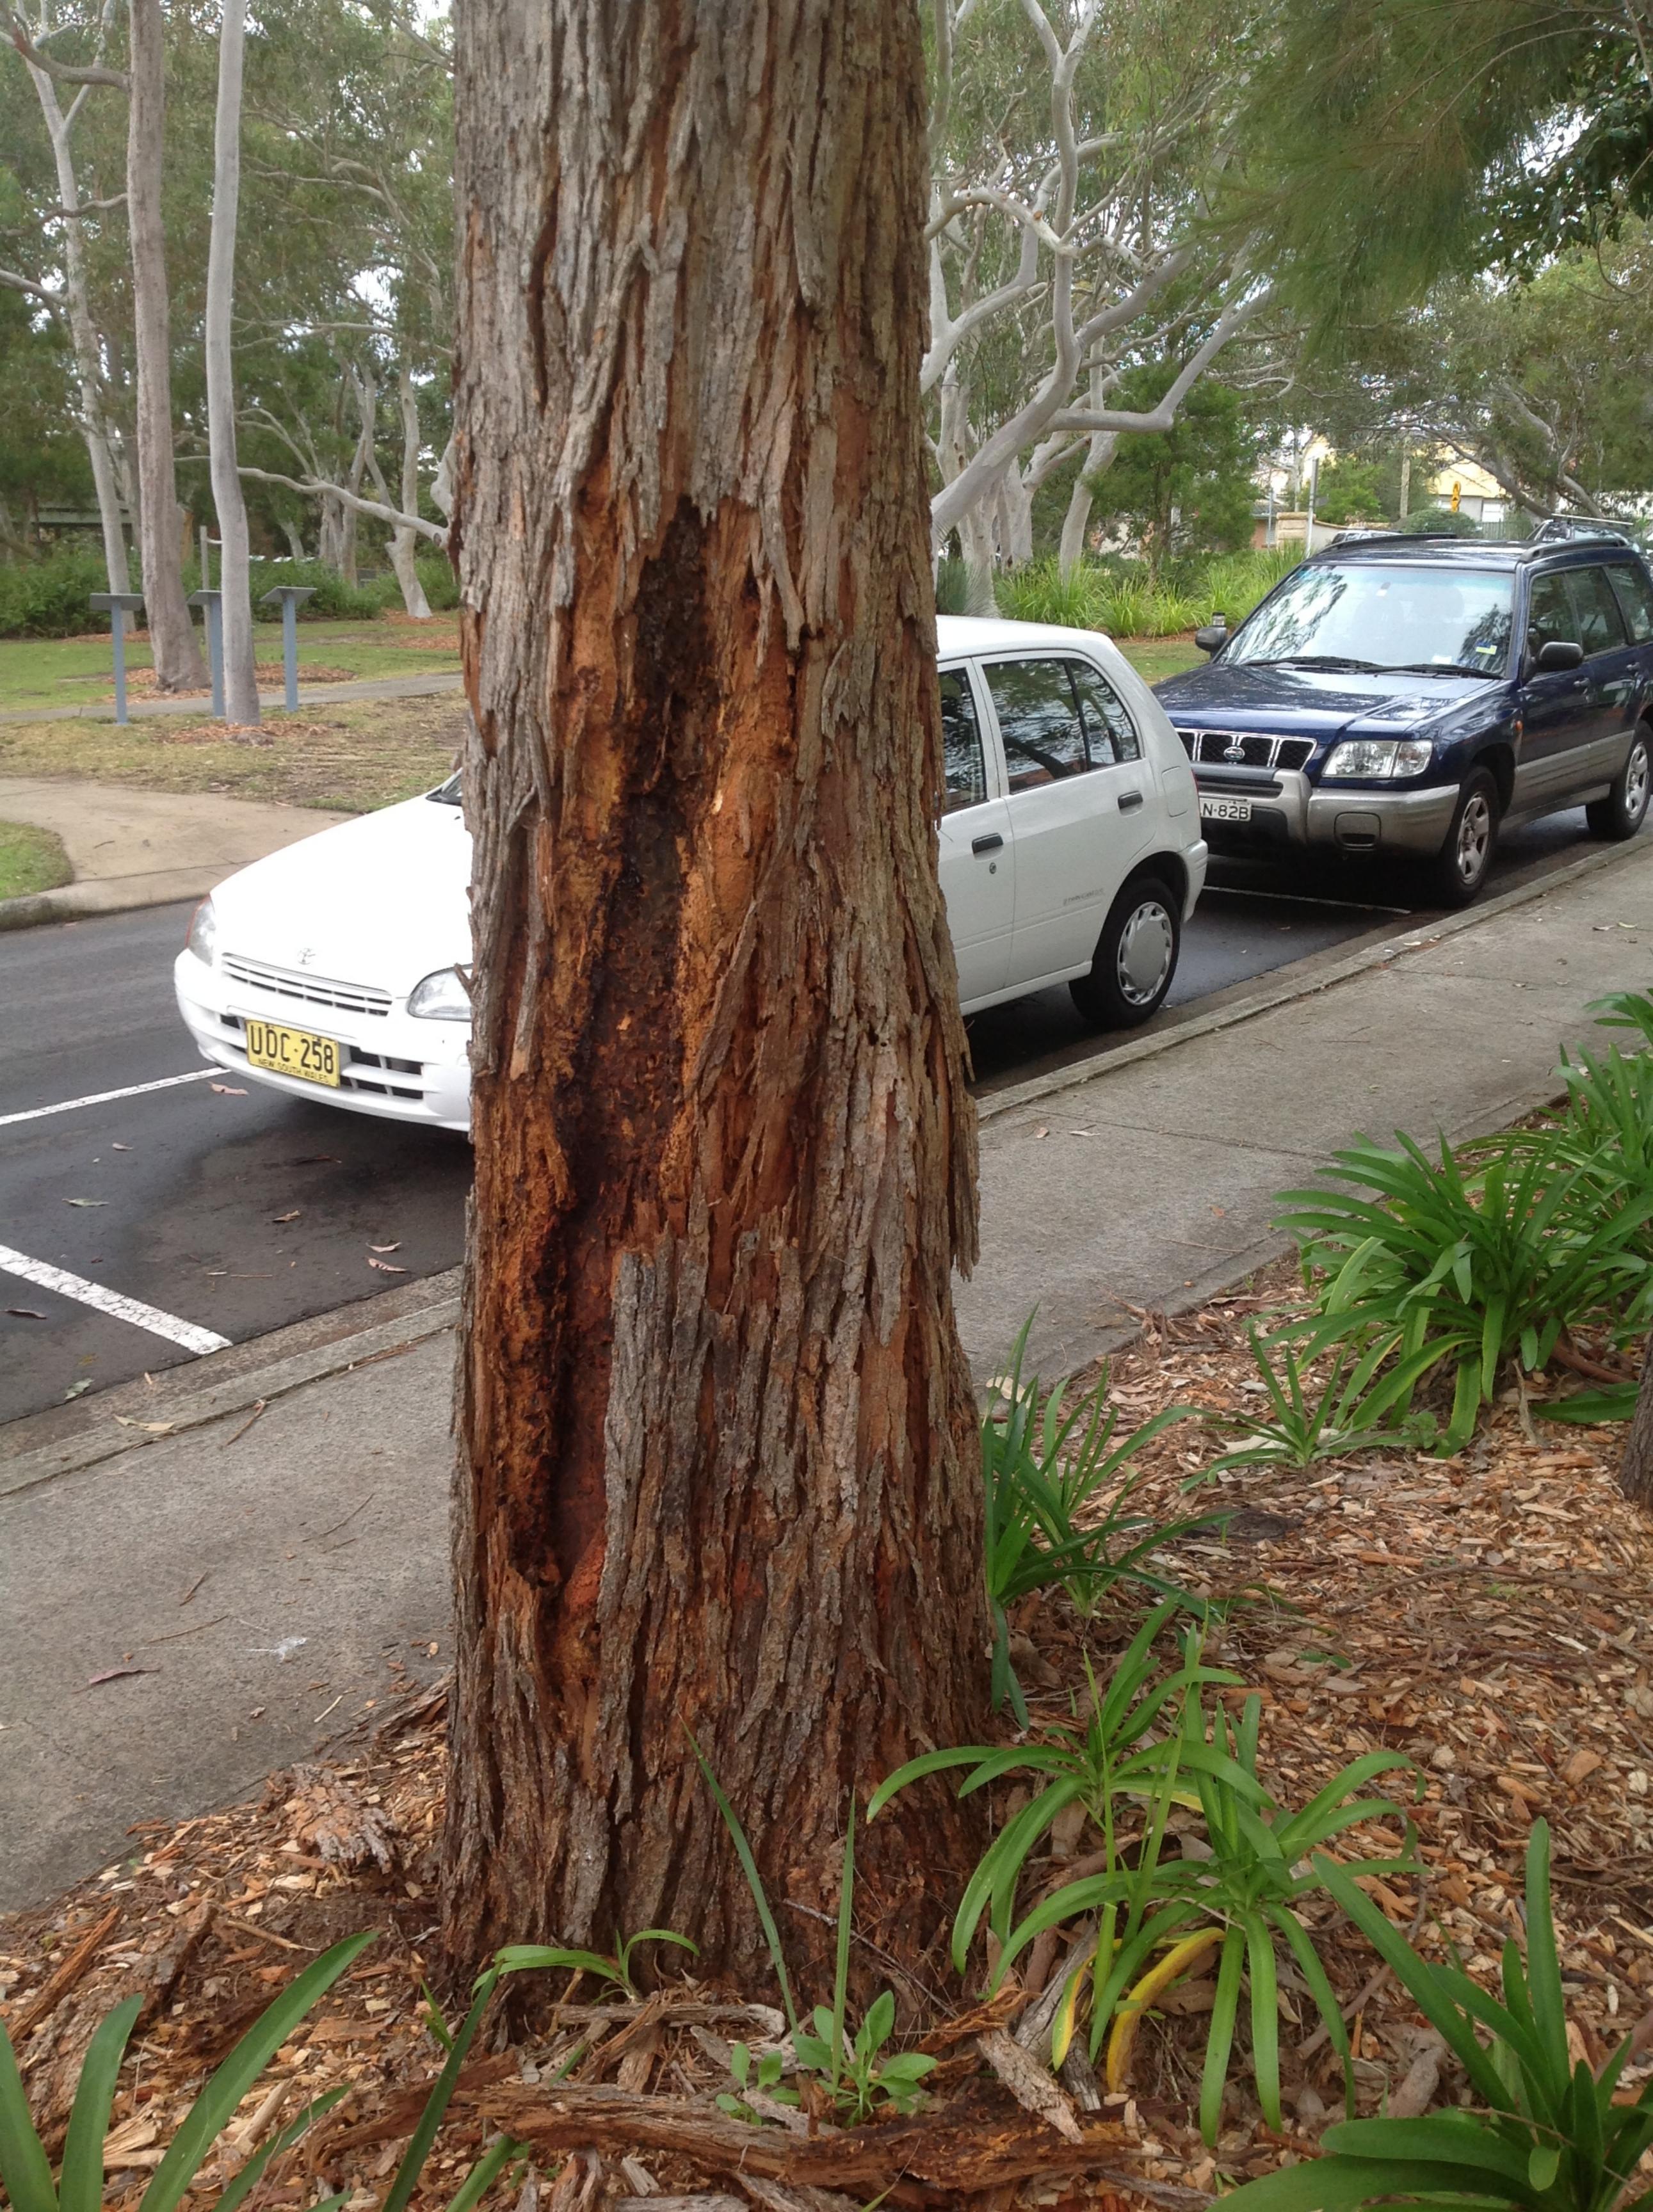
On first sight of this tree displays a good canopy but on closer inspection there were four large cases of bora evident and lateral root degradation. What this means is any works carried out in a southerly or westerly direction within 5 to 8 meters of this tree is likely to jeopardise the structural integrity of the root system. There is also a large water pipe under this tree and if it ever where to rupture this would would have a huge impact on this tree and area around it.

In my opinion this tree is unsustainable and no amount of tree surgery will result in any form of sustainable recovery to full vigour. Any form of excavation work within 5m of this tree will weaken the tree ass possible root failure. This tree looks like it has no lateral roots towards the foot path and drive way it also has a large amount of bora evident in photos. My opinion is this tree should be removed and when completion of works is done a replacement blood wood of significant size should be put back in same place so as to grow within the so rounding area.
