Report Title: Geotechnical Report 52 Hilltop Road, Avalon

Report Date: 4/9/23

Alterations and Additions at **52 Hilltop Road, Avalon**

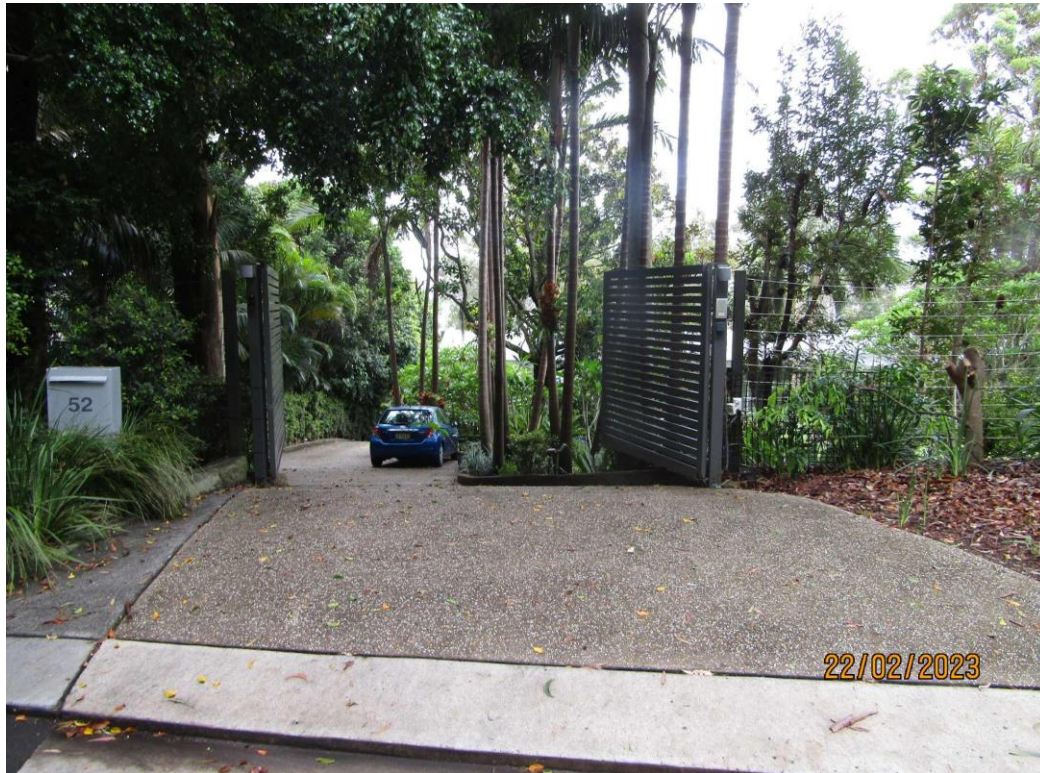
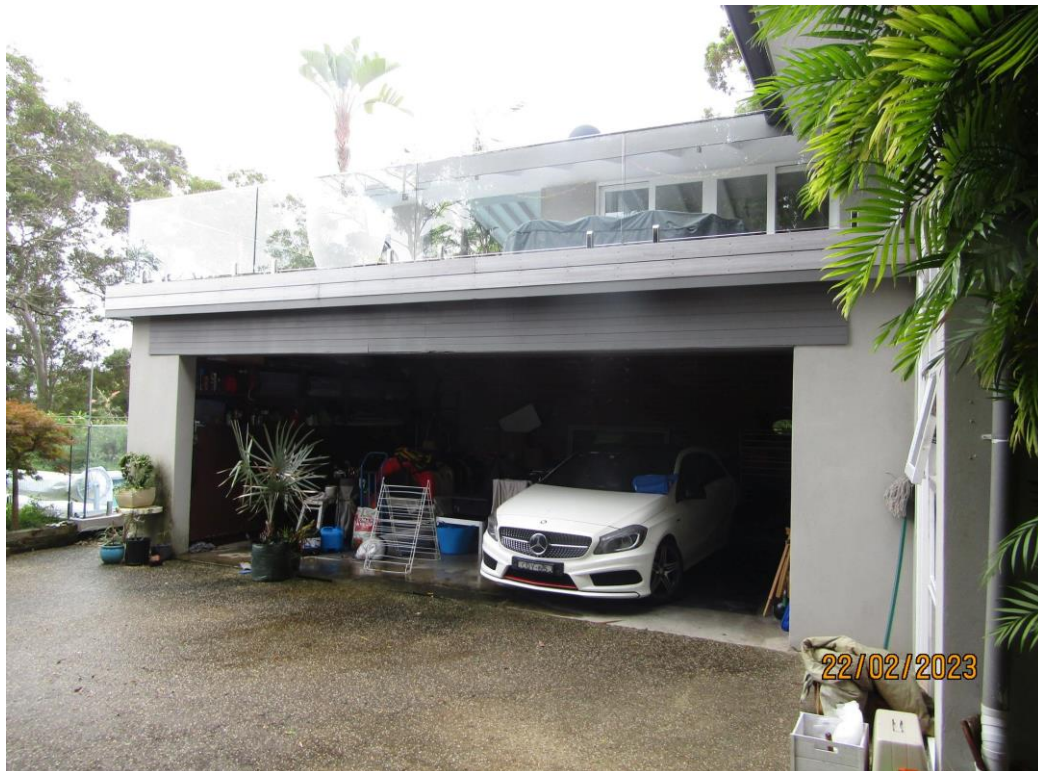
Photo 1

**2.3** At the road frontage, a concrete driveway runs down the slope to a garage on the lower ground floor of the house (Photos 1 & 2). A stable stack rock retaining wall up to  $\sim 1.5$ m high supports a fill for the road reserve and a cut for a garden area on the subject property (Photo 3). Between the road reserve and the house are gently sloping lawn and garden areas (Photos 4 & 5). Stable low stack rock retaining walls support cuts and fills for the lawn/garden areas and a cut for the house. The part two storey rendered masonry house is supported by masonry walls and brick piers (Photos 5 & 6). The external supporting walls show no significant signs of movement. The supporting piers stand vertical (Photo 7).

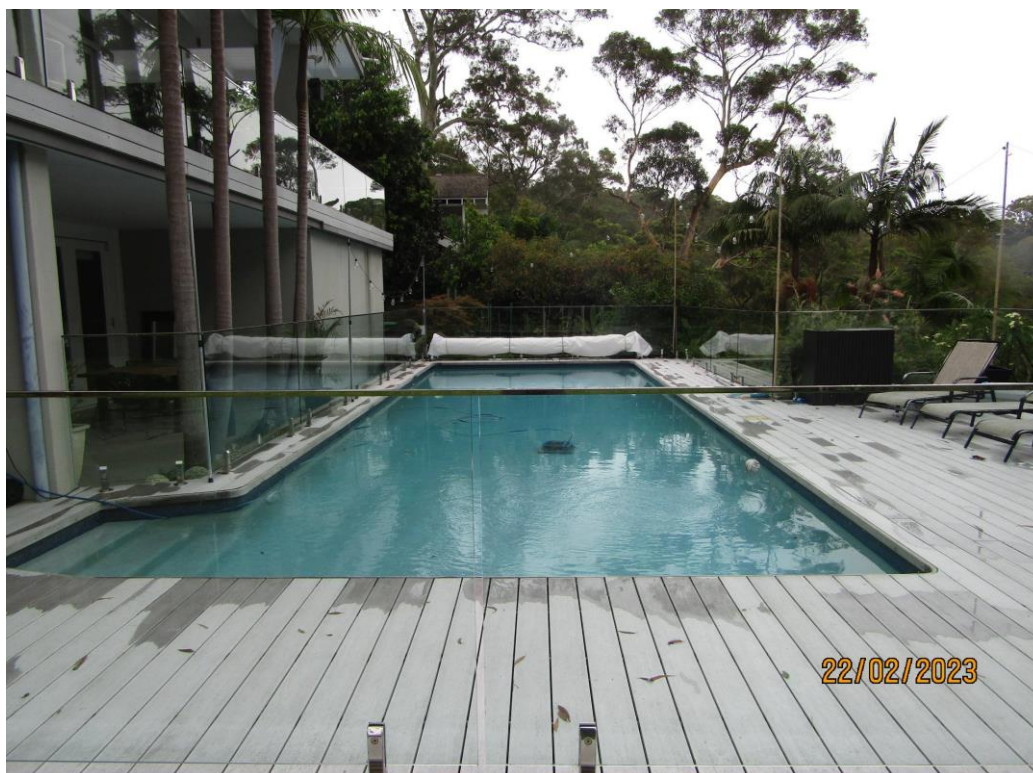
Photo 8

A pool that shows no significant signs of movement is located on the downhill side of the house (Photo 8). Fill provides level platforms for lawn and garden areas beside and downhill of the pool (Photo 9). The fills are supported by stack rock and timber retaining walls up to  $\sim 1.5$ m high (Photos 10 & 11). The timber posts that support timber retaining walls on the SW side of the pool (Photo 12) are tilting downslope slightly, but due to their low height and location, they are not considered a significant threat to life or property. Other lawn and garden areas extend from the downhill side of the retaining walls to the downhill property boundary (Photos 13 & 14). A pathway

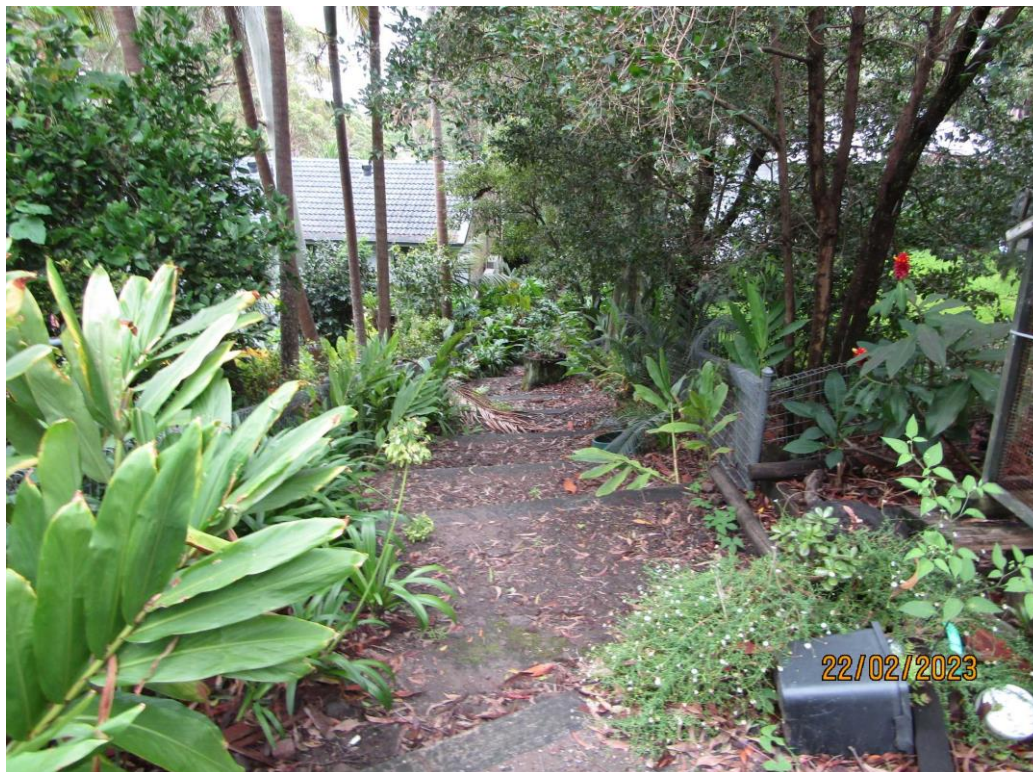
Photo 15

on the subject property runs beside the downhill neighbouring properties and provides access to Hudson Parade (Photo 15). Sandstone bedrock outcrops at the entrance to the pathway above Hudson Parade (Photo 16).

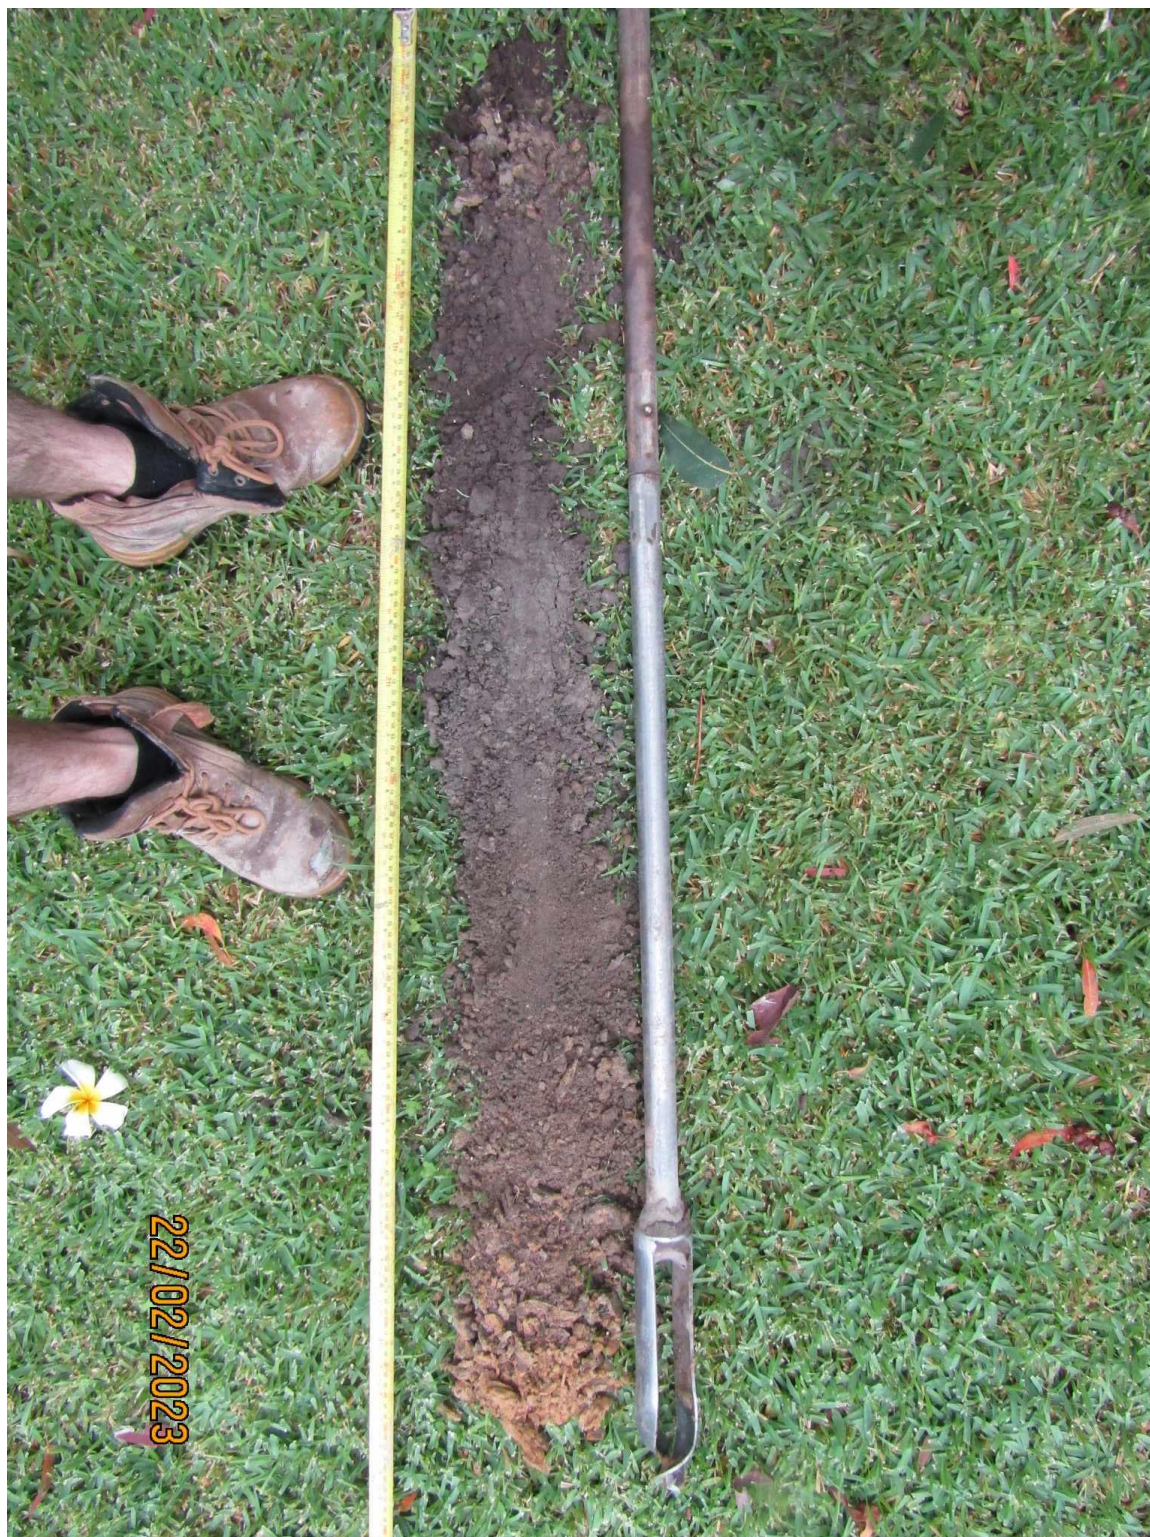
## AUGER HOLE 1 (~RL49.3) – AH1 (Photo 17)

End of hole @ 1.3m in stiff clay. No watertable encountered.

Photo 17: AH1 – Downhole is from top to bottom.

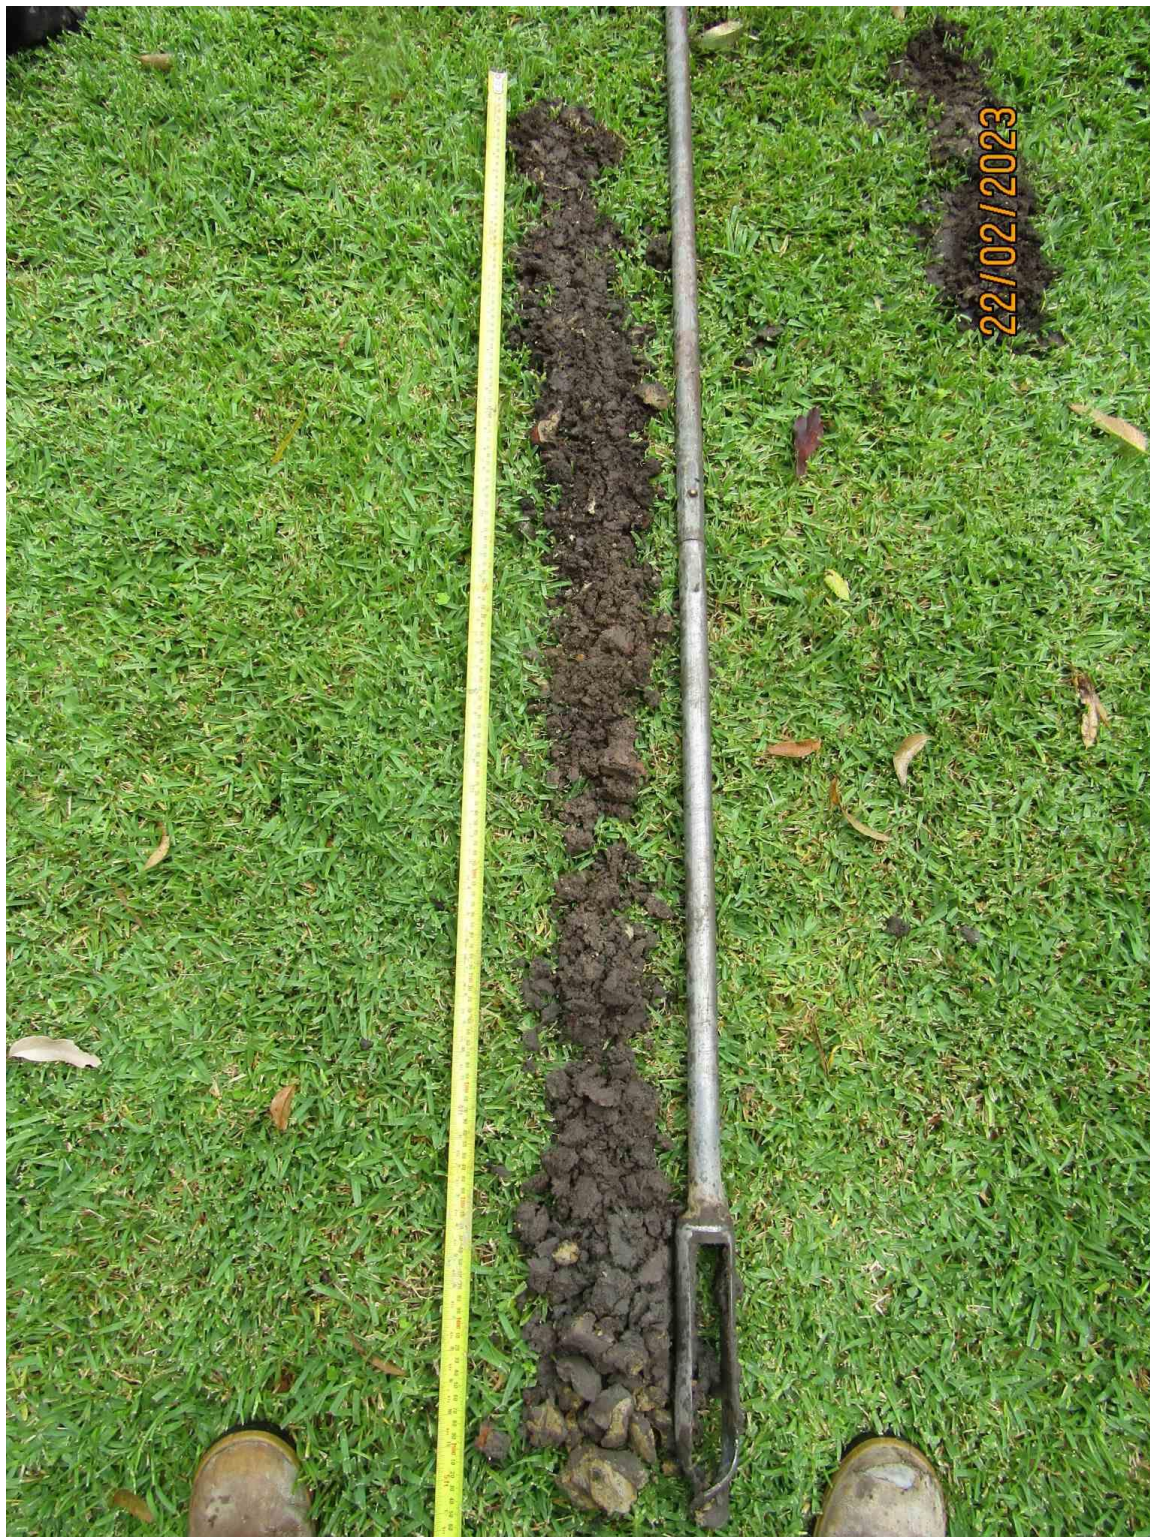
## AUGER HOLE 2 (~RL45.0) – AH2 (Photo 18)

End of hole @ 1.6m in firm clay. No watertable encountered.

Photo 18: AH2 – Downhole is from top to bottom.

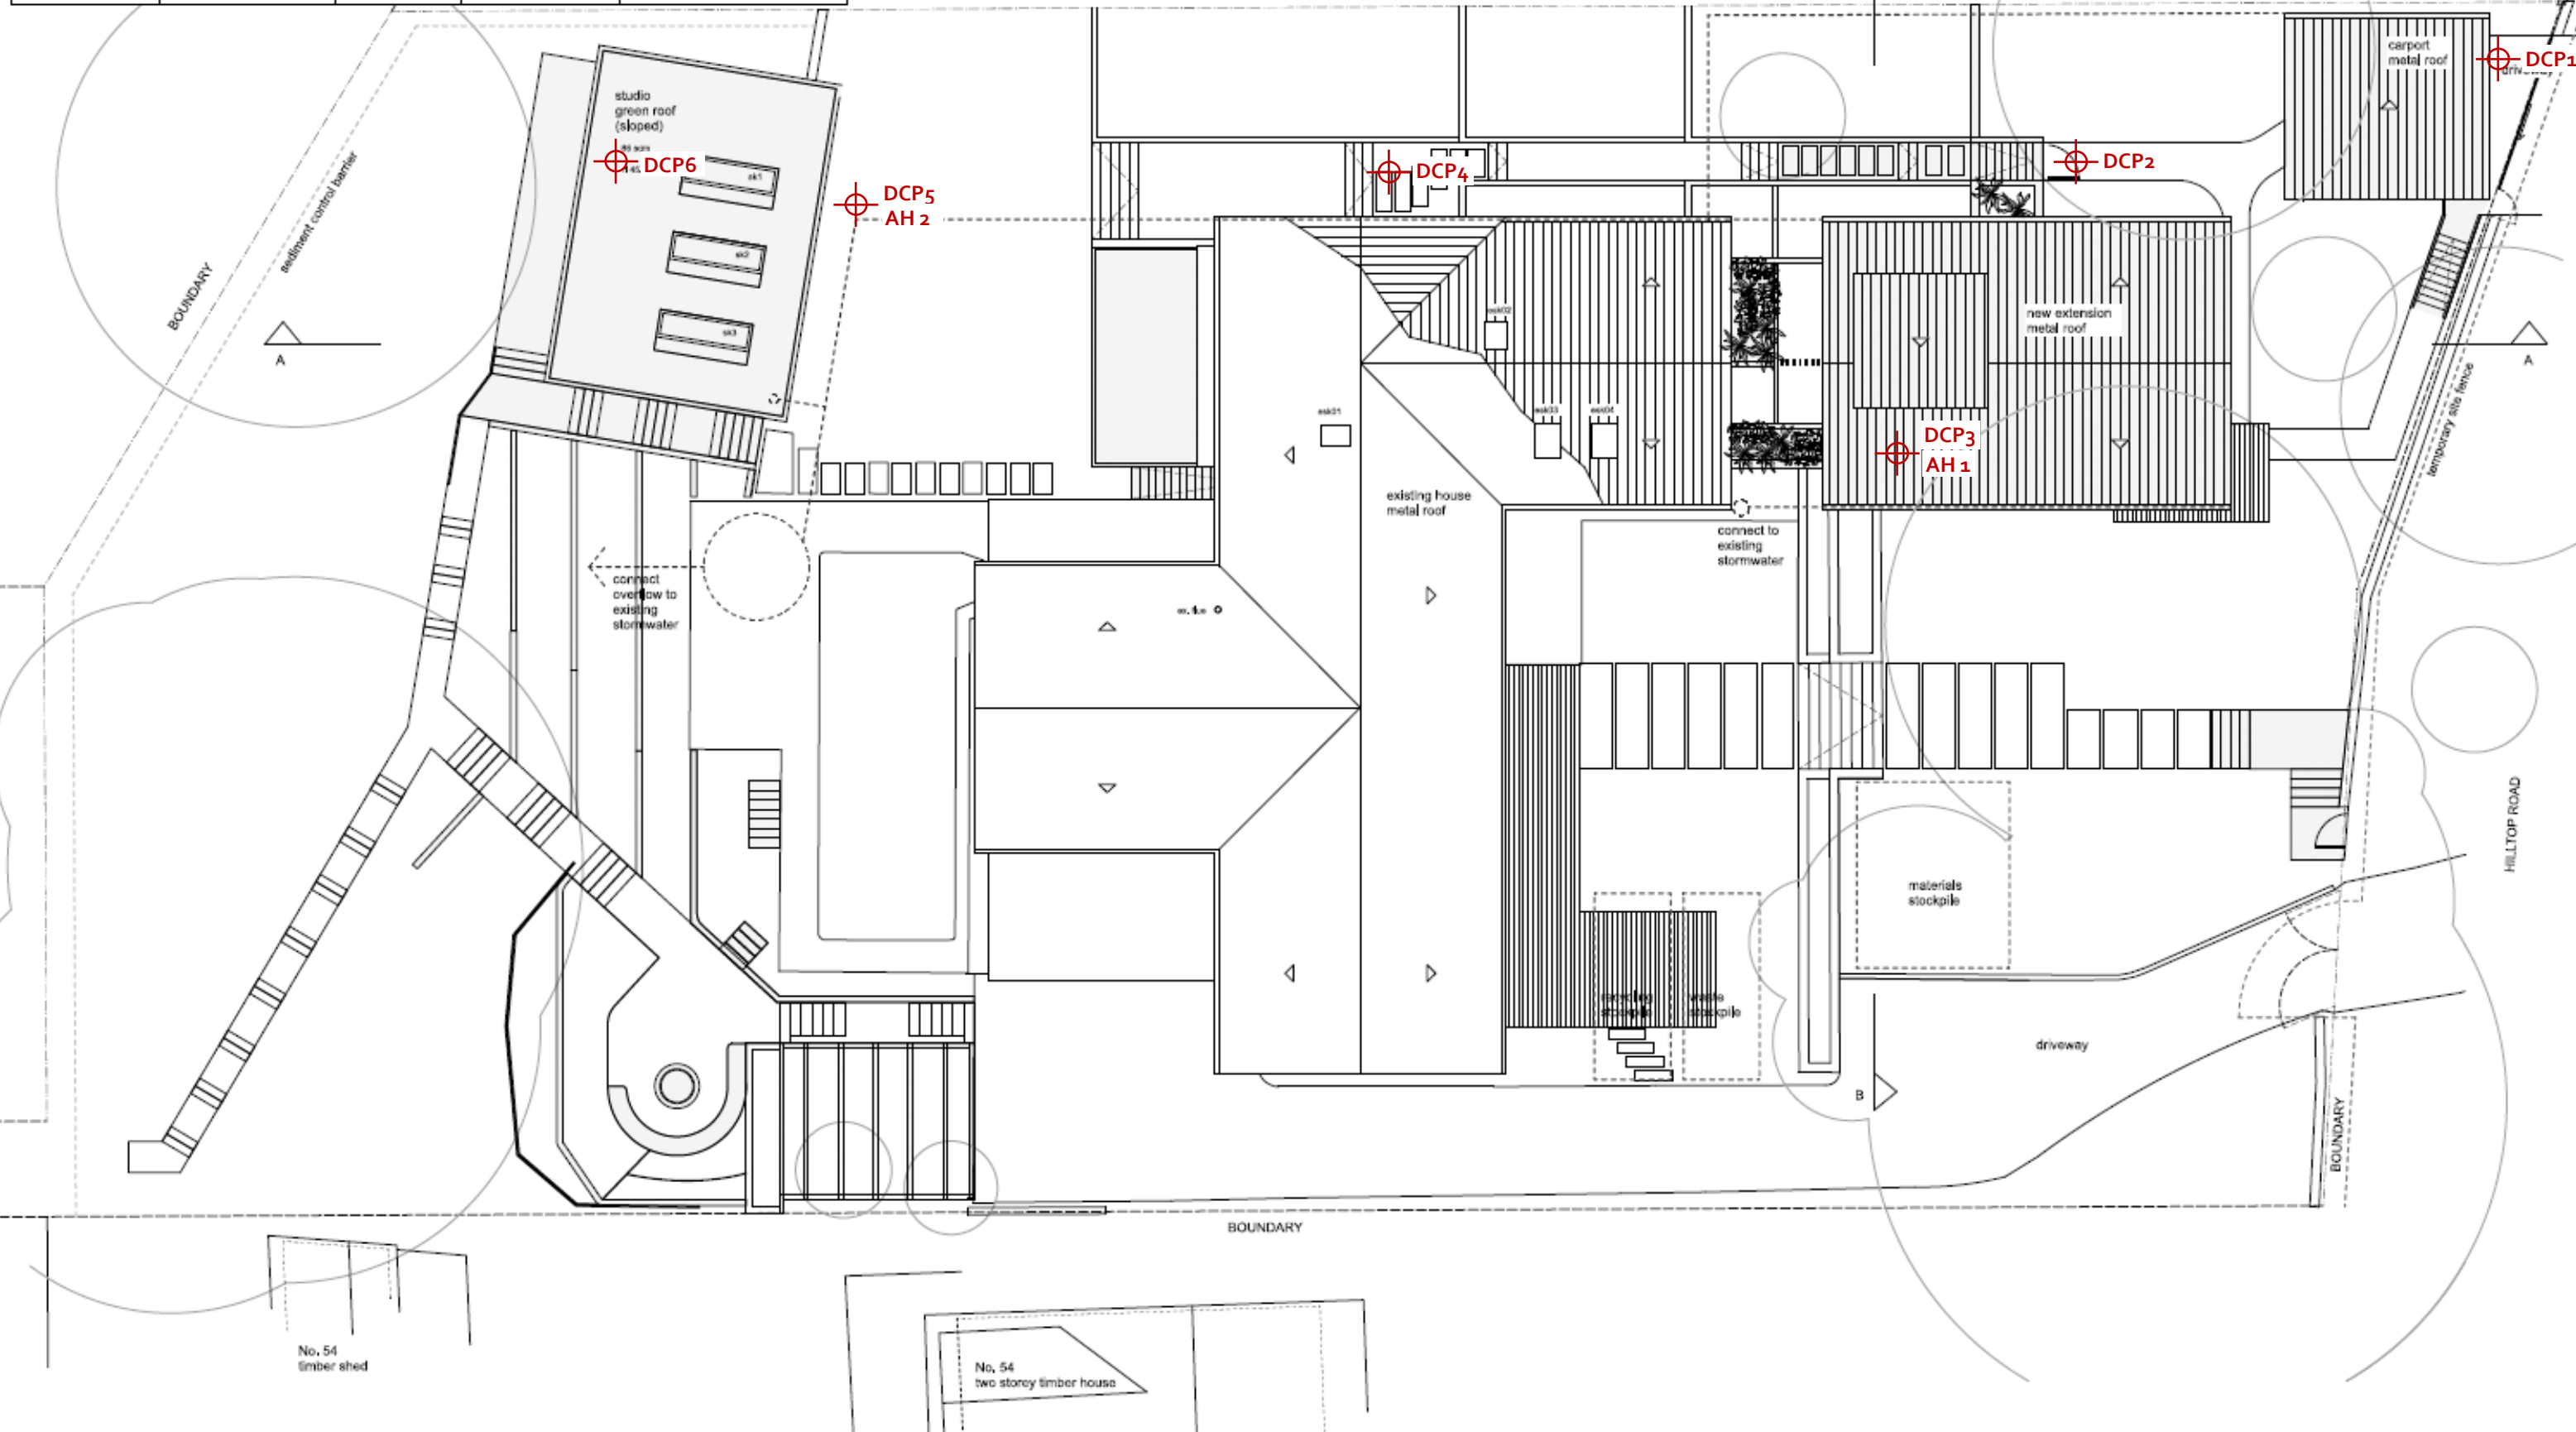
# STUDIO FLOOR PLAN – showing test locations

An excavation to a maximum depth of ~2.5m is required for the proposed house additions. Another excavation to a maximum depth of ~3.3m is required to construct the proposed new studio. The studio excavation comes flush with the N common boundary.

Due to the depths of the excavations and the proximity of the studio excavation to the N common boundary, all sides of the excavations will require ground support installed prior to the commencement of the excavations. See the Mid Ground Floor Plan and Studio Floor Plan attached for the minimum extent of the required shoring shown in blue.

Spaced piled retaining walls are one of the suitable methods of support. Pier spacing is typically ~2.0m but can vary between 1.6 to 2.4m depending on the design. As the excavations are lowered in 1.5m lifts, infill sprayed concrete panels or similar are added between the piers to form the wall. Drainage is to be installed behind the panels. To drill the pier holes for the
