31 July 2018 5QS Ref: 7605

RE: Limited Geotechnical Investigation
Proposed Residence
No 131 Thompson Street, Scotland Island

As requested, 5QS Consulting Group North [5QS] has prepared this report with comments on slope instability risk for the above property. Proposed development of the property is understood to involve the construction of a new pole framed dwelling.

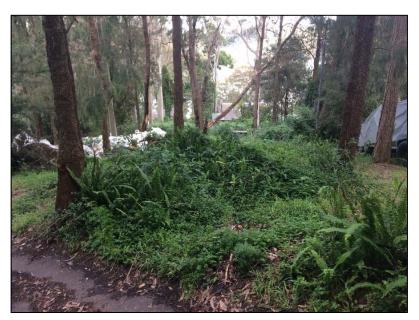
Photograph P1 – View towards south-west, taken from Thompson Street; location of proposed residence in centre of frame

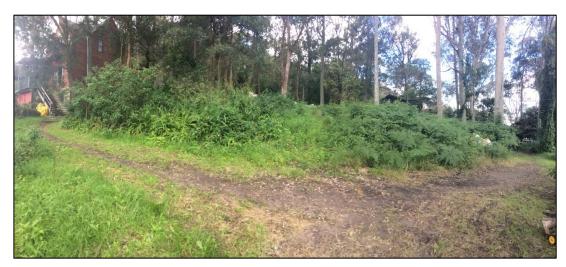
Photograph P3 – View north-west through south-east, taken from near south-western boundary
