## *Arboricultural Impact Assessment & Tree Protection Plan*

Site: 918 Barrenjoey Road Palm Beach 2108

Date of review: 14 February 2022

Version: 3

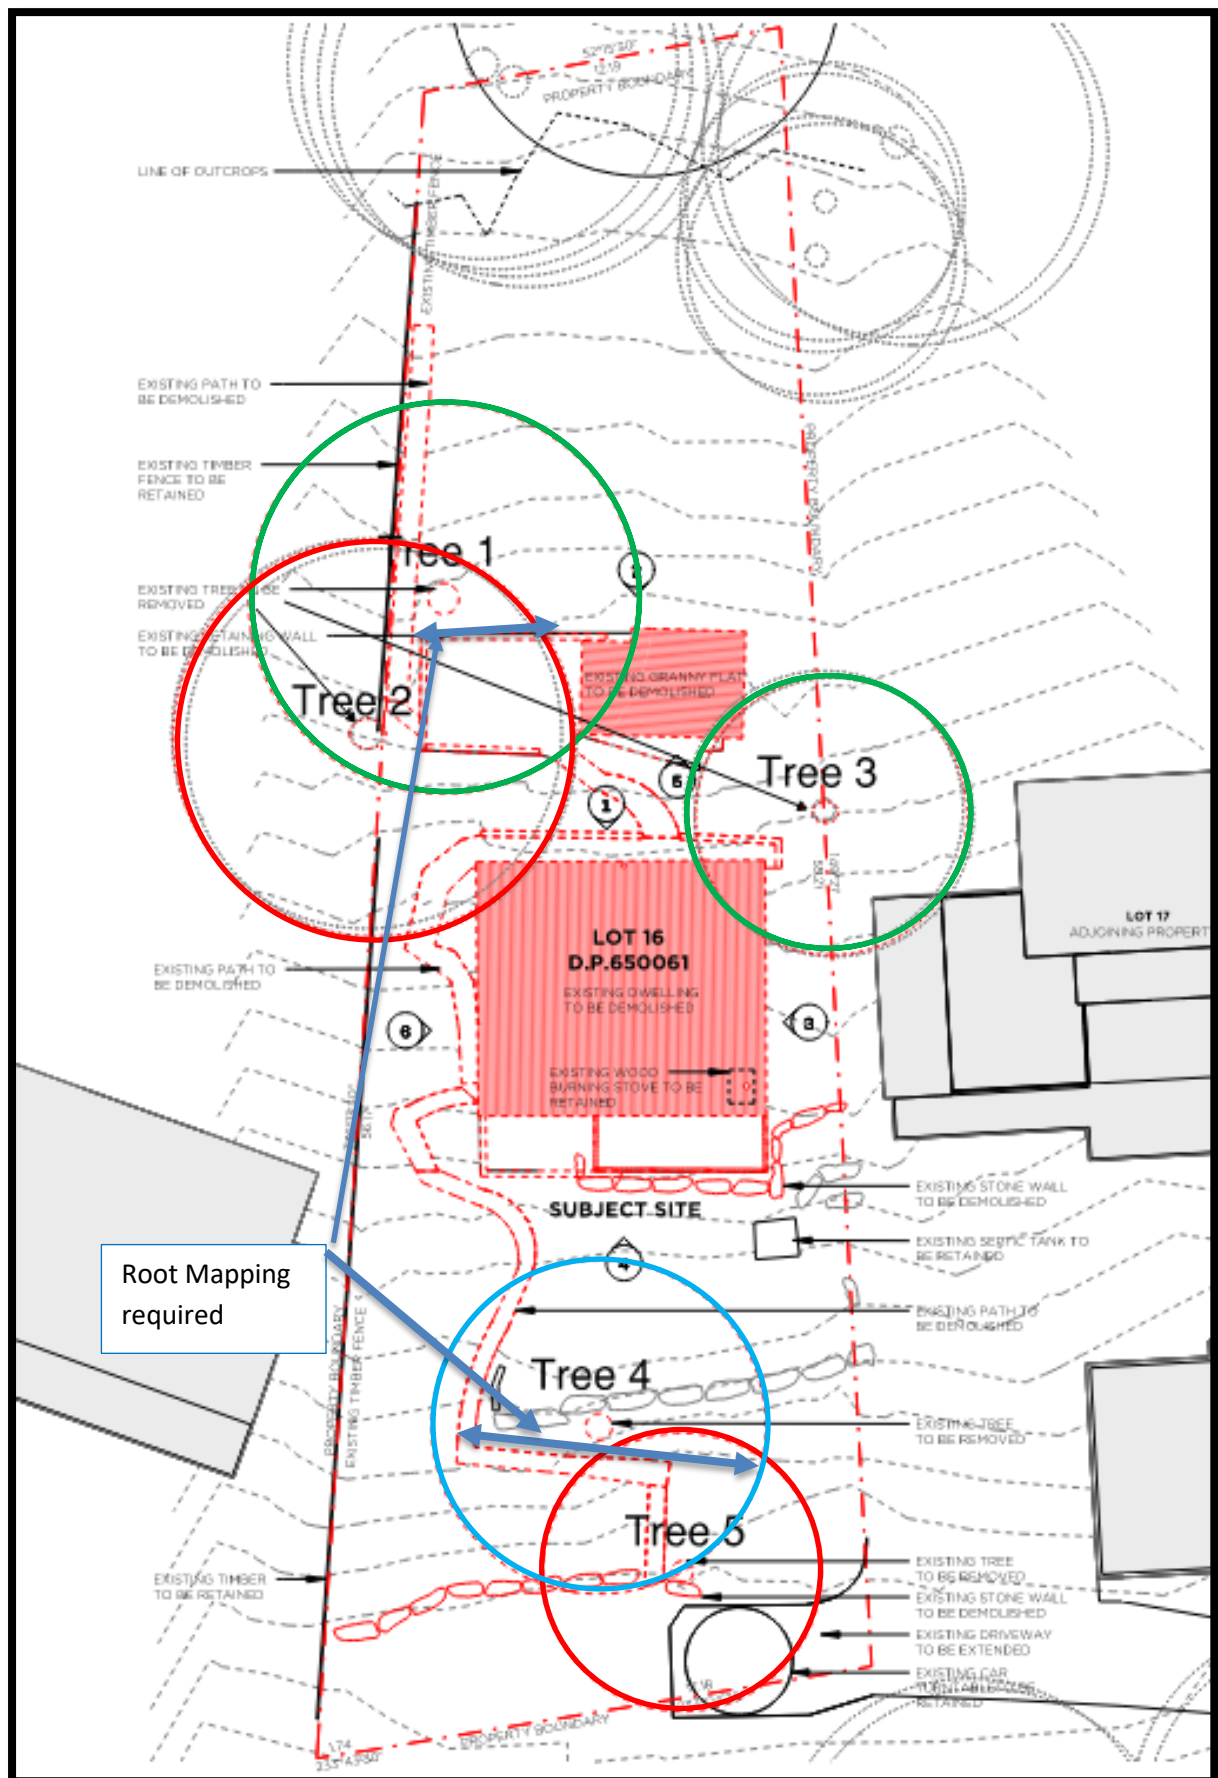
Figure 4 - Existing Site Plan – Trees retained – Green, Remove – red, Further investigation – blue.

| Tree Number | Incursion Percentage % | Retention Value |
|---|---|---|
| 1 | Asymmetric root plate N/A | Retain with conditions |
| 2 | 15 | Remove (APZ Targets) |
| 3 | <5 | Retain |
| 4 | 32% major | Root mapping recommended |
| 5 | 100 | Remove poor health and condition |

- Tree 1 - The site arborist must be present during demolition and excavation within the Tree protection Zone. Excavation shall not exceed the existing footprint of the existing structures. Furthermore, tree sensitive engineering pier footings must be used within the TPZ. For structural support footings the location must be verified via root mapping. Non-destructive excavation is required in addition to certification by the site arborist. The tree is recommended to be retained.

- Tree 2 - To be able to achieve Asset Protection Zone targets there is no viable pruning option of branches in a manner that does not overhang the dwelling and in accordance with the Australian Standard AS4373 "Pruning of Amenity Trees". The tree is recommended to be removed.

- Tree 3 - The tree is recommended to be retained.
- Tree 4 - The garage retaining wall has a setback of 2.2m from the centre of the tree. This results in a 32% major incursion of the TPA & SRZ.

- Tree 5 - The tree is in advanced decline and there are no viable remediation methods. The tree may be replaced with the same species.
