Geotechnical Assessment

Project: New Dwelling
71 Wimbledon Avenue, North Narrabeen NSW

Ref: AG 25215
3 June 2025

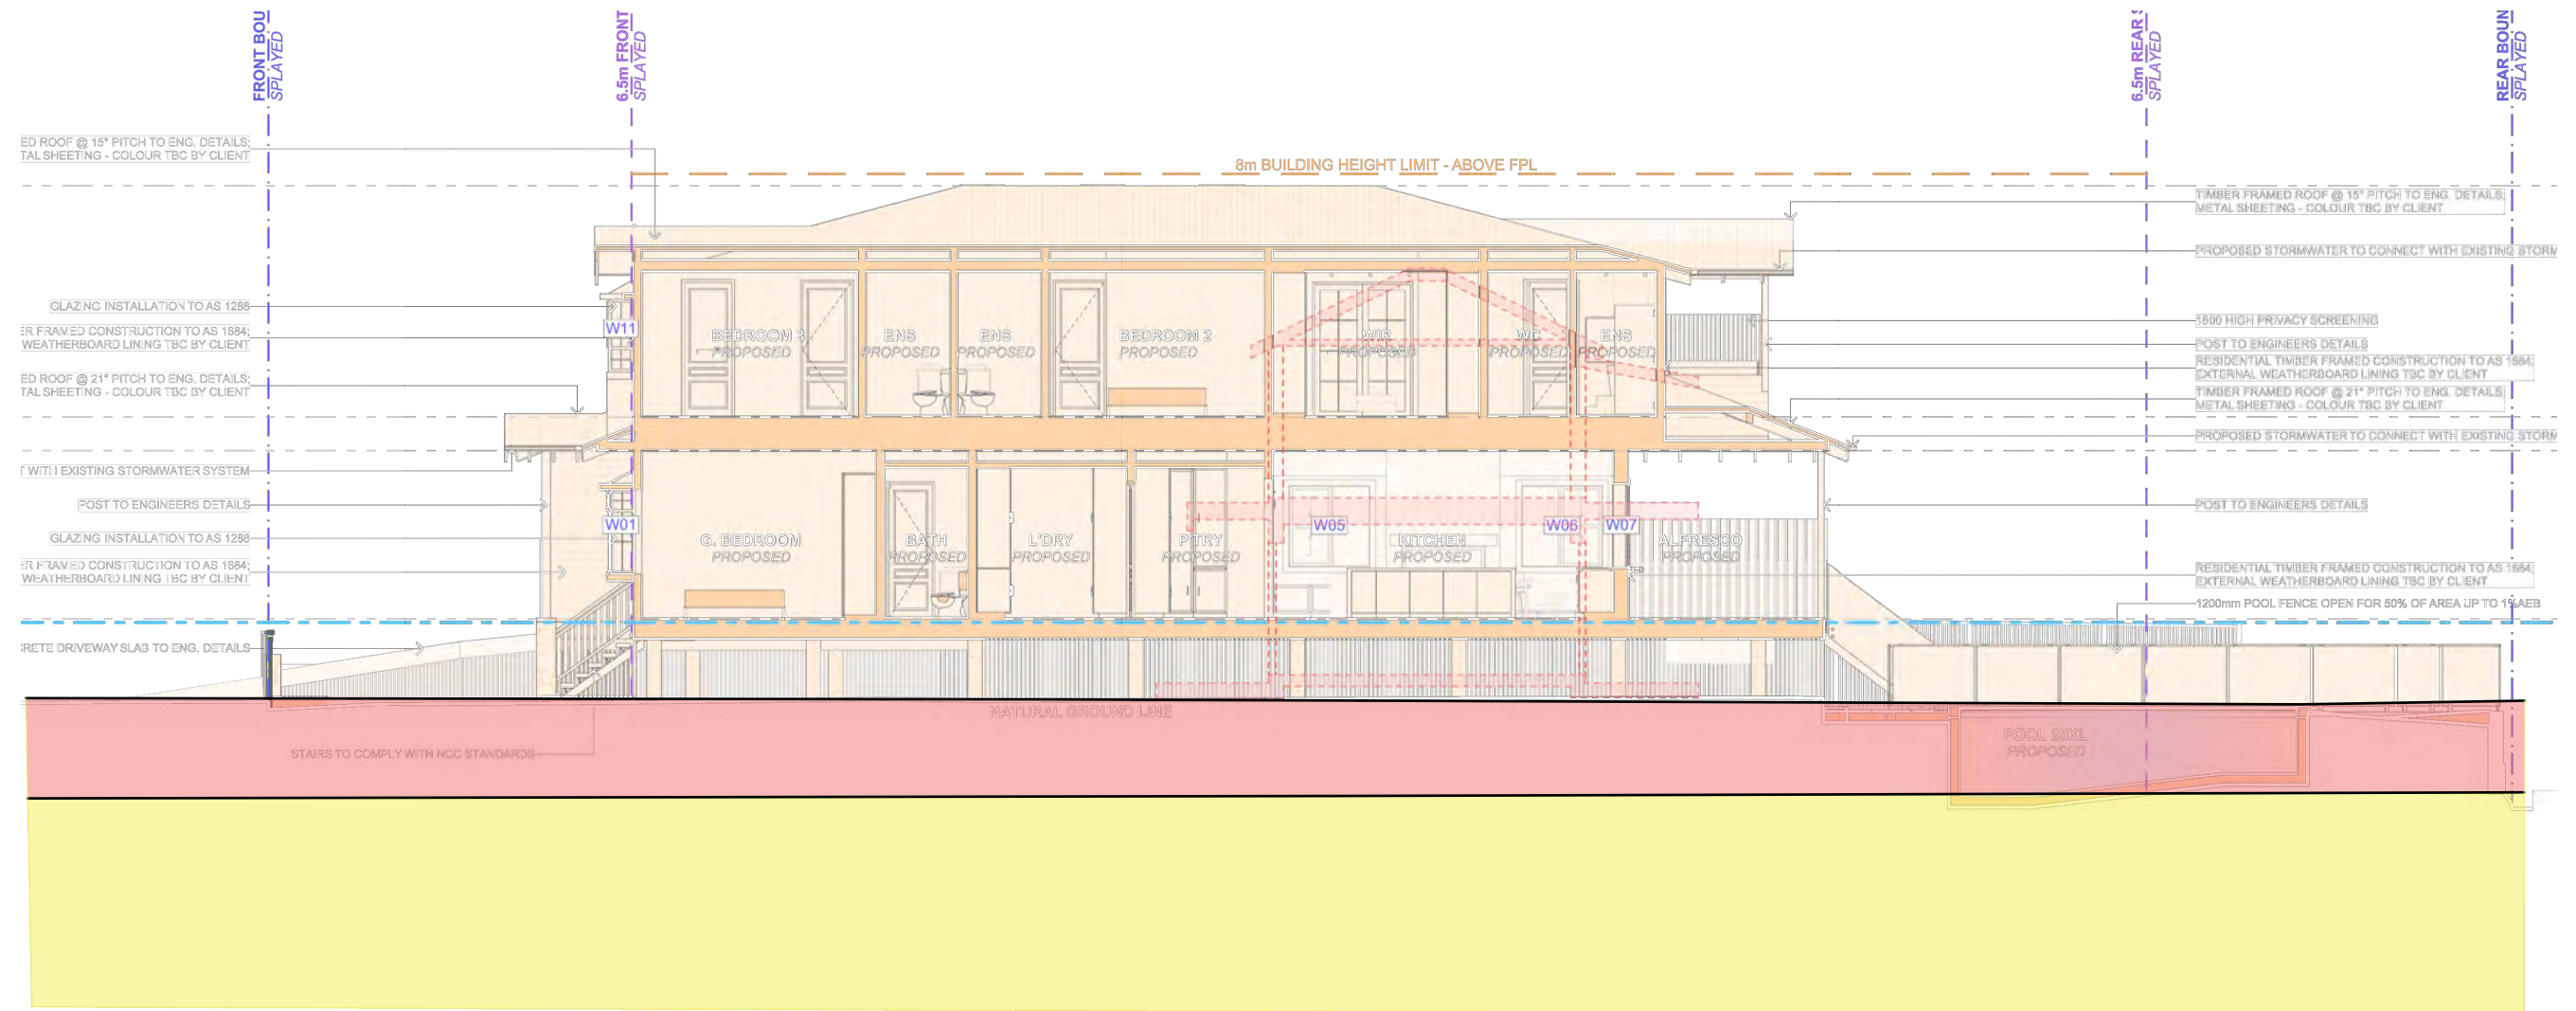
INFERRED GEOLOGICAL SECTION
SCALE NTS

INTERPRETED SUBSURFACE SECTION ONLY.
ACTUAL GROUND CONDITIONS MAY VARY.

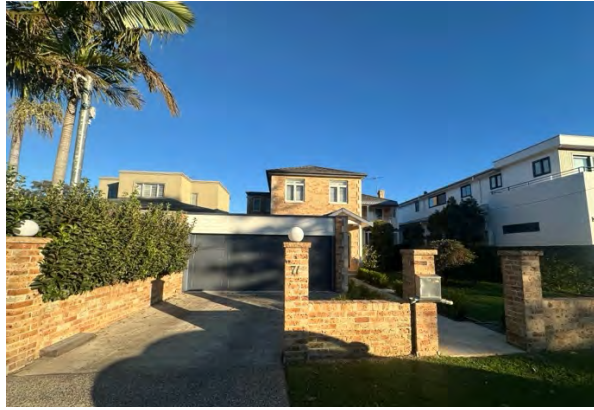
Photo 1: Site frontage, looking west.

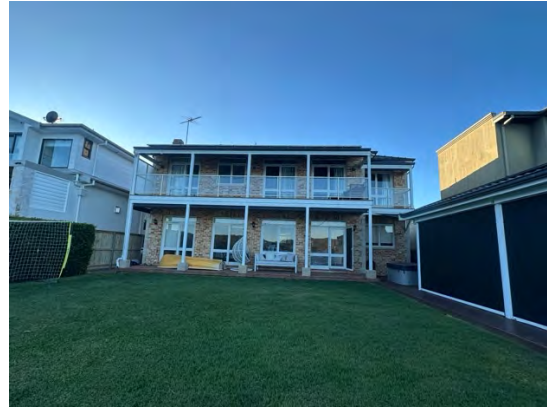
Photo 2: Photo taken from western boundary, looking east.

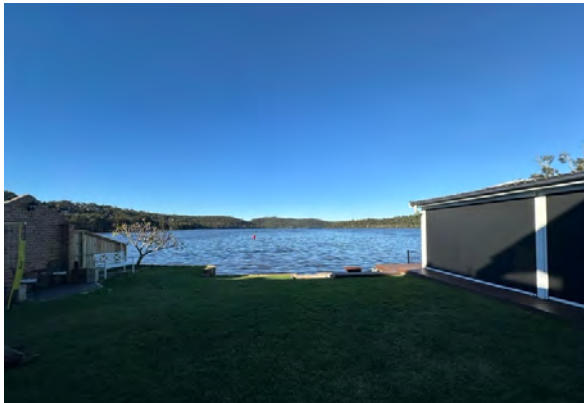
Photo 3: Rear yard of site looking west.

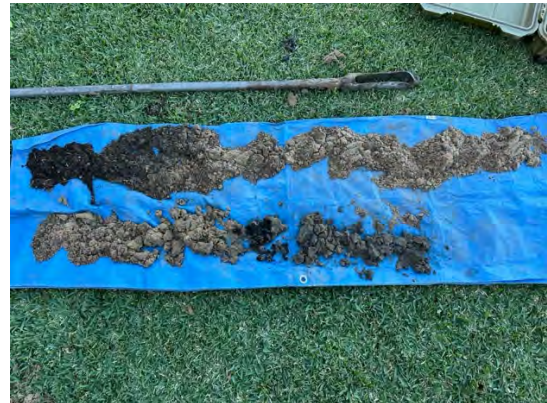
The soil profile consists of shallow uncontrolled silty fill and silty topsoil (O & A Horizons) and silty sand (B Horizon). Based on our observations and the results of testing on site, silty sands were observed to a depth of 3.6m (practical limit of test) and are expected to extend to unknown depths.

Photo 4: Subsurface soil profile of BH01.
