## **REPORT ON GEOTECHNICAL SITE INVESTIGATION**

**PROPOSED NEW HOUSE**

**2075 PITTWATER ROAD, BAYVIEW**

**Project: 2012-176**

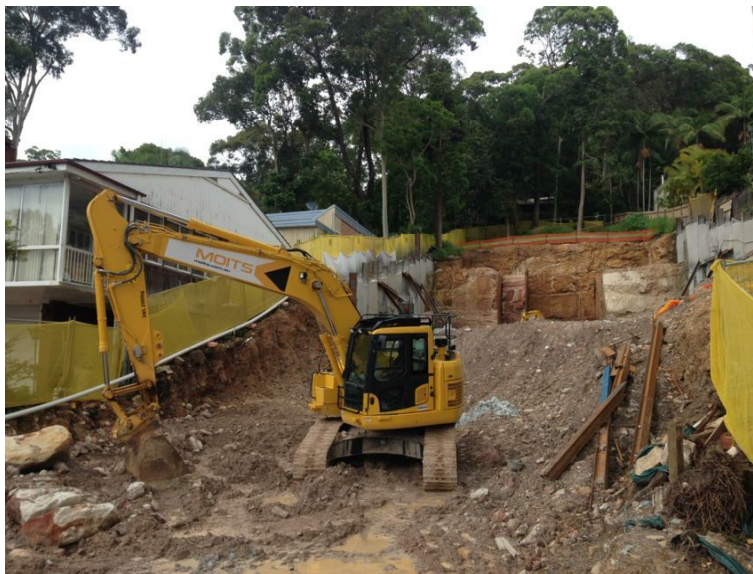
The neighbouring property to the north (No. 2079) is currently under development at the time of the most recent inspection. The previous site structures have been demolished and excavation works have been carried out across the site to 6.0m depth at the rear. The excavation extends to within 0.50m of the common boundary with the front half of the excavation not supported along the boundary and the western half along this perimeter supported by a steel and concrete support wall (see Photo: 1 below).

*Photo: 1 – Development underway in No. 2079*
