# Construction Impact Assessment and Management Plan

## 7 Rock Bath Road, Palm Beach

**Prepared for:** Dylan Ferrell Design

**Dated:** December, 2018

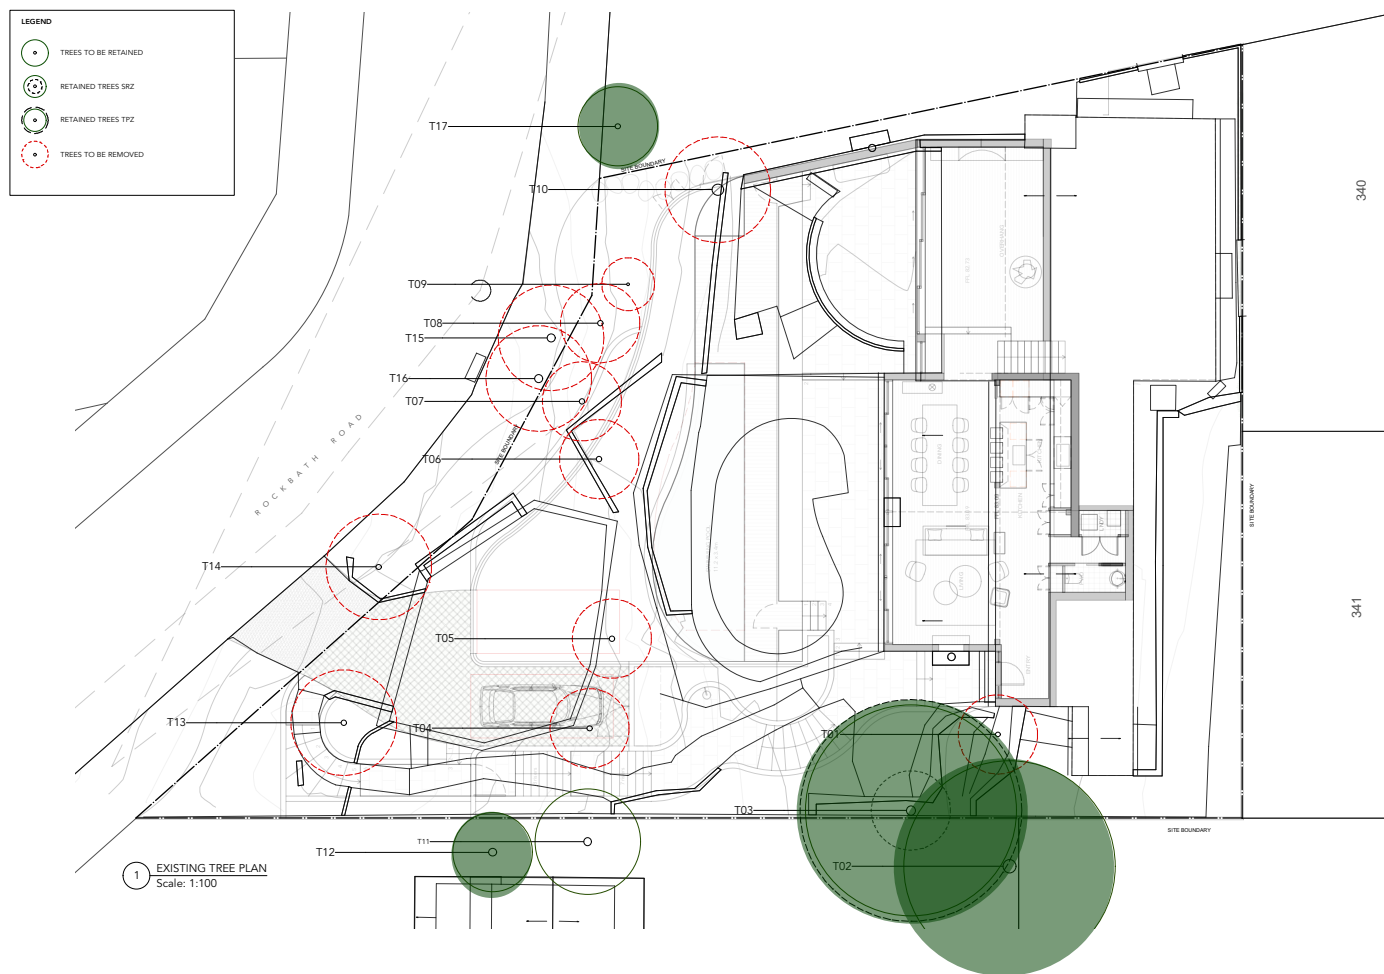
**Figure 1** Shows the locations of the documented trees in relation to the proposed development and the TPZ required for ongoing consideration.

8.3 All Tree Protection Zones as outlined in **Figure 1** will need to be recognised and all works with them done in accordance with AS4970 Standards for the Protection of Trees on Development Sites.

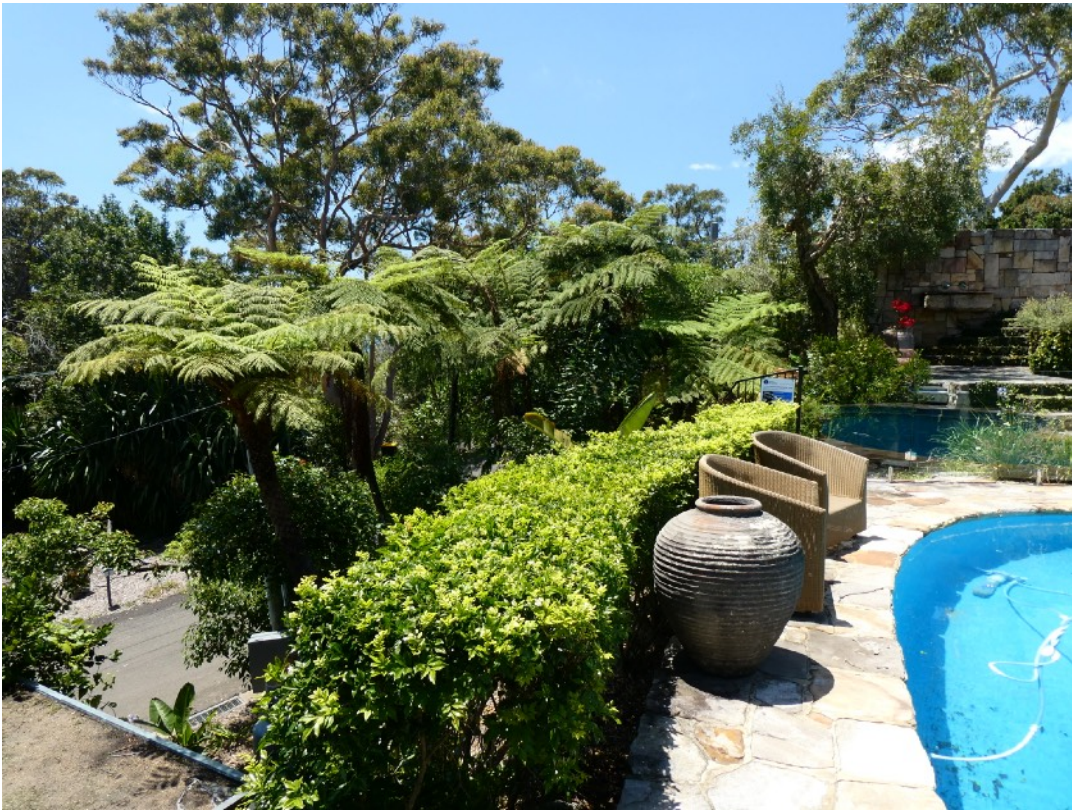
5.3 There is a stand of well established *Cyathea cooperi*, or Australian tree ferns (Trees 4, 5, 6, 7 and 8) located between the rear of the carport and the swimming pool. These appear to be in both good health and condition, clearly benefiting from high soil moisture levels and an impermeable, underground bedrock.

**Figure 2** Shows the existing pool and the tree ferns required for removal.

7.1 The proposed works will involve the excavation of the front portion of the site to allow for the construction. This will require the removal of those trees located here. This includes the *Cyathea cooperi*, or Tree frees detailed as Trees 4, 5, 6, 7 and 8.

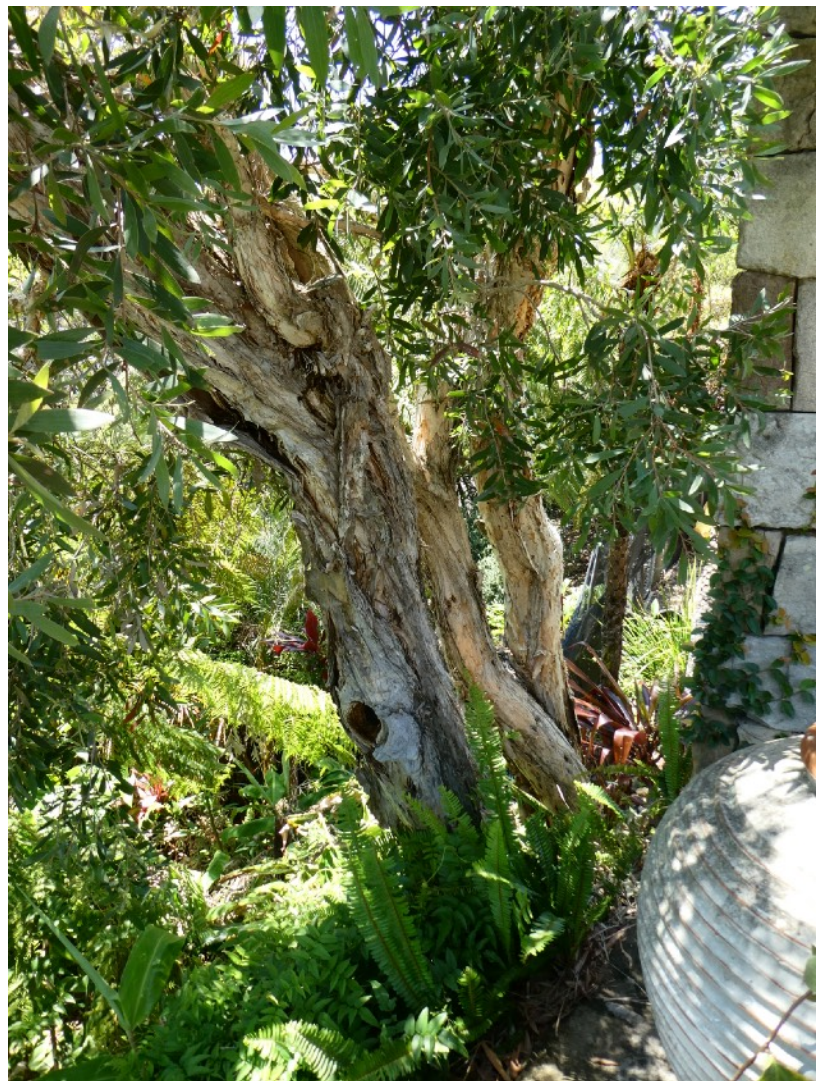
6.7 Trees 10 and 17 are both *Melaleuca quinquenervia*, or Paperbark trees located within the front garden. These are a native tree species that will have been planted here as part of the early landscape works that will have occurred following this portion of the construction. As noted, both have been reduction pruned, or “lopped” to maintain visual access to Palm Beach and the ocean.

**Figure 3** Shows the poor basal structure of the *Melaleuca* documented as Tree 10.

8.1 It will be recommended that Trees 1, 4, 5, 6, 7, 8, 9, 10, 13 and 14 be removed for the reasons outlined. This should be done in accordance with WorkCover Standards [http://www.safework.nsw.gov.au/\\_data/assets/pdf\\_file/0009/52866/Amenity-Tree-Industry-Code-of-Practice.pdf](http://www.safework.nsw.gov.au/_data/assets/pdf_file/0009/52866/Amenity-Tree-Industry-Code-of-Practice.pdf). following formal approval from Northern Beaches Council.
