## **GEOTECHNICAL INVESTIGATION:**

For Proposed Landscaping at **15 Myoora Road, Terrey Hills**

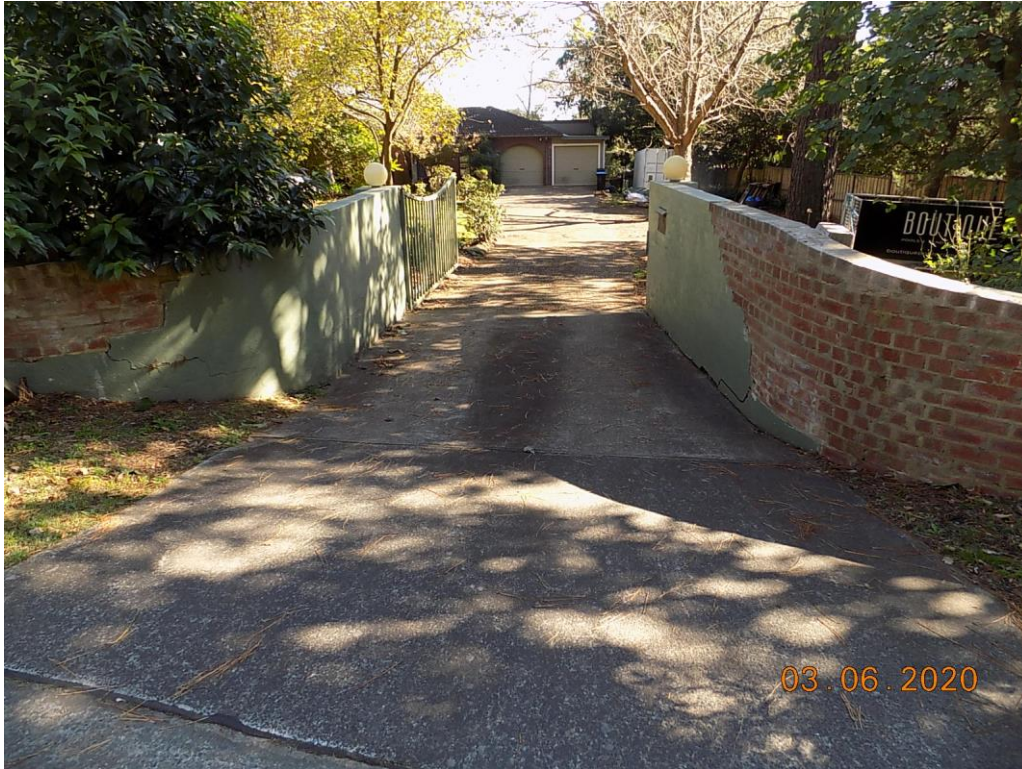
Photo 1

- 2.3** At the N end of the road frontage, a concrete driveway runs to a brick and weatherboard clad house on the E side of the property that will be demolished as part of a previous DA (Photos 1 & 2). Another gravel driveway extends off the S end of the road frontage and runs along the uphill side of the property past construction works which are also part of a previous DA (Photo 3). The fill batter for the equestrian arena is lawn-covered, battered to stable angles, and merges into the natural slope (Photo 4). At the base of the fill batter is a small dam that will be filled in as part of the

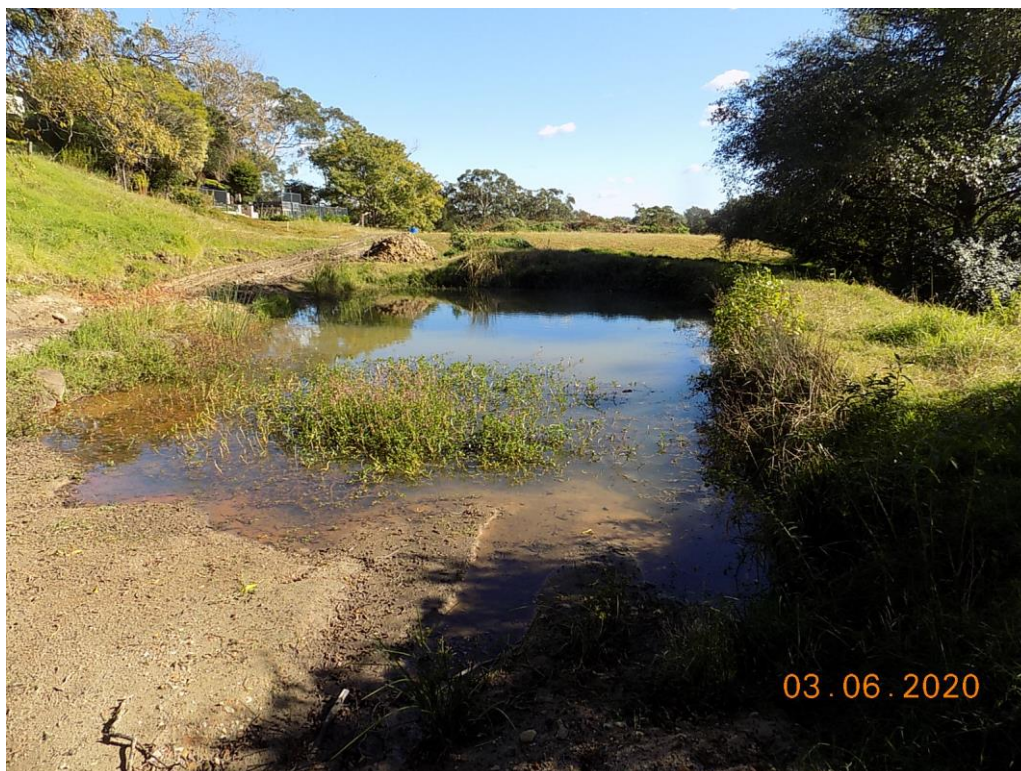
Photo 5

proposed works (Photo 5). The gravel driveway runs to the main house near the W end of the property (Photo 6). The two-storey brick house is supported on brick walls and brick piers (Photo 7). The supporting brick walls display no significant signs of movement and the supporting brick piers stand vertical. An excavation has been made on the downhill side of the house for a pool (Photo 8). The slope between the house and the pool has been terraced with a series of low timber retaining walls. The retaining walls and pool will be demolished as part of the previous DA. The slope below the house and pool is lawn-covered and fenced off for paddocks (Photos 9 & 10). Competent Medium Strength Sandstone outcrops through the lawn in places (Photo 11). Filling has been placed within a paddock on the downhill side of the property, to the N of the existing pool (Photo 12). The fill batter in this location is lawn-covered, battered to stable angles, and merges into the natural slope.

The existing dam below the equestrian arena will need to be emptied. The dam liner, whether it be clay or synthetic, will need holes punched through it so seepage can move through the soil profile.

Where the fill will be placed over the existing dam, the material is to be compacted in an equivalent manner to the surrounding soil.

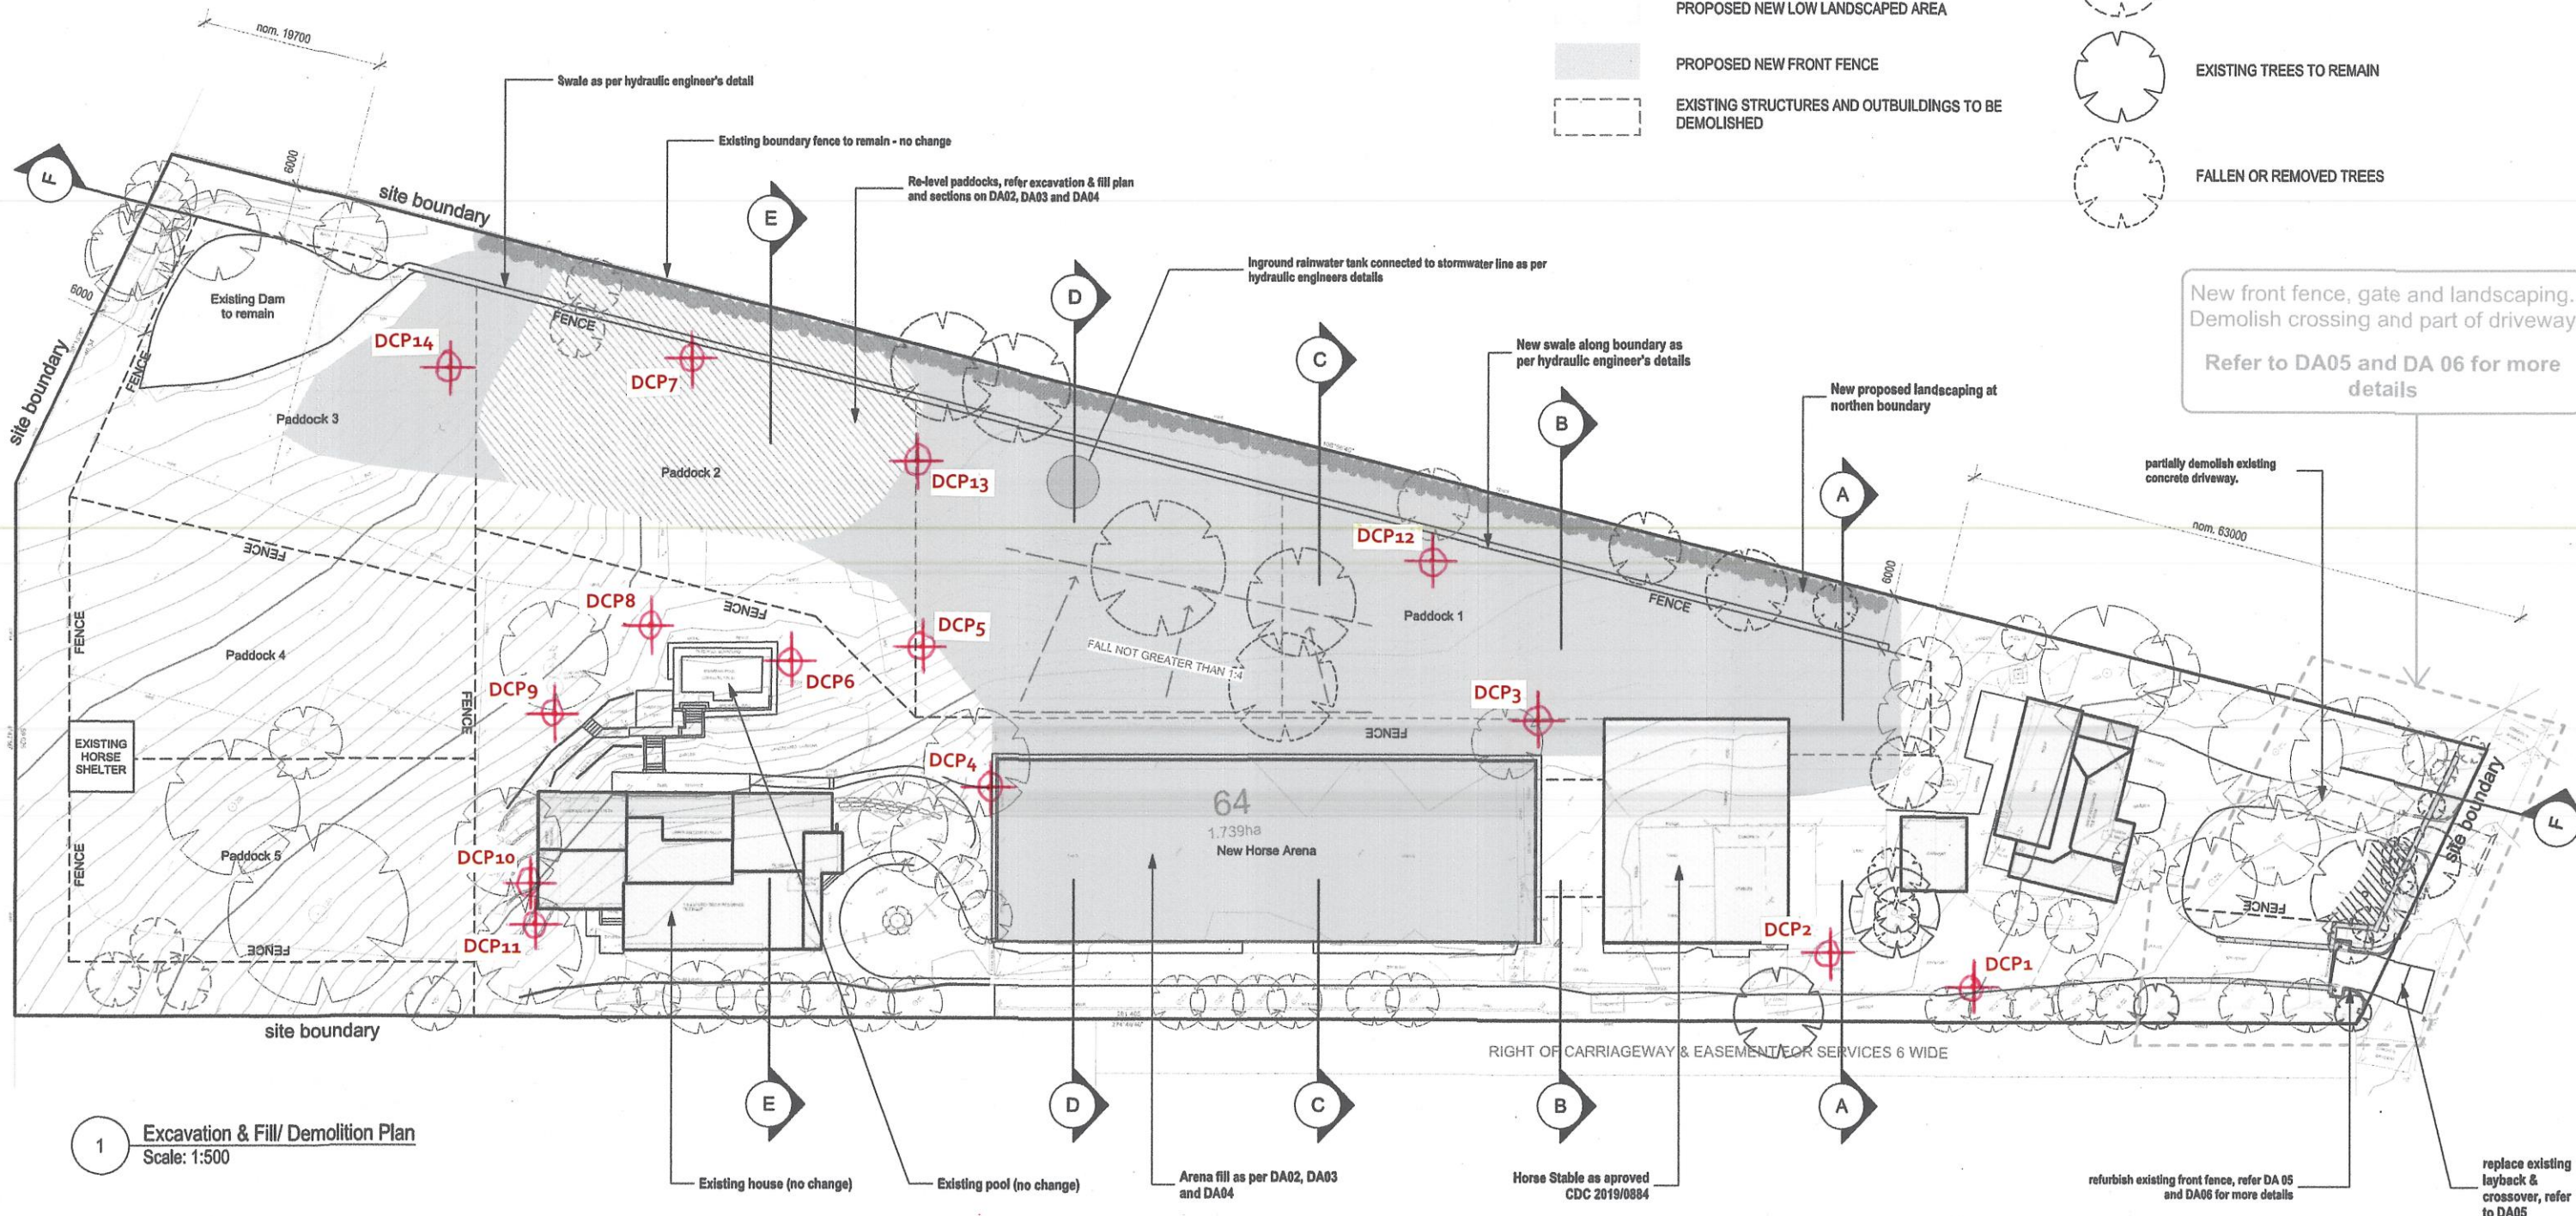
SITE PLAN – showing test locations

Fourteen Dynamic Cone Penetrometer (DCP) tests were put down to determine the relative density of the overlying soil and the depth to bedrock. The locations of the tests are shown on the site plan. It should be noted that a level of caution should be applied when interpreting

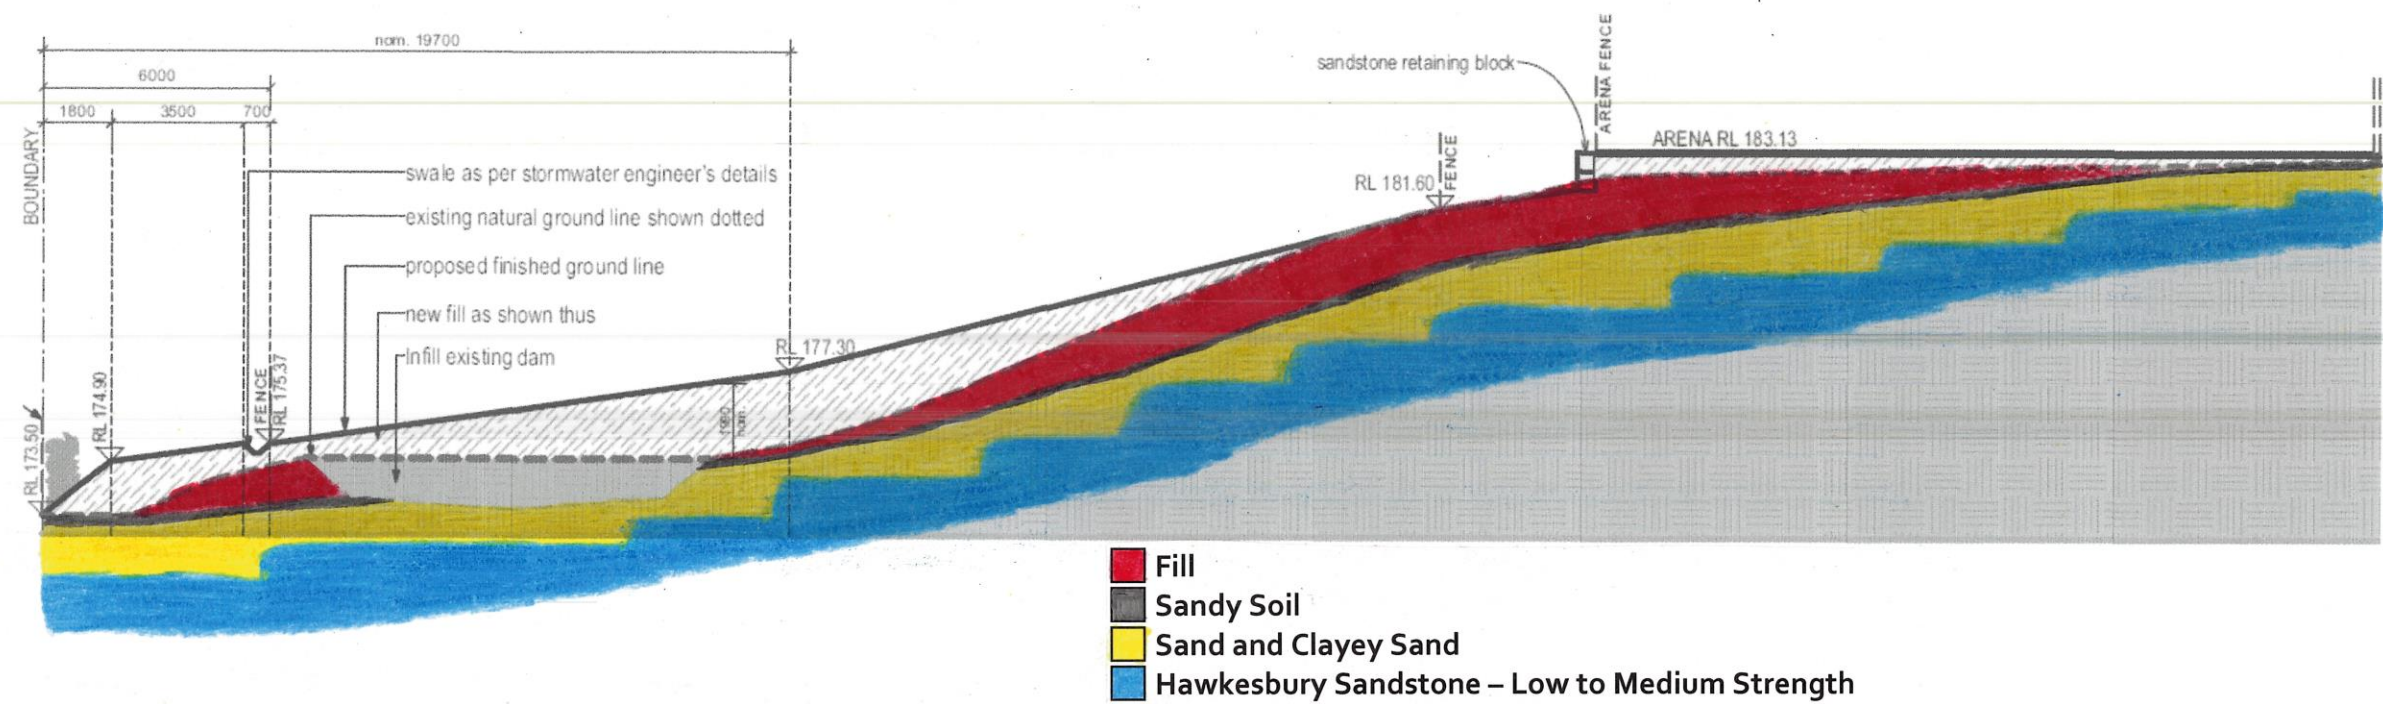
TYPE SECTION – Diagrammatical Interpretation of expected Ground Materials

The surface features of the block are controlled by the outcropping and underlying sandstone bedrock that steps down the property forming sub-horizontal benches between the steps. Where the grade is steeper, the steps are larger and the benches narrower. Where the slope eases, the opposite is true. Filling has been placed across the N side of the property for landscaping. Where the rock is not exposed, it is overlain by manmade fill, sandy soils, and sandy clays that fill the bench step formation. In the test locations, rock was encountered at shallow depths of ~0.6m or less below the current surface but extended to a maximum depth of ~1.9m. As stated above, some of the previous tests are likely to have encountered refusal on obstructions within the fill and during the foundation excavations for the approved stables, rock was not encountered until depths of between 2.0 to 3.6m in that location. The variation in the rock depth are likely due to the rock being slightly deeper where filling has been placed across the site and due to the stepped nature of the underlying bedrock. During previous inspections on site, it was found that the fill for the equestrian arena reaches a maximum depth of ~1.5m, and it is interpreted that the fill within the paddock on the downhill side of the property also reaches a maximum depth of ~1.5m. The sandstone underlying the property was found to be of low to medium strength and similar strength rock is expected to underlie the entire site. See Type Section attached for a diagrammatical representation of the expected ground materials.
