## **GEOTECHNICAL INVESTIGATION:**

### **Alterations and Additions at 108 Cabarita Road, Avalon Beach**

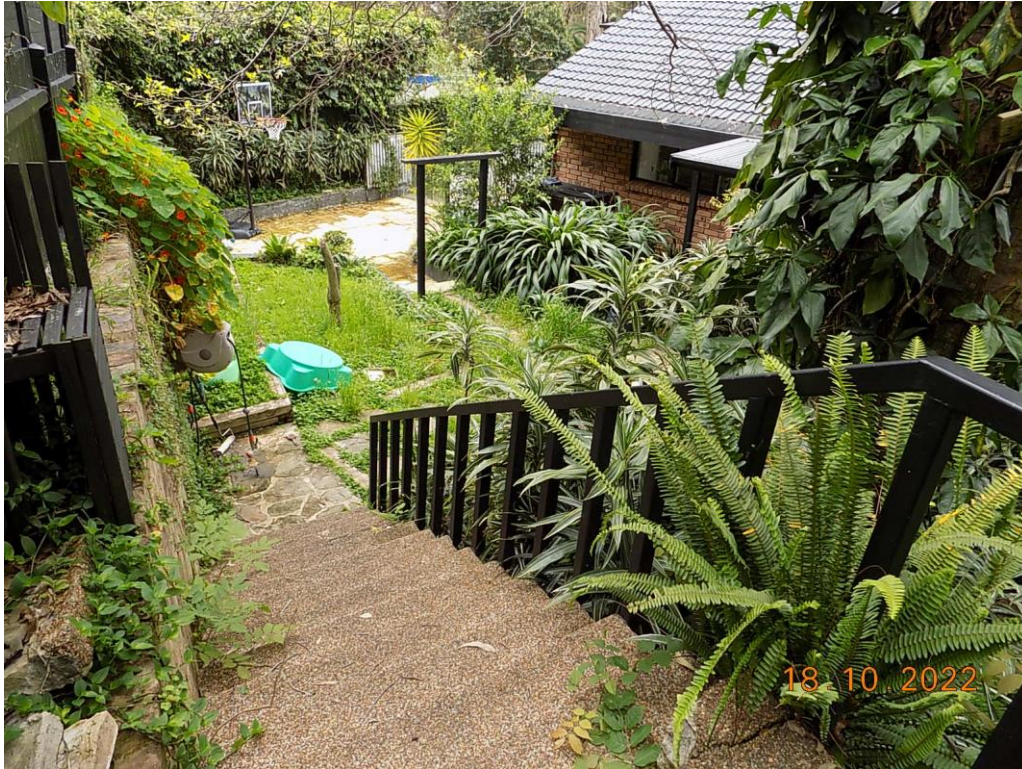
Photo 1

- 2.3** A brick retaining wall ~2.1m high is located along the uphill property boundary that supports the fill for the road reserve and a cut for lawn and garden area on the subject property (Photo 1). Stepped cracking was observed in the mortar between the bricks of the wall (Photo 2). **See Section 12** for recommendations regarding this wall. Low brick and rendered masonry retaining walls support cuts for level paved and lawn/garden areas on the uphill side of the house (Photo 3). A cut has been made in the slope to create a level platform for the S corner of the house. This cut is supported

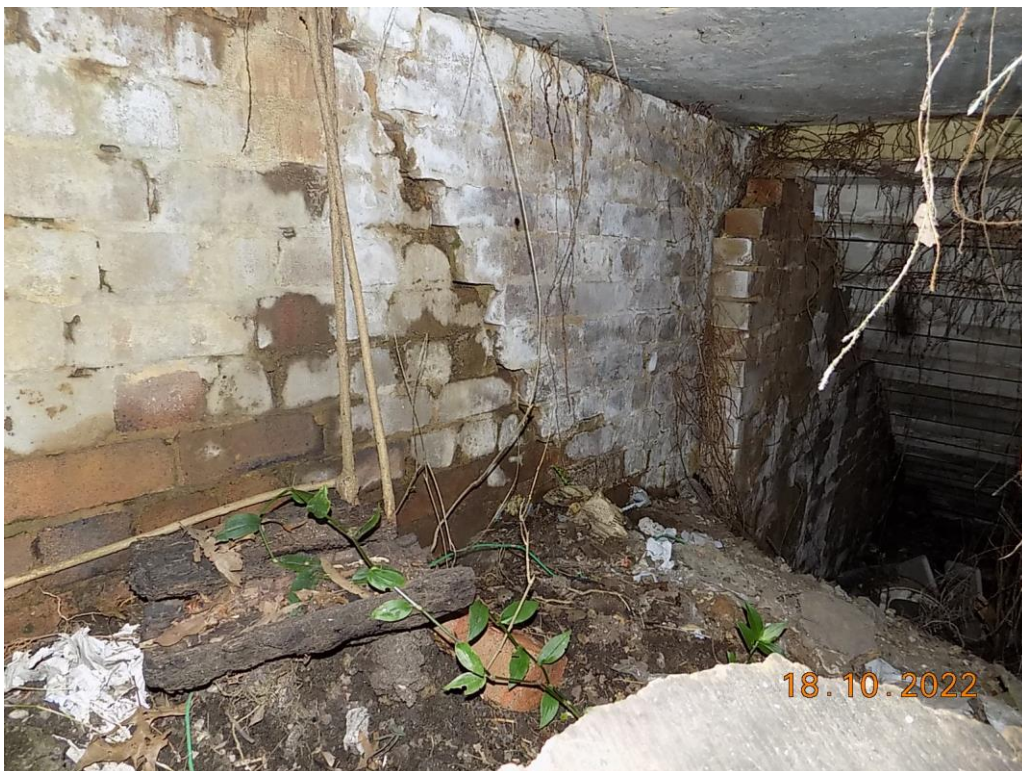
Photo 2

Stepped cracking was observed in the mortar between the bricks of the walls supporting the fill and cut on the uphill side of the property (Photo 2). To be prudent, we recommend the retaining walls be inspected by the owners on a biannual basis or after heavy prolonged rainfall, whichever occurs first, keeping a photographic record of the inspections. We can carry out these inspections upon request. Should any new movement be observed, the geotechnical consultant is to be engaged to assess the movement and provide remedial advice if necessary.

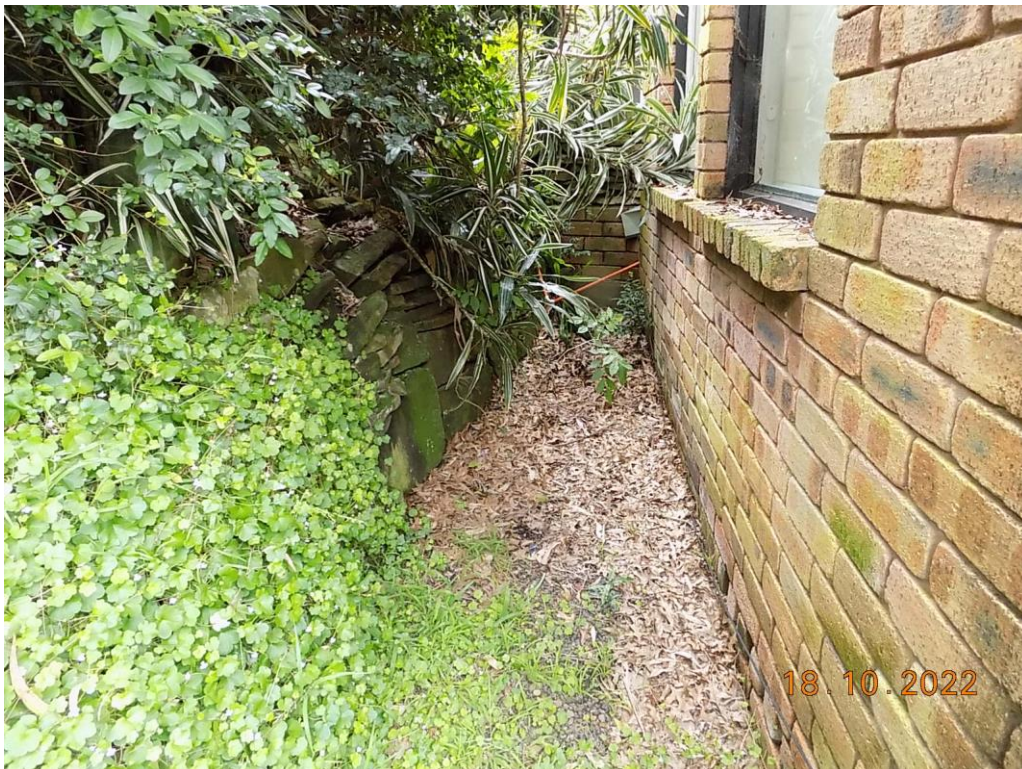
Photo 4

by a stable stack rock wall ~1.0m high (Photo 4). The part three-storey house is supported on brick walls and brick piers (Photo 5). The walls and piers appear to stand vertical and show no signs of deflection. An excavation has been made under the house for the lower floor (Photo 5). The cut has been taken entirely through competent sandstone bedrock and displays no signs of geological defects. This is expected to be a band of sandstone in an otherwise shale dominated profile. On the N side of the house is a pool (Photo 6). The water level of the pool indicates no ground movement has occurred in the shell of the pool since its construction. A partially suspended concrete driveway in the NE corner of the property is accessed by a Right of Carriageway (ROW) off Cabarita Road and runs up the slope to a garage on the lower ground floor of the house (Photo 7). The concrete columns supporting the downhill side of the driveway appear to stand vertical (Photo 8). On the downhill side of the driveway, the slope falls steeply to the E corner of the property (Photo 9). This slope is densely vegetated. Immediately underneath the driveway is an exposed fill batter (Photo 10). The slope is partially terraced on the S side of the slope. The terraces are supported by a series of timber retaining walls ~1.0m high (Photo 11). The walls were observed to be tilting downslope at a maximum angle of ~5°. The owner has informed us that the exposed batter and retaining walls will be replaced in the future. We recommend this be carried out within 2 years of the date of this report.

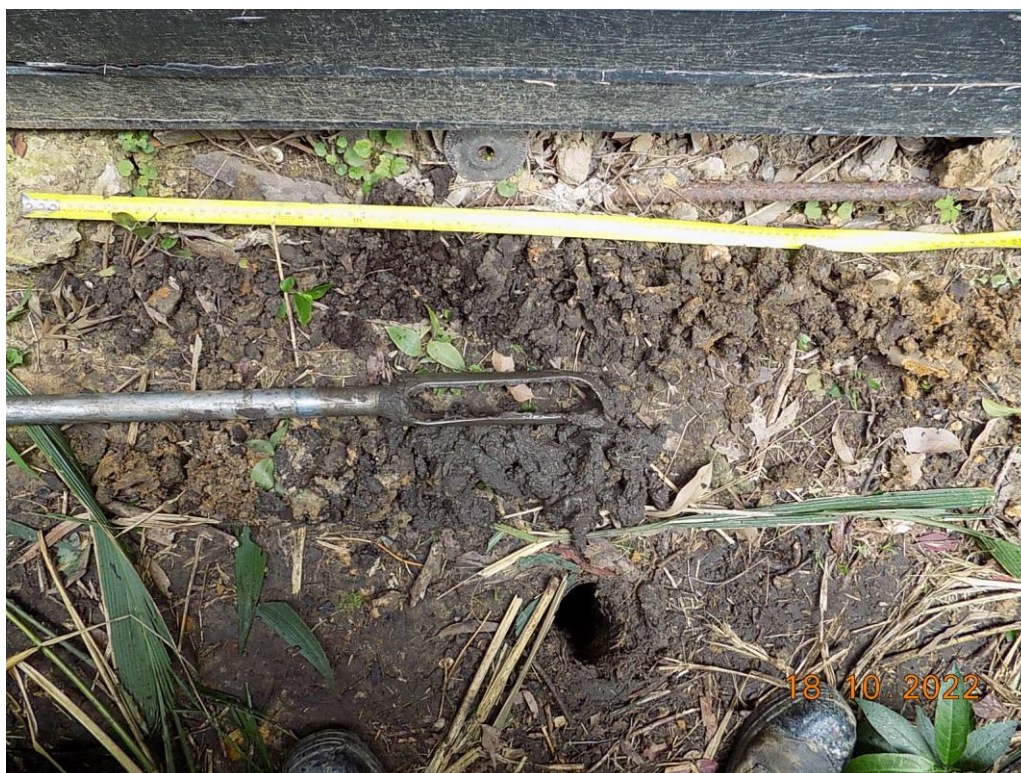
Photo 12 (Downhole is from Top Left to Bottom Right)

#### **AUGER HOLE 1 (~RL20.6) – AH1 (Photo 12)**

| <b>Depth (m)</b> | <b>Material Encountered</b> |
|---|---|
| 0.0 to 1.3 | <b>FILL</b> , disturbed clayey sand and clay, dark brown, brown and orange, very loose to loose, damp, fine to medium grained with rock fragments and fine trace organic matter. |
| 1.3 to 1.5 | <b>CLAYEY SOIL</b> , dark brown, wet, fine to medium grained. |
| 1.5 to 1.6 | <b>SANDY CLAY</b> , dark brown, stiff, wet, fine to medium grained. |

Refusal @ 1.6m auger grinding on rock. No water table encountered.

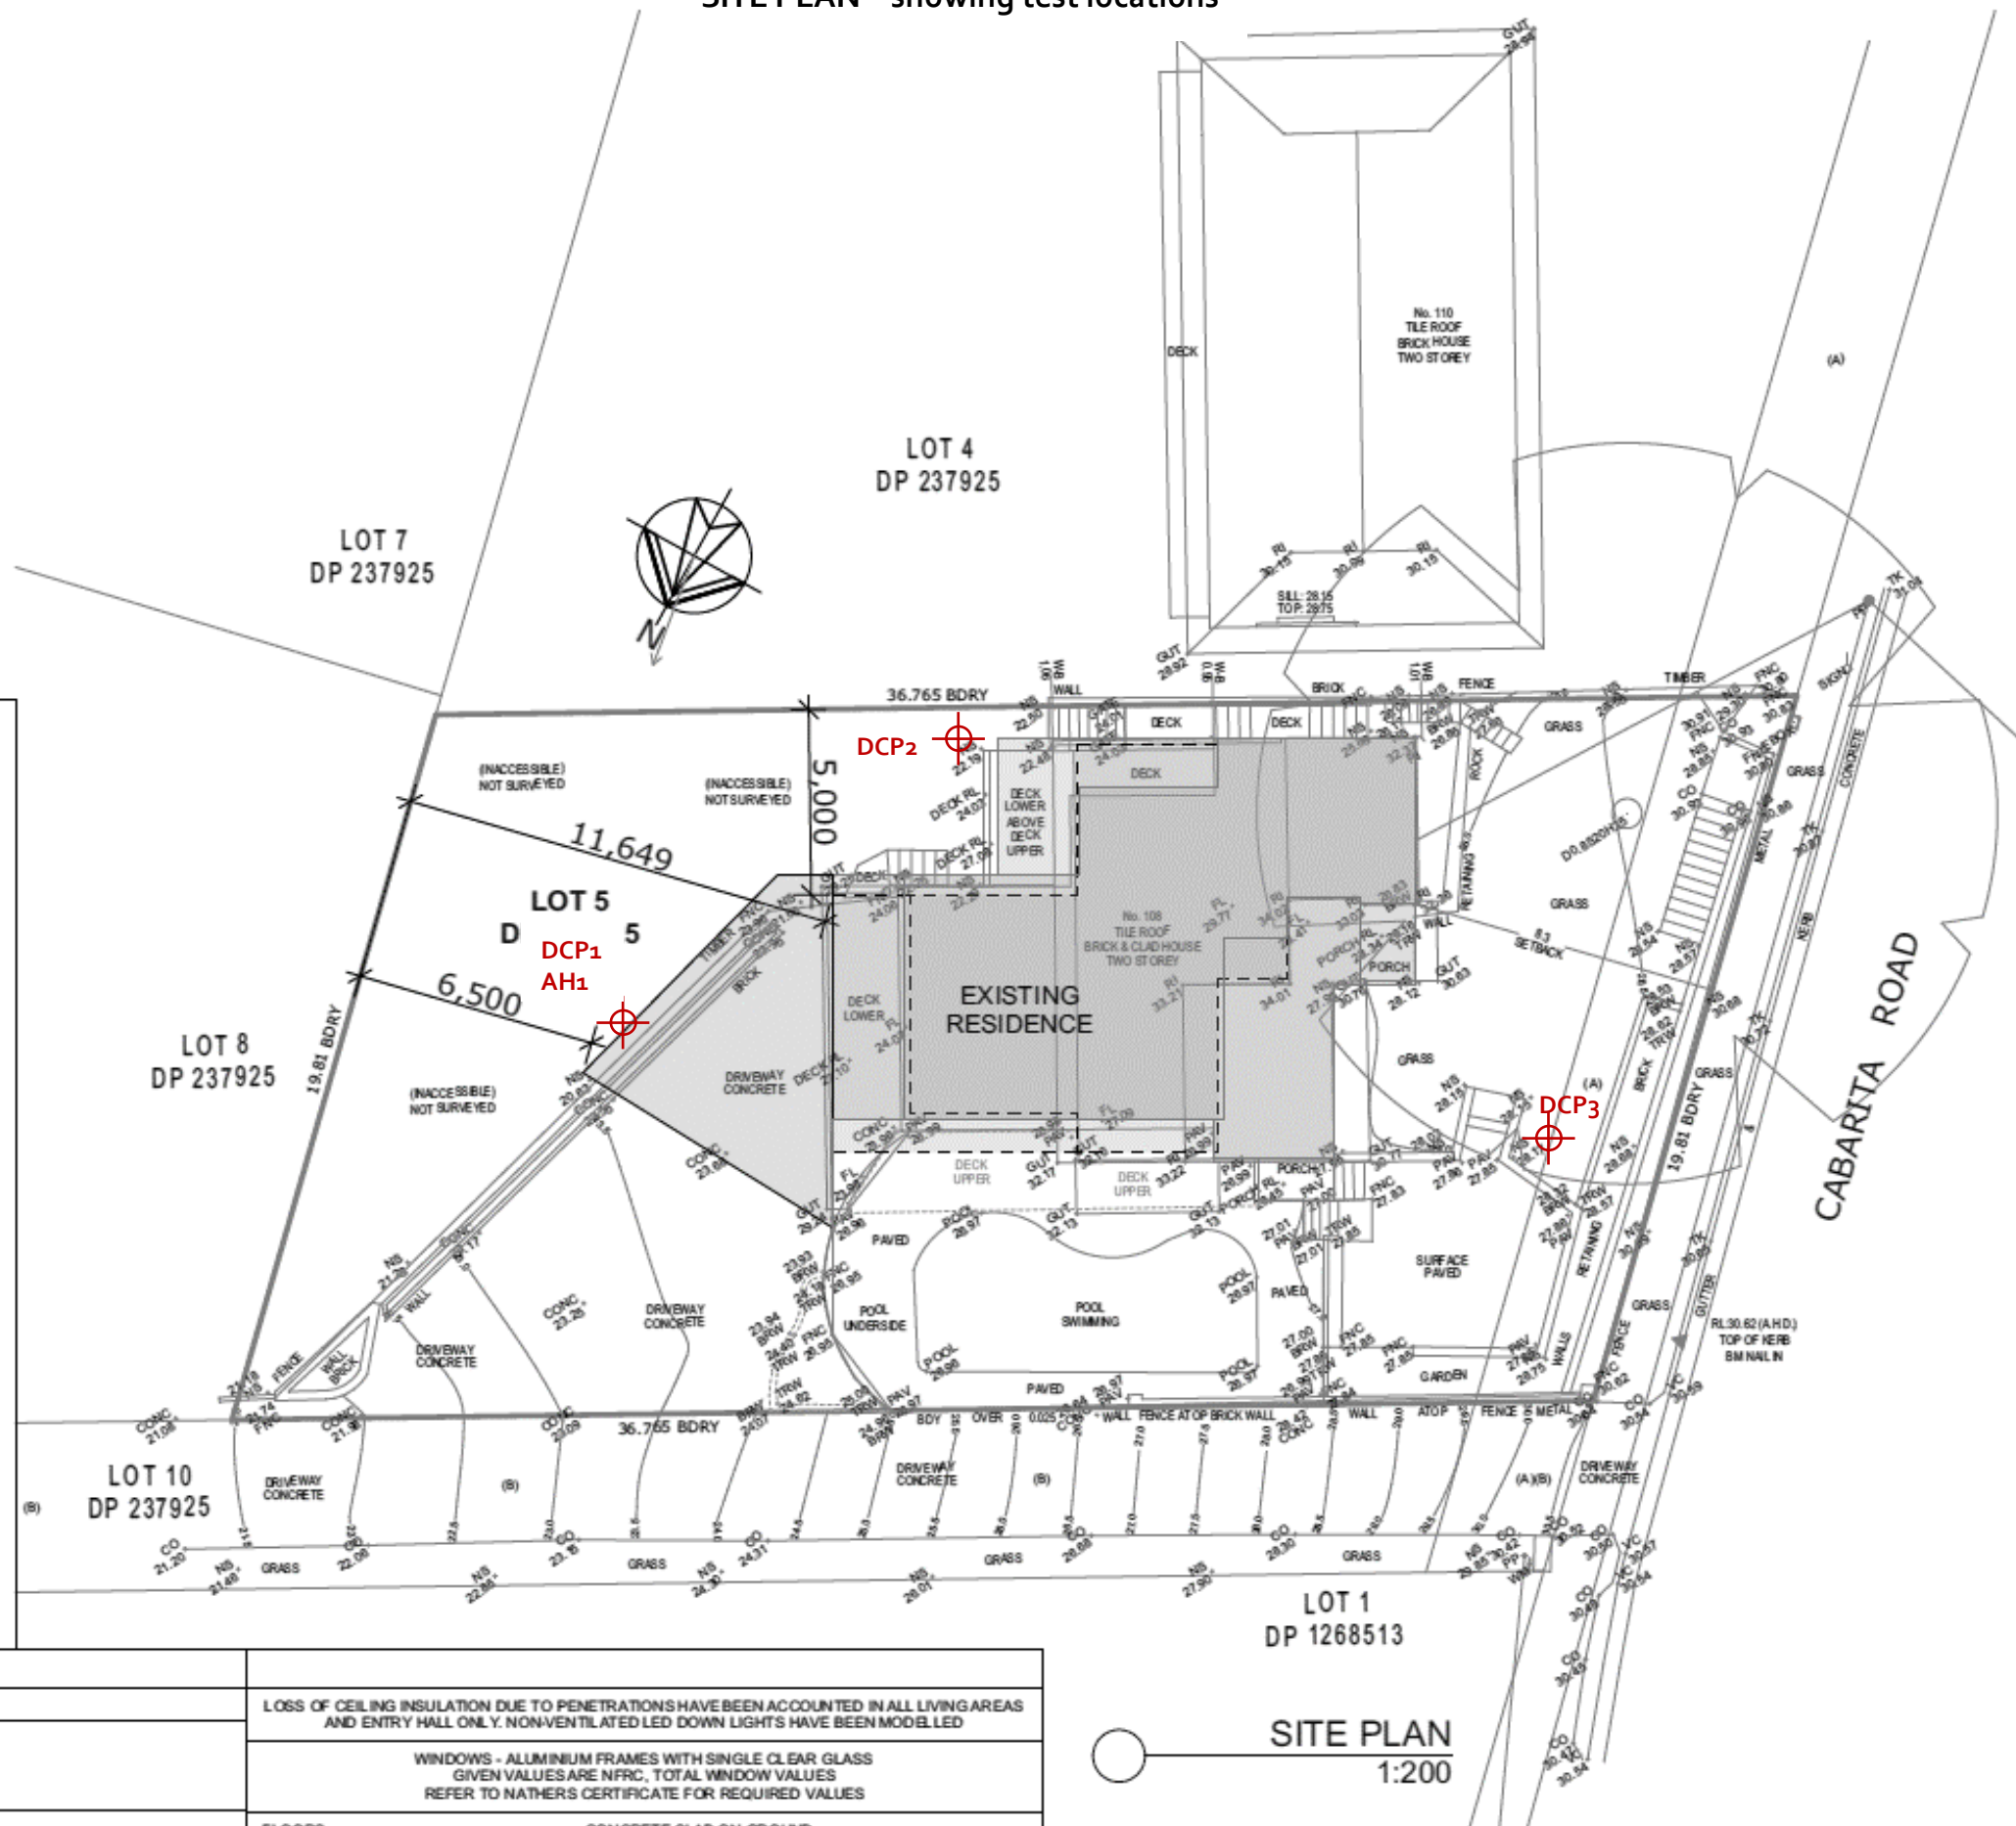
## SITE PLAN – showing test locations

One hand Auger Hole (AH) was put down to identify the soil materials. Three Dynamic Cone Penetrometer (DCP) tests were put down to determine the relative density of the overlying soil and the depth to bedrock. The locations of the tests are shown on the site plan attached.

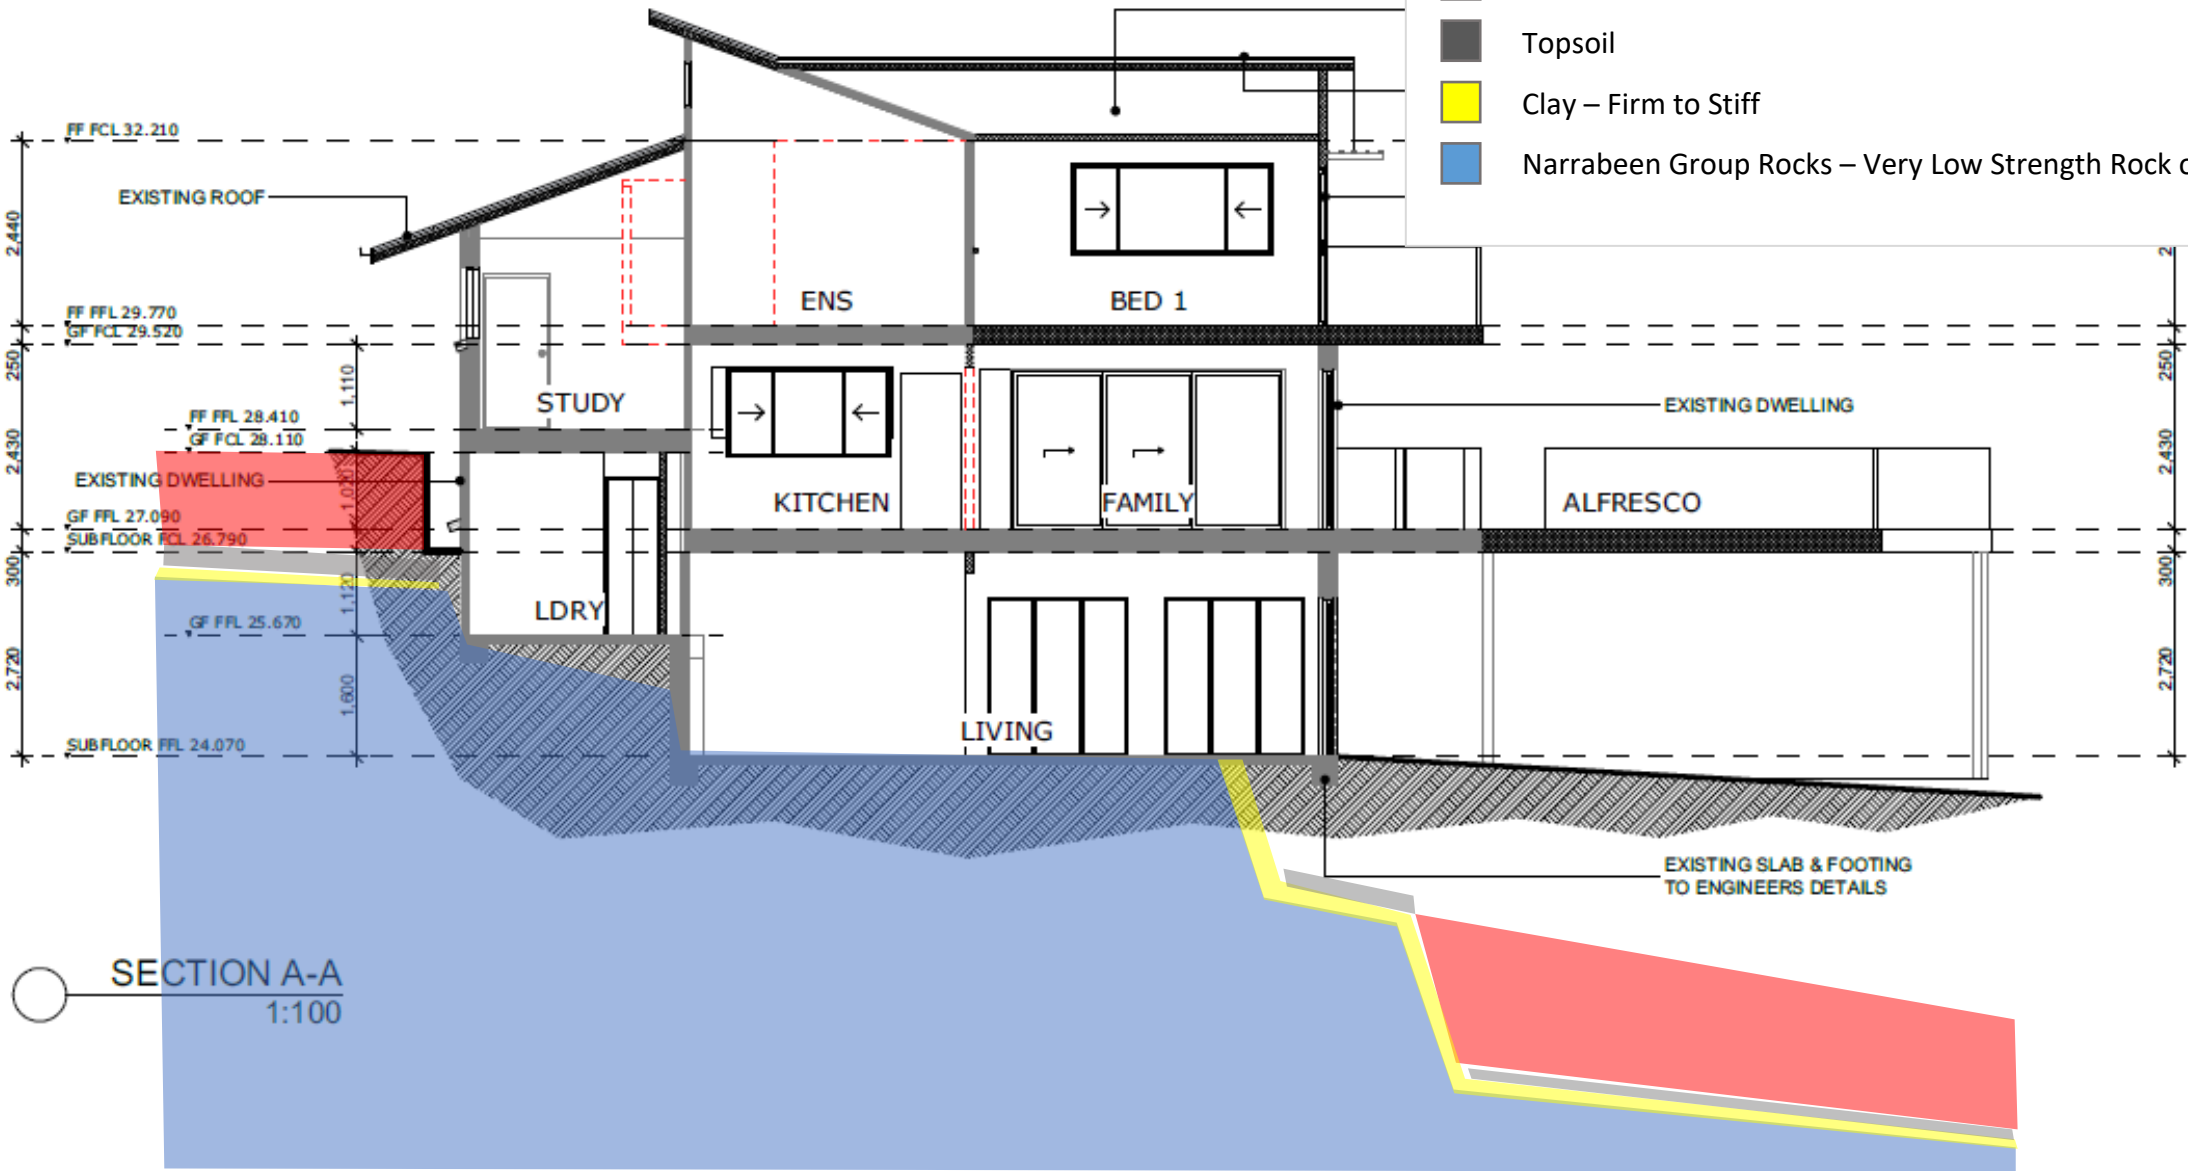
TYPE SECTION – Diagrammatical Interpretation of expected Ground Materials

The slope materials are colluvial at the near surface and residual at depth. In the test locations, the ground materials consist of fill, topsoil and clayey soil over firm to stiff sandy clays. Sandstone bedrock is exposed under the house (Photo 5). This is expected to be a band of sandstone in an otherwise shale dominated profile. In the test locations, the depth to weathered rock ranged from ~1.7m to ~2.2m below the current surface. The weathered zone of the underlying rock is interpreted as Very Low to Low Strength. It is to be noted that this material is a soft rock and can appear as a mottled stiff clay when it is cut up by excavation equipment. See Type Section attached for a diagrammatical representation of the expected ground materials.
