arboricultural impact assessment - proposed sewer pumping station - glenaeon, 207 forest way, belrose

23rd March 2022 - prepared by Melanie Howden - Ass. Dip. Hort. (Haw. Ag. C.), SoA. Arb. MAIH, MIACA

This report has been prepared to assess the condition and significance of a number of trees on and adjacent the proposed sewer pumping station at Glenaeon Retirement Village 207 Forest Way, Belrose and assess the potential impact of the works on the identified trees.

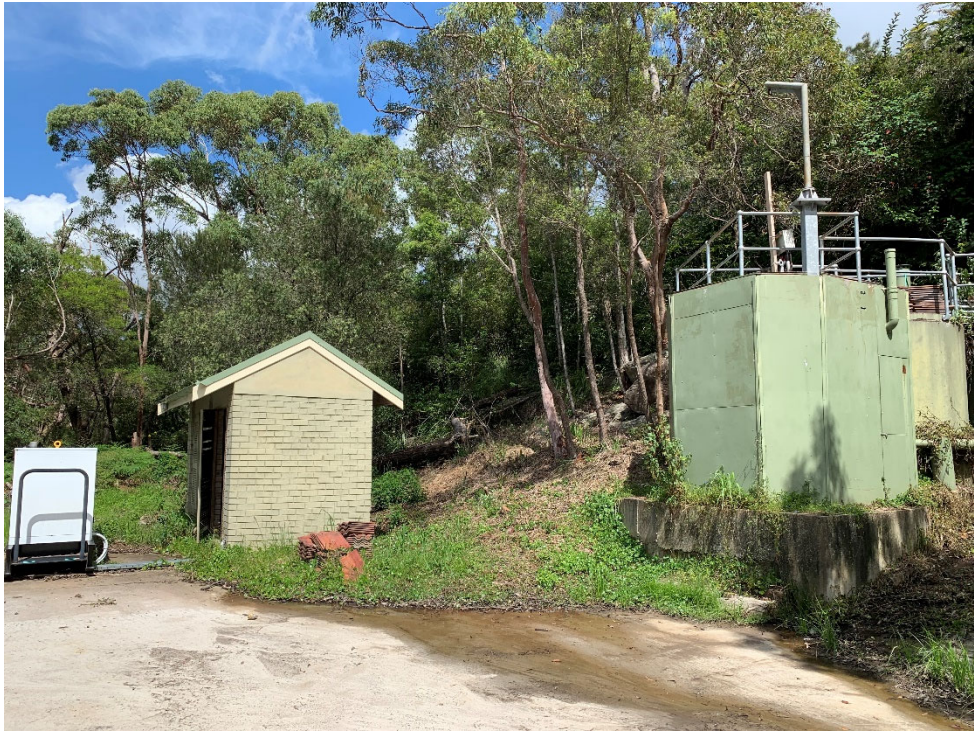
Figure 4.1 - The existing sewer pumping station looking south from the access road.

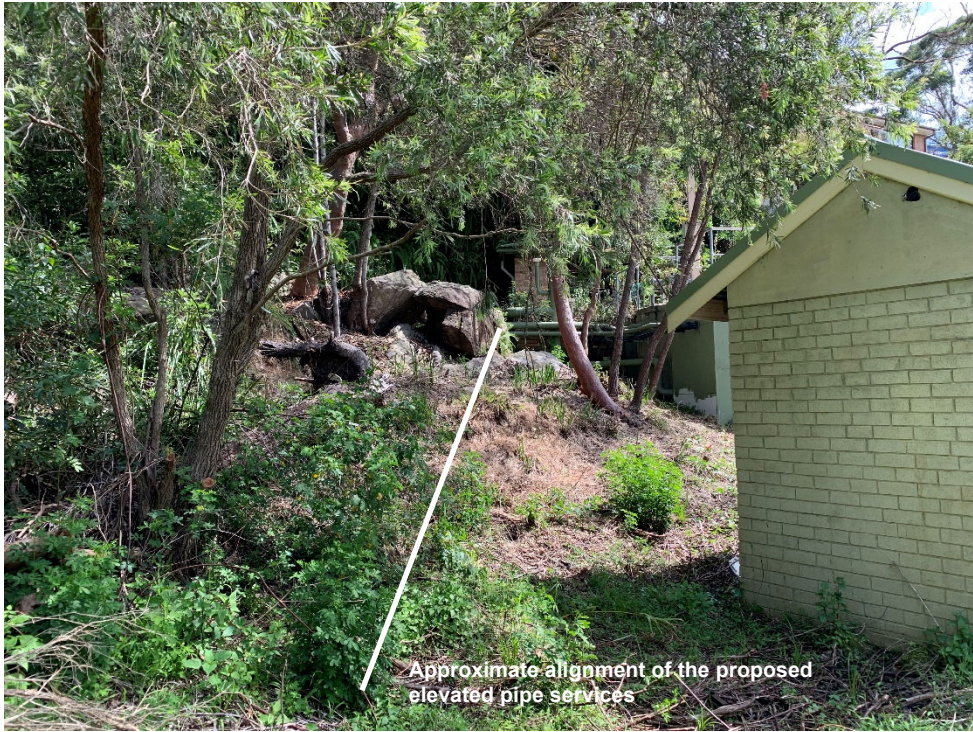
Figure 4.2 - View of the rocky terrain and the alignment of the proposed pipes which are to be elevated above ground and supported on piers.

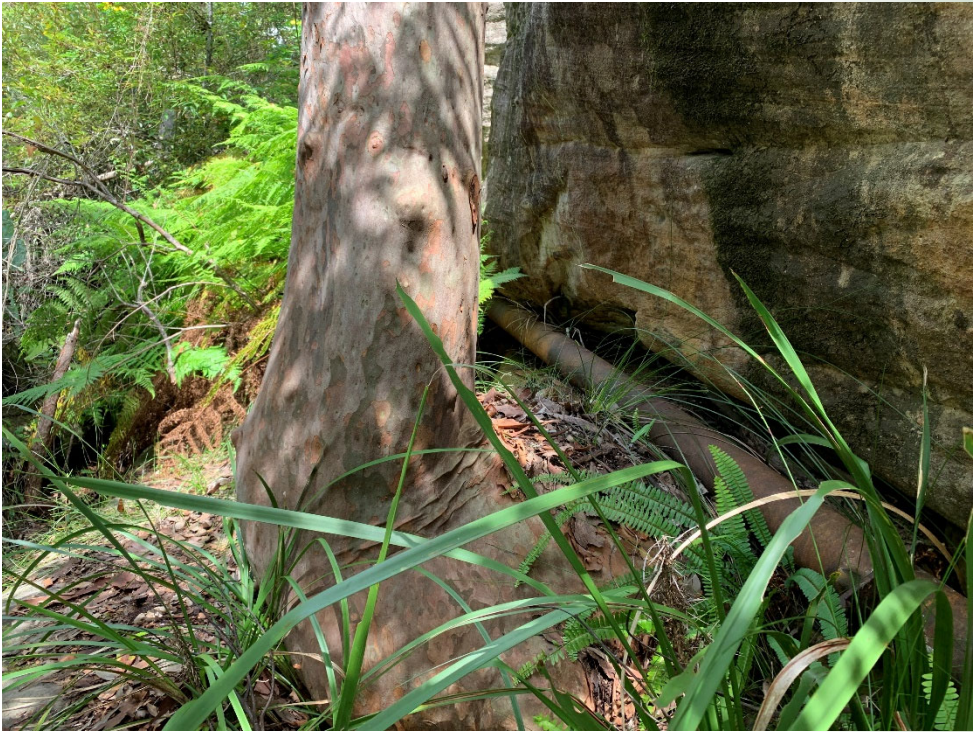
96.1	<i>Angophora costata</i>	Sydney Red Gum	12	12	340	420	Mature single trunk tree with an upright forest form; an upright trunk/s and balanced canopy and branch development. No evidence of significant branch pruning.	High L/scape Sig.	The tree appears stable and its branch attachment appears sound. The tree is considered to be in moderate health and displays good vigour.	Fair	15%	The tree is growing on a rock shelf with some epicormic growth evident..	2	On site	4.10	52.8

Figure 4.3 - The base of Tree No. 96.1 showing the existing cast iron rising sewer main.

96.1	<i>Angophora costata</i>	560	590	2	High L/scape Sig.	6.70	141.00	2.7	The proposed electrical conduit is within 3.0m (west) of the tree and is proposed to be installed between existing boulders adjacent the cast iron rising sewer main	No significant impact	Retained with Tree Protection Measures	On site
