GEOTECHNICAL ASSESSMENT REPORT FOR PROPOSED ALTERATIONS AND ADDITIONS AT 5 CAMBRIDGE AVENUE, NARRAWEENA

- **3.1** The site was inspected on 23rd December, 2021.
- **3.2** This property is located on the low side of the road and has an easterly aspect. From the road frontage, the steep to very steep slope of the land falls across the property at maximum average angles of some 15 to 25 degrees. The slope lessens towards the rear of the property. The block is located towards the top of a steep slope that falls from Alfred Street to Bix Road.

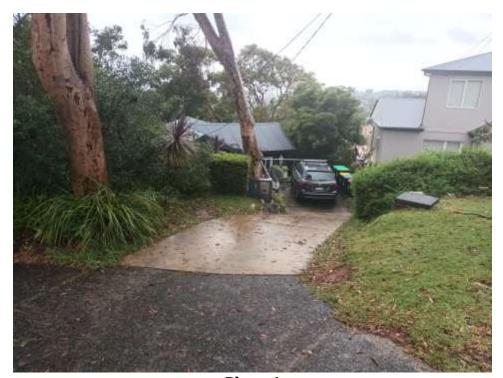
Photo 1

- 3.3 Vehicular access to the block is via a shared concrete driveway on the north eastern side of the cal-de-sac. The concrete driveway to the subject property heads south east from the shared driveway to the car parking hardstand at south western front corner of the existing residence, Photo 1. Council's stormwater pit is visible on the western side of the driveway in the road reserve, Photo 2. Pedestrian access to the main residence is via the concrete driveway and a stairs on the north eastern side of the car parking hardstand to the main entrance near the middle of the existing residence, Photo 3. A concrete pathway heads to the north across the front of the existing residence providing access to the north western corner of the existing residence only, with exposed Hawkesbury Sandstone is visible on the side of the pathway, Photo 4. A patio to the south of the main entry is supported by rock stacked retaining wall leads to stepped pathway on the southern side of the existing residence that provides access to the rear of the property, Photos 5 & 6. Exposed Hawkesbury Sandstone is visible on the southern side of the pathway, Photo 7. The roadside of the lower ground floor level is at the base of the a step in the exposed Hawkesbury Sandstone. Photo 8. The sloping rear lawn area extends out from the rear of the existing residence with small rock stacked retaining wall is across the property, Photo 9. Council's storm system is visible on the property, Photo 10.

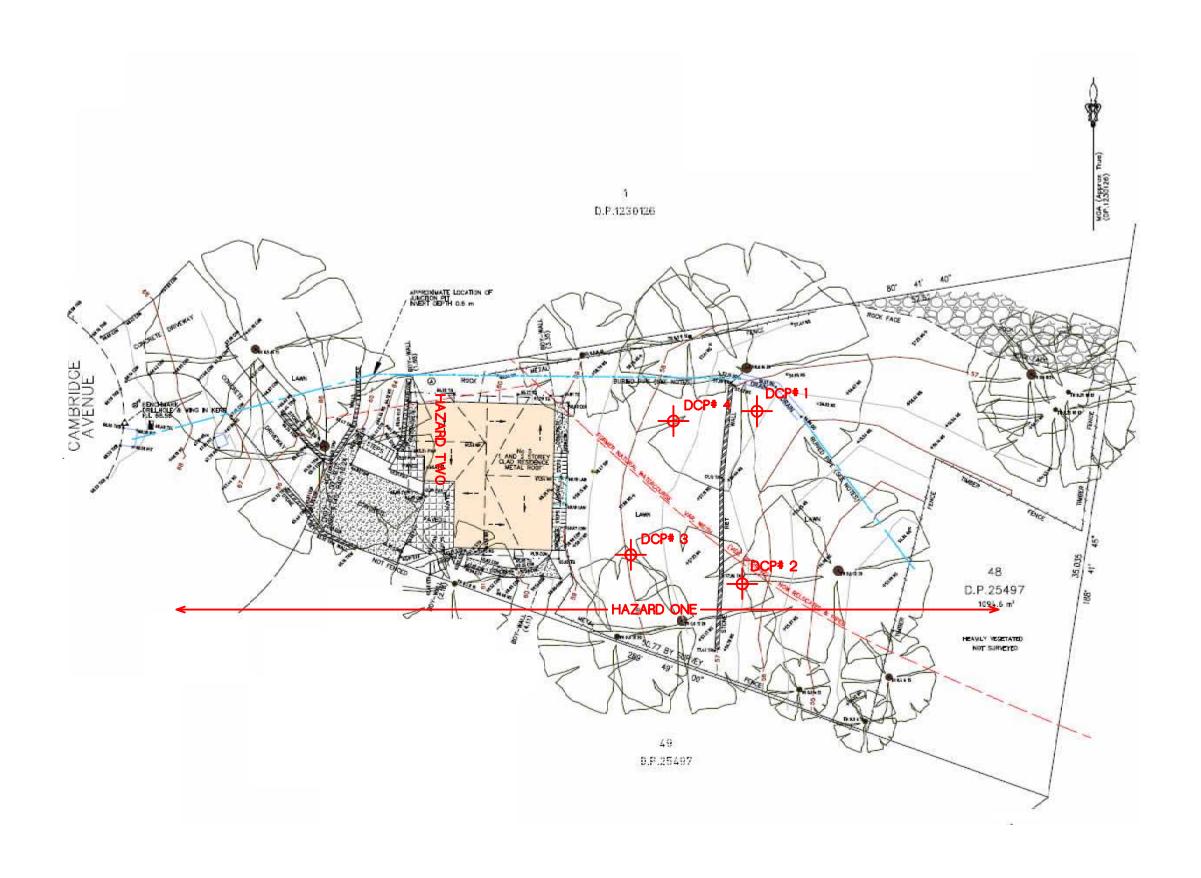
SITE PLAN - HAZARDS & DCP LOCATIONS

5.1 Four Dynamic Cone Penetrometer (DCP) tests were conducted in the locations shown on the site plan. The tests were conducted to the Australian Standard for ground testing: AS 1289.6.3.2 – 1997 (R2013). The results of these tests are as follows:

DCP#1	32 Blows for 0.138m then 8 blows for 0.020m. Slight Double Bounce. Refusal in rock
	or floater.
	Tip damp for 0.9m then wet last 0.9m and with sandstone on very tip.
DCP#2	Drop under self-weight 0.295m. 8 Blows for 0.035m then 8 blows for 0.003m. Strong
	Double Bounce. Refusal in rock or floater.
	Wet last 1.1mdry and tip clean.
DCP#3	13 Blows for 0.230m then 8 blows for 0.018m. Double Bounce. Refusal in rock or
	floater.
	Tip clean and wet last 0.15m.
DCP#4	29 Blows for 0.195m then 8 blows for 0.012m. Double Bounce. Refusal in rock or
	floater.
	Tip grey saturated and sandstone and wet last 0.8m.
Further Notes	When ringing bouncing rock is not encountered, end of test occurs when there is less
	than 0.02m of penetration for 8 blows or danger of equipment damage is imminent.
	No significant standing water table was identified in our testing.
