GEOTECHNICAL REPORT

REMEDIATION DESIGN

60 ALEXANDER STREET, COLLAROY

Project No.: 2020-097

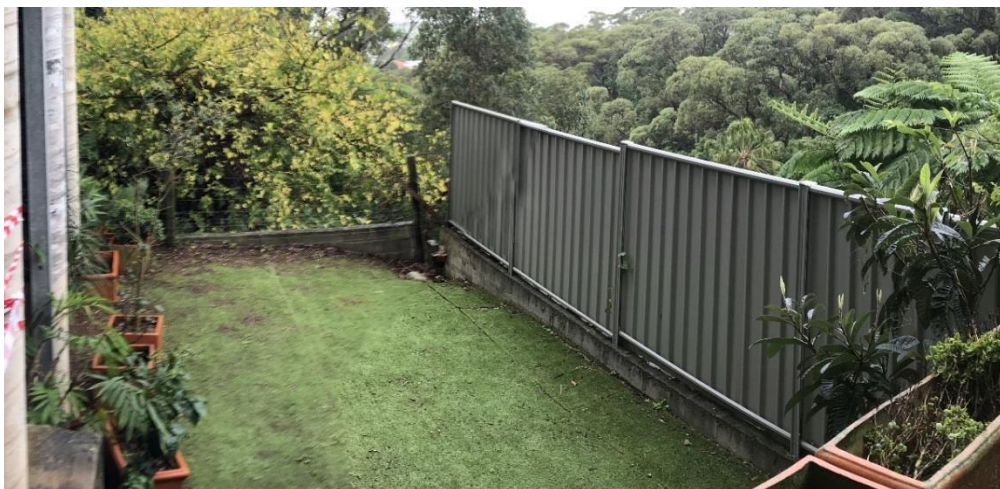
Concrete piers support the site dwelling and are understood to have been constructed as part of the previous alterations and additions to support the additional load and appear in good condition. A view of the rear garden is provided in Photograph 2.

Photograph 2: View of the rear garden of No.70 looking south east.

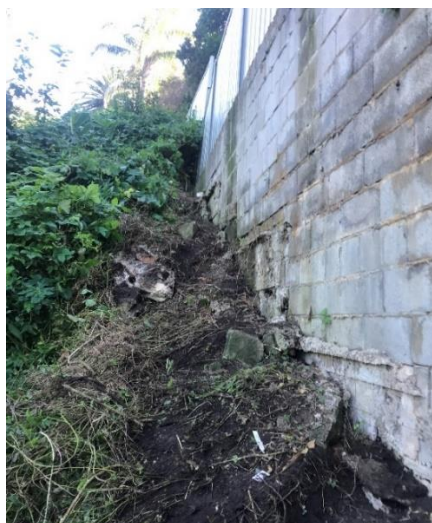
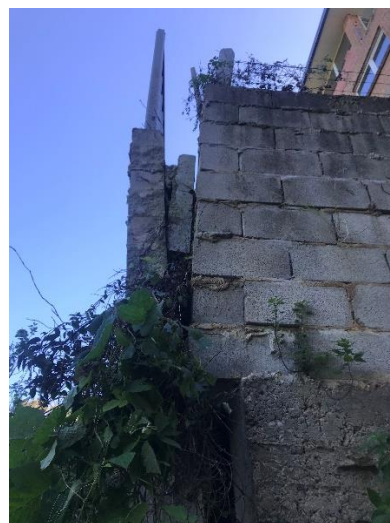
The distressed retaining wall is approximately 12.0m in length and approximately 0.4m in height above the neighbouring land to the south at the west end increasing to 2.5m in height at the east end. The wall is comprised of blockwork masonry with roughly finished cement mortar. The wall supports the rear garden of No.60 which comprises a synthetic grass lawn and extends to the main residential site structure located approximately 5.0m to the north. A metal fence approximately 2.0m in height extends along the length of the wall. A view of the retaining wall is provided in Photograph 3a and 3b.

View of the south side and east end of the retaining wall at the rear garden of No.60

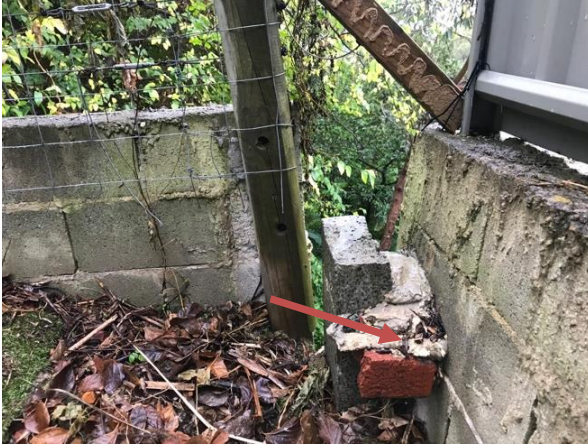
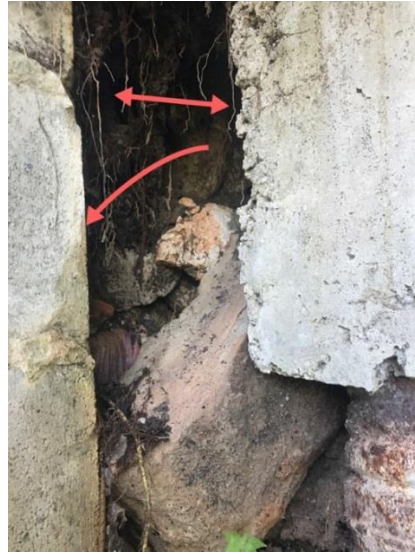
The most obvious sign of distress is the displacement of the wall which appears to have separated from the retaining wall aligned along the east boundary of the rear garden and moved approximately 0.4m to the south (Photograph 4). The displacement appears to be far less at the western end of the wall compared to the east and in addition to outward displacement, the wall also appears to have undergone minor displacement towards the west (Photograph 5).

*Photograph 4 and 5:
Views of the corner of the distressed retaining wall looking east from within the site (4) and west from outside the site (5)*

Where the retained soils could be observed behind the retaining wall (Photograph 5), the materials comprised building rubble including bricks concrete etc.

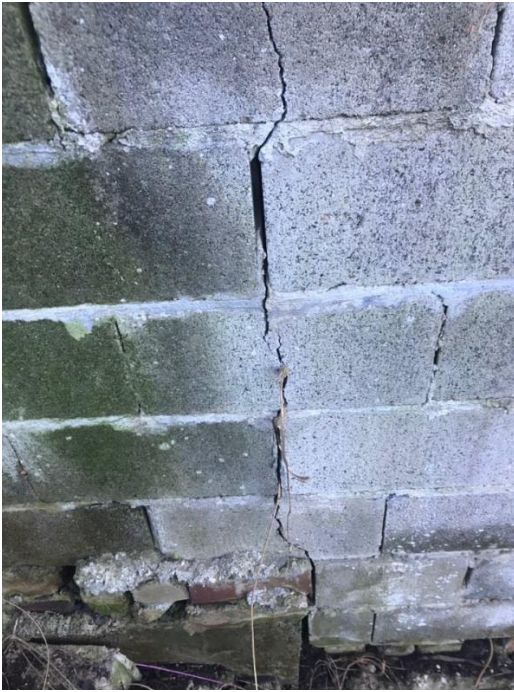
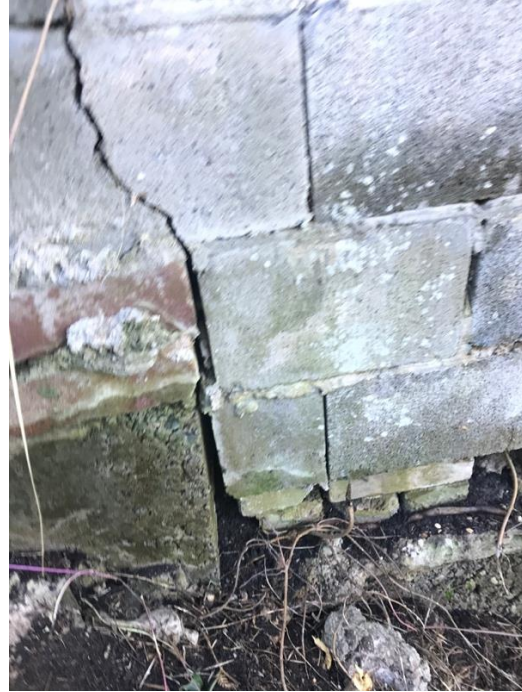
Considering the degree of displacement from the east boundary wall observed, the overall condition on the wall is relatively good and, although rotated outwards, is relatively intact. The exception to this is are broadly vertical cracks which extend through the mortar and individual blocks (Photograph 6 and 7) visible on the south side of the retaining wall.

Photographs 6 and 7: Near vertical cracking in retaining wall taken from the southern side looking broadly north.

It appears that the wall itself is constructed relatively well with limited cracking or bulging evident in the mortar/brickwork considering the amount of displacement observed. The design of the wall is not known and if structural drawings are available, they should be reviewed by the Structural Engineer allowing for elevated water pressures behind the wall and the overpour concrete surcharge.

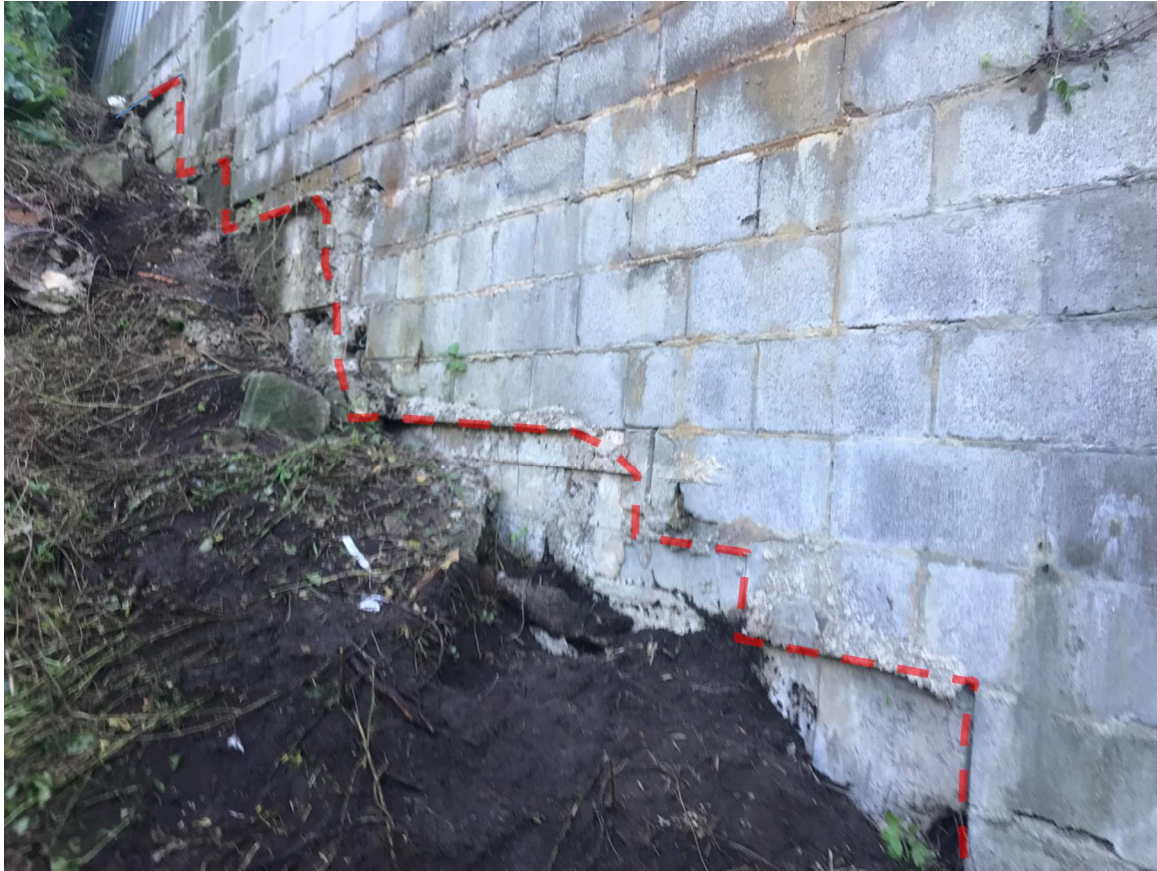
Directly to the south of the retaining wall and exposed at the ground surface or under a thin veneer of topsoil, a layer of concrete was observed which appeared to be present along the entire section of wall. Where sections of concrete were observed it appears that they are related to an overflow of concrete from the original construction of the retaining wall. The concrete appeared to vary between approximately 0.3m and 0.1m in thickness where observed.

This concrete indicates that the ground surface level was previously higher at the base of the wall than it is currently (Photograph 8).

Photograph 8: Probable original ground line (dashed red) on south side of retaining looking broadly west from the east end of the wall.

The layer of concrete observed at the toe of the wall appears to have previously been attached to the retaining wall and probably became detached following settlement of the underlying building refuse. The additional concrete will have increased the load on the lower sections of the wall (prior to detachment) however without knowing the extent of concrete present and history of detachment, it is difficult to determine potential surcharge loads based on field work completed to date.

It is therefore considered that additional, unanticipated surcharge loads resulting from the concrete overpour *may* be a factor in the distress observed in the retaining wall however it is unlikely to be currently affecting the wall as it appears to have become detached.

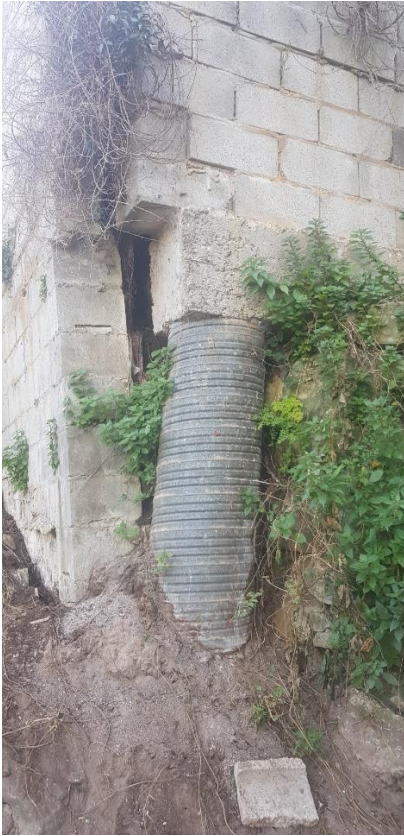
It was also observed that drainage from the wall via an outflow pipe did not appear to be functioning and was dry despite recent rainfall. Based on photographs provided by the client it appears water flow from behind the wall resulting in loss of sand fill has occurred in the past (Photograph 9).

Also shown in Photograph 9 is a pier footing casing liner which appears to be deformed. The movement appears to have occurred within the lower section of the pile and to the south. Based on survey information provided by the client and assuming the top of the pier is in its original position, the top and the bottom of the wall appear to have moved as well as the lower section of the pier footing.

Photograph 9: View of the deformed pier at the corner of the site and outwash sand

The deformation of the pile observed at the south eastern corner may also indicate that the pier founding strata is insufficient to resist downslope movement.

A drain survey should be undertaken of all nearby pipework to determine their condition prior to confirmation of remediation works.
