## **GEOTECHNICAL INVESTIGATION:**

Alterations and Additions and New Pool at **57 Cutler Road, Clontarf**

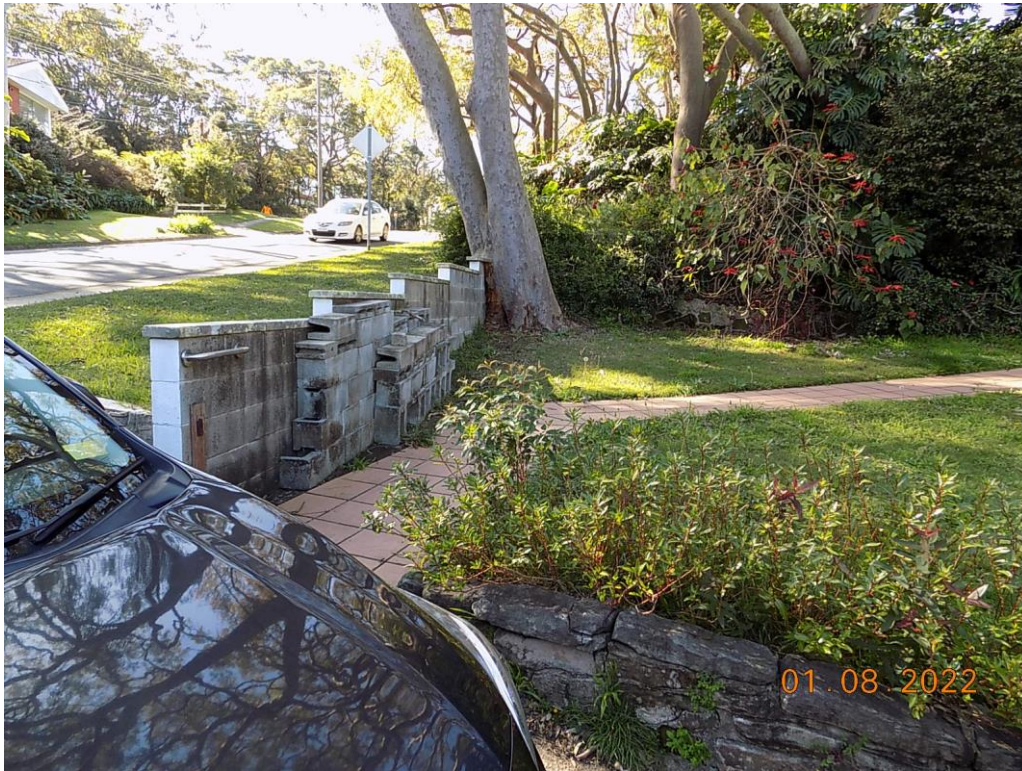
Photo 3

proposed works. A cut has been made in the slope for a gently sloping lawn surrounded by garden beds between the road frontage and the house. The cut is supported by a stable concrete block retaining wall ~1.0m high that lines the road frontage (Photo 3). The part two-storey rendered brick house is supported on brick walls and steel posts (Photo 4). The supporting walls displays no significant signs of movement. Some of the supporting walls and posts were observed to be supported directly off outcropping competent Medium Strength Sandstone within the foundation space of the house. An excavation has been made in the slope to create a level platform for the uphill side of the house. The cut is supported by a brick retaining wall ~0.6m high. The retaining wall displayed vertical cracking through the bricks but no signs of deflection (Photo 5). As such, the wall is considered currently stable. A cut and fill have been made in the SE corner of the property for a level lawn area. The cut is supported by a concrete block retaining wall ~1.8m high. The retaining wall was observed to be cracked and tilting downslope at an angle of ~4° and has been remediated with timber bracing (Photo 6). Additionally, the concrete block components of the wall were observed to not have been core-filled. The wall will be demolished and rebuilt as part of the proposed works. The fill is supported by a concrete block and sandstone block retaining wall which is ~2.0m high (Photo 7 & 8). The sandstone block section of the wall is cracked and displays signs of movement. This wall has also been remediated with timber bracing and will also be demolished and rebuilt as part of the proposed works. Fill has been placed below this wall for a level lawn area. The fill is supported by a concrete block retaining wall which was observed to be supported directly off outcropping competent Medium Strength Sandstone (Photo 9). Competent Medium Strength Sandstone outcrops immediately above the SE corner of the property (Photo 10). The outcrop was observed to be slightly undercut but is considered stable.

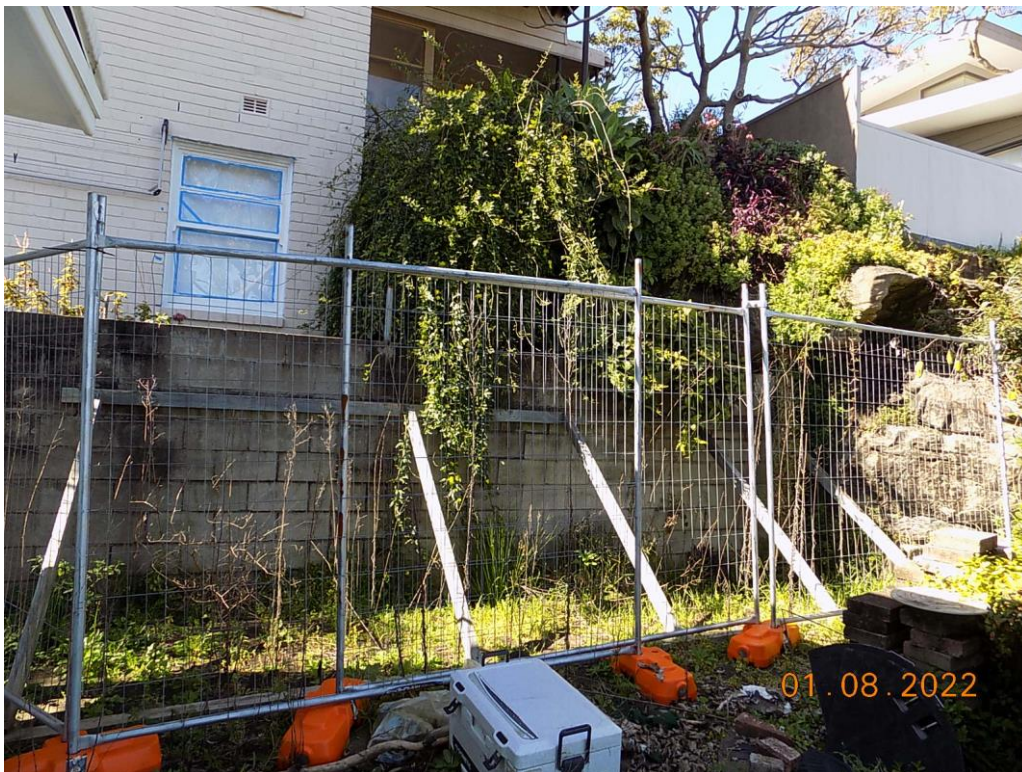
Photo 6

The existing concrete block retaining wall in the SE corner of the property (Photo 6) will be demolished and rebuilt as part of the proposed works. The wall is to be dismantled and rebuilt systematically in a "hit one, miss two" sequence so as not to impact on the uphill neighbouring property and to minimise the chance of instability during the wall construction. The replacement wall is to be designed by a structural engineer following the requirements below.

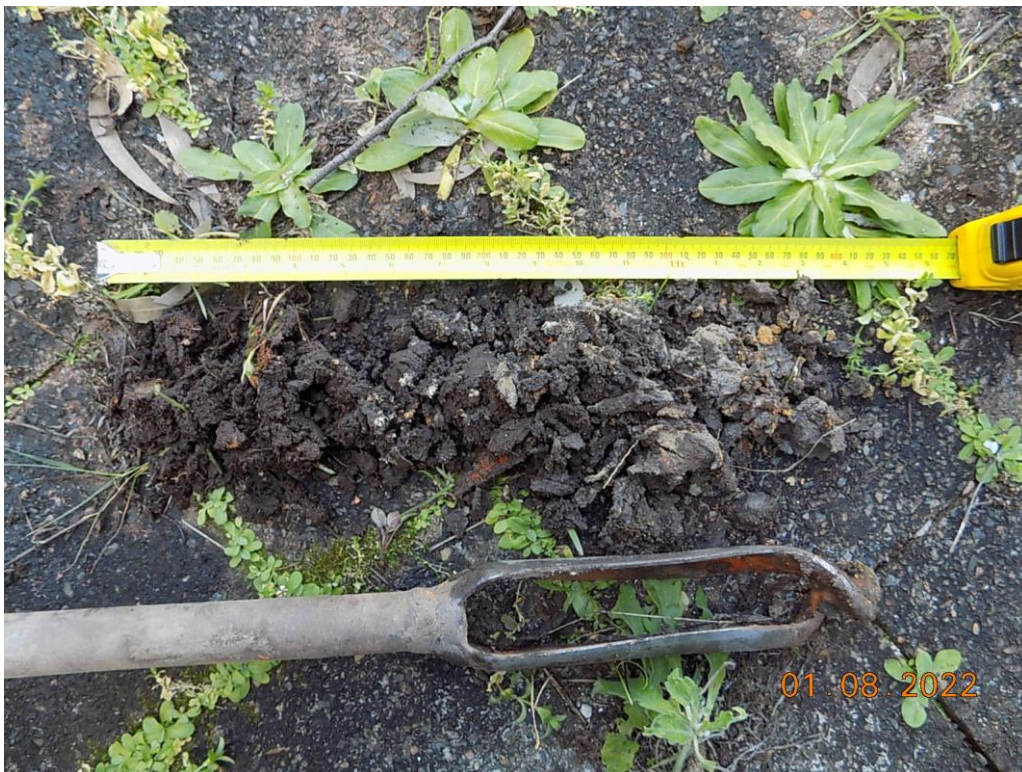
#### AUGER HOLE 1 (~RL51.0) – AH1 (Photo 11)

Depth (m)	Material Encountered
0.0 to 0.3	<b>FILL</b> , disturbed soil, dark brown, dry, medium to coarse grained, fine trace organic matter.
0.3 to 0.4	<b>FILL</b> , disturbed clayey sand, grey & dark grey, damp, fine to coarse grained.

End of hole @ 0.4m at rock surface. No water table encountered.

Photo 11: AH1 – Downhole is from right to left

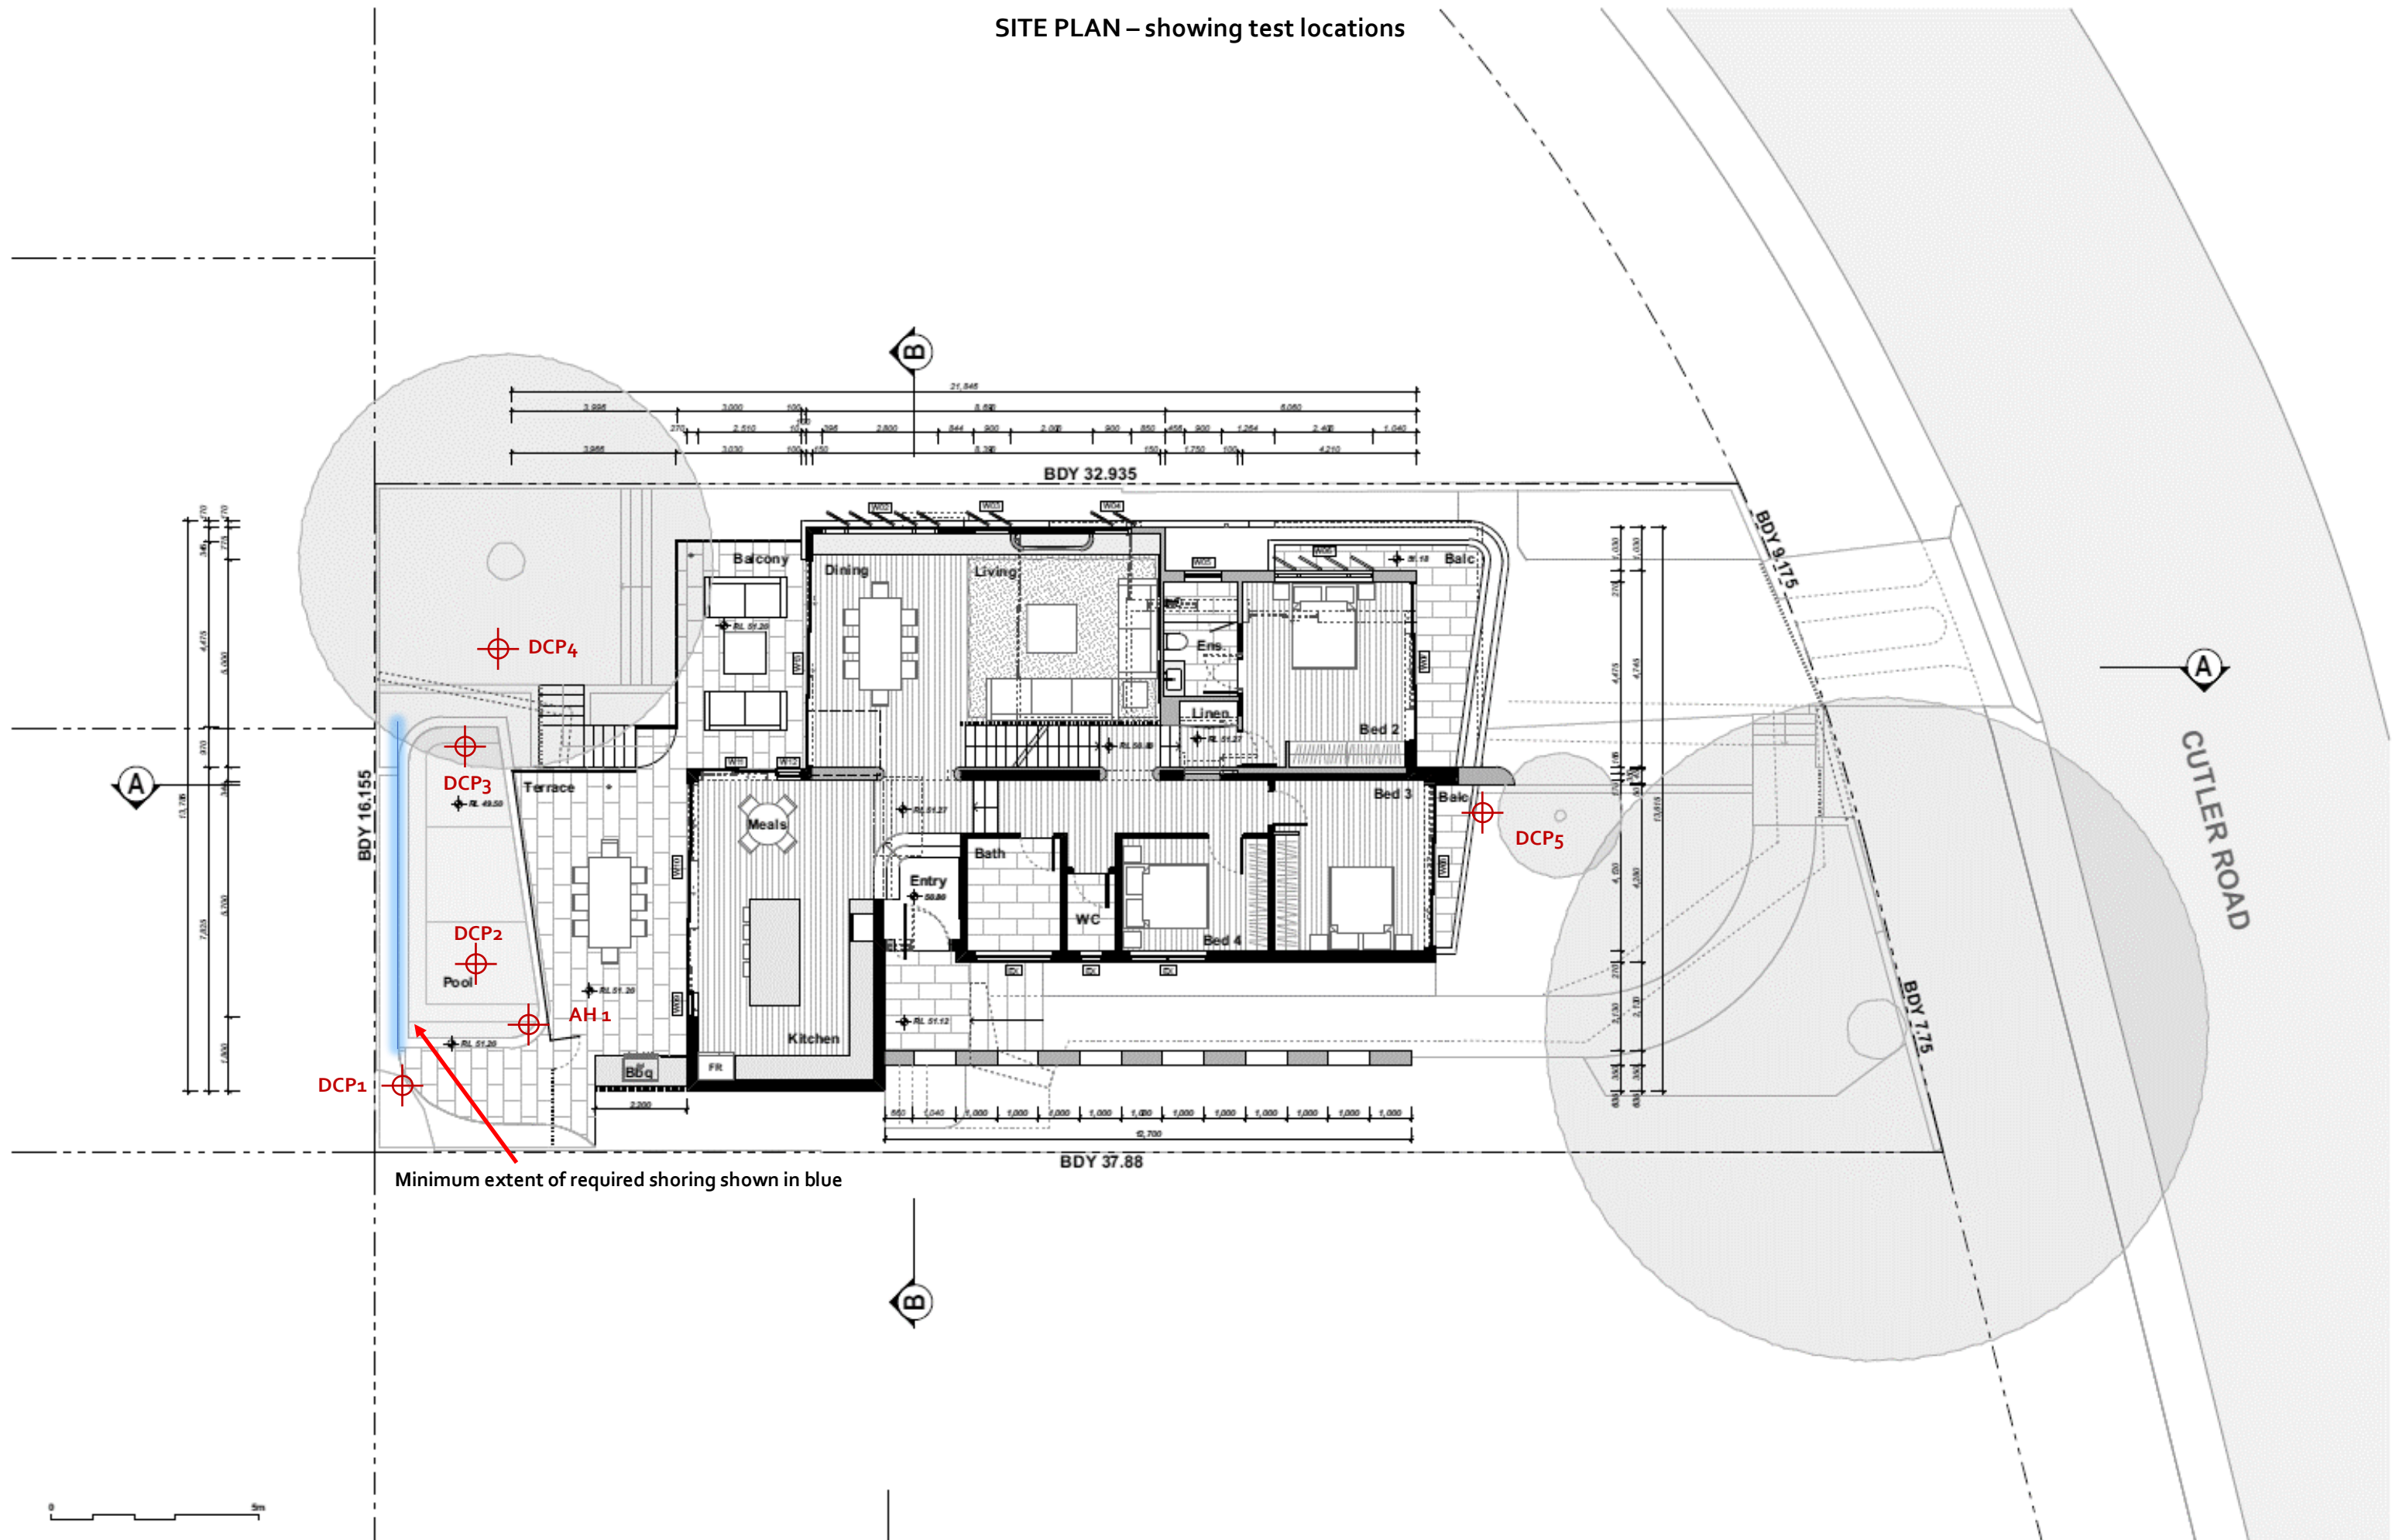
# SITE PLAN – showing test locations

One hand Auger Hole (AH) was put down to identify the soil materials. Five Dynamic Cone Penetrometer (DCP) tests were put down to determine the relative density of the overlying soil and the depth to bedrock. The locations of the tests are shown on the site plan attached. It should be noted that a level of caution should be applied when interpreting DCP test results. The test will not pass through hard buried objects so in some instances it can be difficult to determine whether refusal has occurred on an obstruction in the profile or on the natural rock surface. This is not expected to be an issue for the testing on this site. However, excavation and foundation budgets should always allow for the possibility that the interpreted ground conditions in this report vary from those encountered during excavations. See the appended "Important information about your report" for a more comprehensive explanation. The results are as follows:

The proposed excavation for the pool will be taken to a maximum depth of ~1.5m and will be set back ~0.5m from the S common boundary. No structures on the S neighbouring property will fall within the zone of influence of the excavation. As such, only the S common boundary will be within the zone of influence of the proposed excavation. To ensure the integrity of the S neighbouring property, we recommend the S side of the excavation be temporarily supported with typical pool shoring such as sacrificial form ply, until the pool structure is in place. See the site plan attached showing the minimum extent of the required shoring in blue.

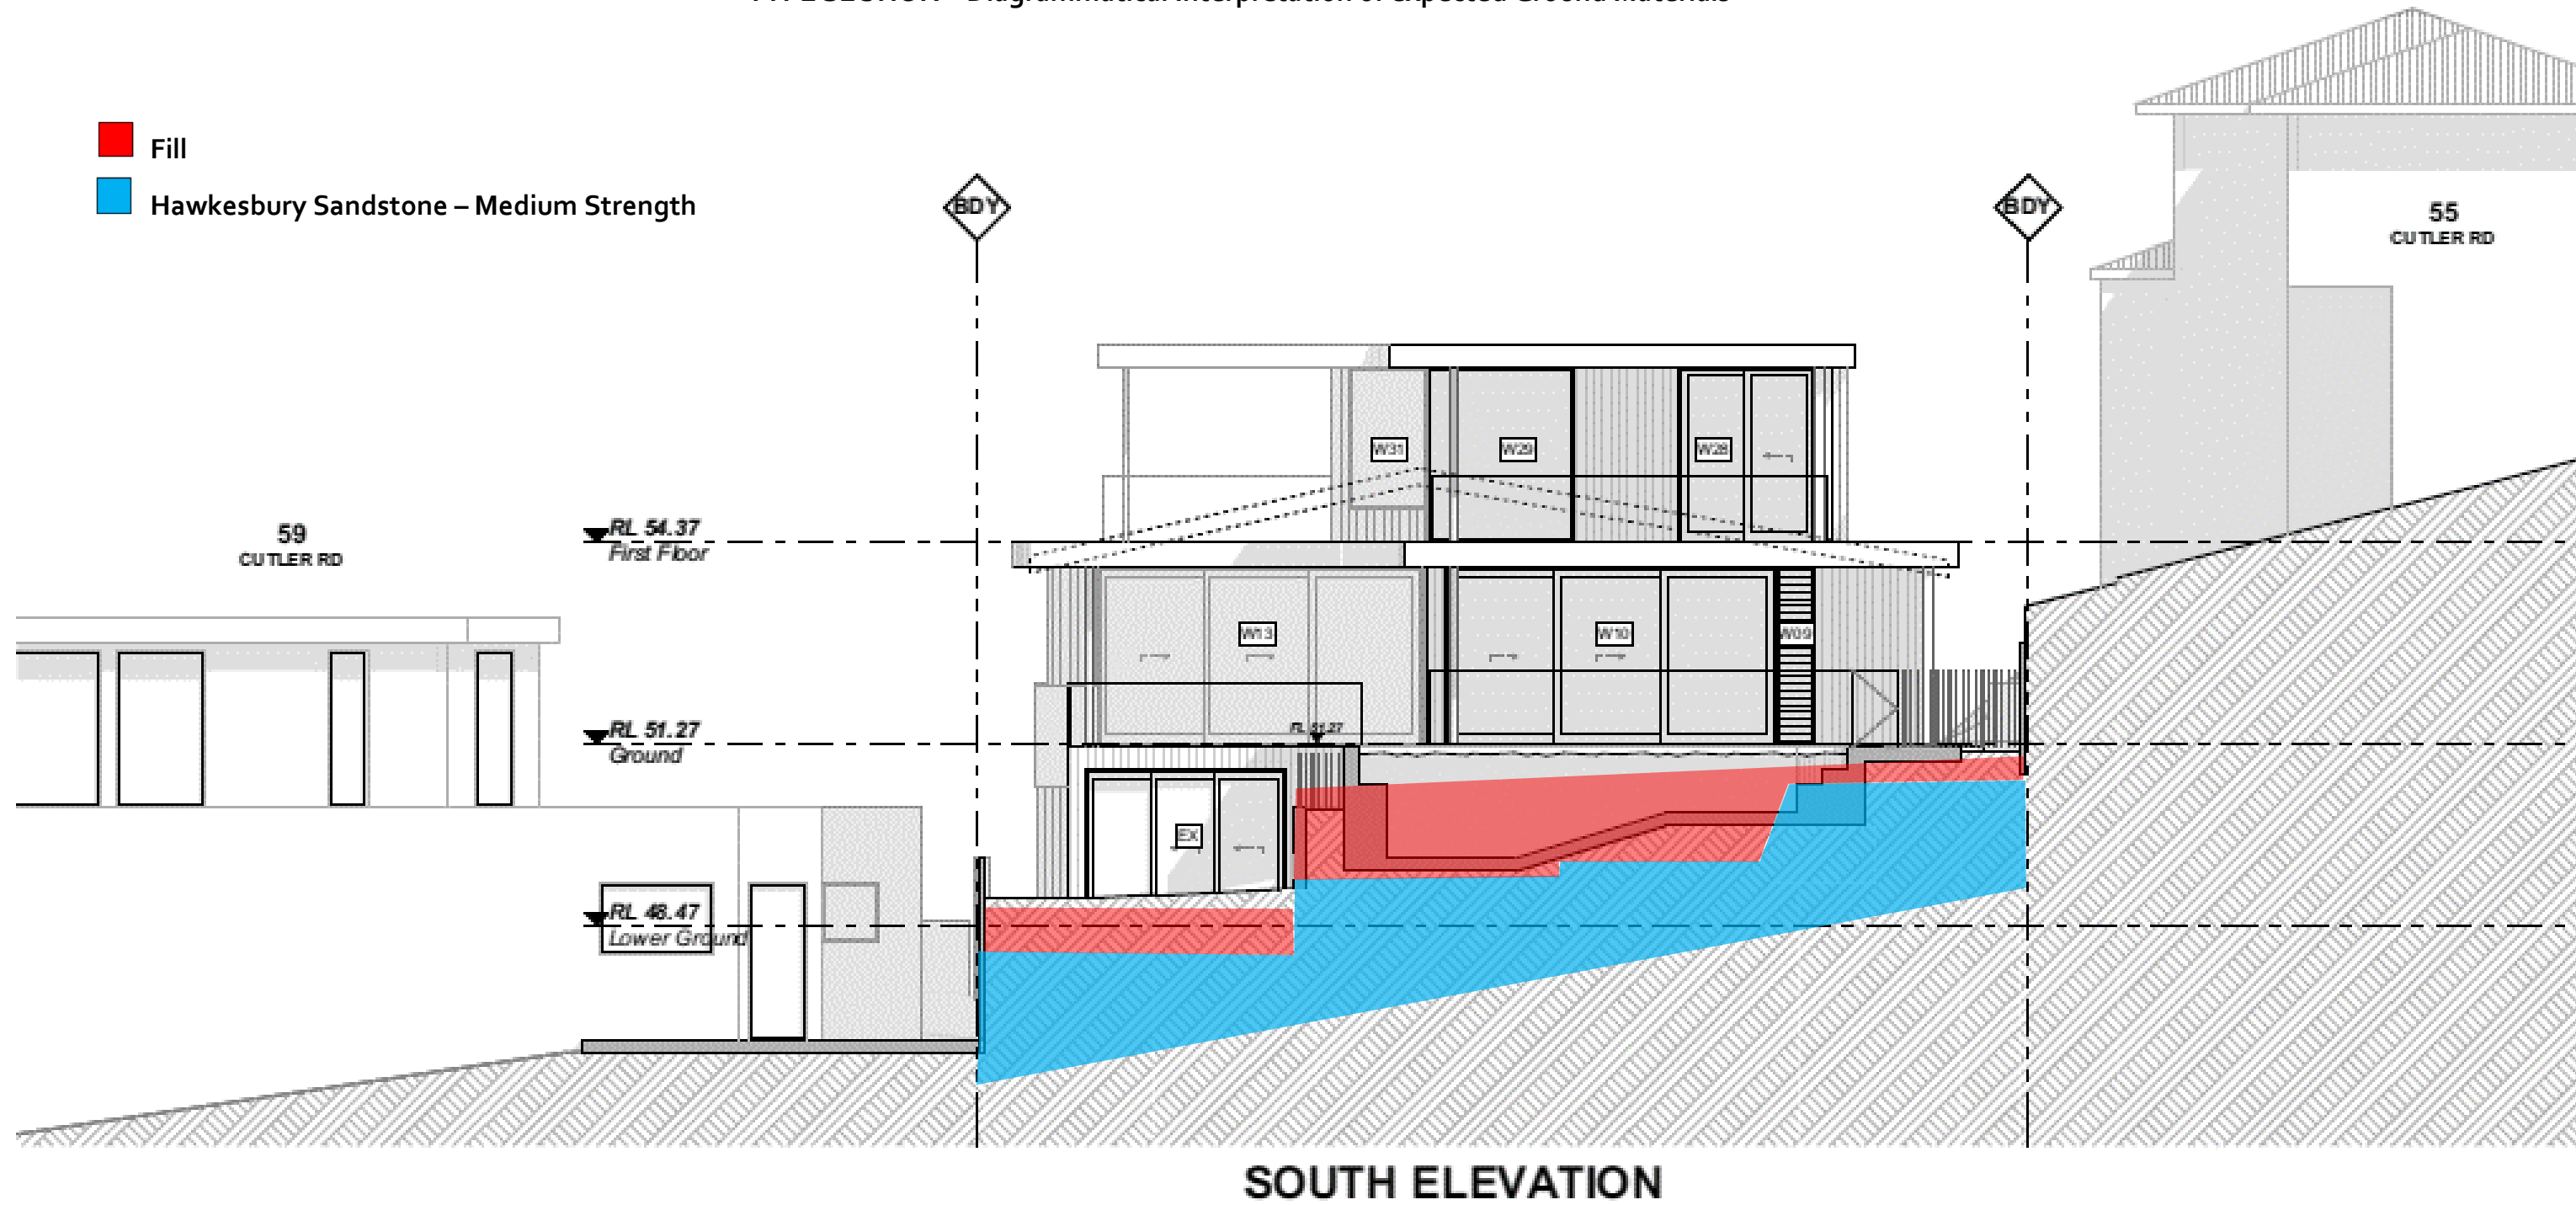
TYPE SECTION – Diagrammatical Interpretation of expected Ground Materials

deeper due to the presence of fill and the stepped nature of the underlying bedrock. The outcropping sandstone on the property is estimated to be Medium Strength or better and similar strength rock is expected to underlie the entire site as all the DCP tests bounced at refusal. See Type Section attached for a diagrammatical representation of the expected ground materials.
