## **Geotechnical Assessment**

**Project:** Alterations and Additions  
11 Wandearah Avenue, Avalon Beach NSW.

**REF: AG 20205**  
18<sup>th</sup> August, 2020

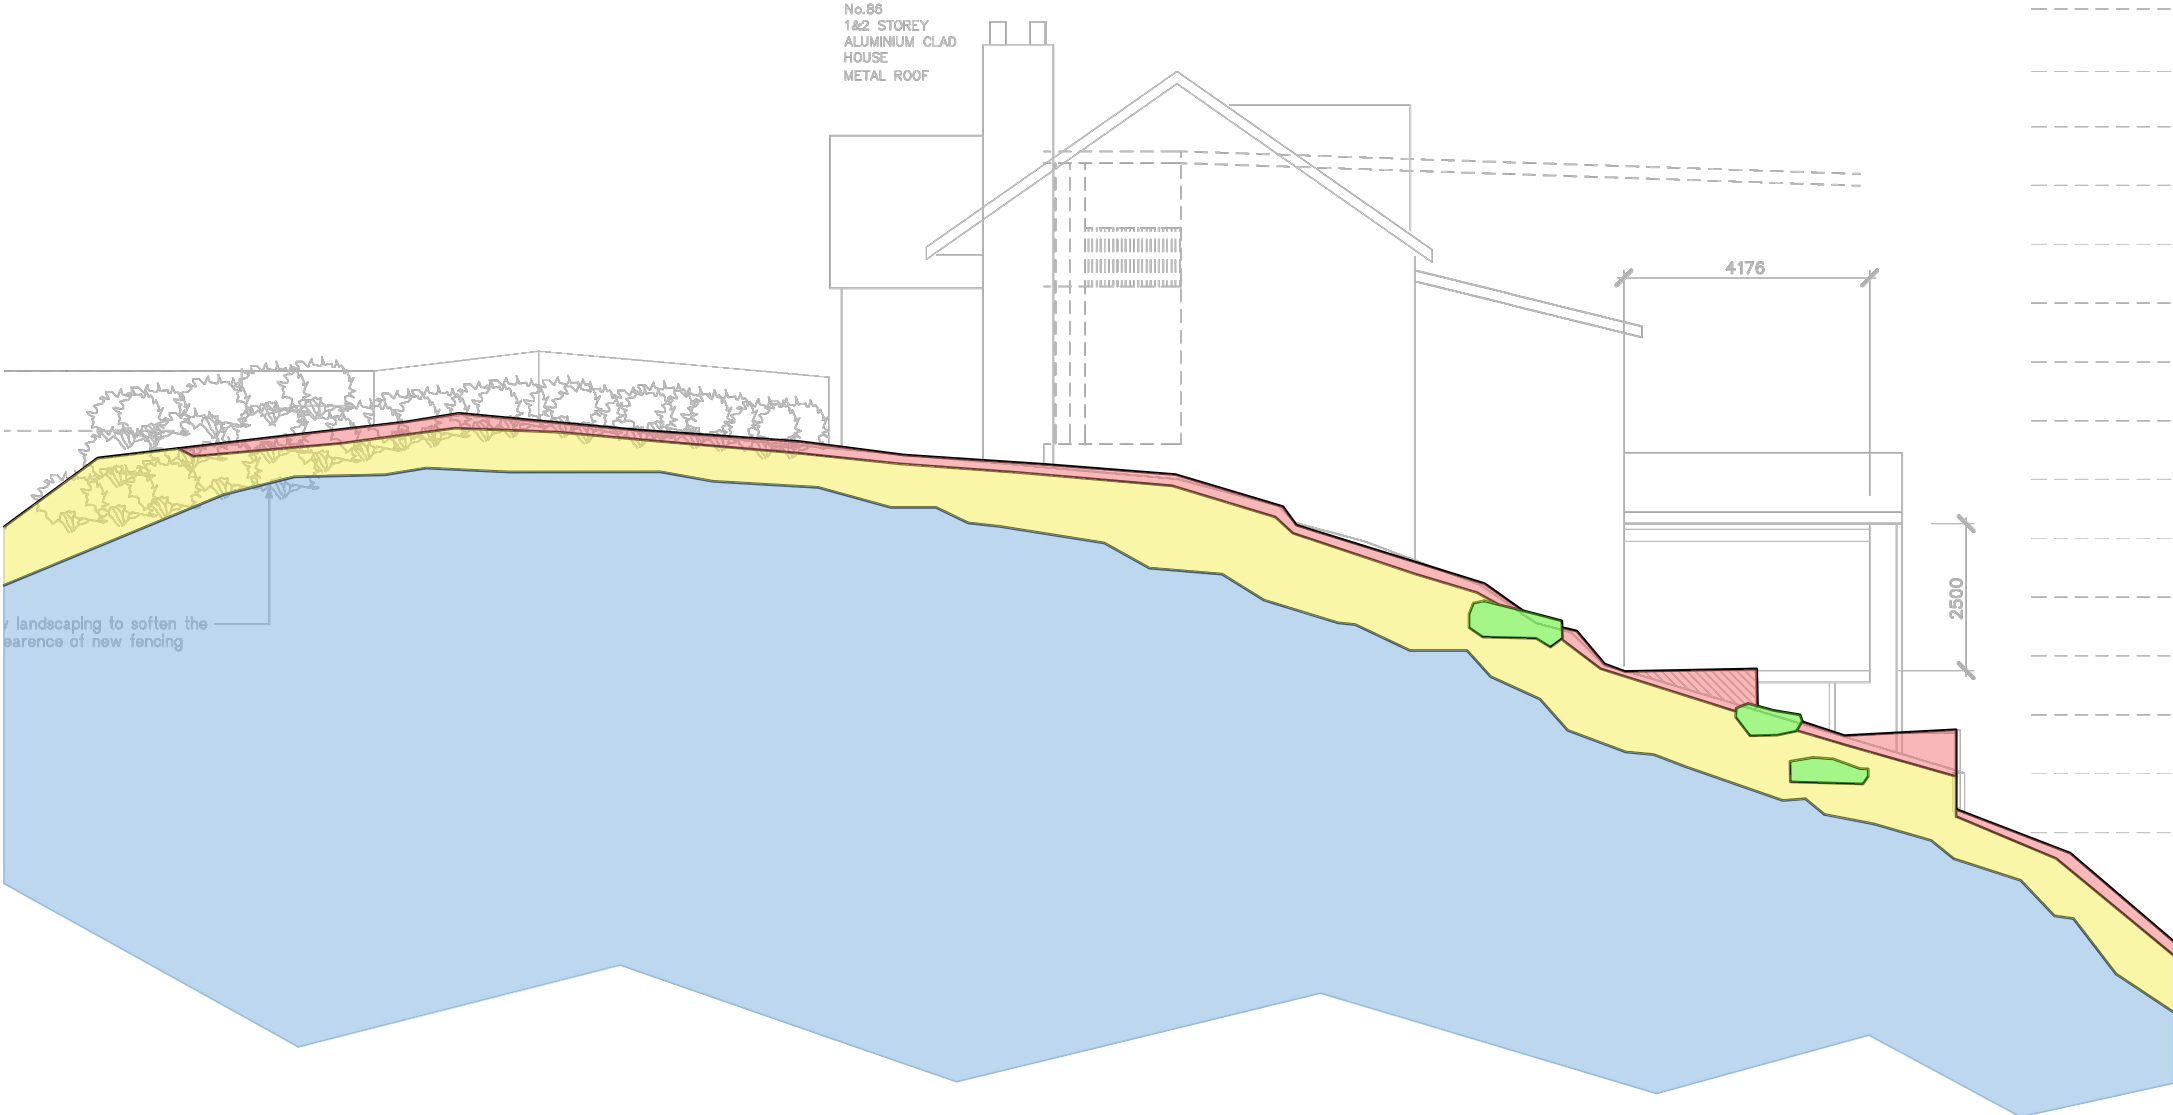
**INFERRED GEOLOGICAL SECTION**  
SCALE NTS

The soil profile consists of shallow uncontrolled fill and silty sandy top soils (O & A Horizons), silty clayey sand (B Horizon), and weathered sandstone bedrock (C Horizon). Based on our observations and the results of testing onsite, we would expect competent weathered bedrock, to be found within 1350 - 1950mm from current surface levels across the site.

INTERPRETED SUBSURFACE SECTION ONLY.  
ACTUAL GROUND CONDITIONS MAY VARY.
