Report Title: Geotechnical Report 201 Whale Beach Road, Whale Beach  
Report Date: 14/12/23

## **GEOTECHNICAL INVESTIGATION:**

New Pool at **201 Whale Beach Road, Whale Beach**

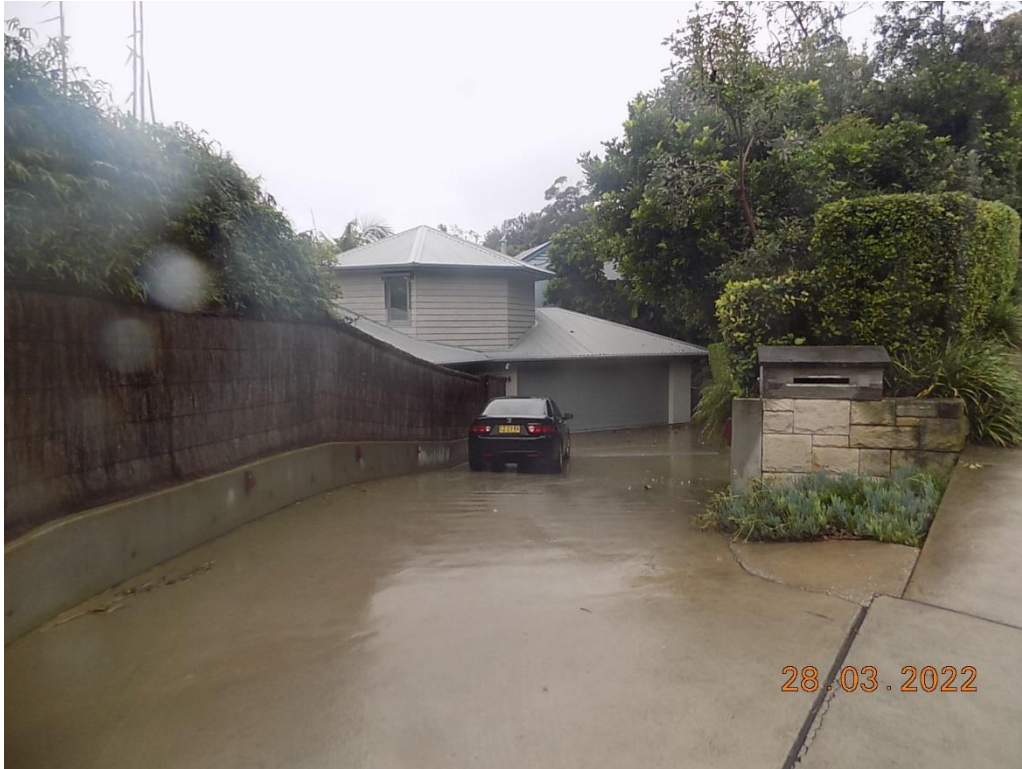
Photo 1

- 2.3** At the road frontage, a partially suspended concrete driveway runs across the slope to a garage attached to the uphill side of the house (Photo 1). The cut for the driveway is supported by a ~1.0m high stable concrete retaining wall (Photo 2). In between the road frontage and the house is a moderately sloping garden area. A stable, ~0.8m high timber log retaining wall supports a fill for a garden bed on the uphill side of the property (Photo 3). A second, stable ~1.2m high timber log retaining wall supports a cut to create the level platform for the uphill side of the house (Photo 4). The cut has been partially taken through an outcropping dislodged joint block that is embedded in the slope. The part four-storey timber clad and rendered

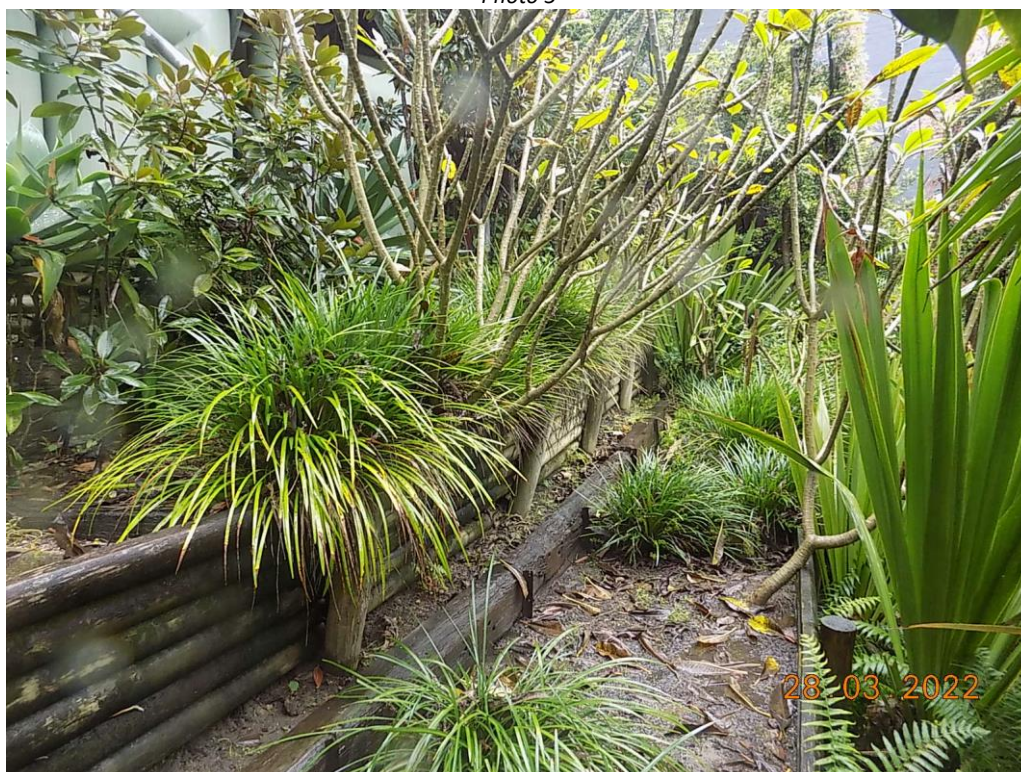
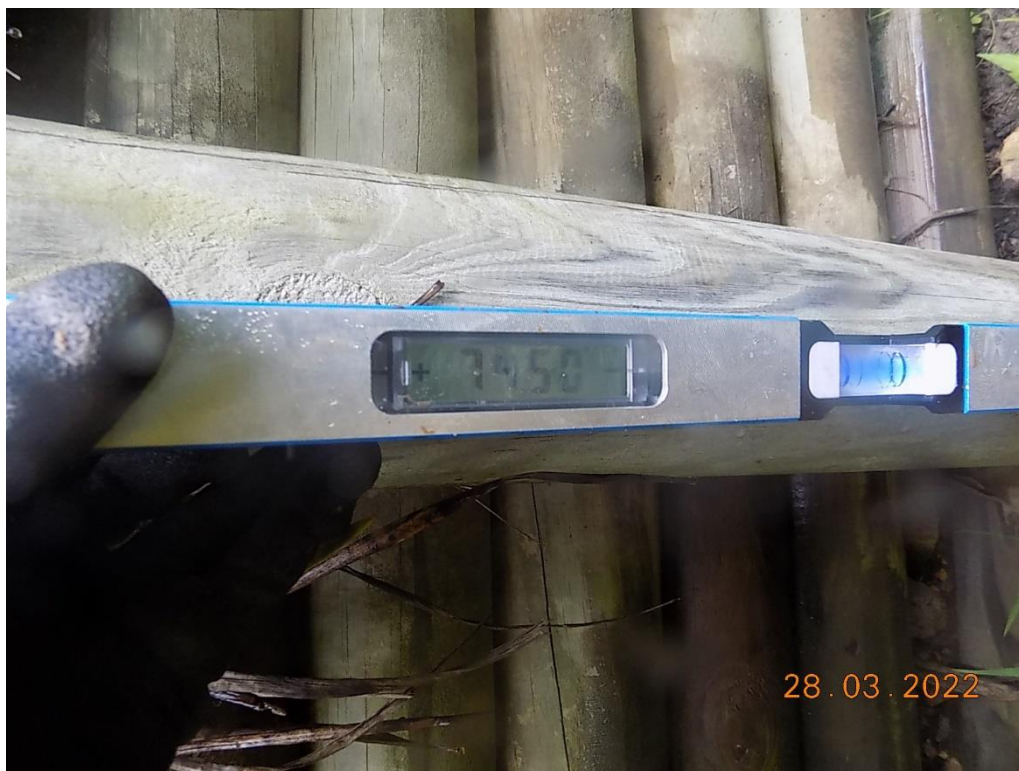
| HAZARDS | Hazard One | Hazard Two | Hazard Three |
|---|---|---|---|
| TYPE | The steep slope that falls across the property and continues above and below failing and impacting on the proposed works. | Further movement of the low timber log retaining wall below the house that causes damage or failure (Photo 6 & 7). | The excavation (to a maximum depth of ~1.5m) collapsing onto the work site before retaining structures are in place. |

The low timber log retaining wall on the downhill side of the property is tilting downslope at a maximum angle of ~15° (Photo 6 & 7). We recommend consideration be made to demolish the retaining wall during the proposed works and battering the soil at stable angles of not more than 30° from horizontal (1.0V to 1.7H). The existing wall will be obscured entirely by the proposed works.

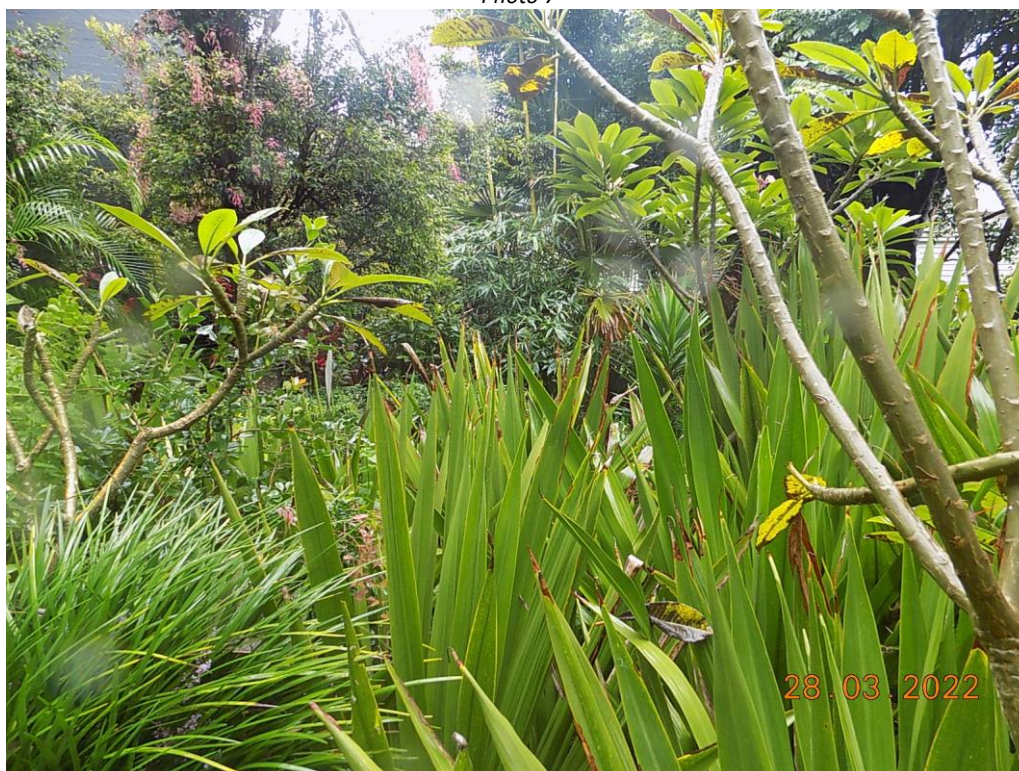
Photo 8

brick house is supported concrete block and brick walls, concrete piers, and steel posts. The concrete block and brick walls show no significant signs of movement and the concrete piers and steel posts stand vertical. A series of timber log retaining walls reaching up to ~1.0m high terrace the slope on the downhill side of the property. One of the timber log retaining walls support a fill to create a level platform for several large rainwater tanks (Photo 5). Another one of these low timber log retaining walls supporting a garden bed is tilting downslope to a maximum angle of ~15° and is in the slow process of failure (Photos 6 & 7). See **Section 14** for advice regarding this wall. A moderately sloping lawn and garden area extend to the lower common boundary (Photo 8).

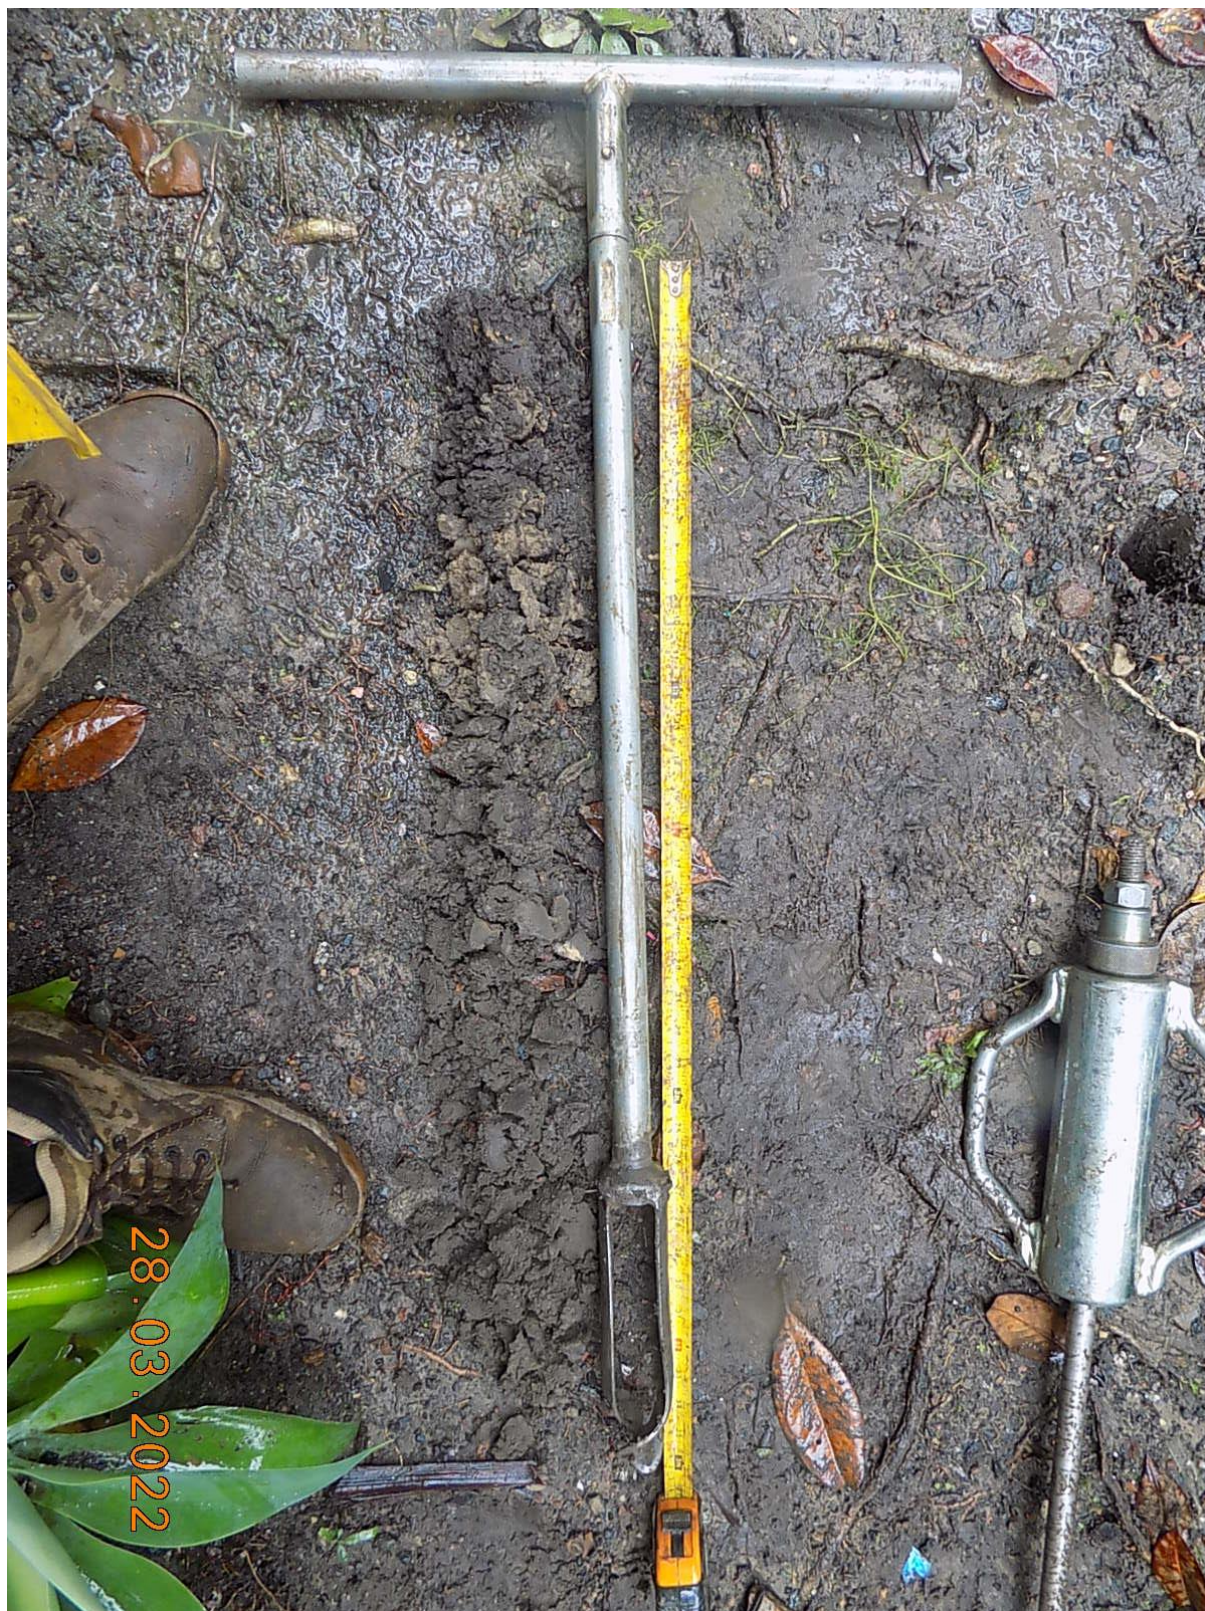
Photo 9 (Top to Bottom)

## AUGER HOLE 1 (~RL32.8) – AH1 (Photo 9)

| Depth (m) | Material Encountered |
|---|---|
| 0.0 to 0.2 | <b>TOPSOIL</b> , dark brown, medium grained, loose, fine trace of organic matter, damp. |
| 0.2 to 0.5 | <b>CLAY</b> , brown, fine grained, firm to stiff, damp. |
| 0.5 to 0.9 | <b>CLAY</b> , yellowy brown, fine grained, firm to stiff, damp. |

End of test @ 0.9m. No water table encountered.

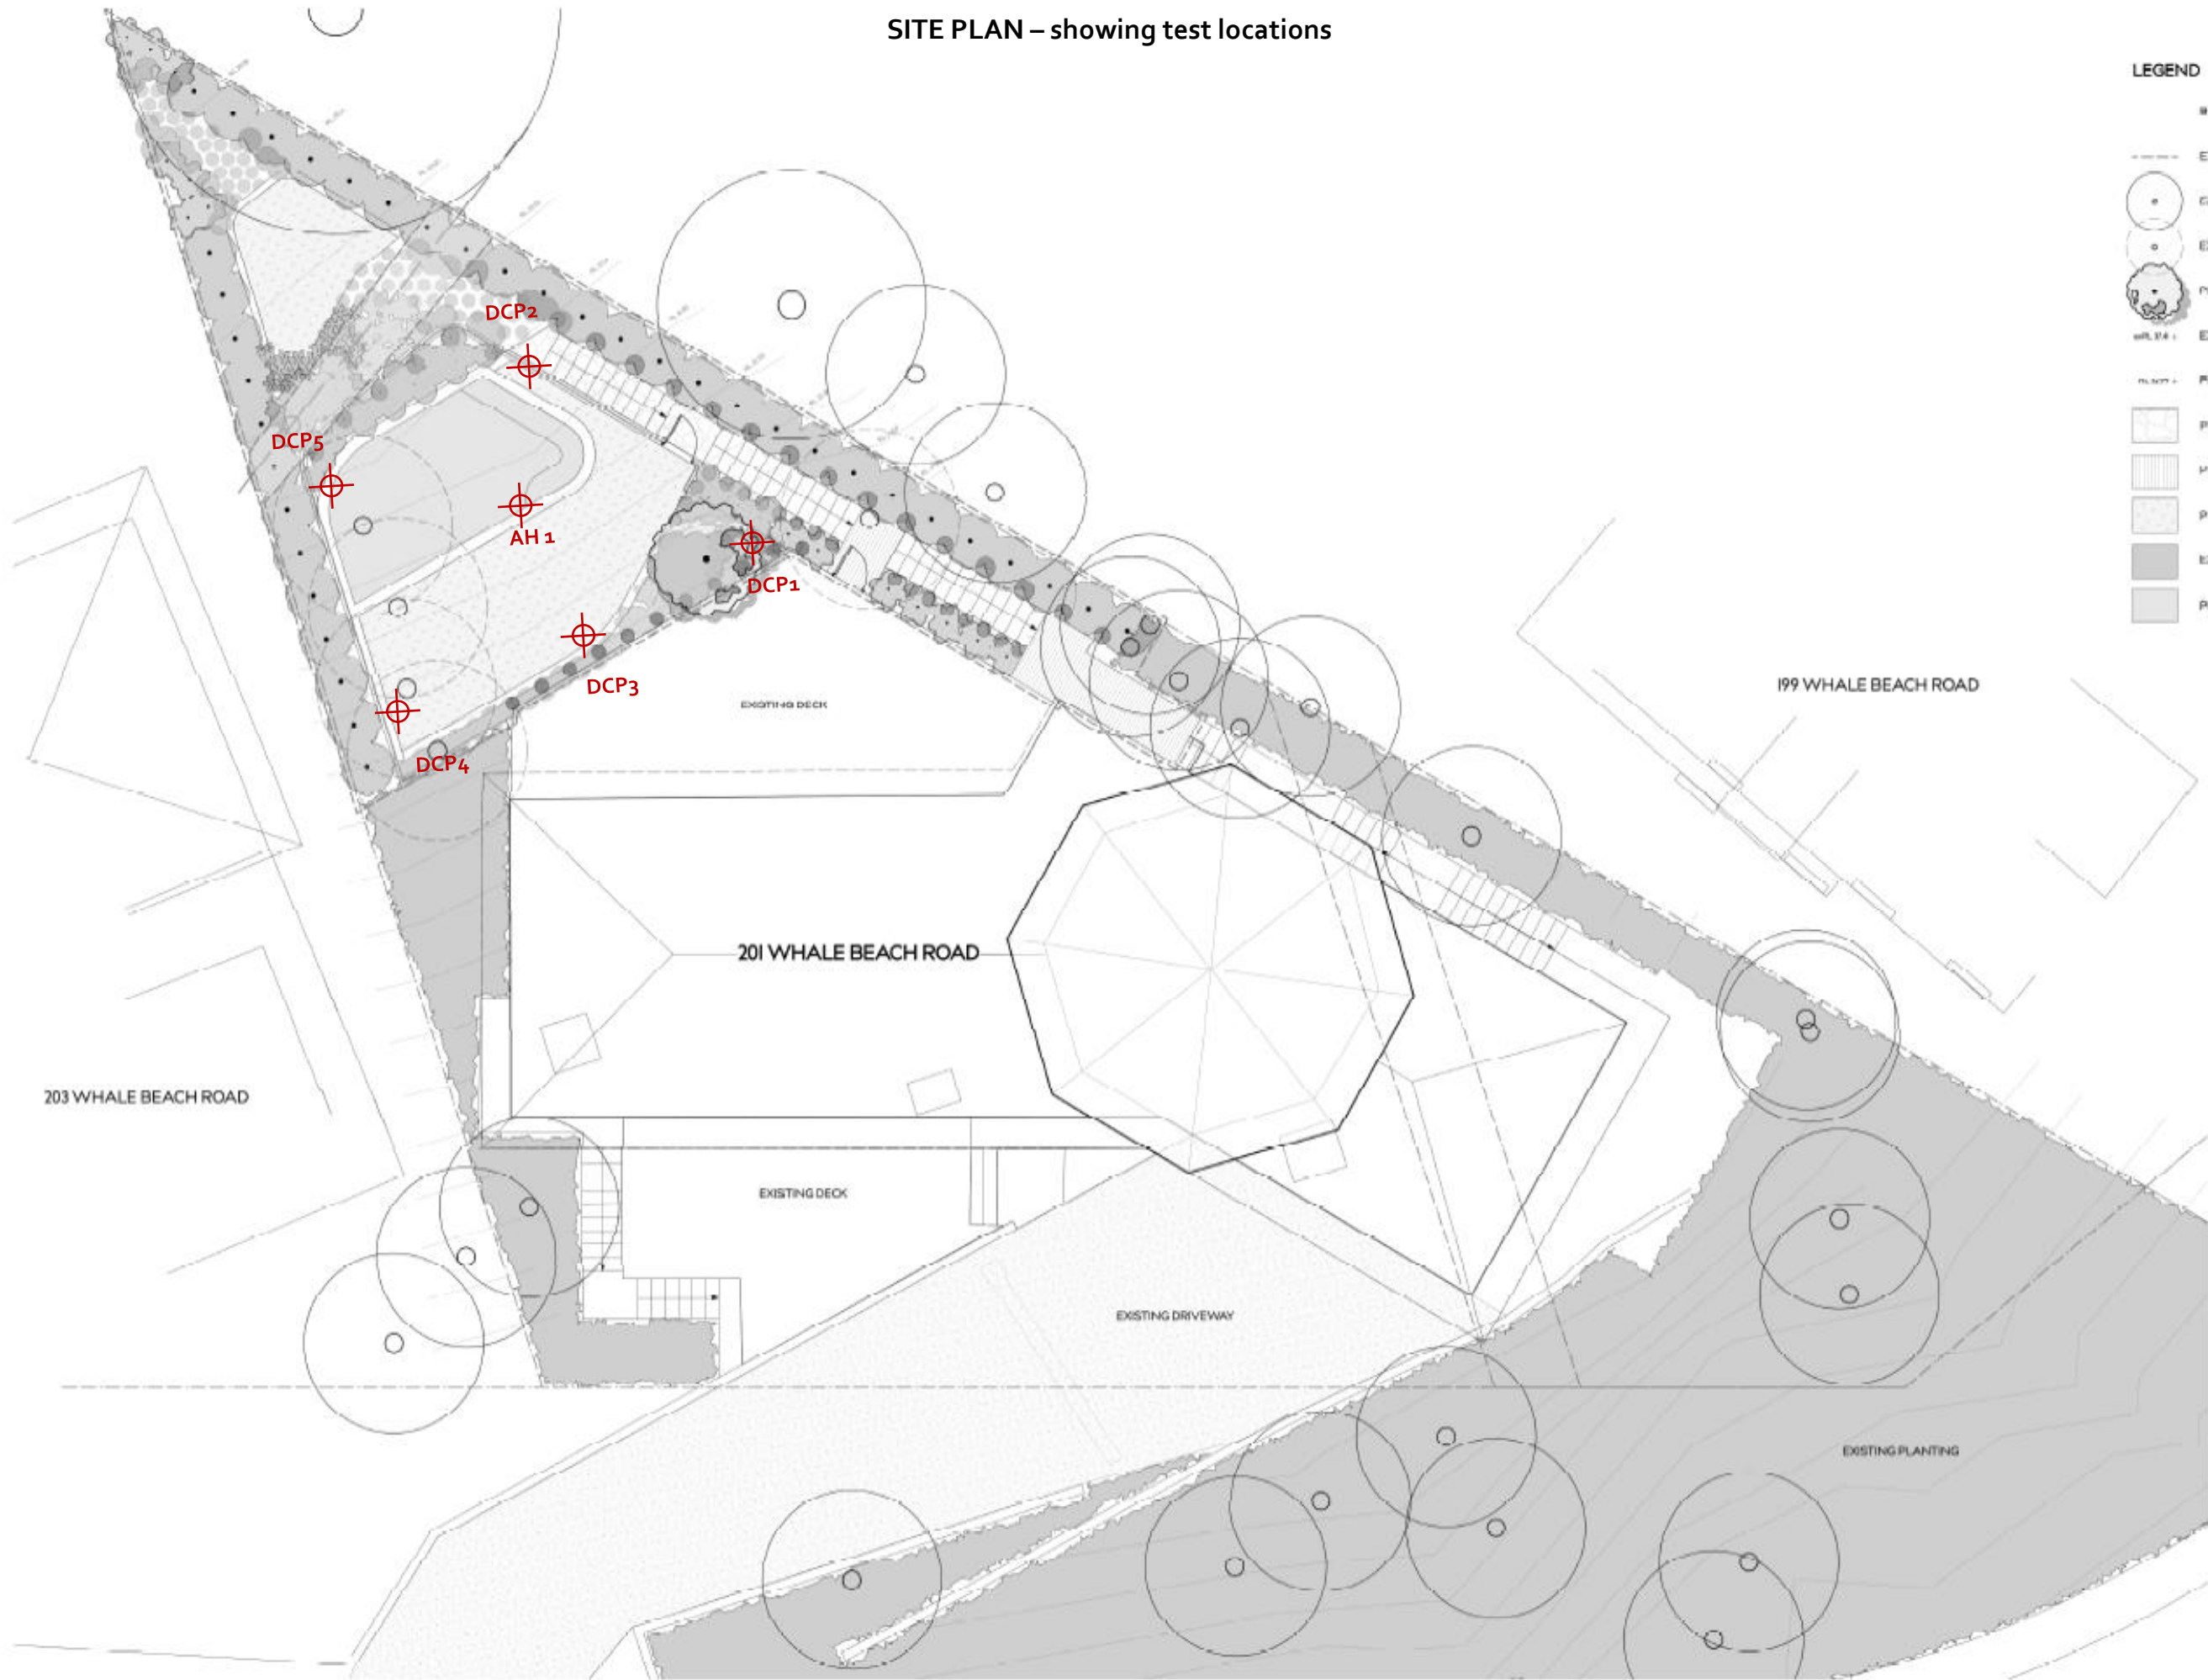
SITE PLAN – showing test locations

One hand Auger Hole (AH) was put down to identify soil materials. Five Dynamic Cone Penetrometer (DCP) tests were put down to determine the relative density of the overlying soil and the depth to weathered rock. The locations of the tests are shown on the site plan attached. It should be noted that a level of caution should be applied when interpreting DCP test results. The test will not pass through hard buried objects so in some instances it can be difficult to determine whether refusal has occurred on an obstruction in the profile or on the natural rock surface. It is likely that DCP1 and DCP2 may have refused on large dislodged joint blocks in the profile. See the appended "Important information about your report" for a more comprehensive explanation. The results are as follows:

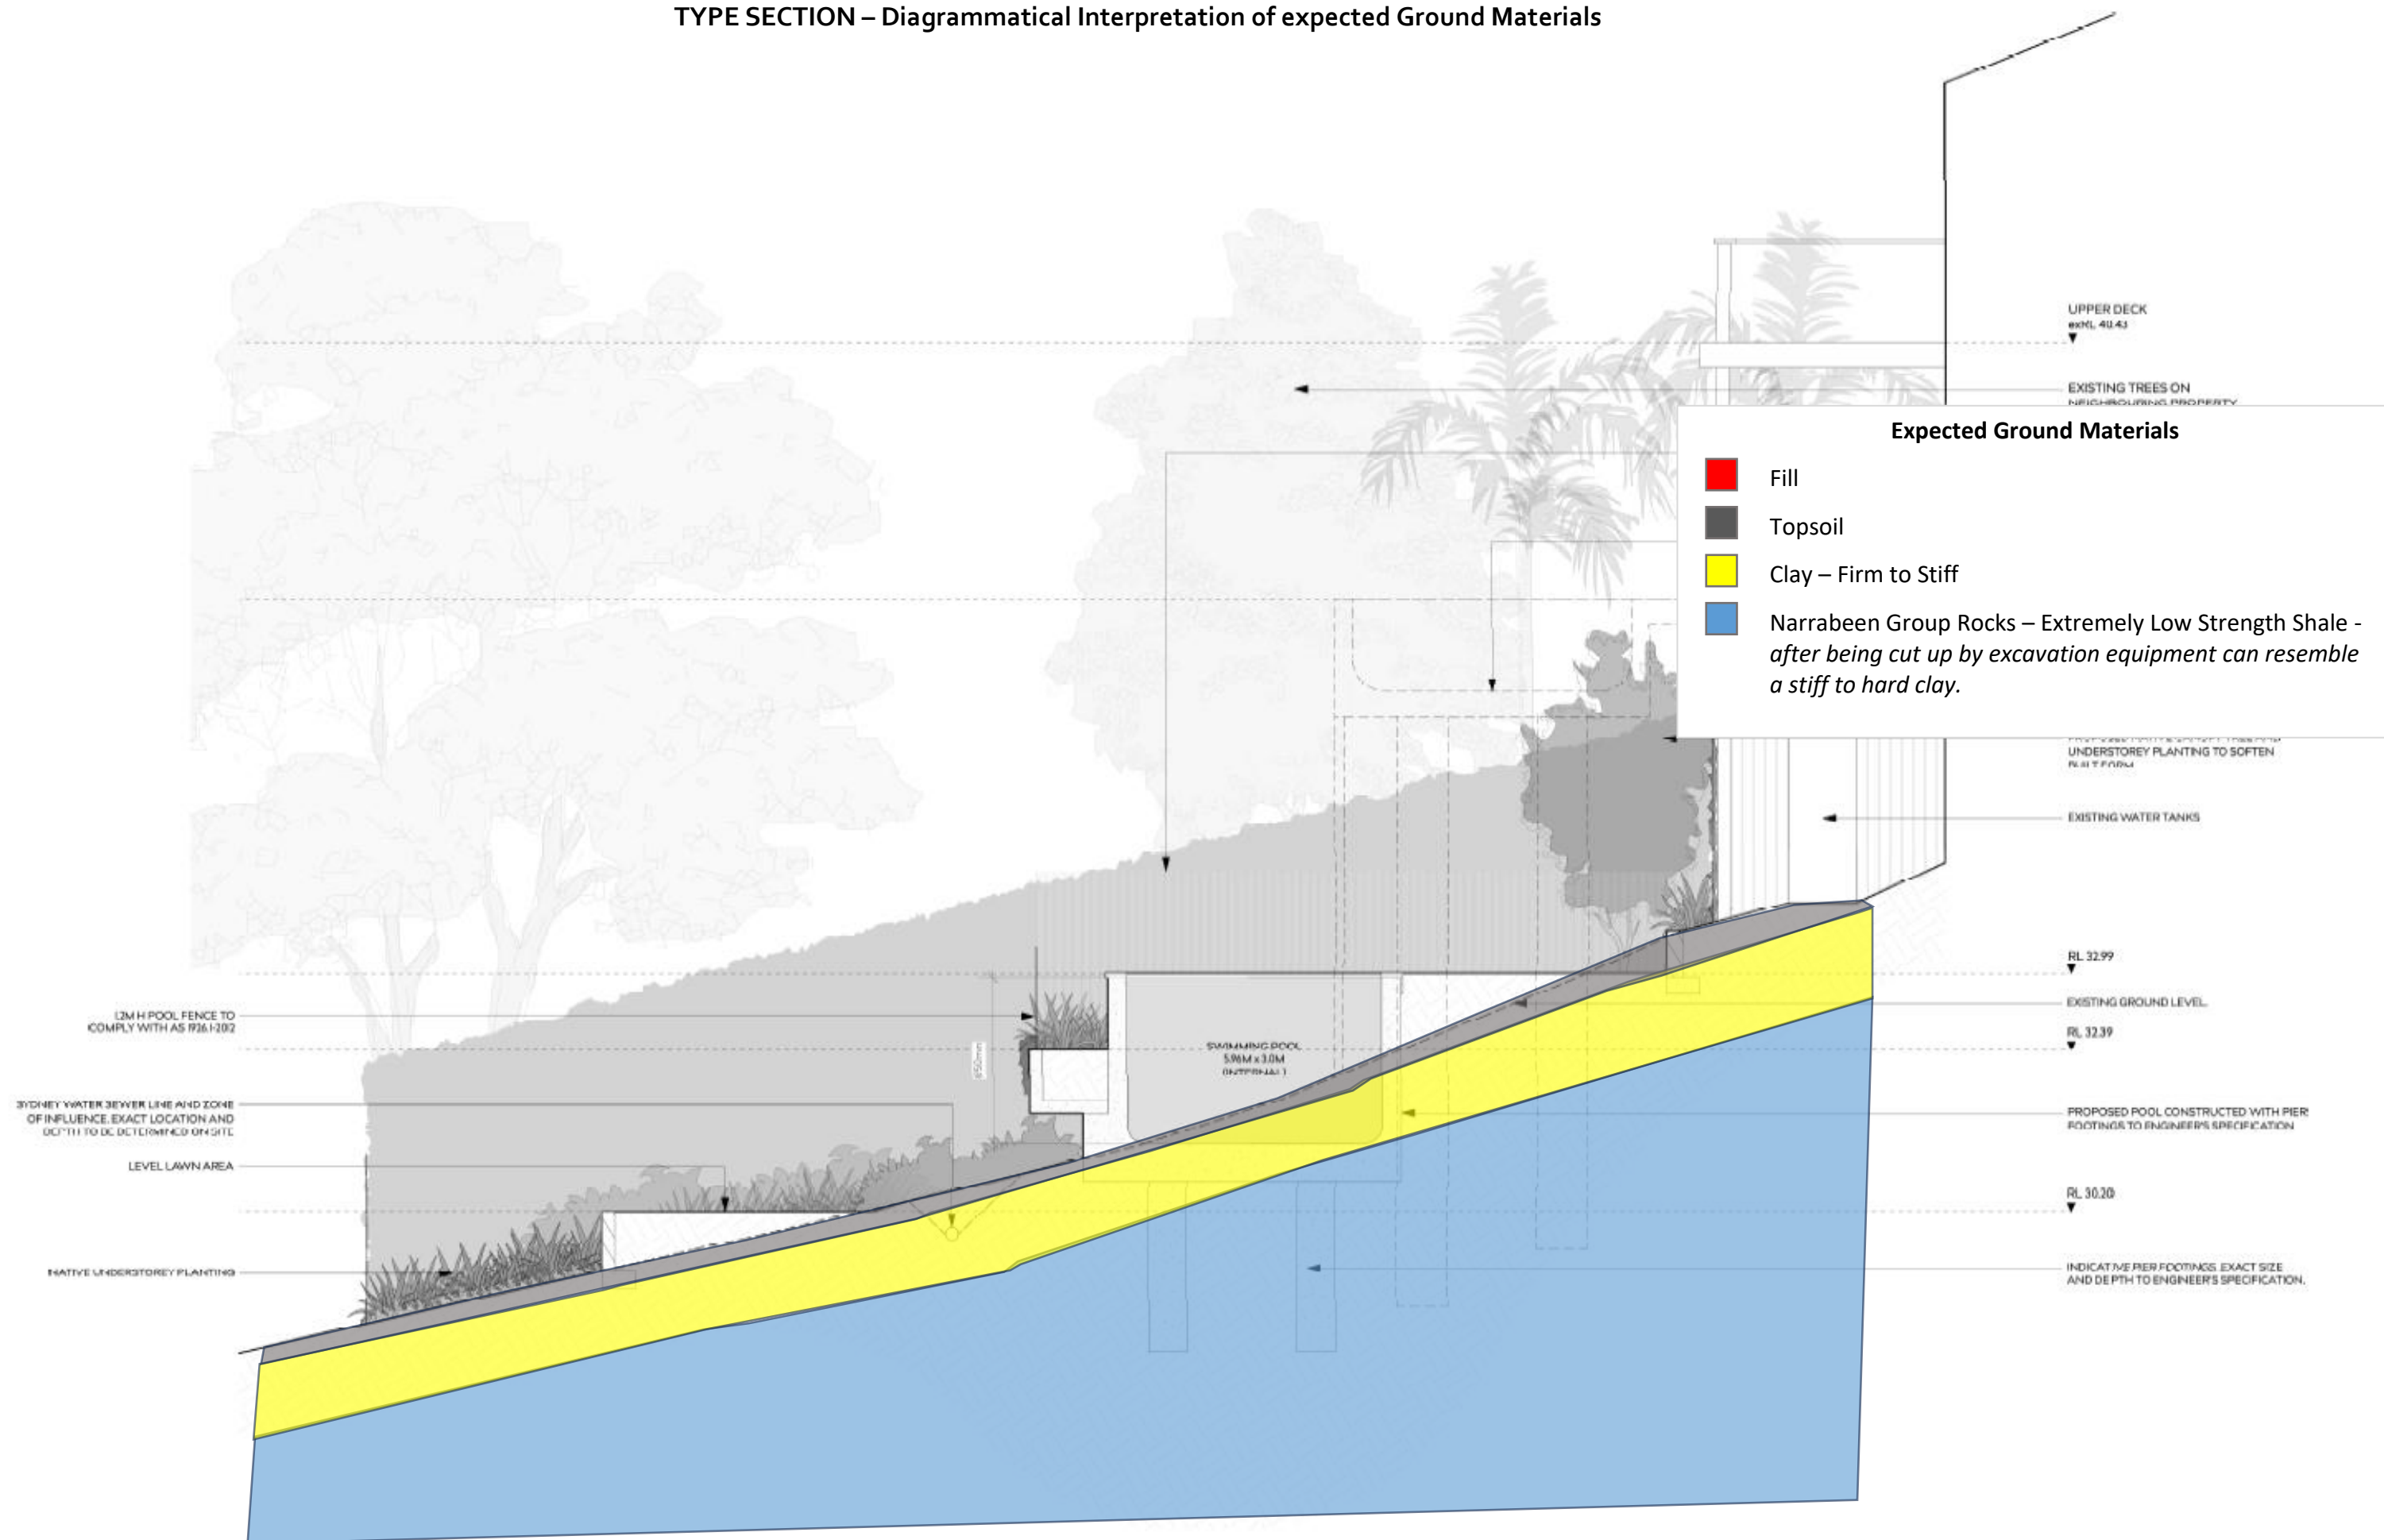
# TYPE SECTION – Diagrammatical Interpretation of expected Ground Materials

The slope materials are colluvial at the near surface and residual at depth. In the test locations, the ground materials consist of shallow soils over clays. The clay merges into the underlying weathered rock at depths of between ~1.2m to 1.5m below the current surface. The weathered zone is interpreted to be Extremely Low Strength Shale. Sandstone boulders were observed embedded in the slope above the house. It is interpreted that DCP1 and DCP2 refused on an underlying boulder similar to the ones at the surface. See Type Section attached for a diagrammatical representation of the expected ground materials.

from becoming saturated. If the cut batters through soil and clay remain unsupported for more than a few days before pool construction commences, they are also to be supported with typical pool shoring until the pool structure is in place. The support will need to be designed by the structural engineer. See site plan attached for extent of minimum required shoring shown in blue.
