**Date:** 25<sup>th</sup> October 2022

**Project No.:** 2022-247

### **Preliminary Assessment for 19 Tarra Crescent, Dee Why, NSW.**

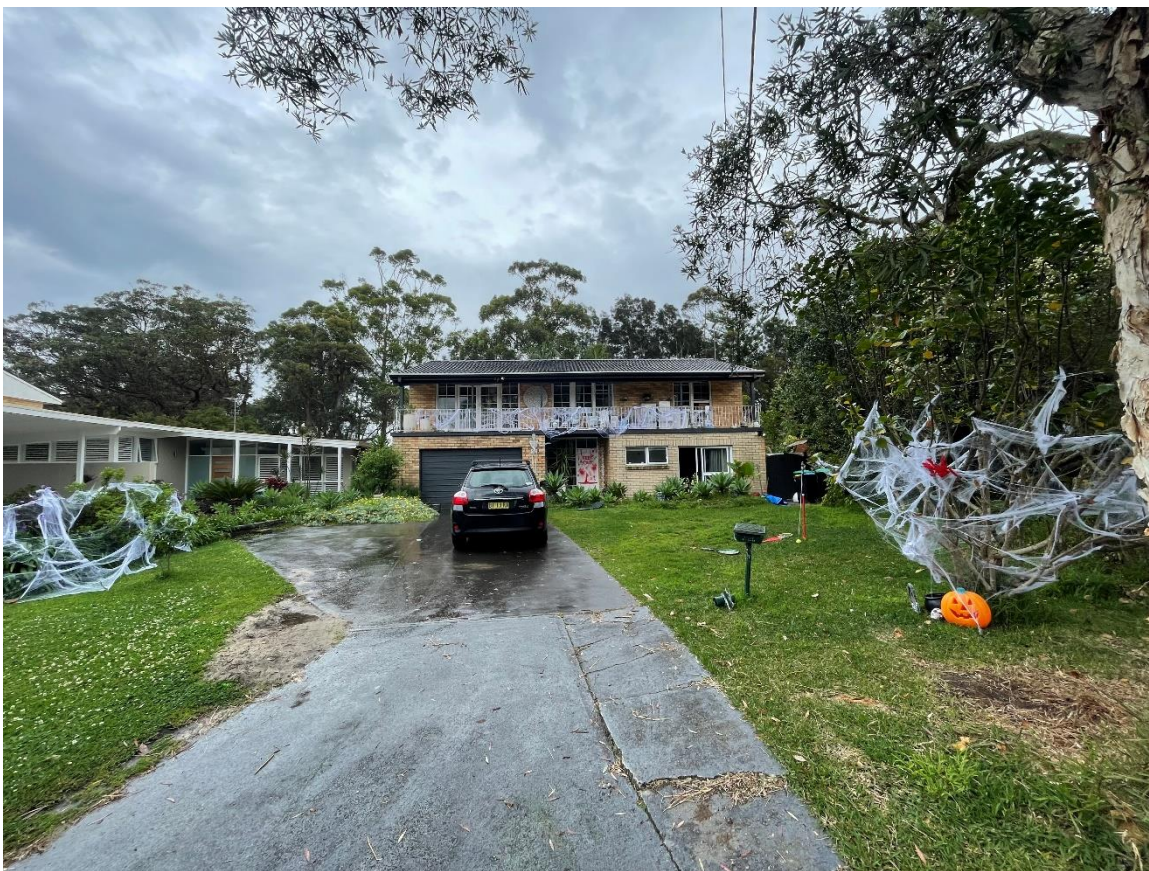
The front of site comprises a flat lawn area broadly bisected by a concrete driveway which extends from the roadway to the front edge of the dwelling. The dwelling comprises a two storey masonry structure, anticipated to be of >40 years construction age. The structure appears to be in good condition with no signs of excessive settlement or cracking observed on the external walls. A view of the front of the site is provided below as Photograph 1.

*Photograph 1: View of the front of site, looking broadly south west from the roadway*

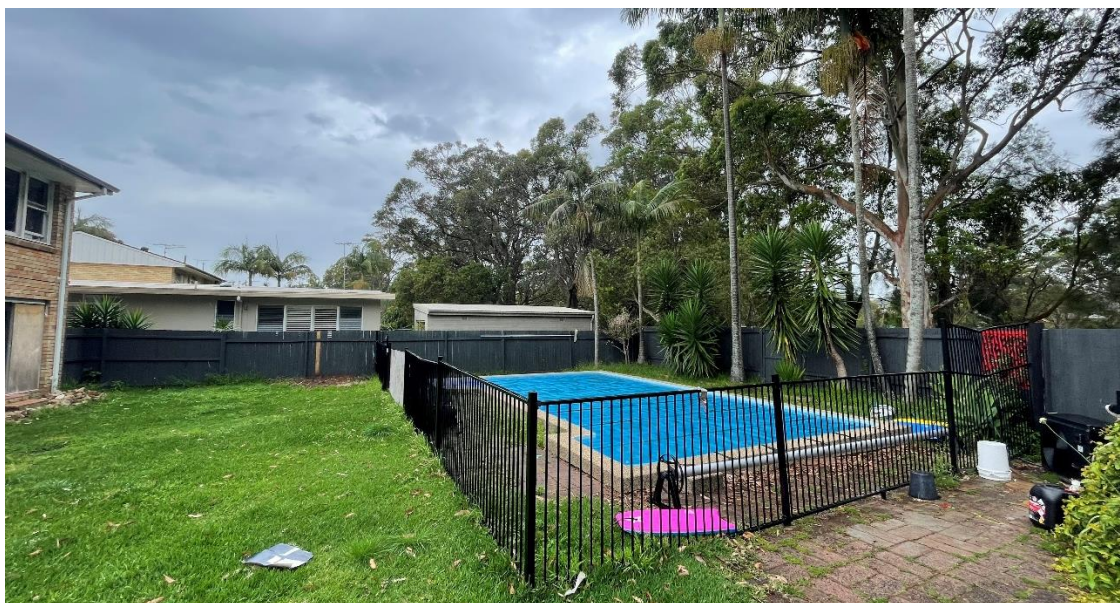
Access to the rear of the site was gained via a concrete pathway which extends around the northern edge of the dwelling. The rear of site comprises a relatively flat lawn area immediately adjacent to the dwelling with an inground pool situated adjacent to the rear western boundary. Photograph 2 below provides a view of the rear of the site.

*Photograph 2: View of the rear garden of the site, looking broadly south from the northern boundary*
