## **GEOTECHNICAL INVESTIGATION:**

New Carport and Driveway at **9 Beatrice St, Clontarf.**

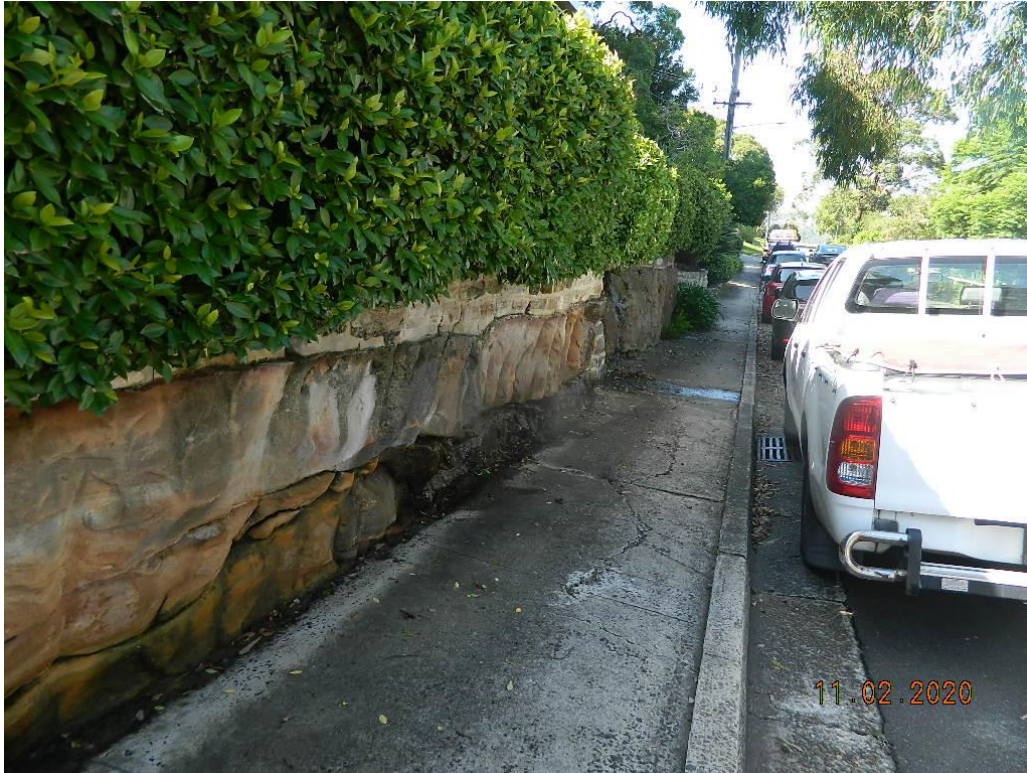
Photo 1

- 2.3** Sandstone bedrock is outcropping on the uphill side of the Beatrice Street road frontage (Photo 1). The fill batter for the road merges into the natural slope that is supported at the toe by two stable stepped sandstone block retaining walls (Photos 2 & 3). The entire slope from the road to the upper retaining wall has a thick ground cover of creeper with some scattered shrubs and trees (Photo 4). The lower retaining wall has some stepped cracking through the mortar that is likely the result of the tree gum tree growing, immediately behind the wall (Photo 5). At the N side of

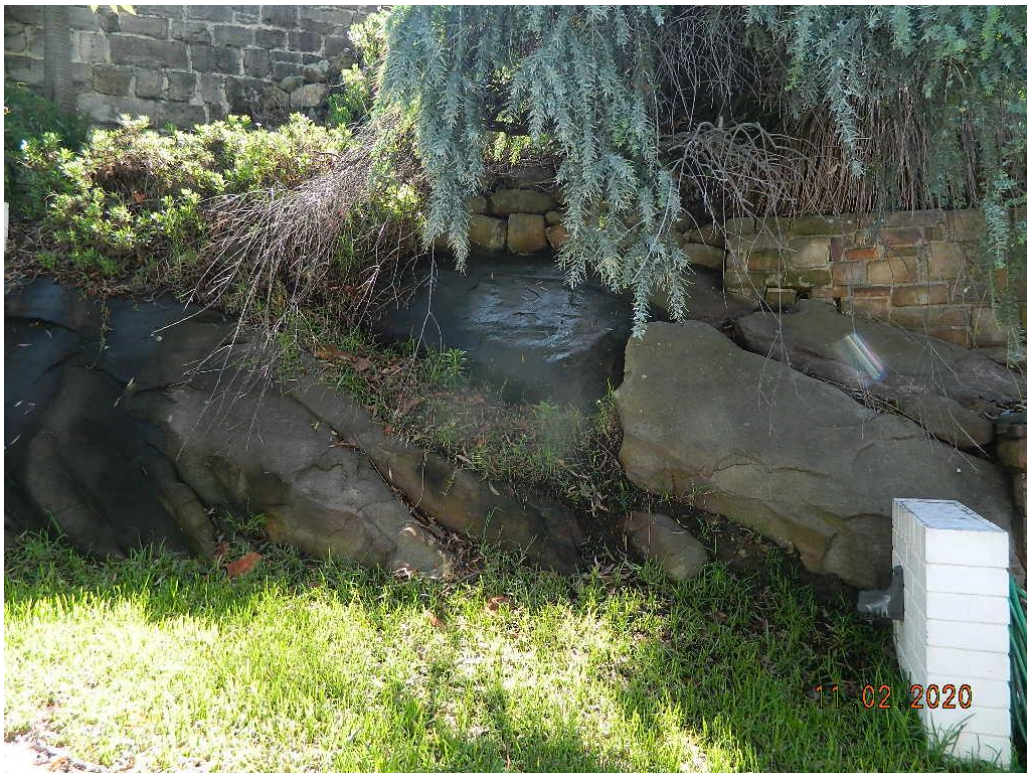
Photo 6

the sites the stepped retaining walls terminate at outcropping sandstone Bedrock that extends across the slope to the N common boundary where a ~ 3.0m high concrete block retaining wall in good condition supports a fill on the adjoining property (Photos 6 & 7). The wall can be seen to be founded on rock (Photo 8). At the S side of the frontage a timber staircase provides pedestrian access down the slope from the road frontage (Photos 9 & 10). Below the stepped walls a level lawn extends to the uphill side of the house (Photo 11). The single storey brick house is supported on walls that step down the slope (Photos 12 & 13). A concrete balcony extends off the downhill side of the house at a lower level to the living area of the house (Photo 14). The house structure is supported on brick walls, concrete piers and a concrete slab. The supporting walls and piers stand vertical and show no significant signs of movement (Photos 15 to 18). Low sandstone stack rock retaining walls line the slope along the N property boundary and well-constructed sandstone block retaining walls support the slope downhill of the balcony (Photo 19). Sandstone gabion retaining walls support the slope near the S side of the house (Photo 20). No signs of slope instability were observed on the property.

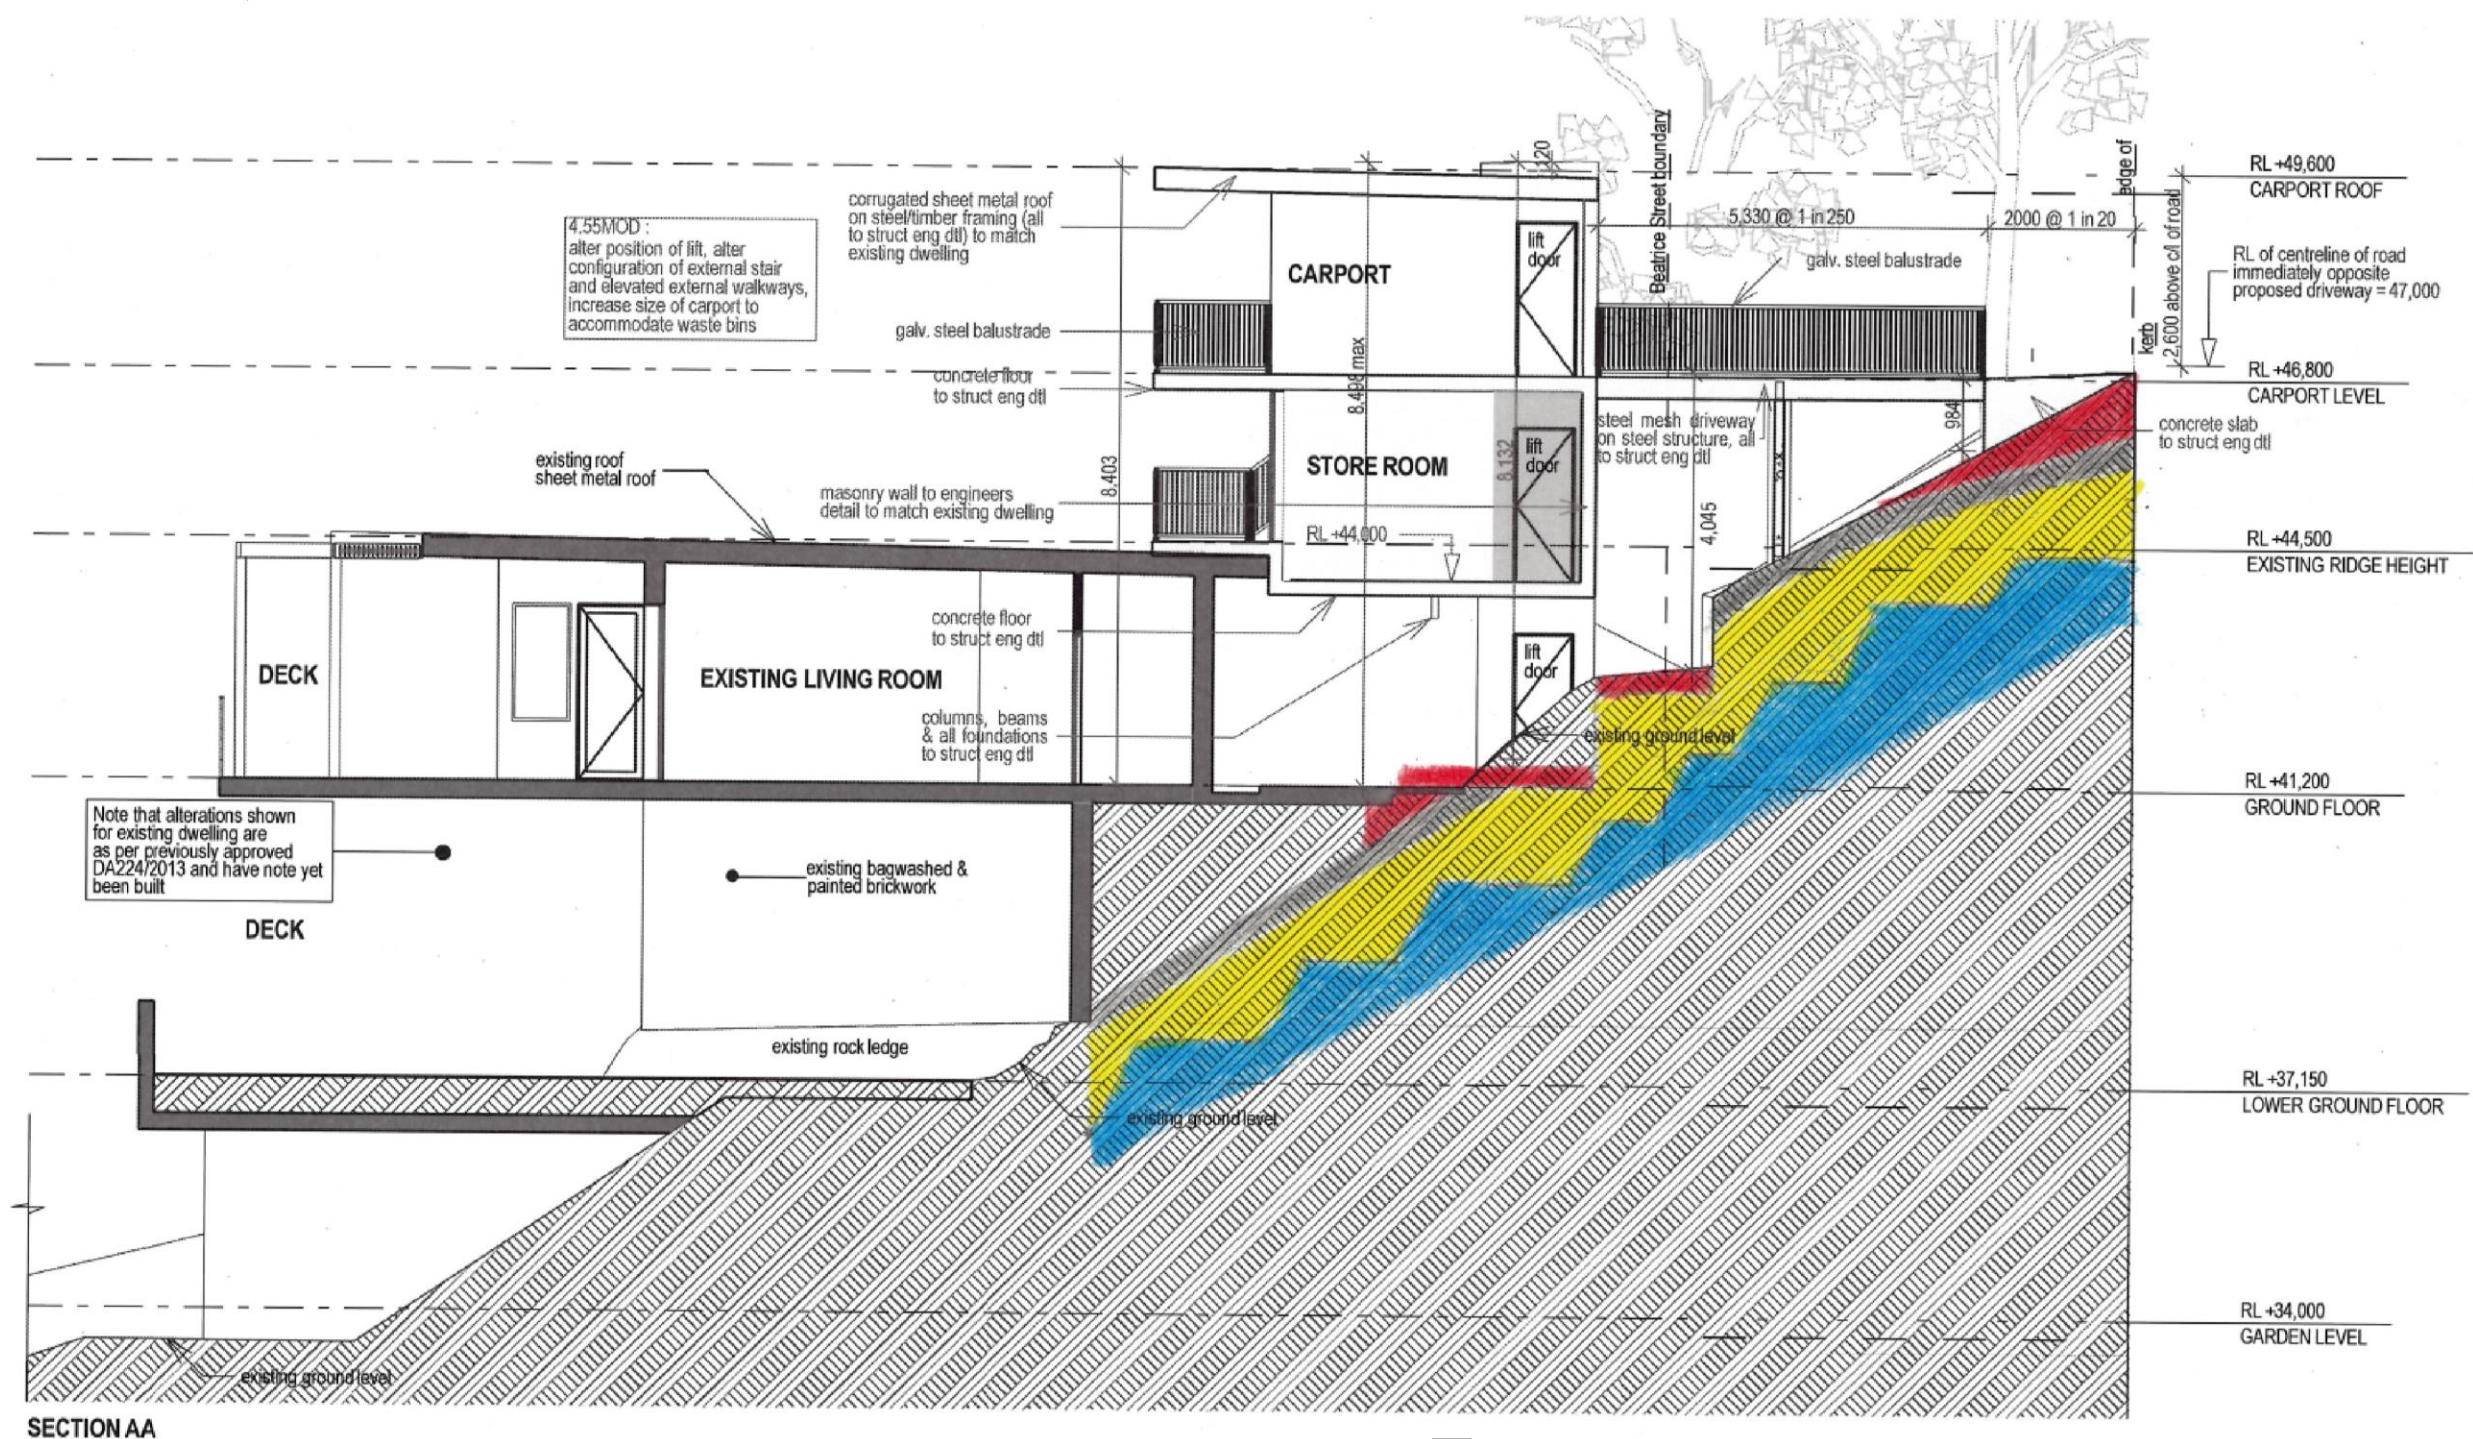
# TYPE SECTION – Diagrammatical Interpretation of expected Ground Materials

The surface features of the block are controlled by the underlying sandstone bedrock that steps down the property forming sub-horizontal benches between the steps. Where the grade is steeper, the steps are larger and the benches narrower. Where the slope eases, the opposite is true. The rock is overlain by soil and clay that fills the bench step formation. In the test locations, the depth to rock ranged between 0.4m to 1.9m below the current surface. The sandstone underlying the property is estimated to be Medium Strength or better. See Type Section attached for a diagrammatical representation of the expected ground materials.
