# **Arboricultural Impact Assessment Report**

<u>Client Name</u>: Barrie and Iyuko Fieldman <u>Site Address</u>: 95 Bower Street, Manly NSW

**Phone:** 0426 836 701 **Date Prepared:** 8<sup>th</sup> April 2021

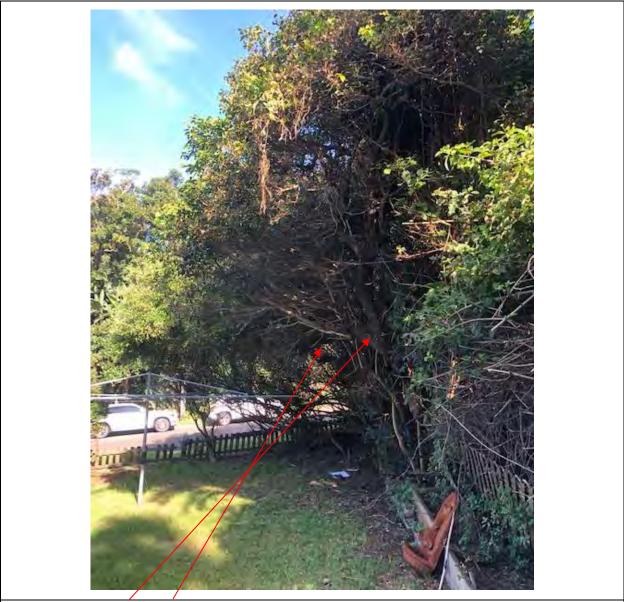
| Tree ID | Species | Retention value | TPZ radius (m) | SRZ radius (m) | TPZ encroachment | Discussion/ Conclusion | Recommendation |
|---|---|---|---|---|---|--|---|
| 1 | Cheese Tree | Z10 | 3.8 | 2.2 | Major | Tree has been proposed to be replaced as part of the landscaping works. The tree has been assessed as in fair to poor condition with minimal potential for improvement. | Remove |
| 2 | African Olive | Z10 | 5.4 | 2.4 | Major | Tree has been proposed to be replaced as part of the landscaping works. The species is listed as exempt from protection in NBLGA. | Remove |

Photo A: Trees 1 and 2 are low value and suppressed.

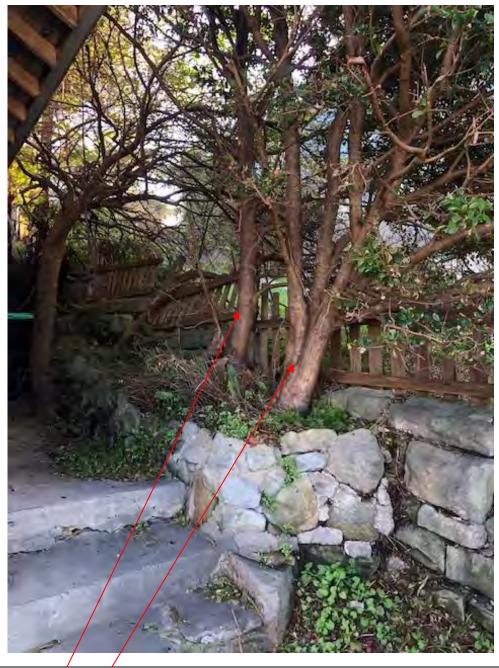
Photo B: Trees 6 and 7 within 2 metres of the existing dwelling.
