**FINAL OCCUPATION CERTIFICATE**

**CC2008-00439**

Address 213-215 Riverview Road, AVALON 2107  
Lot No Y  
DP - 110460

| Description | Demolition of existing structures & Construction of new dwelling & swimming pool |

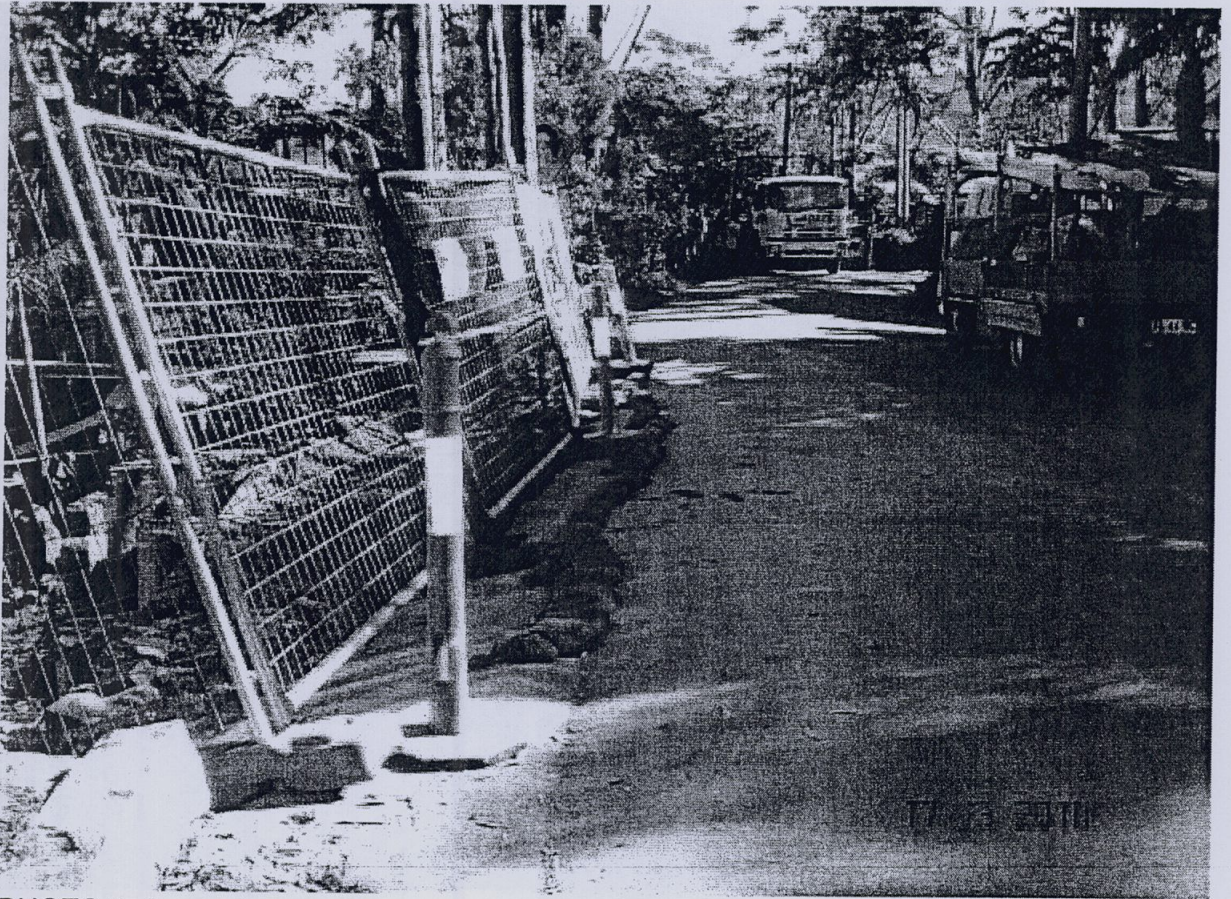
PHOTO 1: As previous.

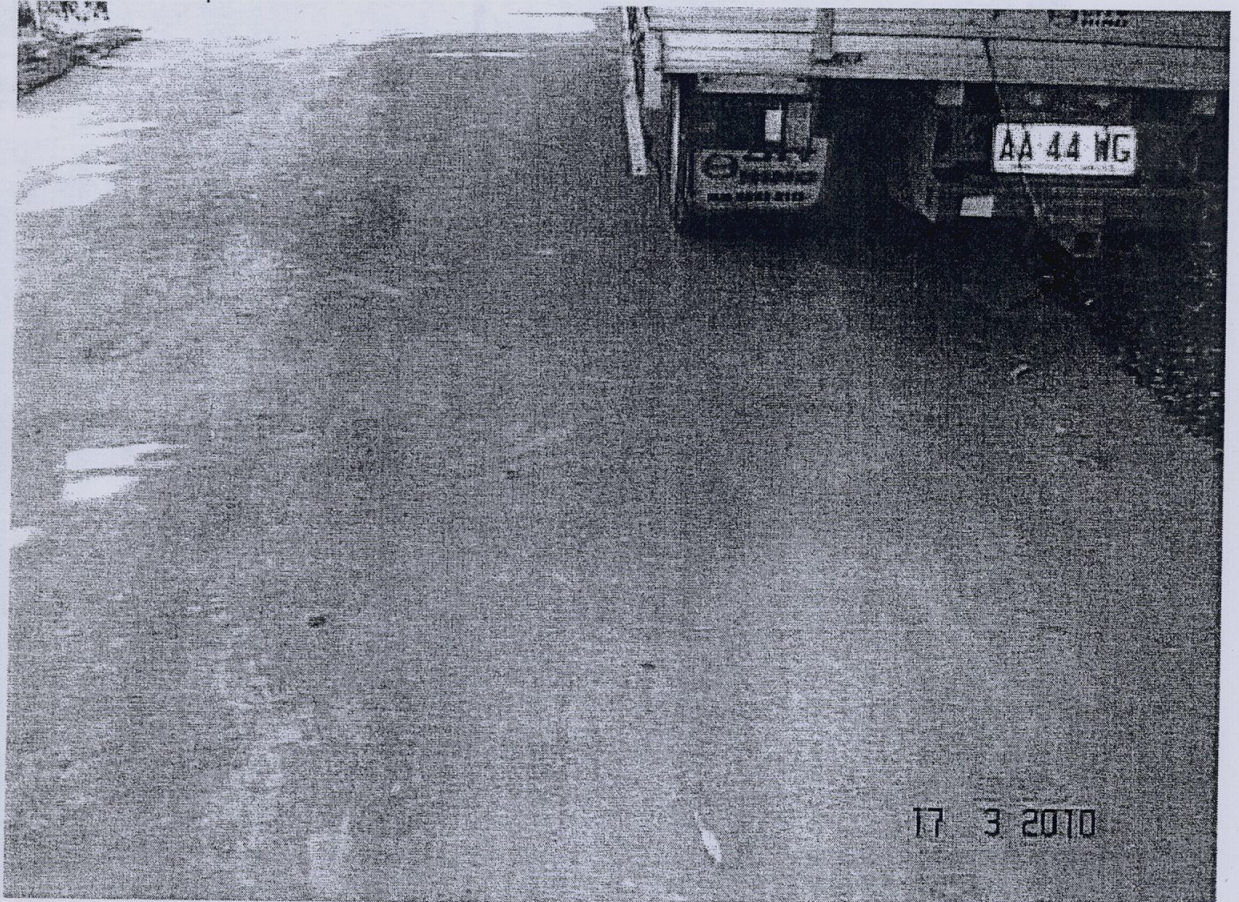
PHOTO 2: Previous cracking not evident.

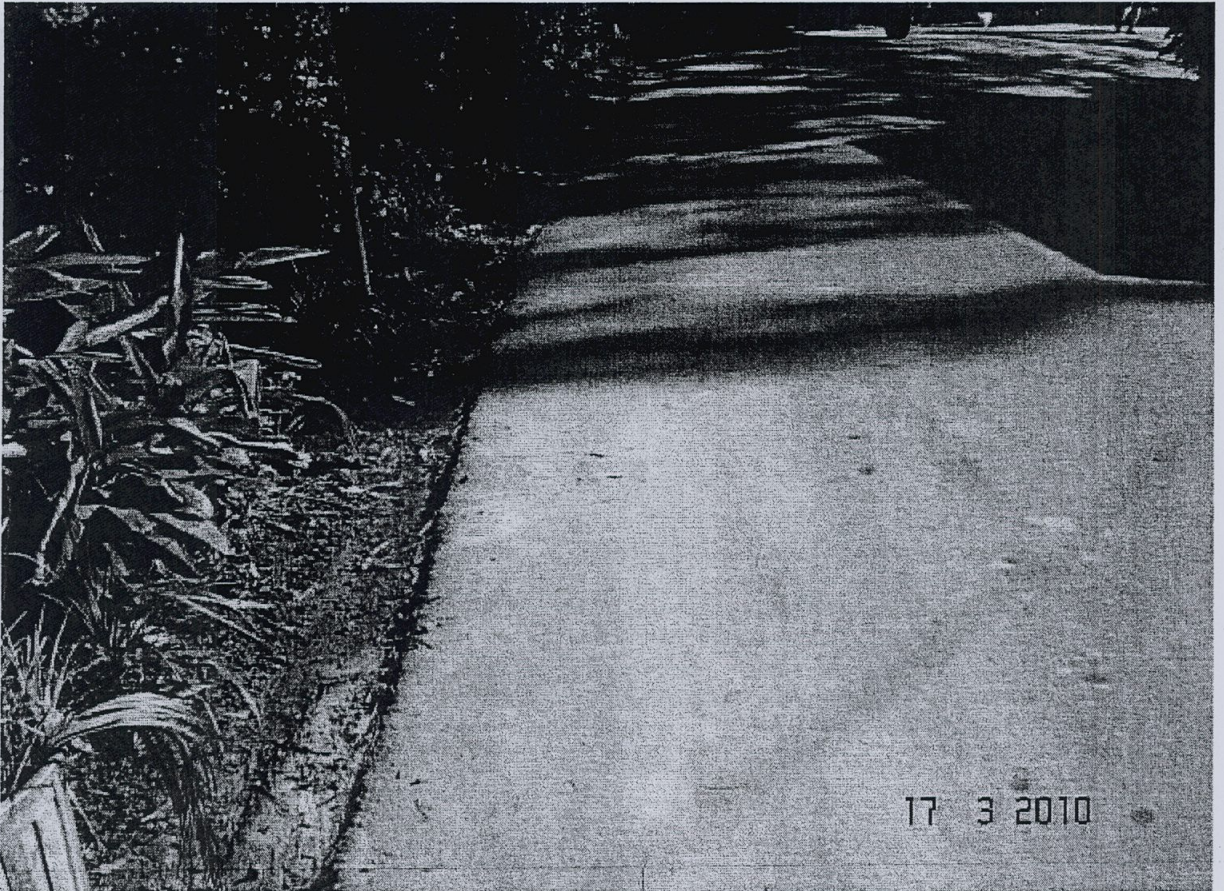
PHOTO 3: Previous cracking not evident.

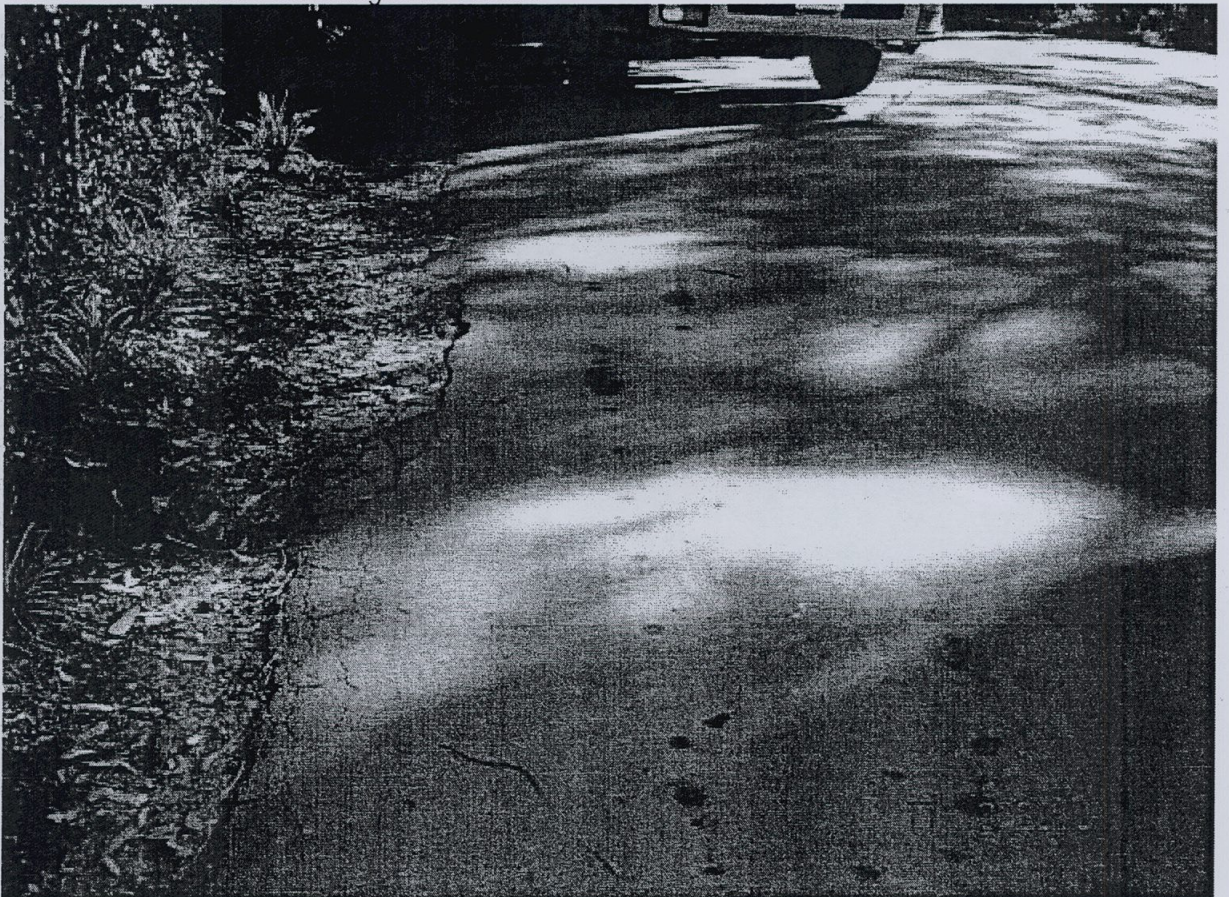
PHOTO 4: As previous.

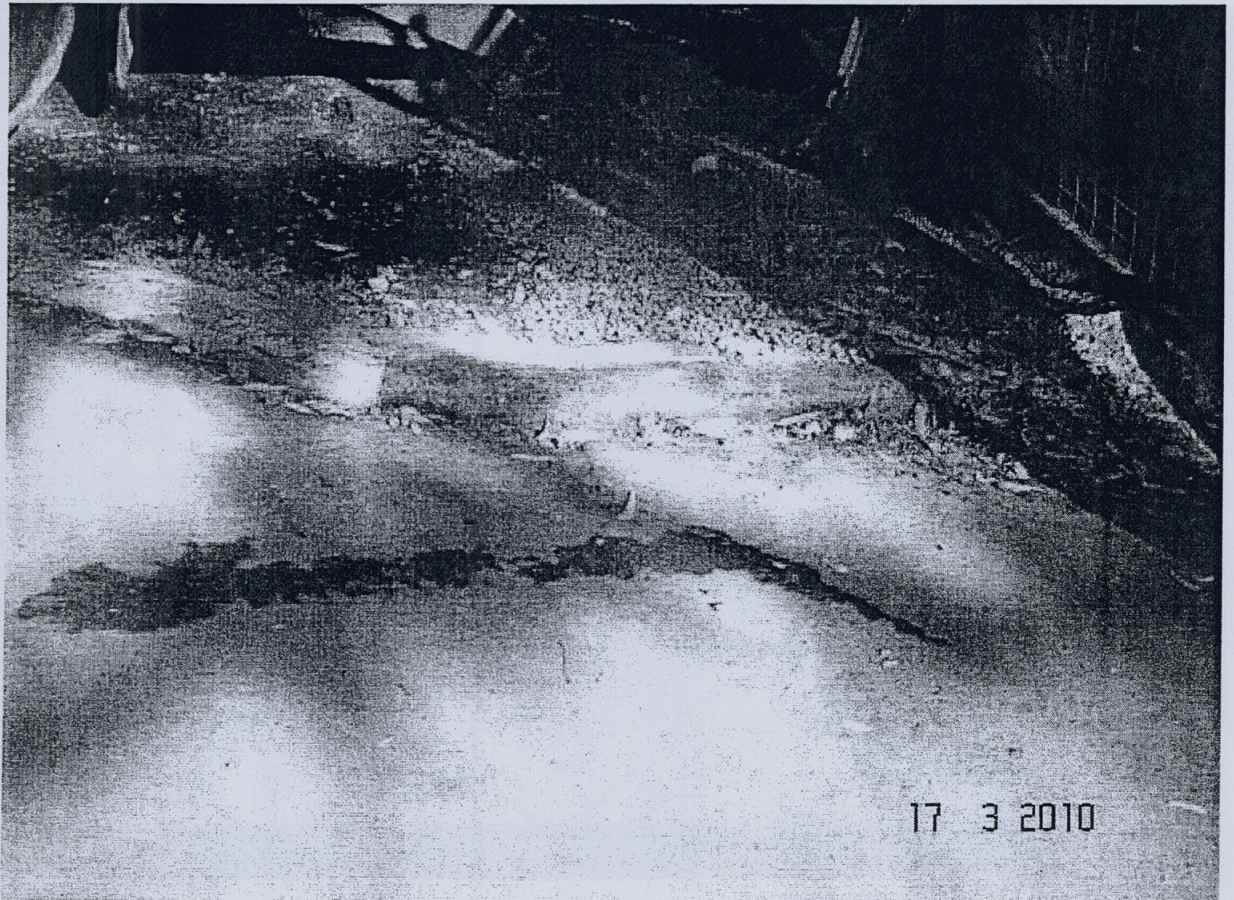
PHOTO 6: Construction site entrance.

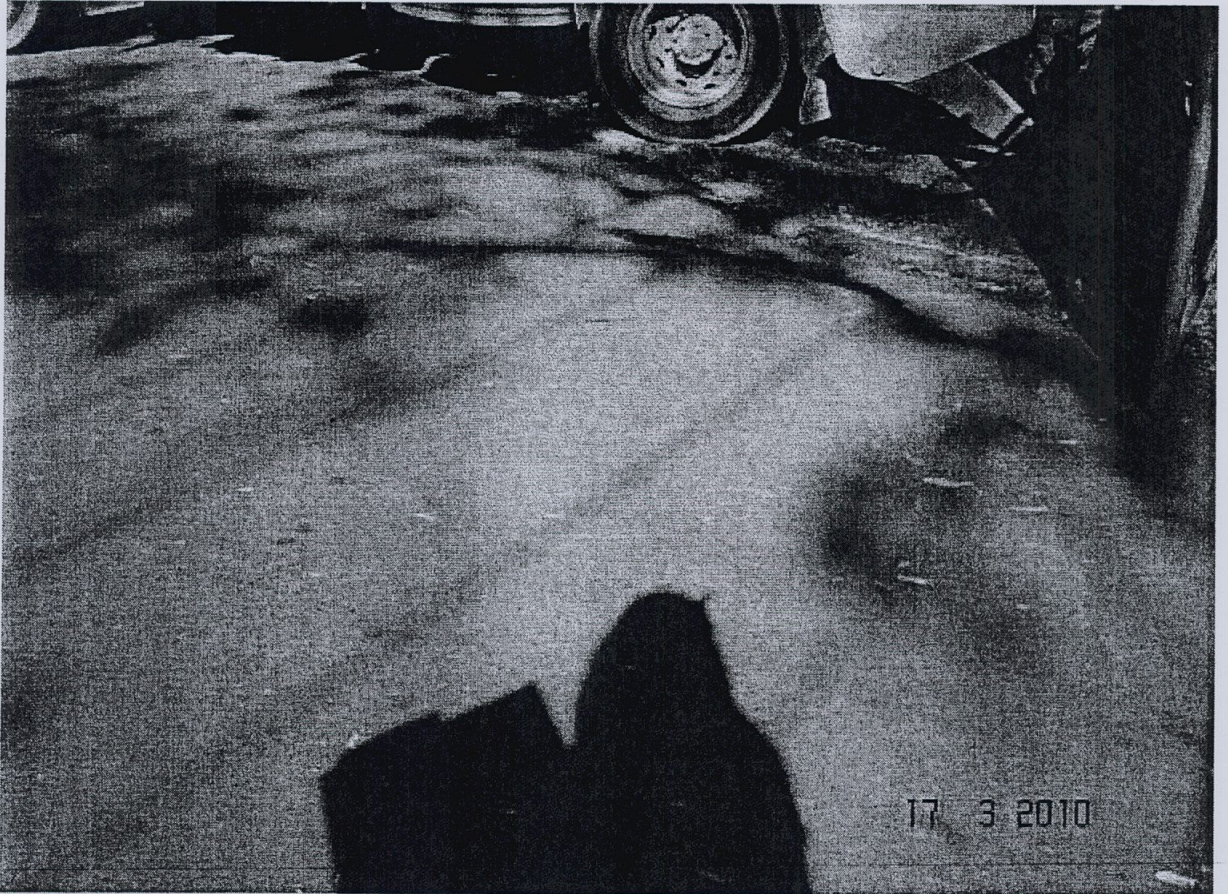
PHOTO 7: Construction site entrance.

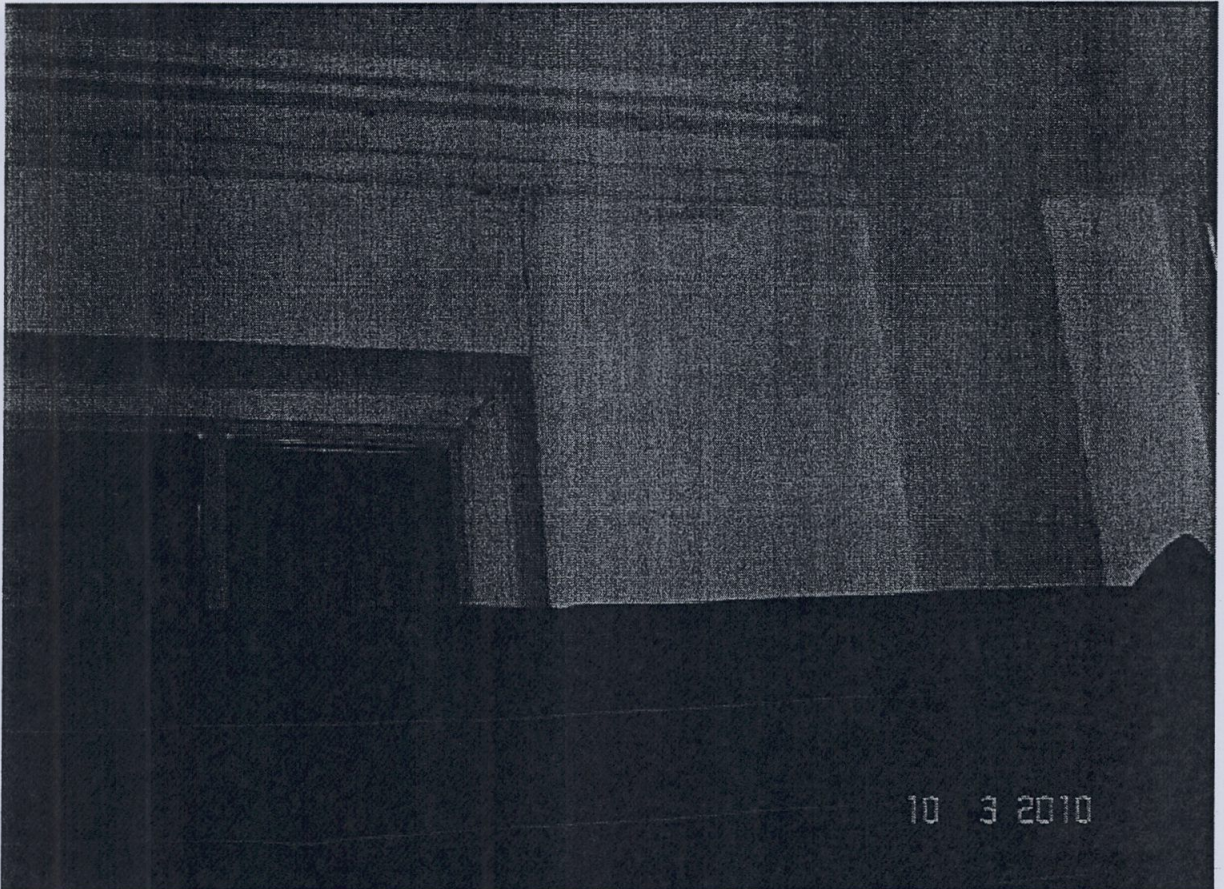
PHOTO 6a: Previously patched crack in wall.

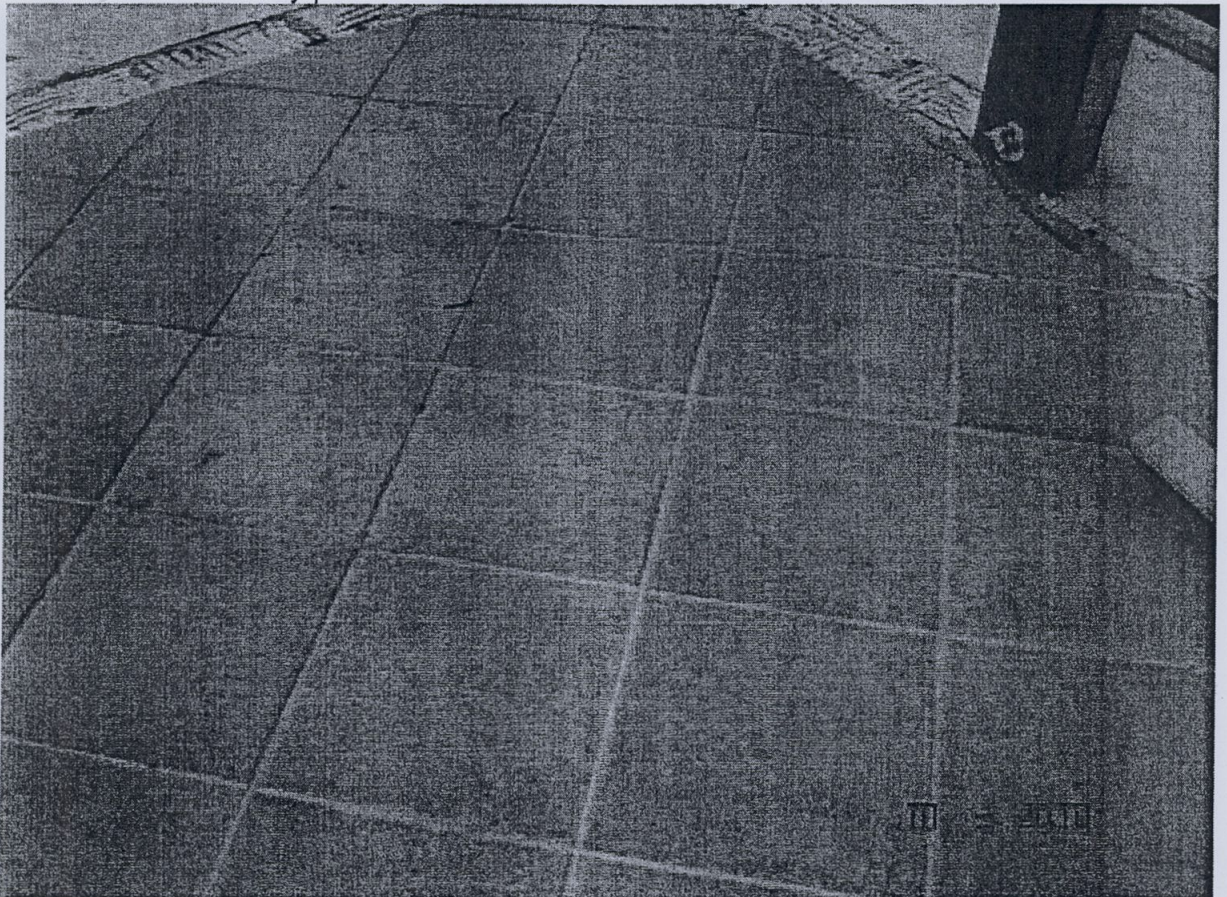
PHOTO 7: Deck being extended.

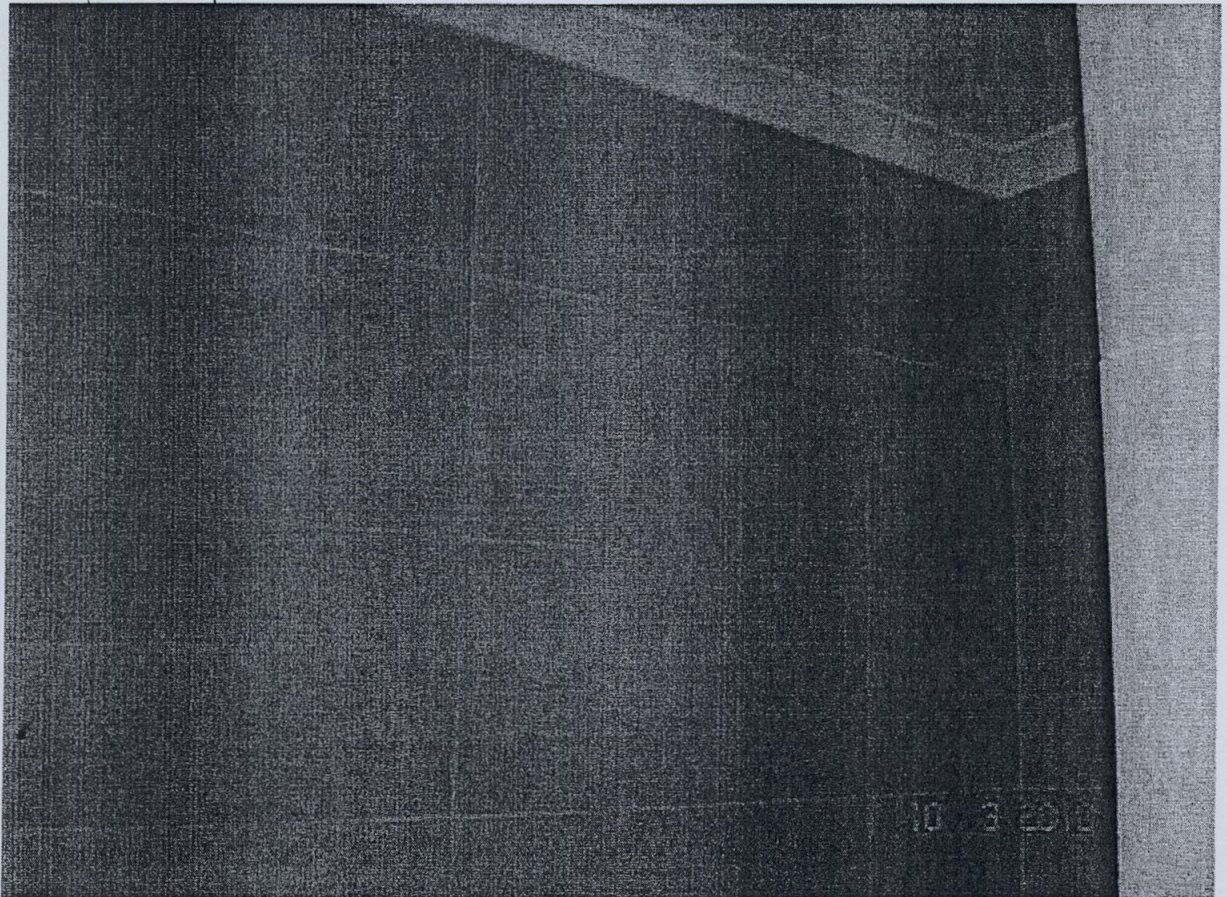
PHOTO 23: Ensuite undergoing renovations.

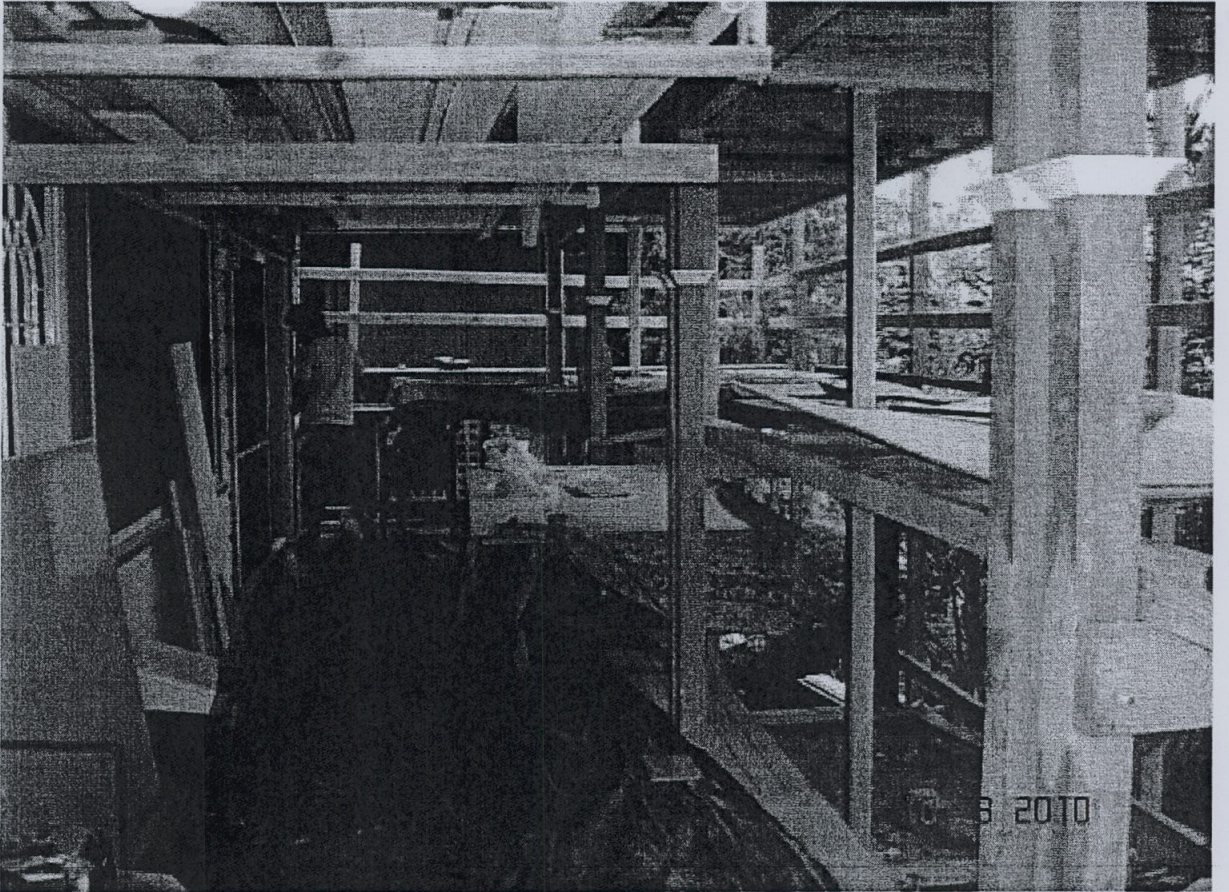
PHOTO 32: Decks being extended.

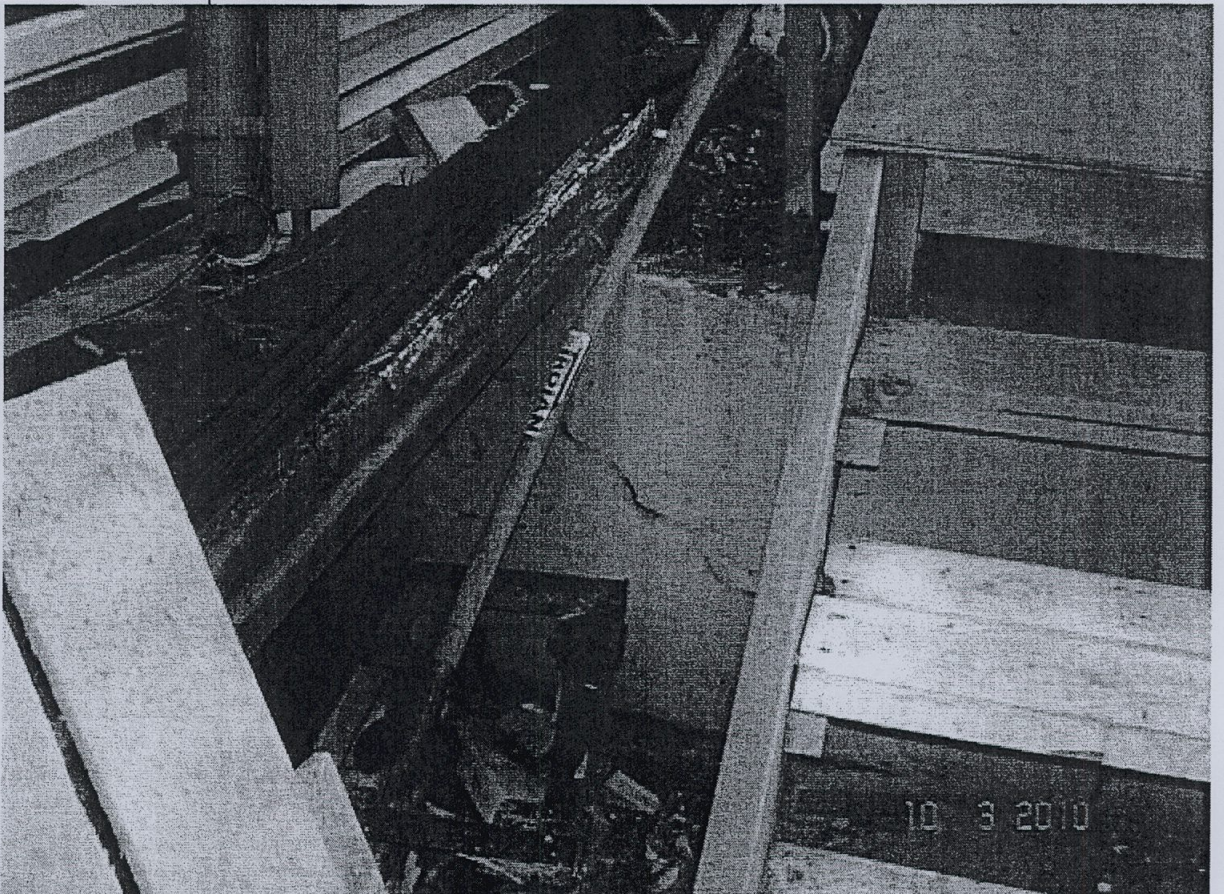
PHOTO 37: Stepped crack as previous - courtyard undergoing renovations.

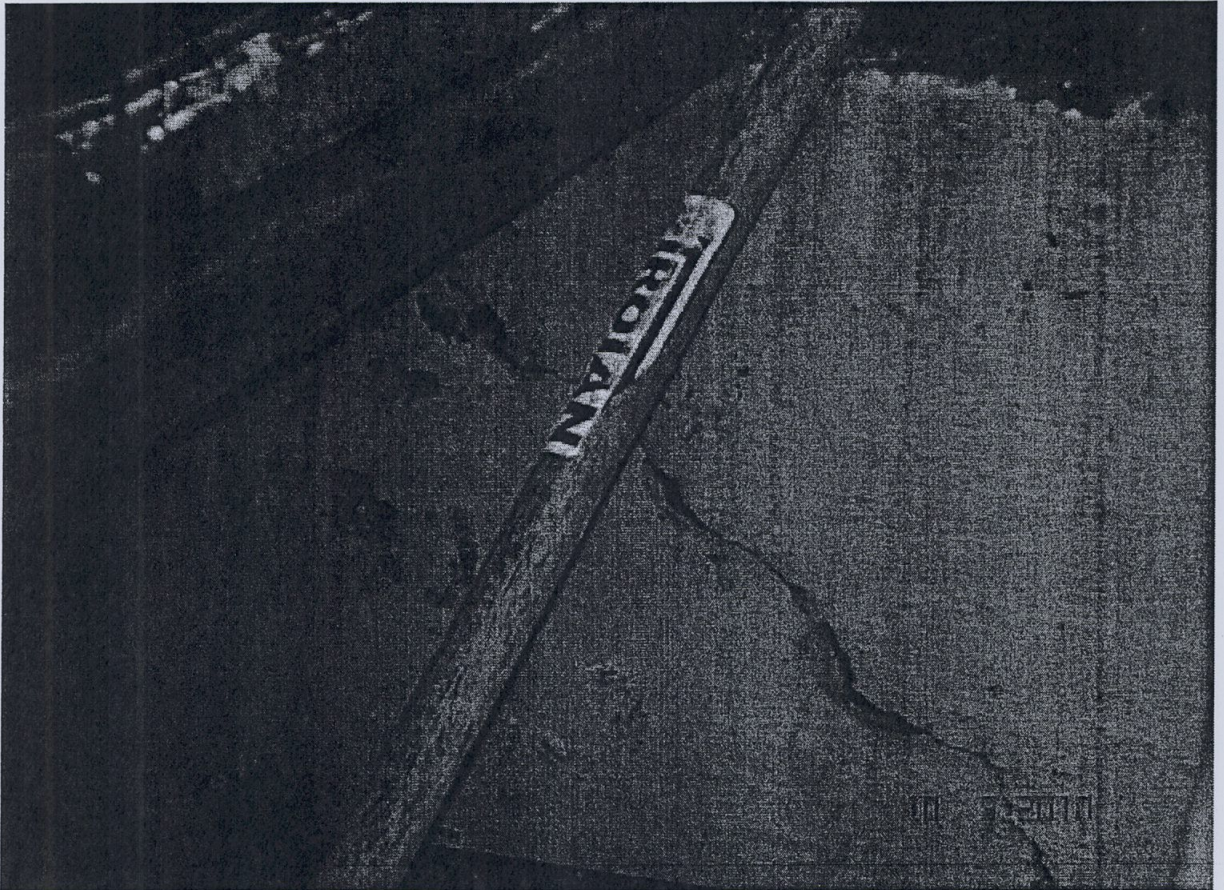
PHOTO 38: As above.

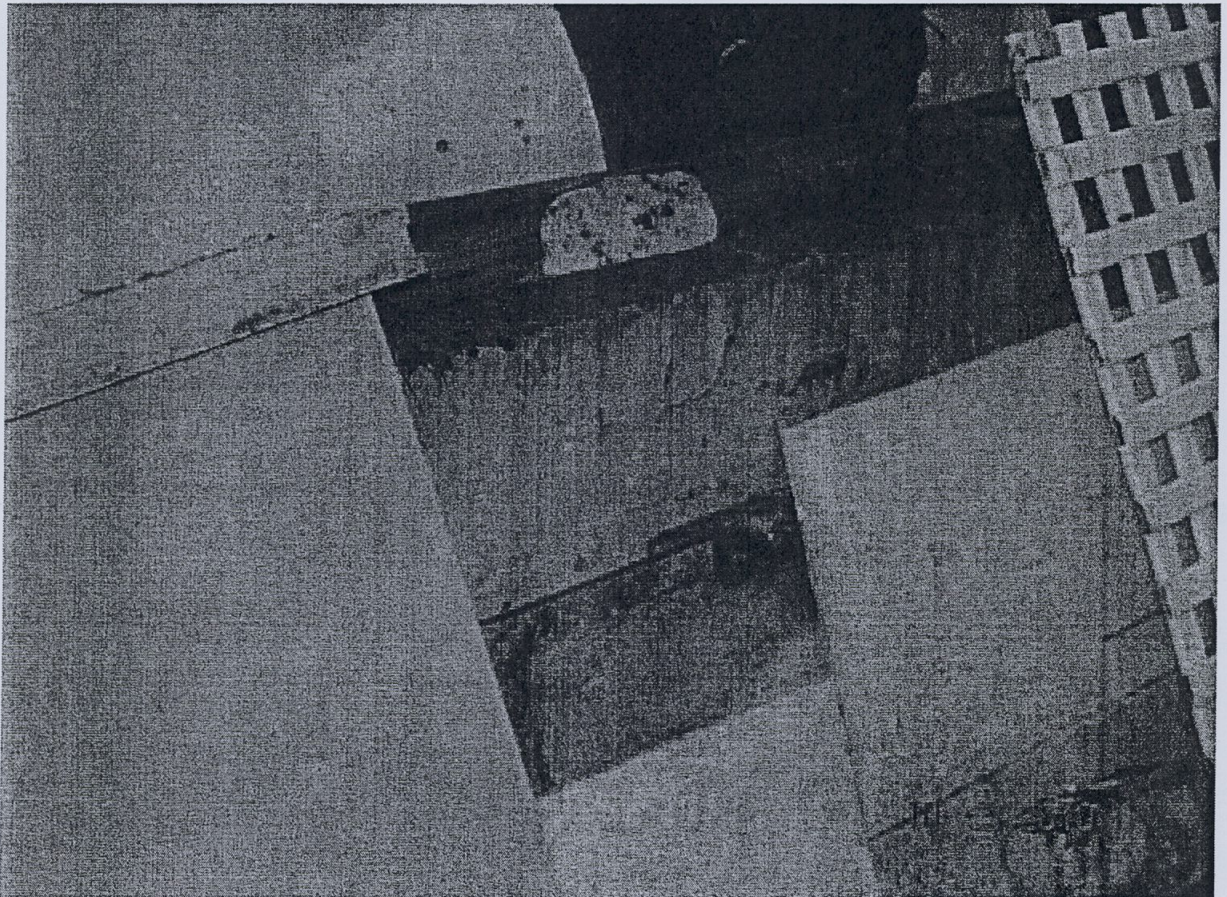
PHOTO 39: Courtyard undergoing renovations.

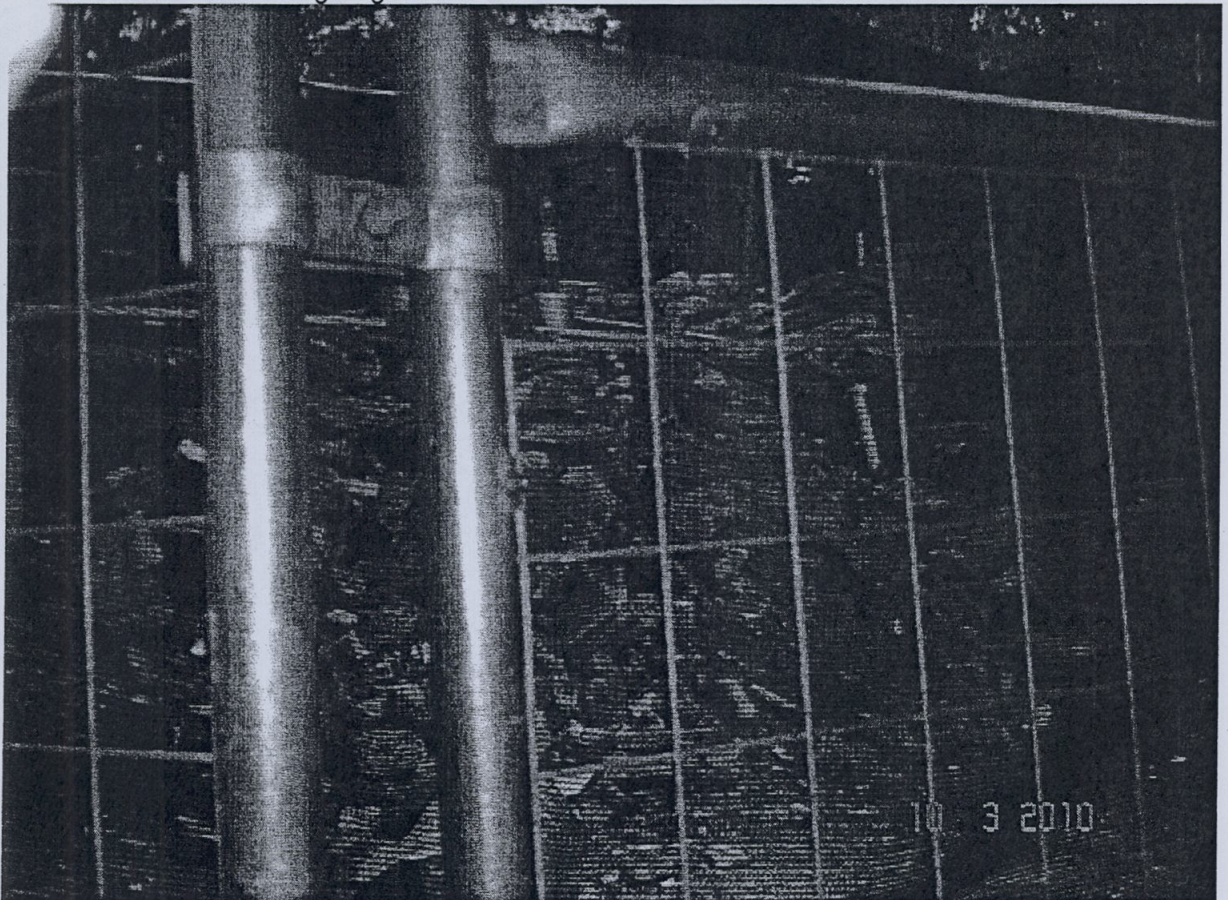
PHOTO 47: Area undergoing renovations.

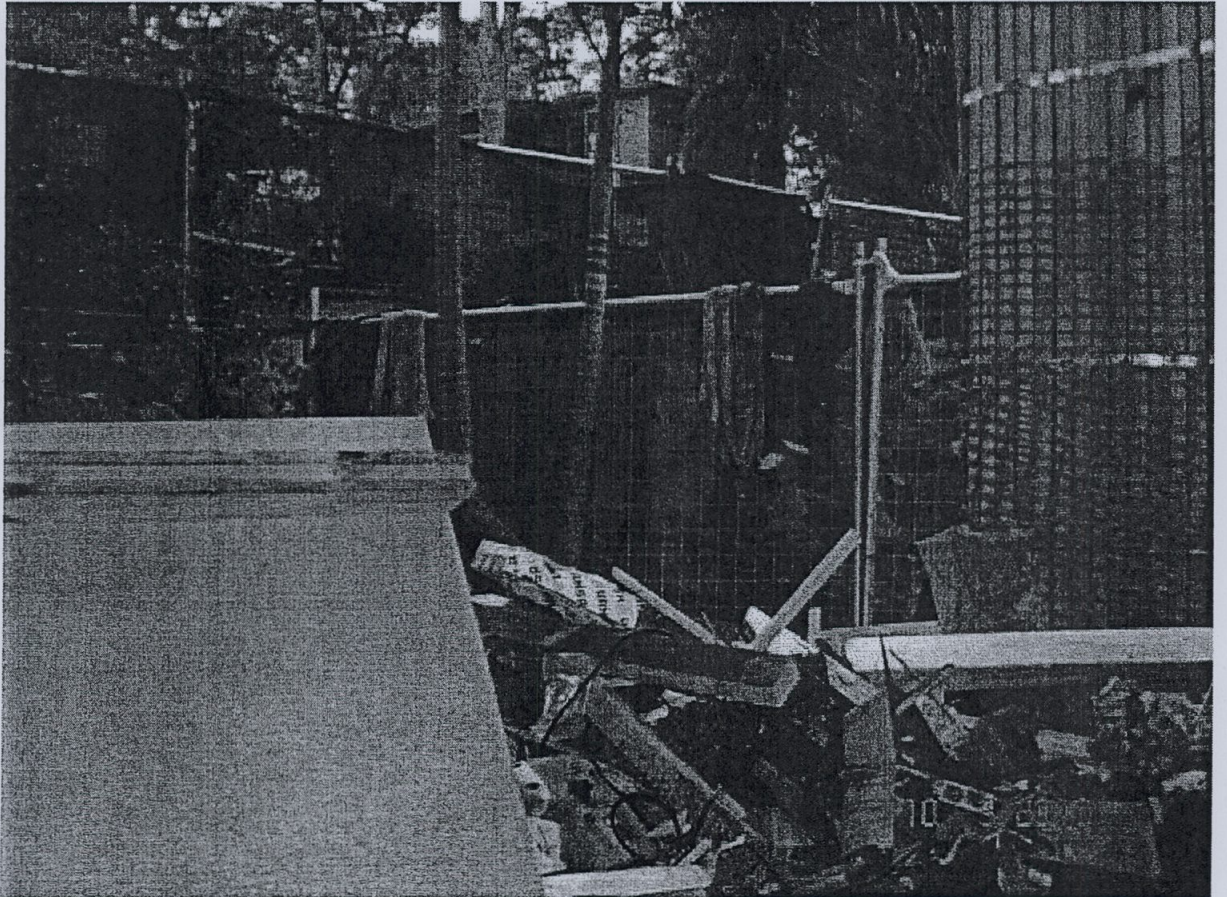
PHOTO 53: Carport demolished and front yard undergoing renovations.

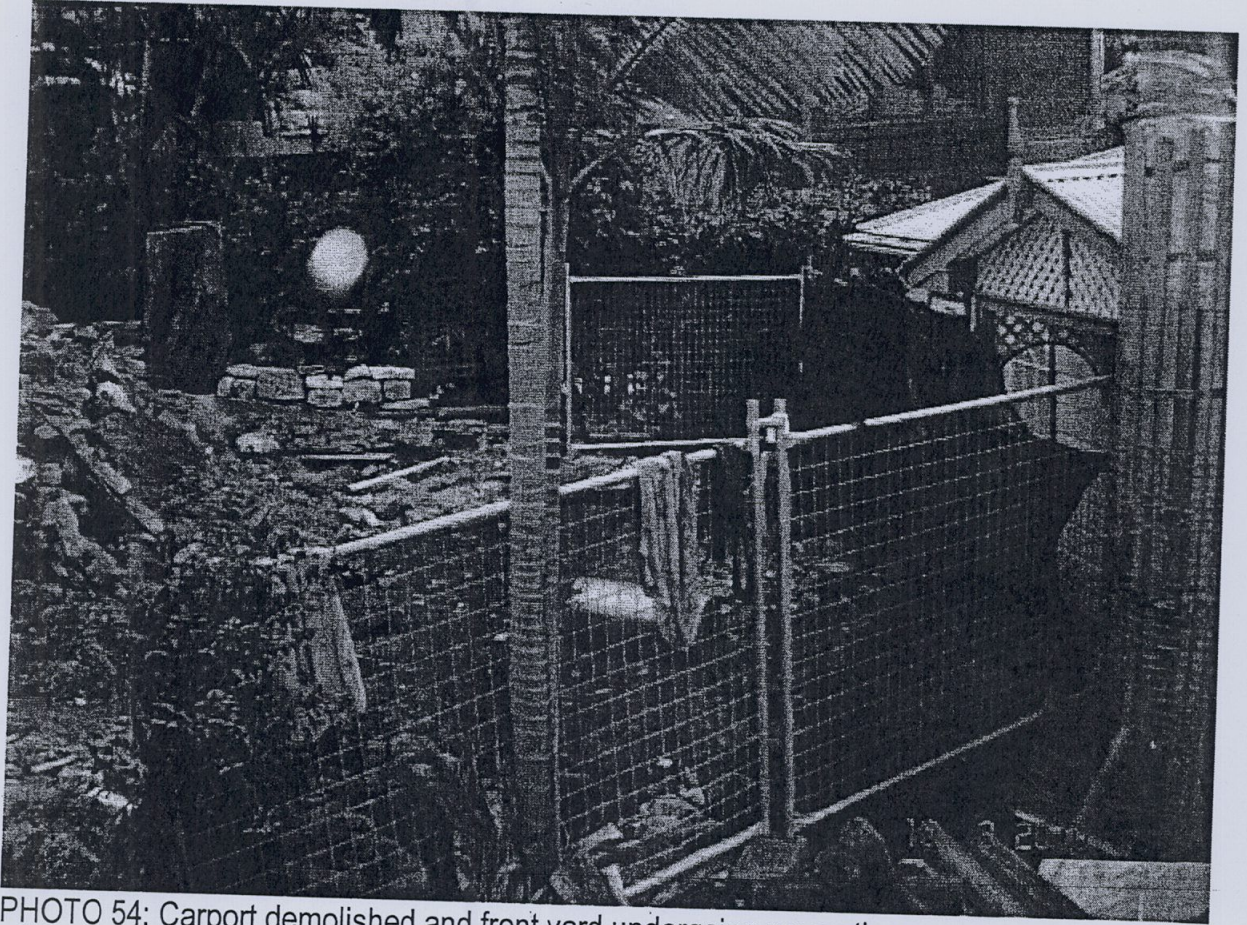
PHOTO 54: Carport demolished and front yard undergoing renovations.
