## **GEOTECHNICAL INVESTIGATION:**

Alterations and Additions and New Pool at **1/6 College Street, Manly**

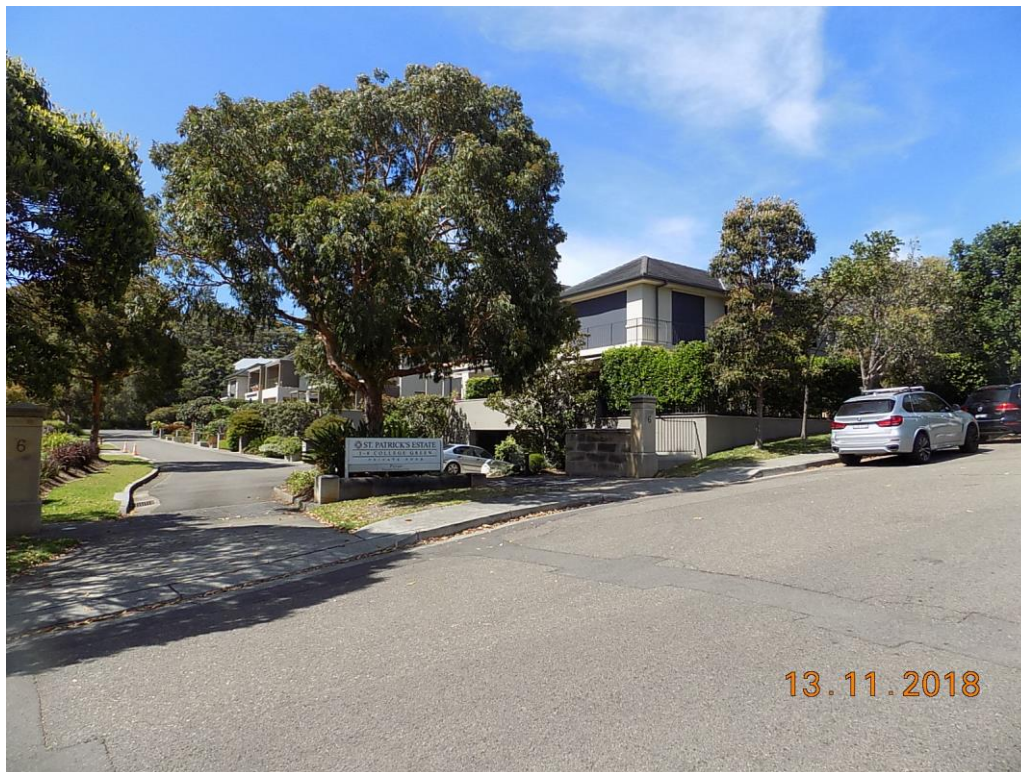
Photo 1

- 2.3** The block is on the corner of College Street and a Right of Carriageway (ROW) off College Street (Photo 1). A tile-paved driveway runs to a garage under the unit that has been cut into the slope (Photo 2). The cut for the garage has been taken entirely through competent Medium Strength Sandstone bedrock (Photos 3 & 4). Between the road frontage to College Street and the unit is a gently sloping lawn-covered fill (Photo 5). The fill is supported by a stable rendered masonry retaining wall reaching ~1.8m high (Photo 6). The two-storey rendered concrete block unit is supported on concrete block walls (Photo 7). No significant signs of movement were observed in the supporting walls which were observed to be supported directly off Medium Strength

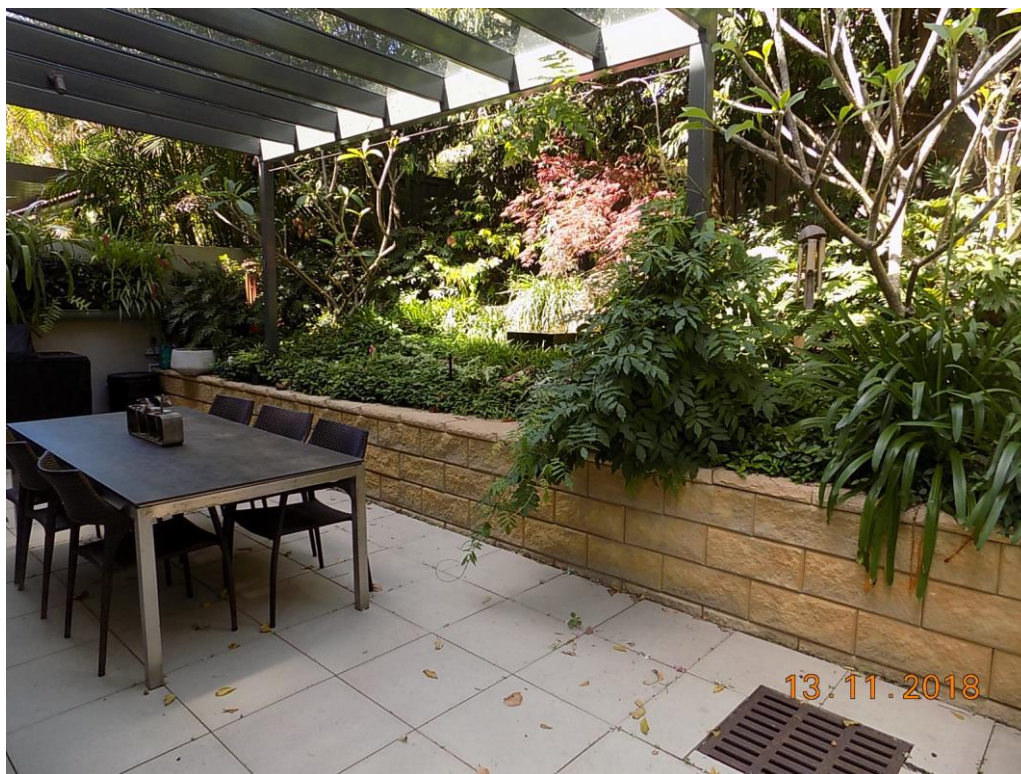
Photo 8

Sandstone. A low cut has been made in the slope for a tile-paved patio that extends off the uphill side of the unit (Photo 8). The cut for the patio area is supported by a stable sandstone block retaining wall ~0.6m high.

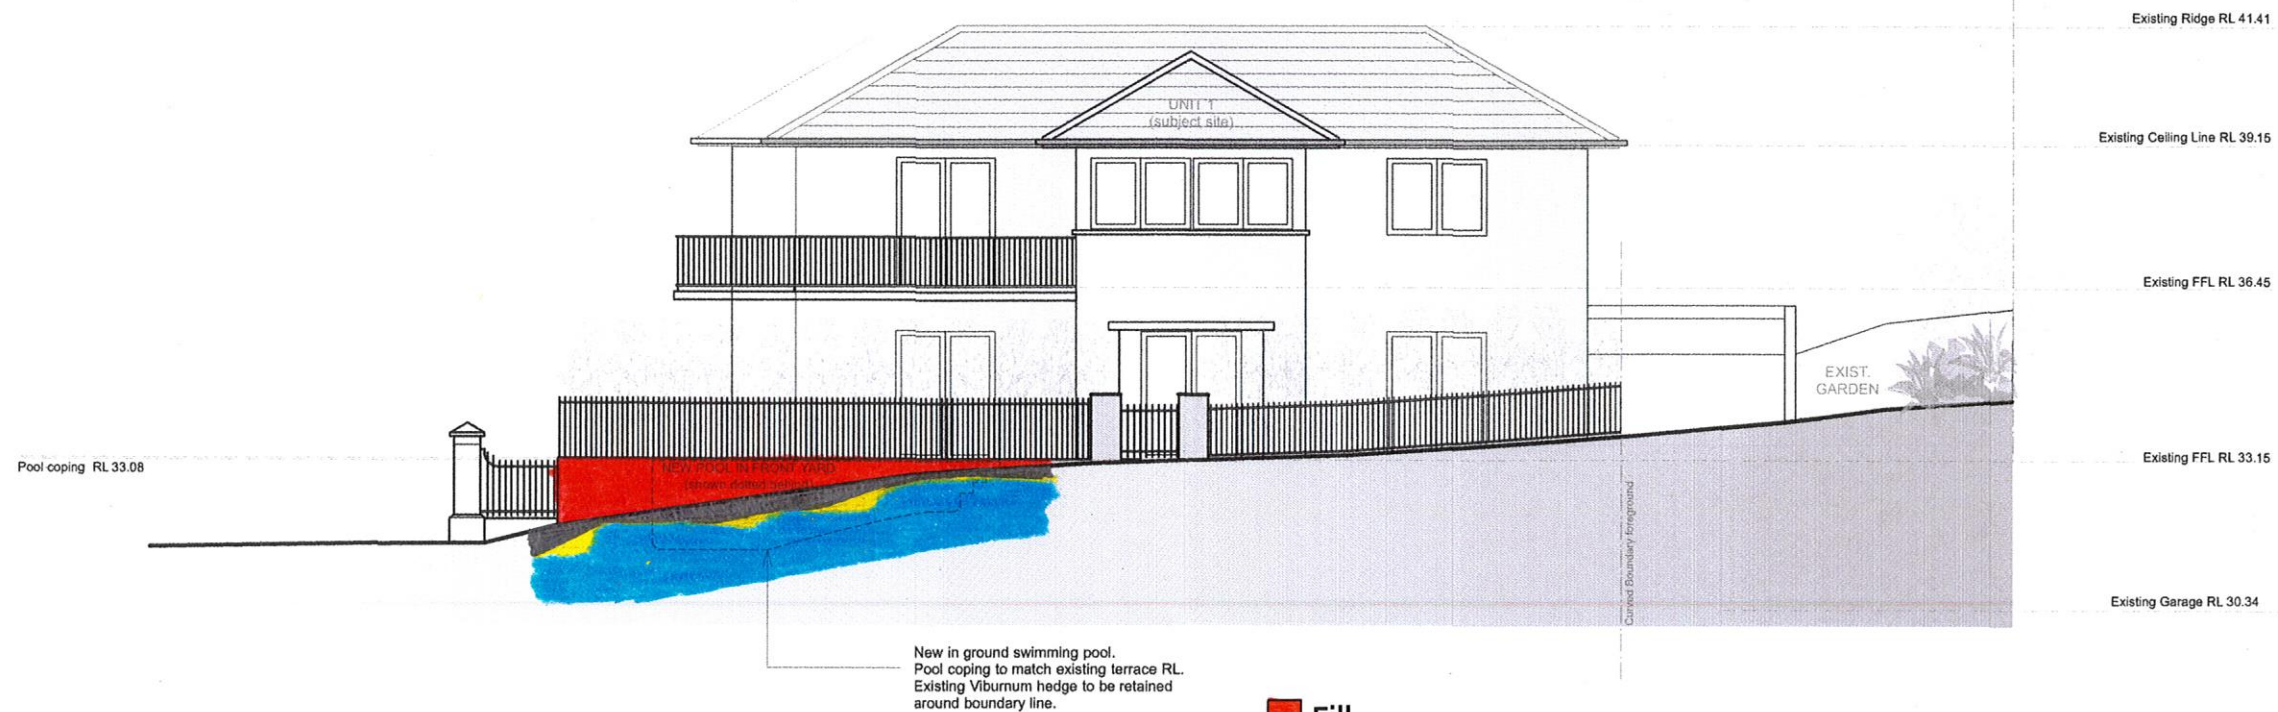
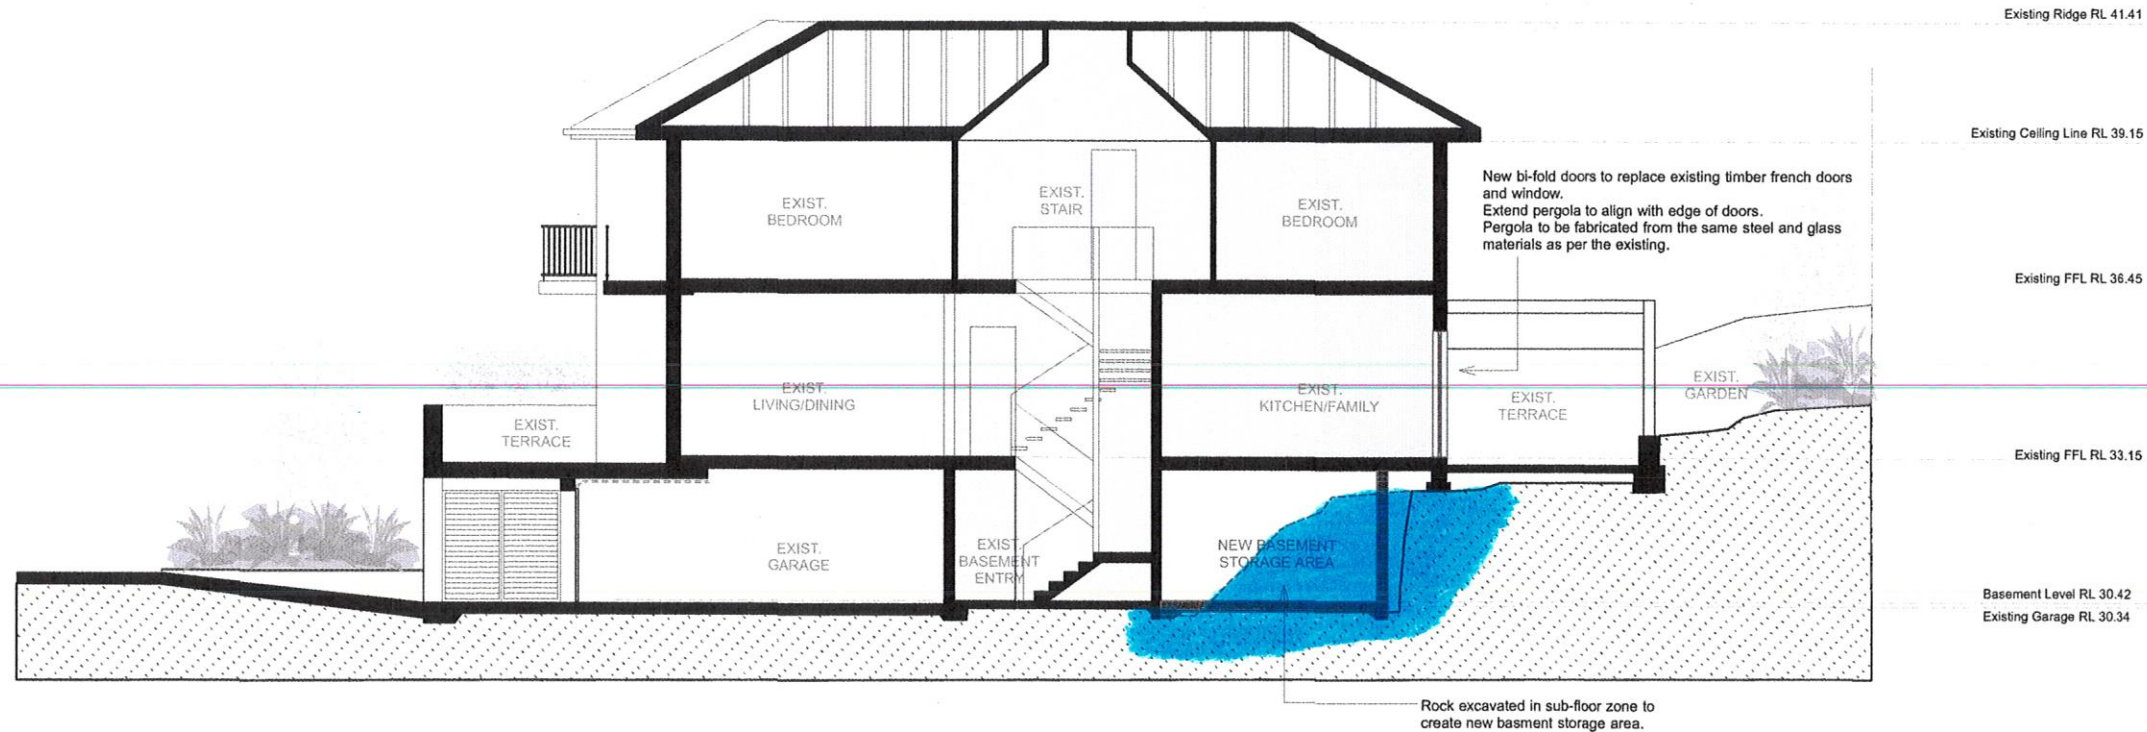
# TYPE SECTION – Diagrammatical Interpretation of expected Ground Materials

The surface features of the block are controlled by the outcropping and underlying sandstone bedrock that steps up the property forming sub-horizontal benches between the steps. Where the grade is steeper, the steps are larger, and the benches narrower. Where the slope eases, the opposite is true. The rock is overlain by manmade fill over natural sandy soils and firm to stiff sandy clays that fill the bench-step formation. In the test locations, the depth to Medium Strength Sandstone ranged between 0.3 to 1.3m below the current surface, being deeper where filling is present and due to the stepped nature of the underlying rock. See Type Section attached for a diagrammatical representation of the expected ground materials.

- Fill
- Sandy Soil
- Sandy Clay – Firm to Stiff
- Hawkesbury Sandstone – Medium Strength
