Date: 21th July 2021 Client: Nicole Keogh Job No. 200831 Engineer: CMcL/CJ

Site: 1031 BARRENJOEY ROAD, PALM BEACH

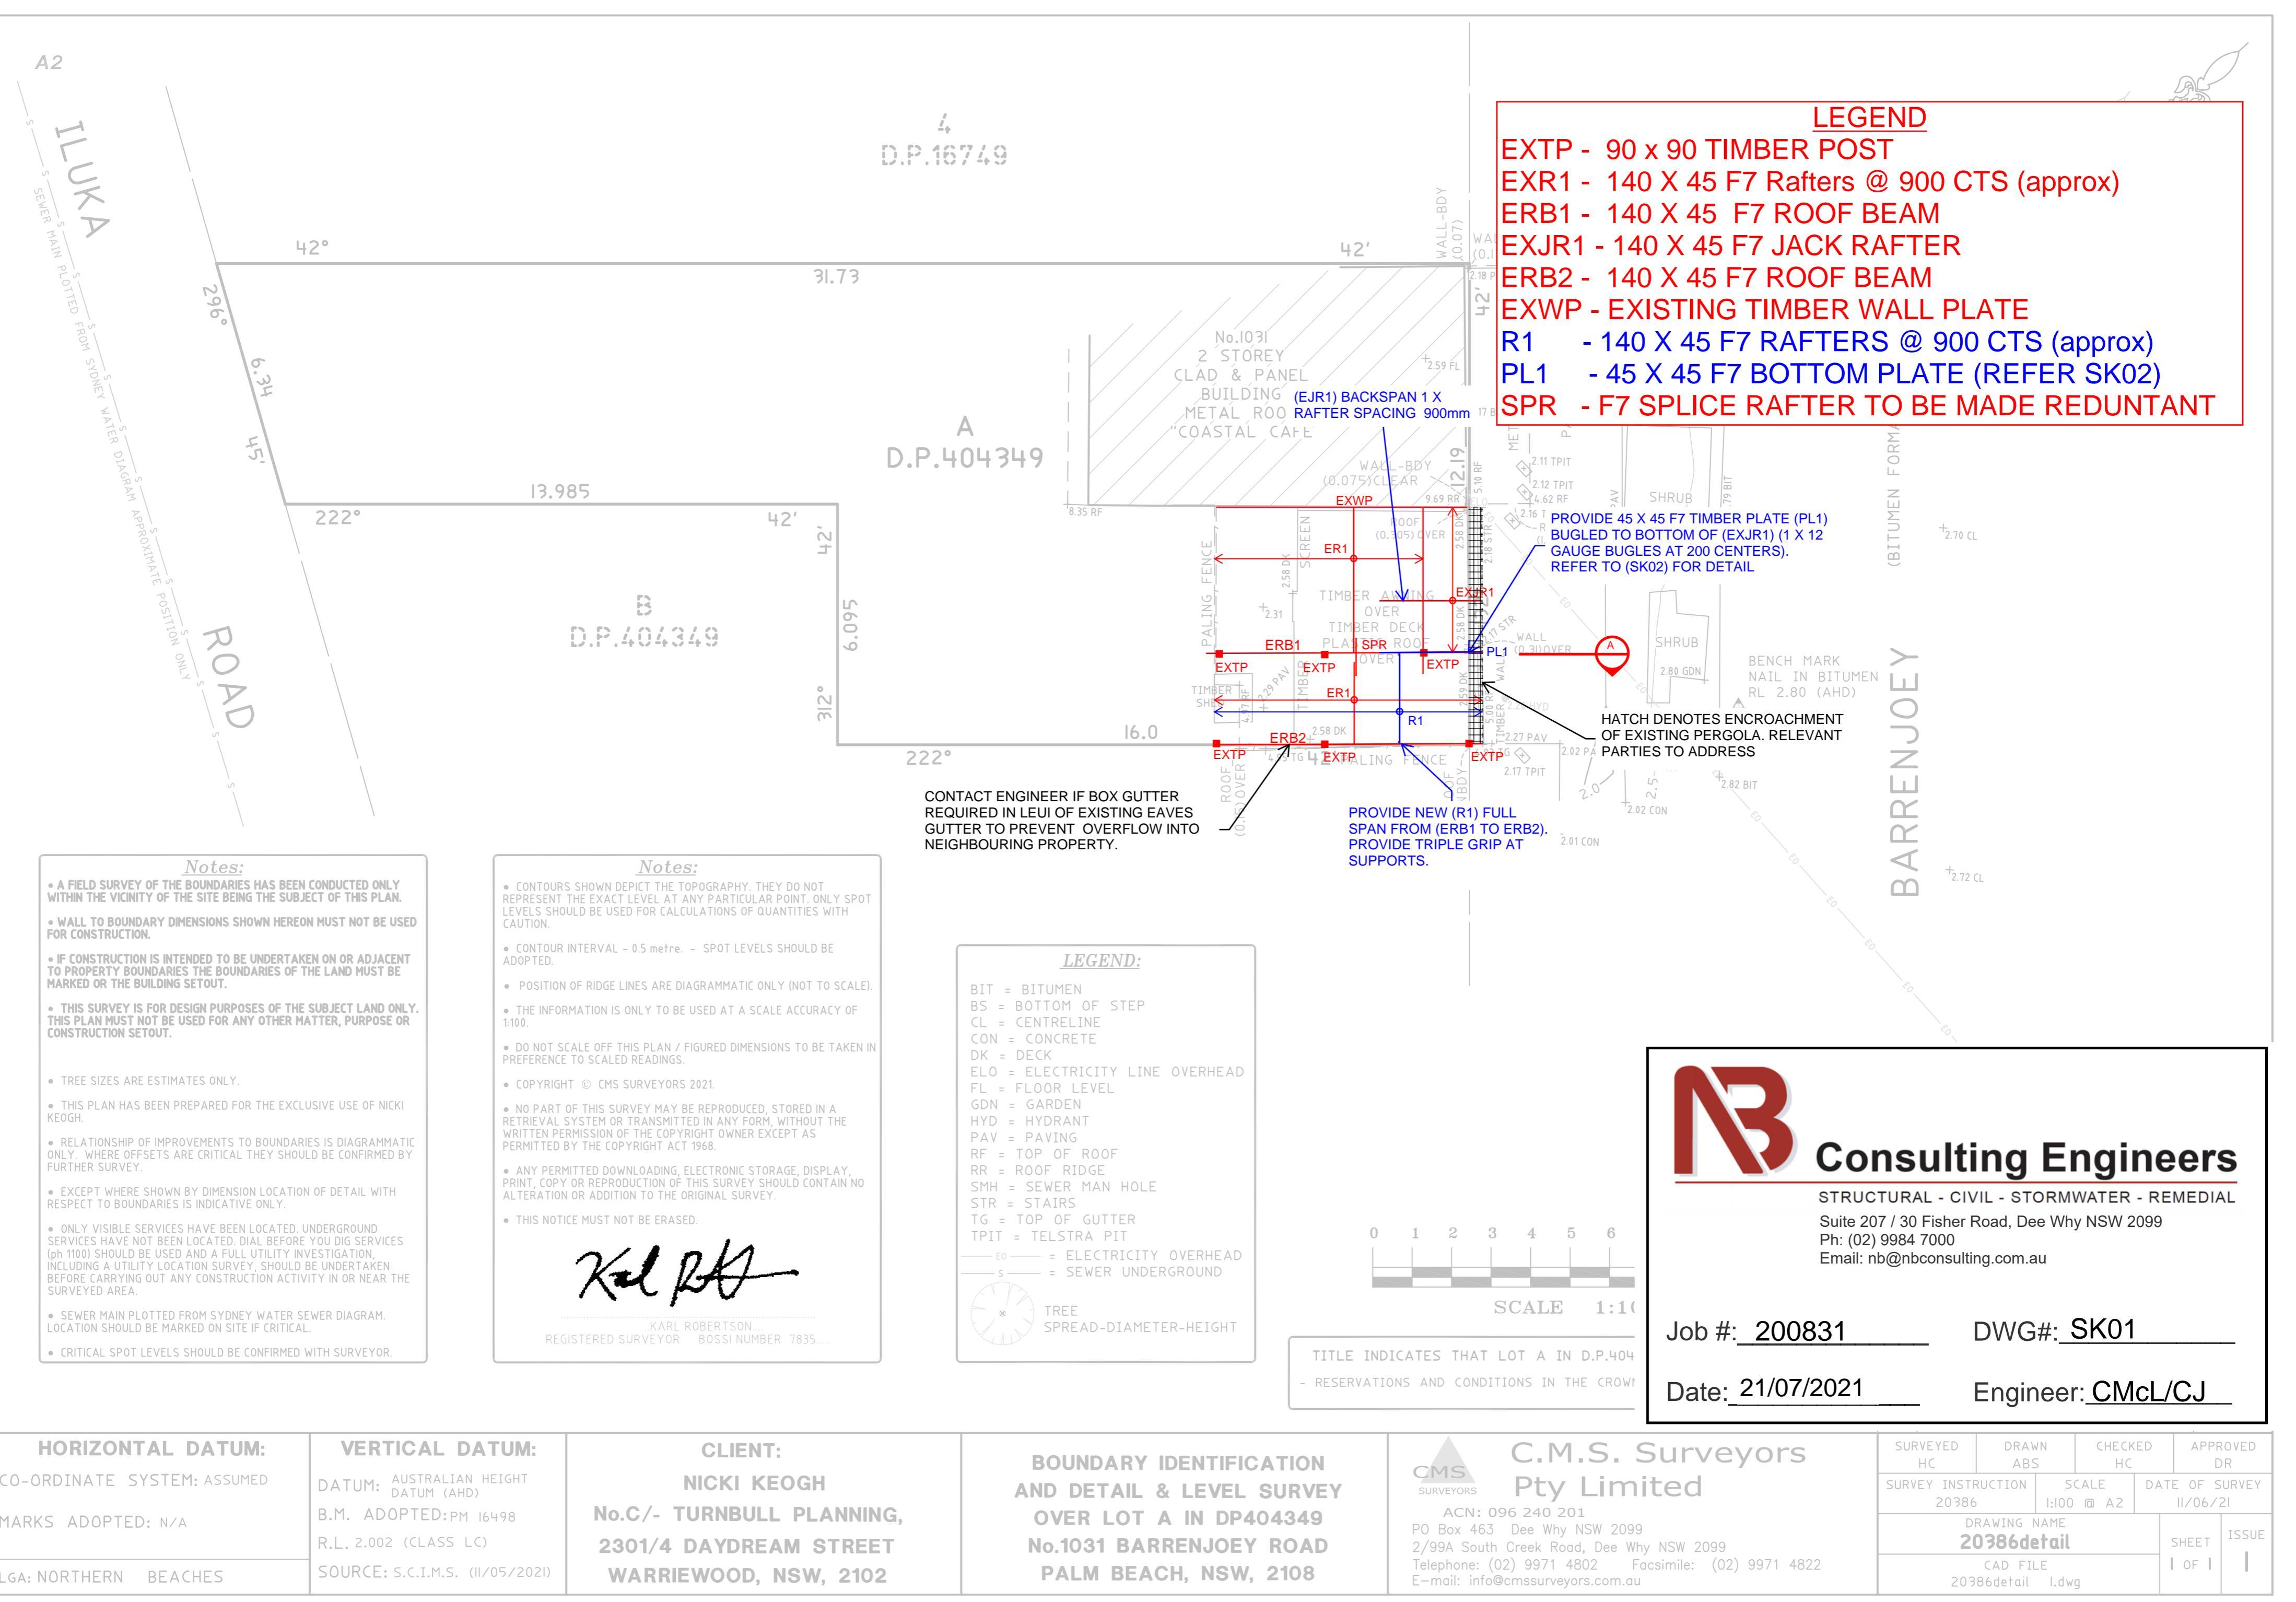
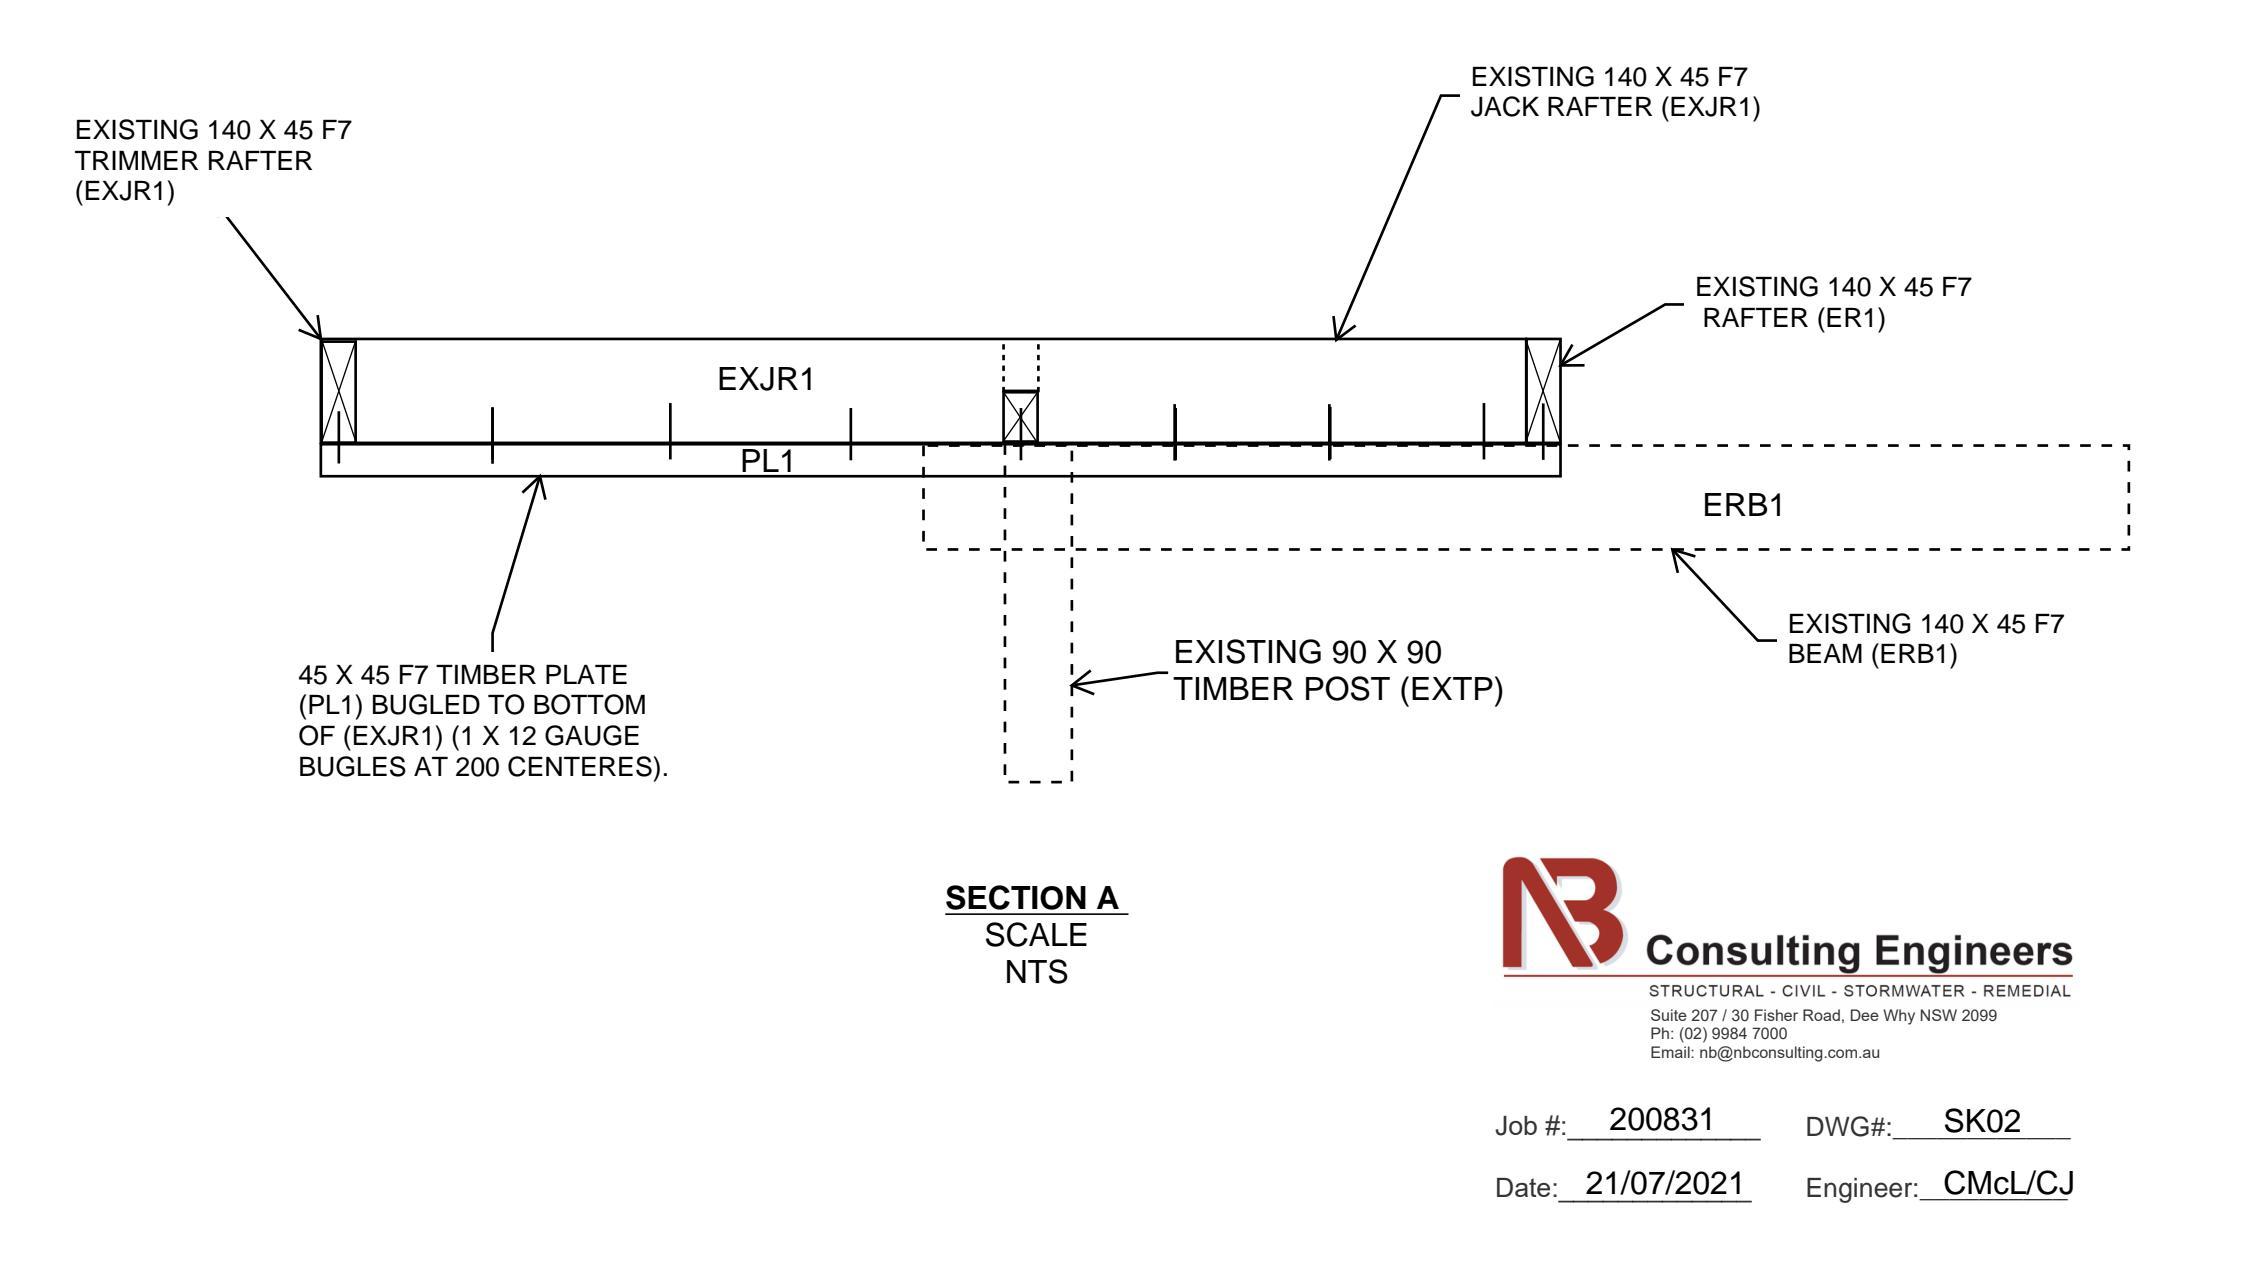
- At the time of inspection, the deck structure was not accessible for inspection. Therefore, Northern Beaches Consulting Engineers P/L cannot currently certify the deck structure. Certification of the deck structure may be considered if the builder can provide clear, detailed photographs of the deck under construction (subject to engineering review) and a statutory declaration.
- At the time of inspection, the extension to the existing roof structure was deemed not compliant with the relevant Australian standards. The following amendments need to be made to the roof structure to achieve compliance with Australian Standards.

Please refer to the following structural requirements as detailed on the attached SK01 & SK02.

- 1. Provide triple grips or min 2 x 12-gauge bugles to connect rafters to beam supports (every rafter).
- 2. Provide a full span rafter (R1) between the existing timber beams (ERB1 & ERB2) refer attached SK01. Currently, the rafters for the new extension are spliced onto the existing rafters at midspan location and are not adequate.
- 3. Provide 45 x 45 F7 timber plate (PL1) bugled to bottom of (EJR1) (1 x 12 gauge bugles at 200 centers). Refer to sk02 for detail.
