# **MARINE POLLUTION RESEARCH** PTY LTD

## **AQUATIC ECOLOGY ASSESSMENT FOR THE PERMANENT USE OF THE BERTHING AND PONTOON FACILITIES AT 38 CABARITA RD, AVALON BEACH.**

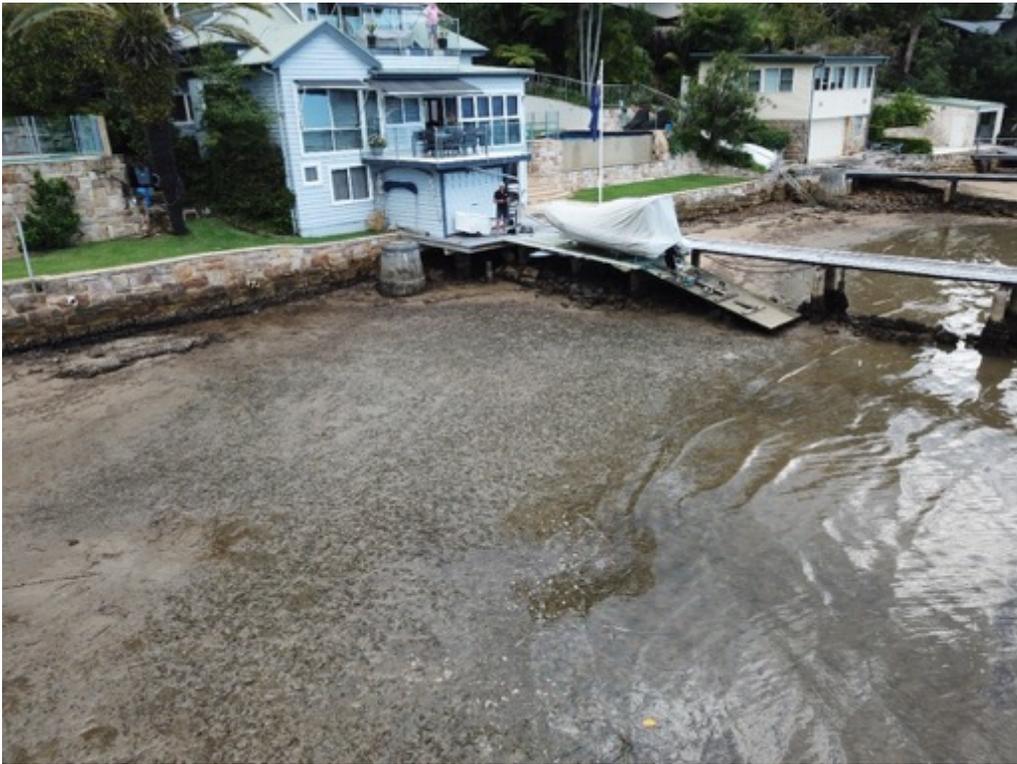
**Figure 5** Sandstone block seawall retaining grassed area. with some exposed basement rock to the south and stacked rock rubble under the Ramp. Note sewer inspection structure alongside the seawall at the site. Note also short form intertidal *Zostera* in foreground.

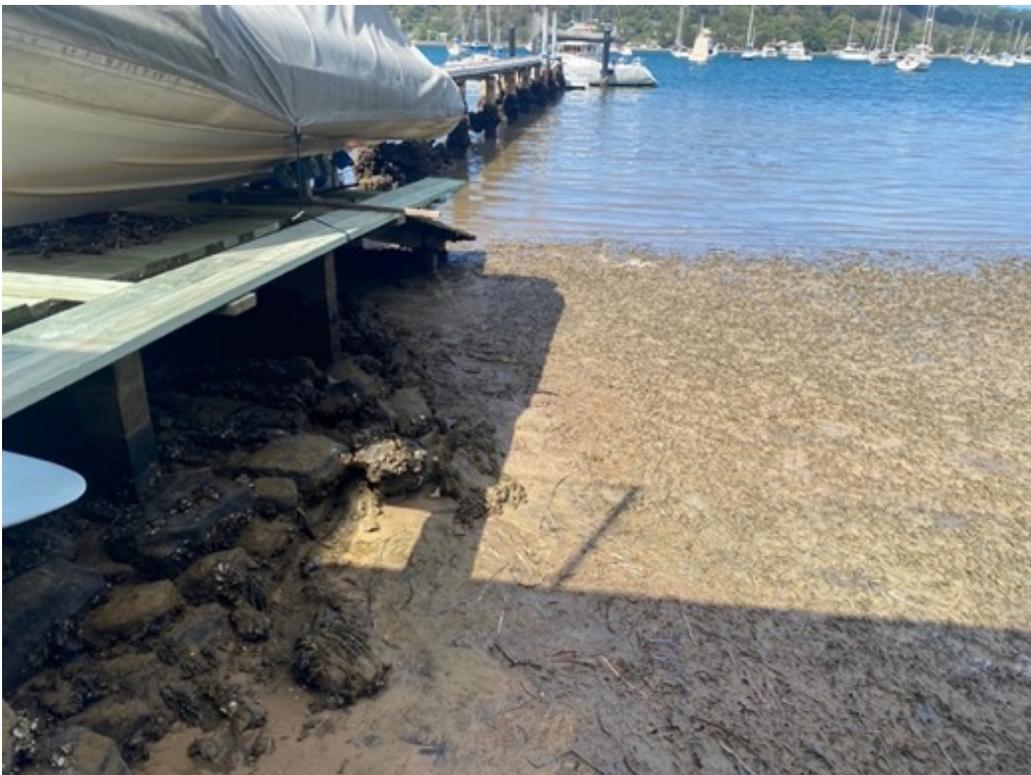
**Figure 6** Intertidal oysters on rock rubble and intertidal short-form *Zostera* on south side (see also **Figure 8**).

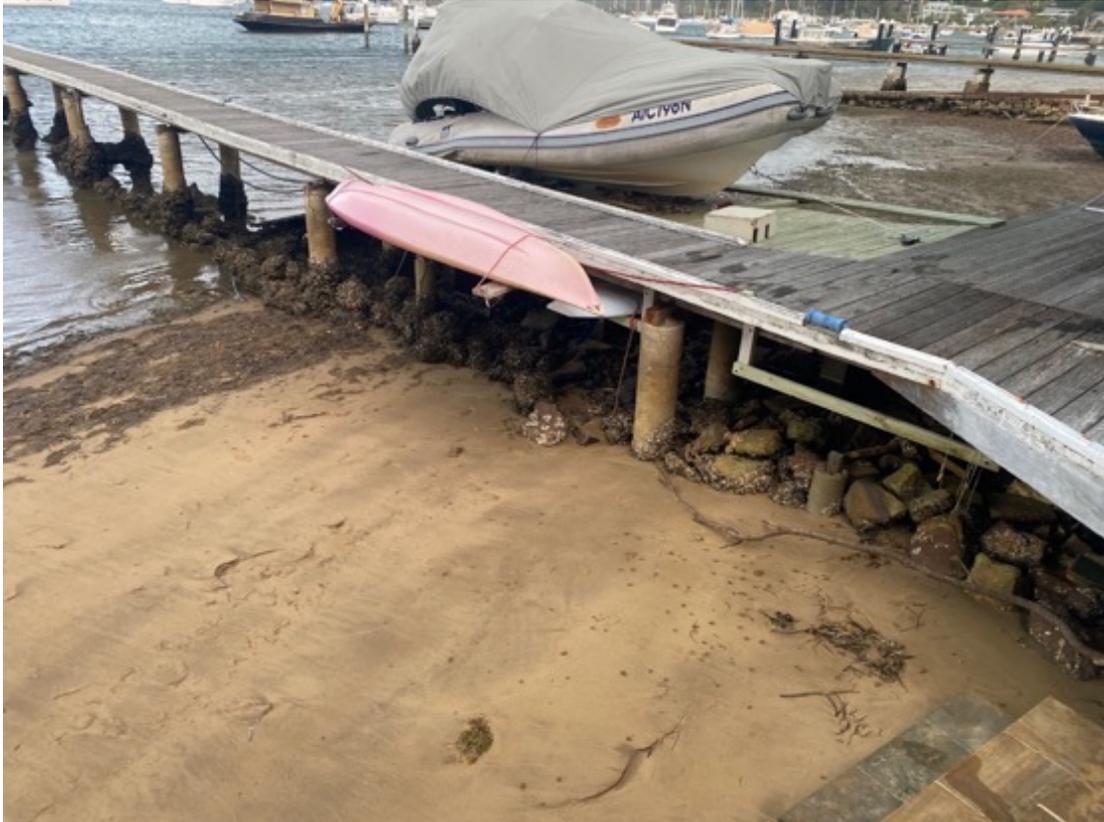
**Figure 7** High intertidal bare sandy beach habitat on north side of jetty formed against the stacked intertidal rock rubble extending out from the seawall under the jetty/ The rock rubble supports an oyster assemblage and no algae growth inshore but with small amounts of Neptune's necklace *Hormosira banksia* on the outermost rocks. Note sandstone seawalls in right lower corner of the photograph,

- The intertidal wetted surfaces of the sandstone seawall and intertidal rock rubble supported an oyster-based assemblage with no macro algae and a variety of gastropods, mainly *Morula sp.*, *Bembicium sp.* & *Austrocochlea sp.* (**Figure 7**).
- There is a distinct bed of short-form *Zostera* (green line in **Figure 4**) on the south side of the facility between about -0.4 and -0.6m ISLW (**Figure 8**).
- Un-grassed sediments offshore from the northern sandy beach on **Figure 7** and between the intertidal short form *Zostera* and the shallow sub-tidal *Zostera* beds offshore transitioned from sandy to silty sands with depth and there was a small portion of low intertidal exposed rock (see **Figure 4**) to the north that supported oysters, Neptunes Necklace and some *Sargassum sp.*

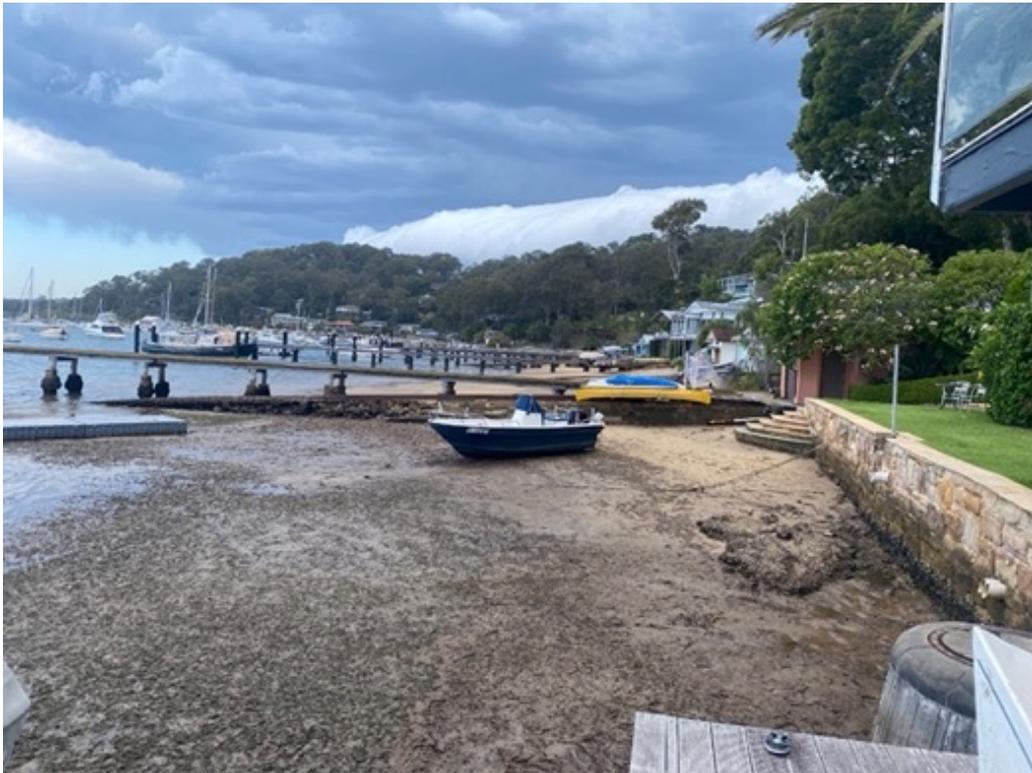
**Figure 8** There is short form intertidal *Zostera* habitat immediately inshore on the south side of the jetty and ramp and no bare sandy beach, and only a small fillet of beach sand south confined between the portion of inshore basement rock and the rock ramp facility to the south.

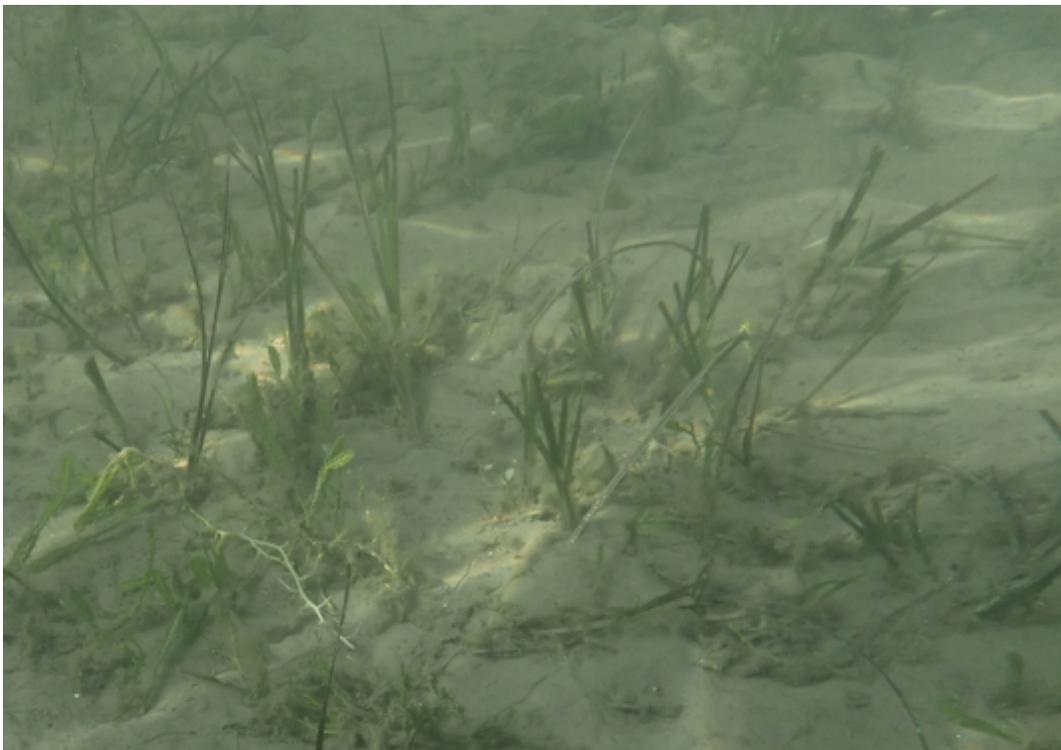
**Figure 9** Shallow sub-tidal *Zostera* seagrass with *Caulerpa taxifolia*. The *Zostera* bed became progressively denser and even with depth offshore.

- The offshore shallow *Zostera* beds to the north and south of the outer jetty shown as a blue line on **Figure 4** (from about -0.9m to about -1.2m ISLW) comprised sparse and uneven normal-length *Zostera* shoots interspersed with sparse listed pest algae *Caulerpa taxifolia* (**Figure 9**).

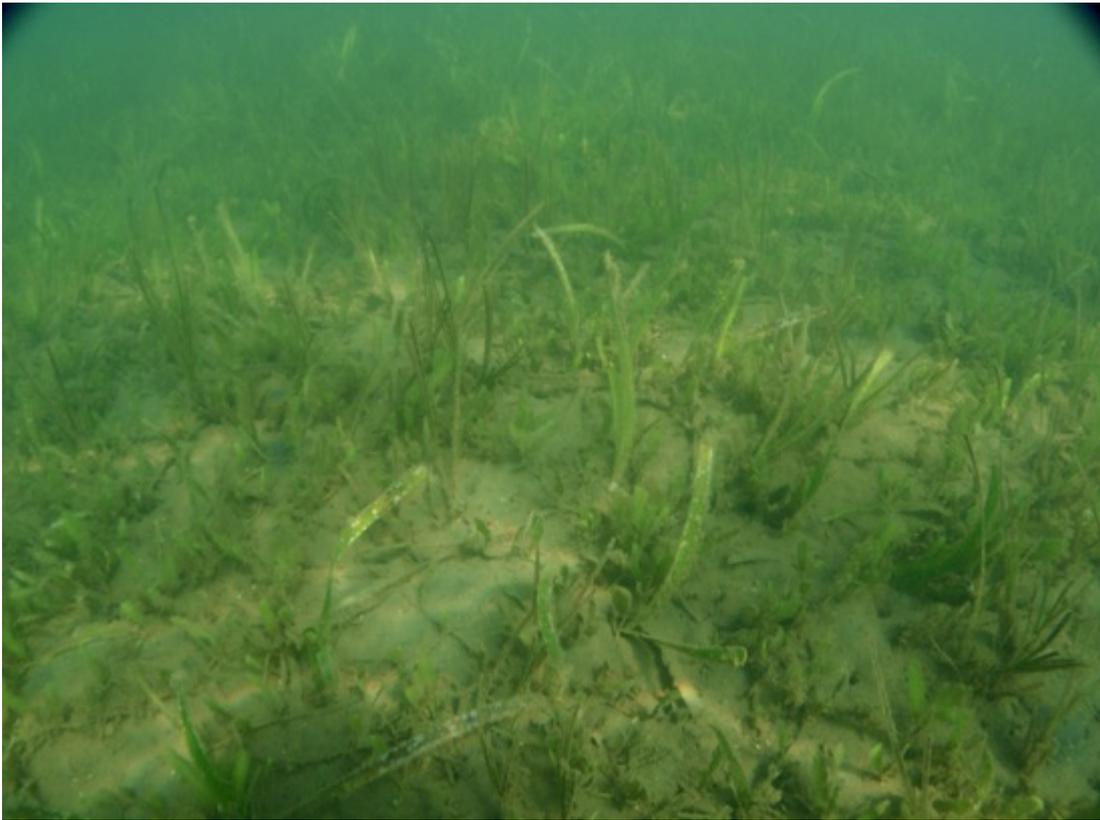
**Figure 10** Sparse *Posidonia* and *Caulerpa* habitat (red line area in **Figure 4**).

- The *Zostera* bed transitioned from medium density *Zostera* to sparse to medium density *Posidonia* seagrass (**Figure 10** and red lines on **Figure 4**) between -1.0 to -1.9m ISLW with individual *Posidonia* shoots observed to about -2 m depth.

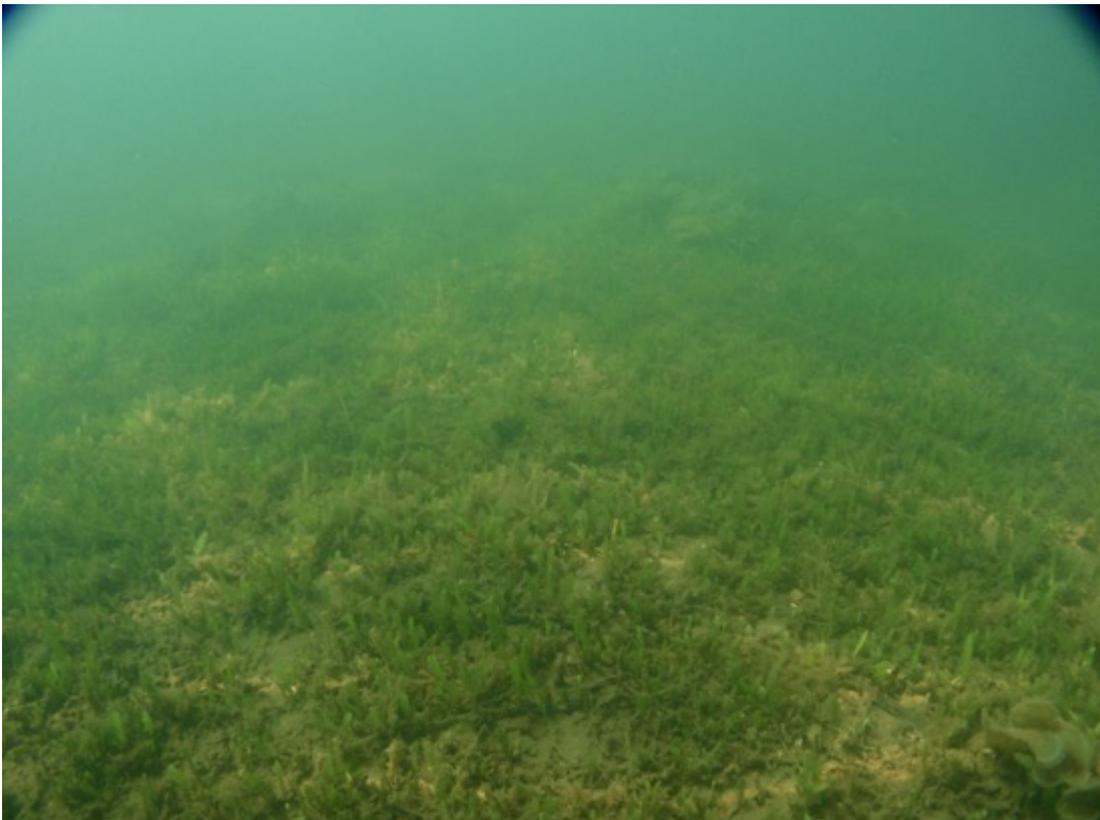
**Figure 11** There was dense *Caulerpa taxifolia* growth in the depression at the end of the existing pontoon and under the yacht.

- *Caulerpa taxifolia* was present throughout the outer seagrass beds and into deep waters beyond the *Posidonia* limit to about -23.4m ISLW, and the scour hole depression in the mooring pen (green cross hatched area in **Figure 4**) supported a high density cover of *Caulerpa taxifolia* with no seagrass evident (**Figure 11**).

As per the aquatic ecological survey this scour hole is now habitat for a listed pest species *Caulerpa taxifolia* that is currently found throughout the combined offshore *Zostera* and *Posidonia* beds and slightly further offshore from the present *Posidonia* outer depth limit. As this algae species is very prone to fragmentation from propeller thrust, the presence of the bed attests to the fact that the scour hole is stable and has not been scoured in recent times.

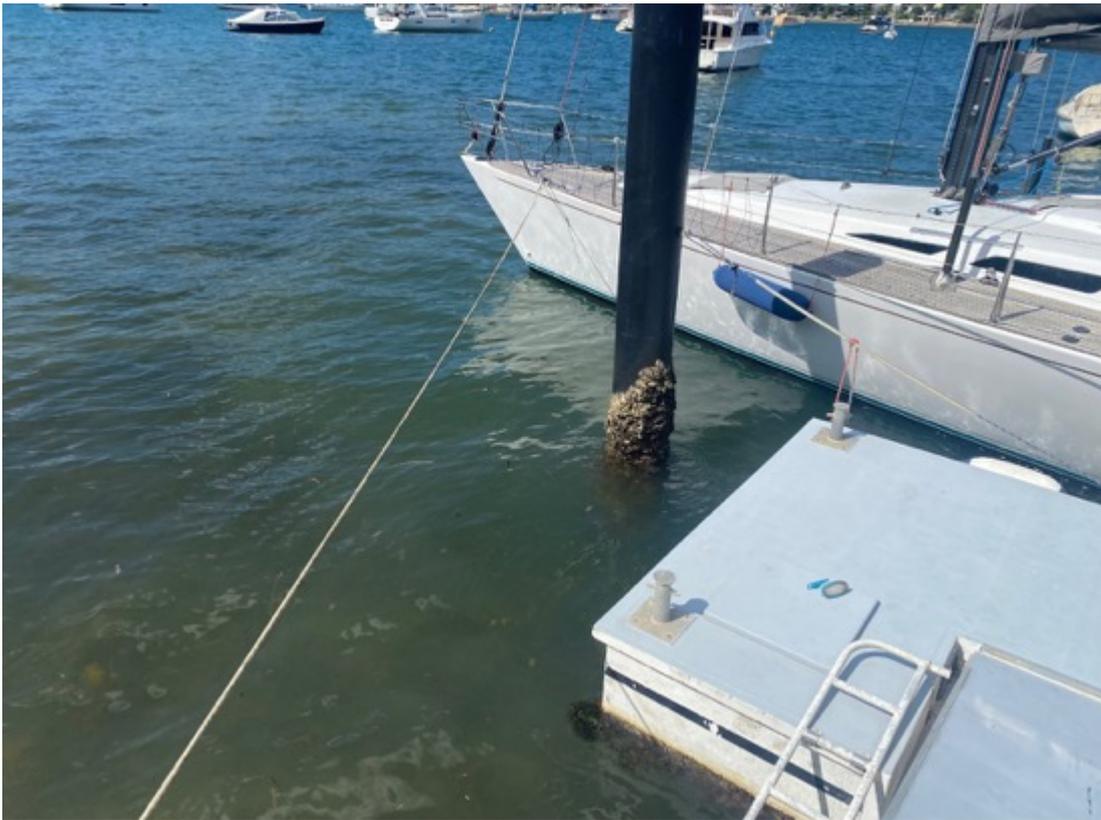
- The intertidal portions of piles supported an oyster-based assemblage with little or no attached biota in deeper waters and the pontoon vertical wetted surfaces supported a simple oyster based assemblage with some *Codium* algae (**Figure 12**).

**Figure 12** Oyster growth on intertidal pile sections, plus *Codium* on pontoon waterline.

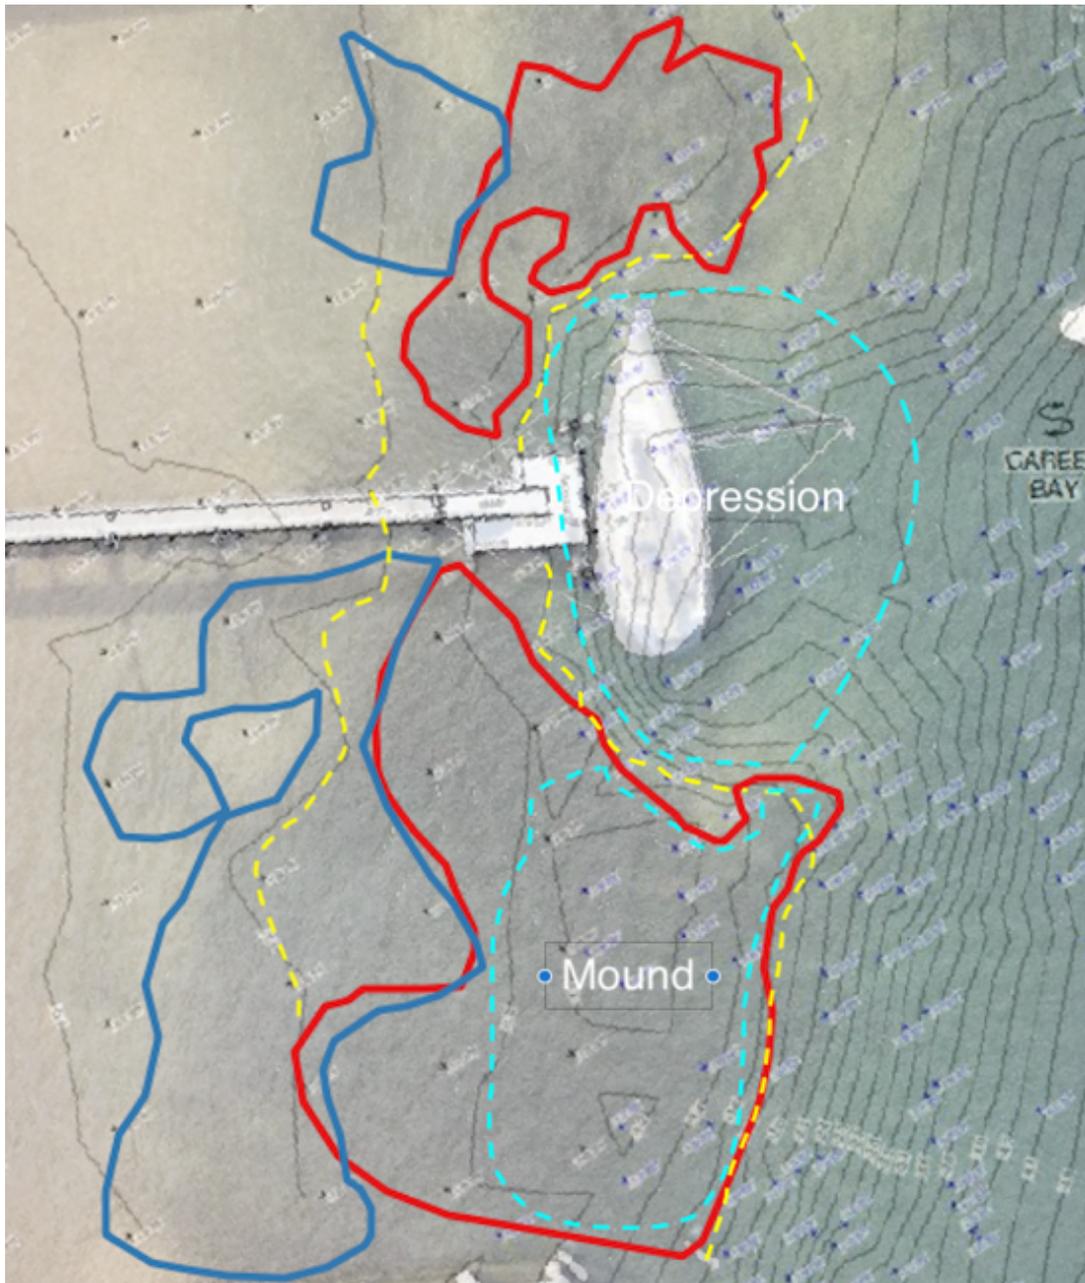
**Figure 15** below shows the main seagrass bed habitat mapping superimposed over the CMS 25 February 2025 bathymetric survey. This indicates that for the most part the *Posidonia* seagrass is presently constrained between the -1.1m and -1.6m contours and thus could be expected to occur within the current footprint of ramp and pontoon facility. However, the pontoon and mooring pile facility is located over essentially bare sediment habitat with *Posidonia* beds either side.

**Figure 15** Main outer seagrass habitats superimposed onto the CMS February 2025 Hydrosurvey. Dark Blue is *Zostera* bed limit, Red is present *Posidonia* limit. Yellow line is current (and approximate) *Posidonia* inner and outer depth limits, and the light blue lines indicate the depression and mound locations based on the bathymetric survey data.

The **Figure 15** CMS hydrosurvey superimposed over the seagrass mapping presented above indicates a distinct depression under the existing vessel and a corresponding but less distinct mound located to the south of the depression that together suggest that the mooring pen has

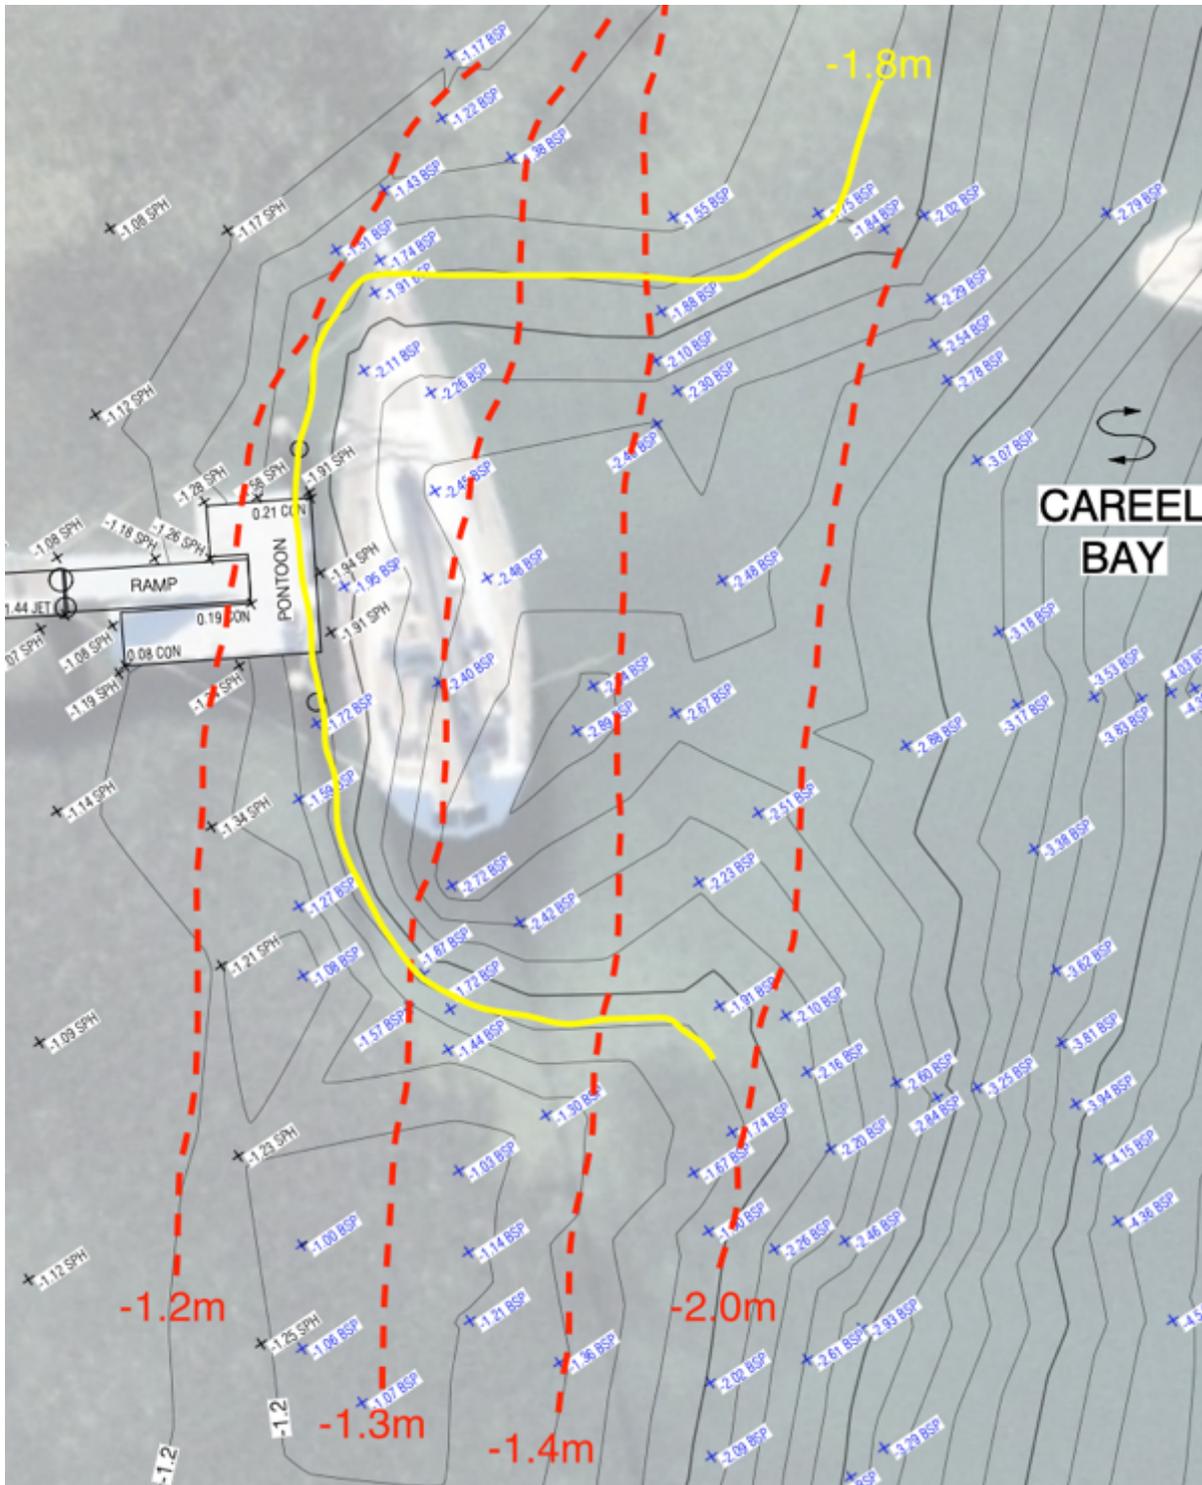
**Figure 17** Estimated probable contour lines (red) prior to scour event with present -1.8m depth contour limit (at LAT) for present 1.8m draft yacht indicated in yellow.

**Figure 17** above provides a rough estimate of where the seabed contours may have been located prior to the presumed scouring event(s) and in regards to the present vessel (and presumably for the similar sized yachts shown at the site since at least 2005 in the mooring pen) it is not possible that such a vessel can have contributed to this scouring either deliberately or inadvertently as at Lowest Astronomical Tide (0m ISLW) the moored vessel would even now would be stranded in the depression hole with more than 1.8m depth and consequently more than 1m water depth between the propeller wash and the seabed. Before the scour hole was there, there would not have been sufficient depth to bring such a deep draft vessel into the mooring at LAT and vessel entry would have been limited to tides above 1.8m which is a very limited high tide event close to the HAT of 2.0m ISLW.

Whilst the scour hole at the mooring pen location has more likely been manufactured many years ago (i.e., at least more than 20 years ago) it would appear to have been sufficiently stable to the extent that additional scouring has not occurred and approvals for the continued use of the scour hole as a mooring pen could be made contingent on say bi-annual hydrosurvey to demonstrate scour hole natural stability.
