24 NORMA ROAD
PALM BEACH

RISK ANALYSIS & MANAGEMENT FOR BUILDING CERTIFICATE AT 24 NORMA ROAD PALM BEACH

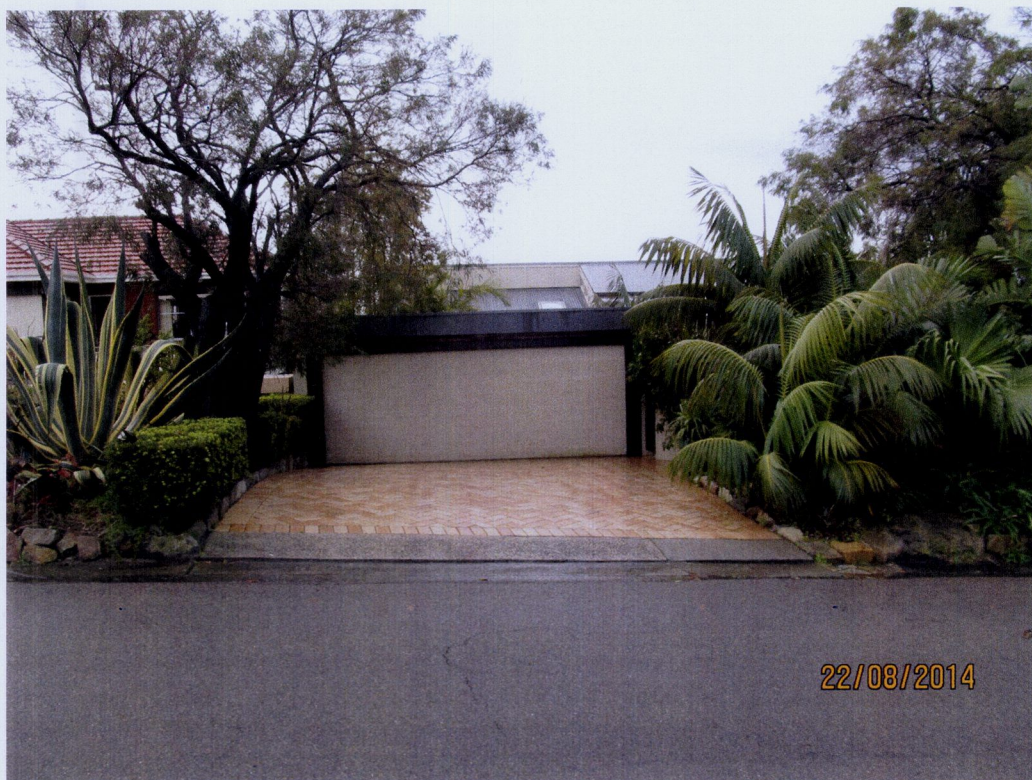
Photo 1

2.3 From the road frontage a short paved driveway enters the western side of the block to a double garage that is constructed above the ground level and supported on stable rendered masonry walls (Photos 1 & 2). Access to the main entrance of the house is from a short bridge that joins the garage with the house (Photo 2). Steps and a path provide access from the eastern side of the garage to level platform and the secondary entrance on the uphill side of the house (Photo 3). Access to the rear of the house is by a concrete path down the western side (Photo 4). A concrete pool and decking extend from downhill side of the house (Photo 5). The pool structure is supported on stable concrete piers supported on the outcropping sandstone (Photo 6). The slope below the outcrop has been landscaped in a series of terraces (Photo 7). These are supported by a series of low stack rock, timber crib and stone block walls. This section of the site has not been maintained and the garden is over grown with native and exotic shrubs and trees. An open dish drain enters the road frontage and runs down the eastern side of the property (Photos 8 & 9). It was raining heavily on the day of our inspection and the dish drain was effectively draining large amounts of

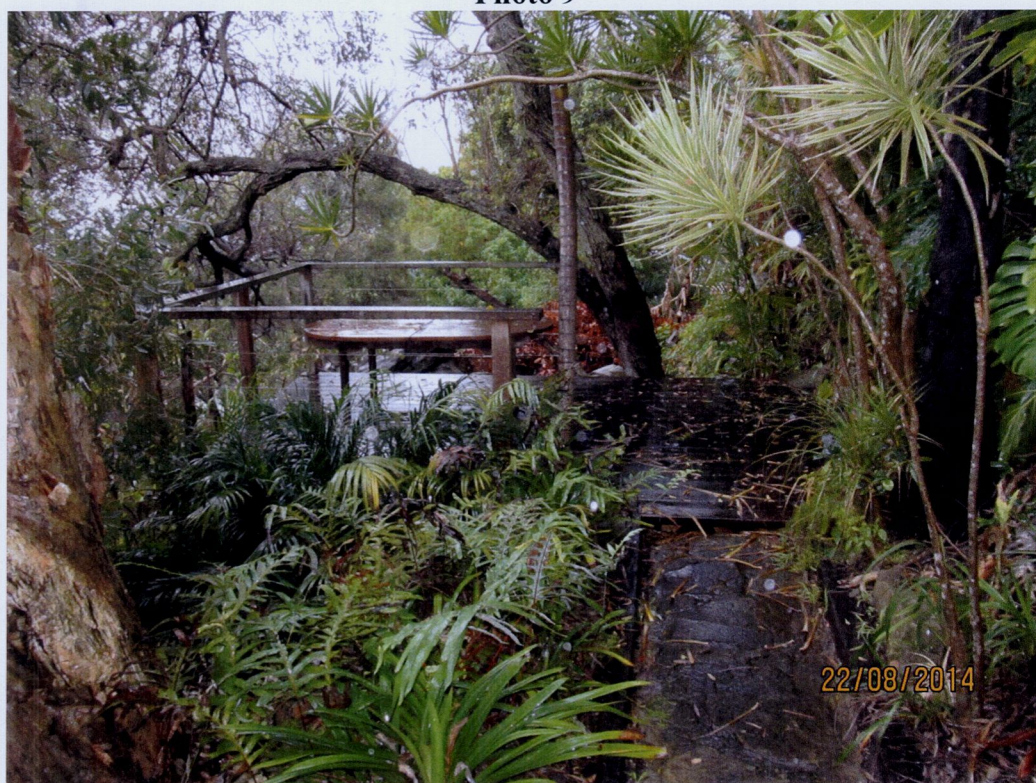
Photo 10

water away from the area. A small timber deck is situated below the pool (Photo 10). The deck is partially supported on a concrete block wall that is significantly cracked (Photo 11). The wall, though badly cracked, appears to be stable in its current condition. The condition of the wall has not deteriorated significantly since our firms previous inspection in 2007. We recommend the area be monitored periodically and should further movement be identified then the wall be demolished and replaced with an engineered wall. No evidence of significant slope instability was identified at the time of our inspection.
