## **Site Classification:**

New House at **Lot 9, 6-6A Orchard Street, Warriewood**

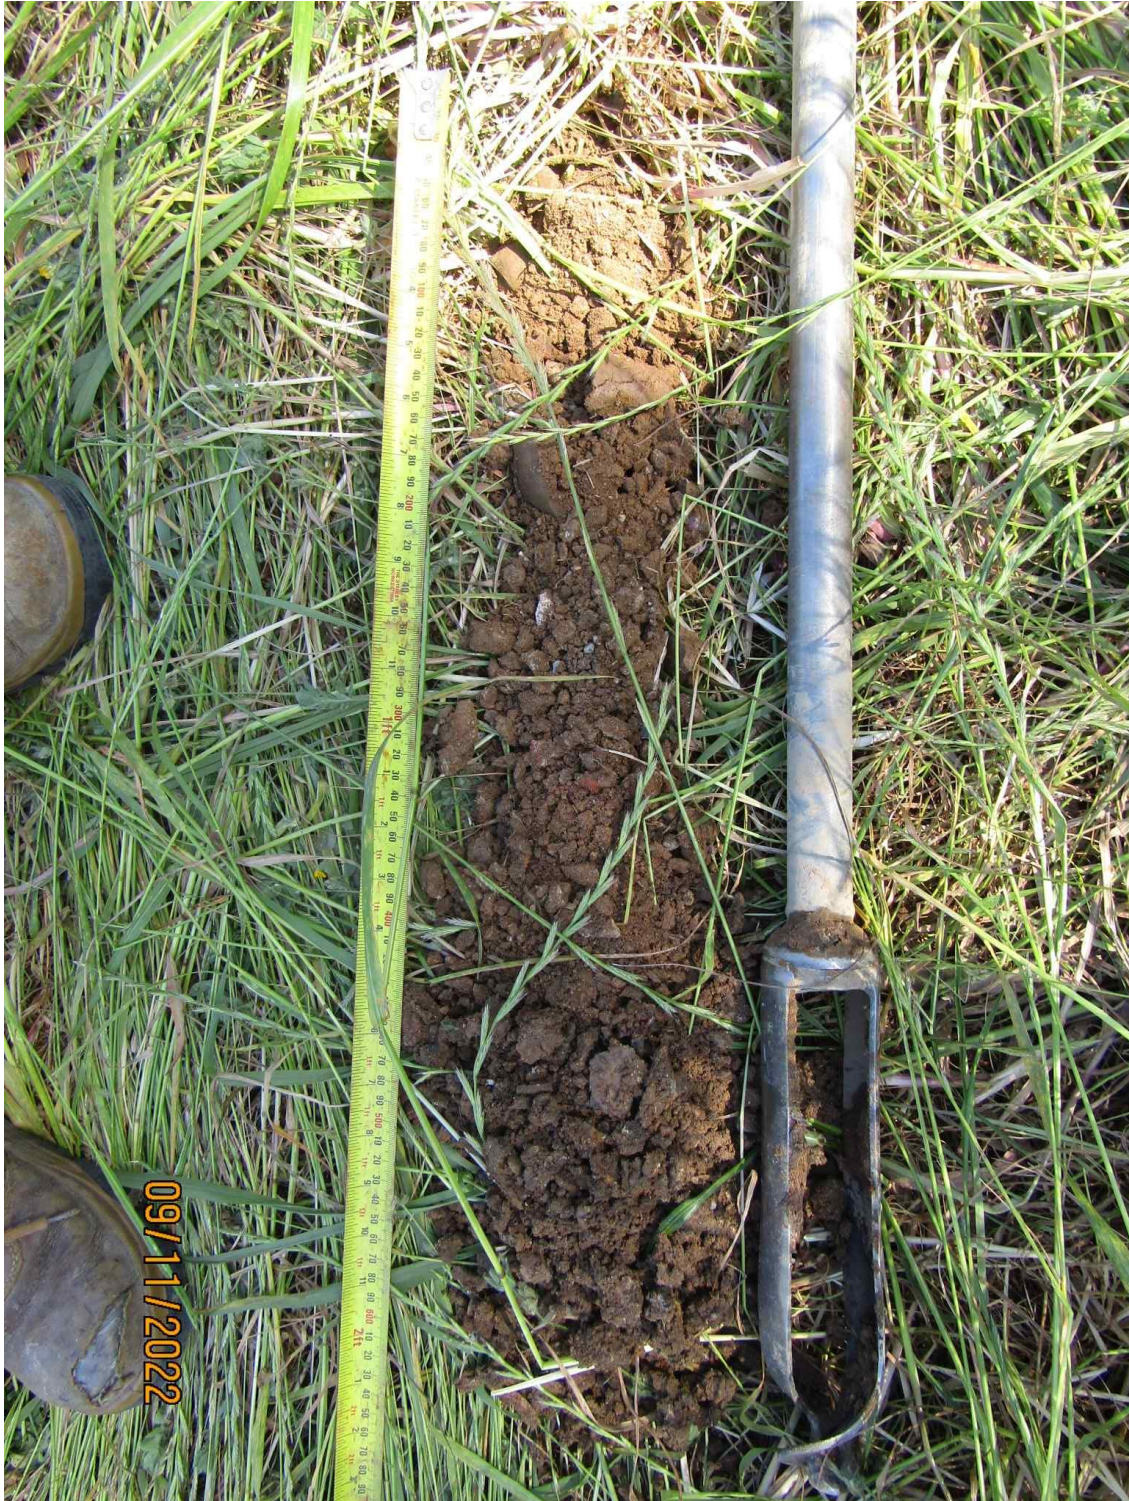
## AUGER HOLE 1 (~RL28.4) – AH1 (Photo 1)

| Depth (m) | Material Encountered |
|---|---|
| 0.0 to 0.7 | FILL, soil, clay, with rock fragments, brown, orange, white, dry to moist, fine to course grained. |

Refusal @ 0.7m in fill. No watertable encountered.

Photo 1: AH1 – Downhole is from top to bottom.
