Project No: LONG/REEF/24 Report No: LONG/REEF/AIA/A

# ARBORICULTURAL IMPACT ASSESSMENT TREE PROTECTION SPECIFICATION

**Long Reef Golf Club**  
**Anzac Avenue**  
**COLLARROY**

4<sup>th</sup> April 2025

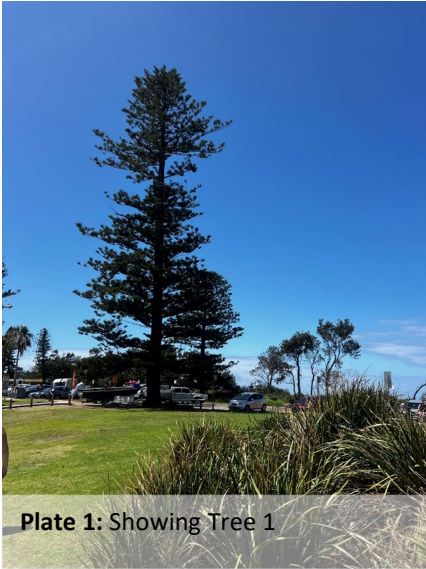
**Plate 1: Showing Tree 1**

3.1.1 Tree 1 was identified as *Araucaria heterophylla* (Norfolk Island Pine) and is a large, mature specimen located to the south-east of the existing golf club building. The tree is good health and good structural condition with no significant defects identified at the time of assessment. Tree 1 is of high Landscape Significance and has been allocated a Retention Value of *Priority for Retention*.

3.1.2 The supplied plans show footpaths and minor grading is proposed within the Tree Protection Zone (TPZ) of Tree 1. The extent of work represents a *Major Encroachment* as defined by AS-4970. Clause 3.3.4 of AS-4970 outlines that design factors should be considered when determining the potential impact of the encroachment.

- TPZ fencing should be established at the perimeter of the TPZ to the north of the tree and along the edge of the existing footpath to the south of the tree. To provide for development access, fencing should be set back along the edges of the proposed footpaths in the eastern and western sections of the TPZ.
- The new pavements within the TPZ should be installed above the existing grade (including sub-base layers). Alternatively, the footpath footprint could be excavated by hand with the finished levels adjusted or pavement/subbase materials thinned to allow for the retention of roots (>25mm $\varnothing$ ) as required by the Project Arborist
- Over excavation beyond the footprint of the pavements should be avoided.
- Minor grading works should be limited to less than 10% of TPZ and outside of the Structural Root Zone (SRZ)

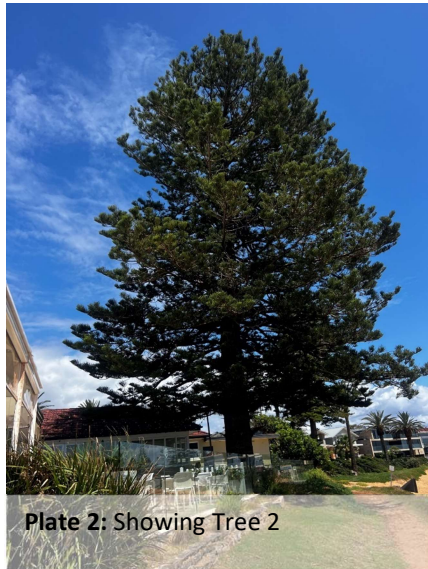
**Plate 2: Showing Tree 2**

3.2.1 Tree 2 was identified as *Araucaria heterophylla* (Norfolk Island Pine) and is a large, mature specimen located within outdoor terrace adjacent to the northern site boundary. The tree is good health and good structural condition with no significant defects identified at the time of assessment. Tree 2 is of high Landscape Significance and has been allocated a Retention Value of *Priority for Retention*.

3.2.2 The supplied plans show refurbishment of the golf club building, removal and replacement of the existing pavement surface within the outdoor terrace and the installation of a new bench seat is proposed within the TPZ of Tree 2. The extent of work represents a *Major Encroachment* as defined by AS-4970. Clause 3.3.4 of AS-4970 outlines that design factors and the presence of existing or past structures or obstacles affecting root growth should be considered when determining the potential impact of the encroachment. The proposed works fall within the footprint of the existing golf club building and terrace area, and the proposed internal floor and external paving level is above existing landscape levels within the TPZ.

- TPZ fencing should be established at the perimeter of the TPZ to the south of the tree and along the edge of the existing golf club building.
- Trunk protection should be installed to protect the tree from impact damage.

- The existing pavement should be demolished using a compact excavator (<2.5t) and monitored by the Project Arborist. The excavator should be fitted with a flat bladed bucket and guided by a spotter to identify roots. The excavator should work from un-demolished sections of existing pavement at all times. Existing sub-base/slab materials within the TPZ should remain in-situ and be reused where possible. If the existing sub-base is to be removed, these works should be undertaken using hand tools with roots (>25mmØ) retained and protected as required by the Project Arborist.

- Exposed roots (>25mmØ) should be protected from direct sunlight, drying out and extremes of temperature by covering with a damp 10mm thick jute geotextile fabric.

- Installation of the new subbase/slab should avoid excavation within the TPZ. Where required the subbase/slab layer should be locally thinned over any surface roots. A protective covering of a compressible layer (e.g. AbelFlex) should be installed over roots prior to the subbase/slab installation.

- The new bench seat should be installed on top of the new slab. Where required, piers should be installed using hand excavation with the piers located to allow for the retention of significant roots (as determined by the Project Arborist).

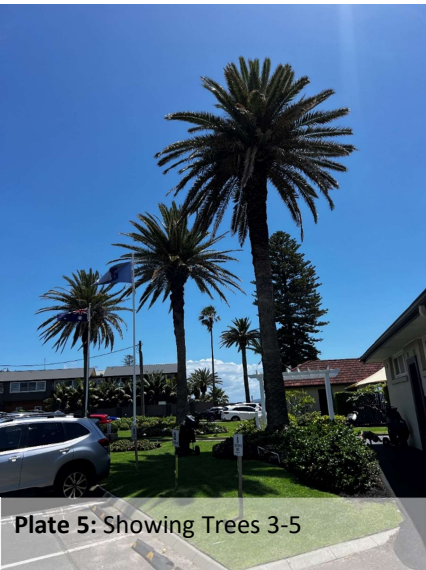
**Plate 5: Showing Trees 3-5**

3.3.1 Trees 3 and 4 were identified as *Phoenix canariensis* (Canary Island Date Palm) are mature specimens located at the entry to the existing golf club building. The trees are in good health and good structural condition with no significant defects identified at the time of assessment. Trees 3 and 4 are of moderate Landscape Significance and have been allocated a Retention Value of *Consider for Retention*.

3.3.2 The supplied plans show that Trees 3 and 4 are proposed for removal to accommodate the new guest drop off area. *Phoenix canariensis* (Canary Island Date Palm) is an exotic palm species which was introduced to Australia in the late 1800s. It may be possible to transplant these palms. However, new plantings of this species are now uncommon due to its propensity to self-seed and become weedy, and its susceptibility to the fungal disease *Fusarium oxysporum* f. sp. *Canariensis*.

3.4.1 Tree 5 was identified as *Phoenix canariensis* (Canary Island Date Palm) is a mature specimens located to the west of the existing golf club building. The tree is in good health and good structural condition with no significant defects identified at the time of assessment. Tree 5 is of moderate Landscape Significance and has been allocated a Retention Value of *Consider for Retention*.

3.4.2 The supplied plans show a new pavement area is proposed within the TPZ of Tree 5. The extent of work represents a *Minor Encroachment* as defined by AS-4970. The encroachment into TPZ should be compensated for by extending the TPZ to the north.

- Replacement trees should be planted as part of the development works to help off-set the loss of canopy cover and amenity resultant from the tree removal.
- Replacement trees should be supplied as advanced size specimens and in accordance with *Australian Standard 2303 (2015) Tree Stock for Landscape Use*.

- TPZ fencing should be established at the perimeter of the TPZ setback to accommodate the installation of new pavement areas.
- Trunk protection should be installed to protect the tree from impact damage.

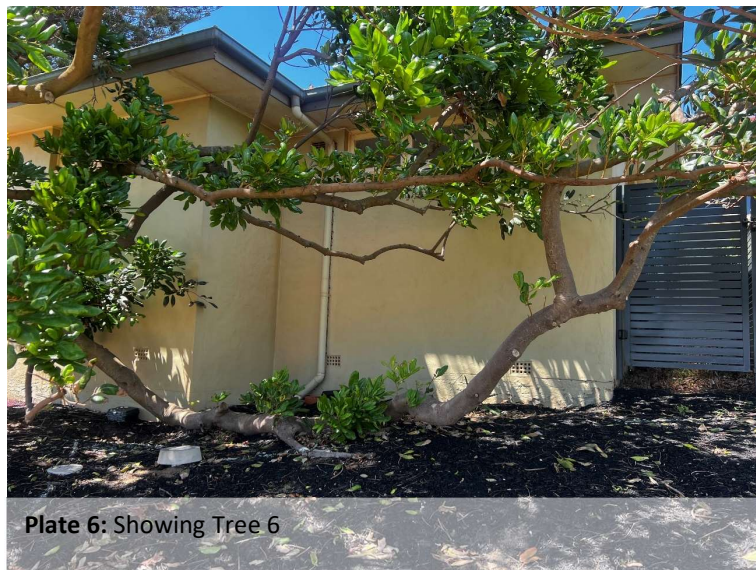
**Plate 6: Showing Tree 6**

3.5.1 Trees 6 and 14 were identified as *Cupaniopsis anacardioides* (Tuckeroo) and are located directly north of the existing golf club building. The trees are in good health and fair structural condition. Tree 6 shows signs of previous, partial root plate failure however the tree appears to have restabilised. Trees 6 and 14 are of low Landscape Significance and have been allocated a Retention Value of *Consider for Removal*.

3.5.2 The supplied plans show refurbishment of the golf club building and installation of landscape wall is proposed within their TPZ areas. The extent of work represents *Major Encroachments* as defined by AS-4970. Clause 3.3.4 of AS-4970 outlines that the presence of existing or past structures or obstacles affecting root growth should be considered when determining the potential impact of the encroachment. The proposed refurbishment works fall within the footprint of the existing golf club building. It should be noted that where root growth has been deflected by an inground obstruction such as footing, particularly within a tree's SRZ, the obstruction may be providing additional stability to the tree's root plate. Where possible, inground structures should be left in situ as part of the demolition works.

- TPZ fencing should be established at the perimeter of the TPZ areas setback to allow for demolition of the existing golf club building.
- TPZ fencing should be moved to the perimeter of the southern perimeter of the TPZ areas once the demolition works are completed. TPZ fencing on the northern side of the trees should be setback to allow for construction of the sandstone wall.

- If roots (>25mm $\phi$ ) are encountered during the demolition works, these roots must be retained in an undamaged condition and advice sought from the Project Arborist.

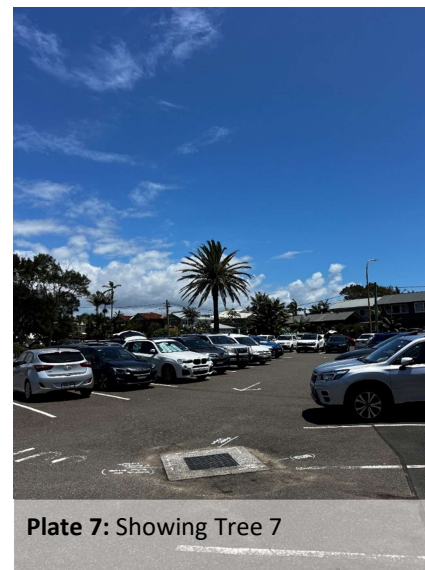
**Plate 7: Showing Tree 7**

3.6.1 Tree 7 was identified as *Phoenix canariensis* (Canary Island Date Palm) and is a mature specimen located within the carpark to the west of the existing golf club building. The tree was good health and good structural condition with no significant defects identified at the time of assessment in November 2024. However, the golf club has advised this tree has now died. TreeIQ have reviewed photos of the tree and it is likely to have been infected with the fungal disease *Fusarium oxysporum* f. sp. *Canariensis*.

- A replacement tree should be planted as part of the development works to help off-set the loss of canopy cover and amenity resultant from the tree removal.
- The replacement tree should be supplied as advanced size specimens and in accordance with *Australian Standard 2303 (2015) Tree Stock for Landscape Use*.

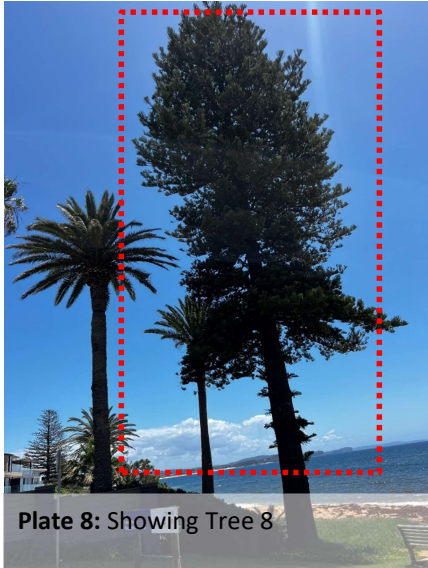
Plate 8: Showing Tree 8

3.7.1 Tree 8 was identified as *Araucaria heterophylla* (Norfolk Island Pine) and is a large, mature specimen located to the north-west of the existing golf club building. The tree is good health and good structural condition with no significant defects identified at the time of assessment. Tree 8 is of high Landscape Significance and has been allocated a Retention Value of *Priority for Retention*.

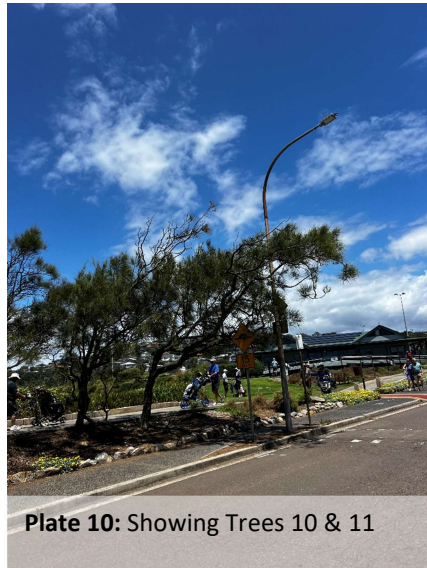
Plate 10: Showing Trees 10 & 11

3.9.1 Trees 10-12 were identified as *Casuarina glauca* (Swamp She-Oak) and Tree 13 was identified as *Leptospermum laevigatum* (Coastal Tea Tree). Tree 10 is in fair structural condition due to the presence of minor bark inclusions and wounds with decay. Trees 11 and 12 are in fair health due to the presence of small (<25mm $\emptyset$ ) and medium (25-75mm $\emptyset$ ) deadwood in moderate volumes. Tree 13 is in fair health due to a reduced crown density and the presence of small (<25mm $\emptyset$ ) and medium (25-75mm $\emptyset$ ) deadwood in moderate volumes. The tree is in fair structural condition due to the presence of bark inclusions (some which have partially failed) and wounds with decay. Trees 10-13 are of low Landscape Significance and have been allocated a Retention Value of *Consider for Removal*.

- Replacement trees should be planted as part of the development works to help off-set the loss of canopy cover and amenity resultant from the tree removal.
- Replacement trees should be supplied as advanced size specimens and in accordance with *Australian Standard 2303 (2015) Tree Stock for Landscape Use*.

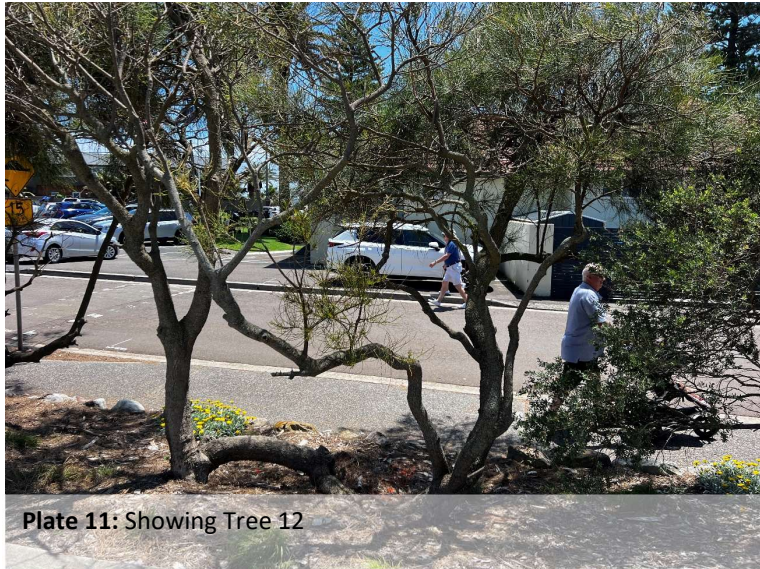
Plate 11: Showing Tree 12

12	<i>Casuarina glauca</i> (Swamp She-Oak)	200 200 200	5	4	Fair	Good	Small (<25mm $\phi$ ) & medium (25-75mm $\phi$ ) deadwood in low volumes. Previously failed root plate, now appears stable.	Mature	5-15	Low	Consider for Removal	4.2	2.2	Remove.
13	<i>Leptospermum laevigatum</i> (Coastal Tea Tree)	200 200 100	5	4	Fair	Fair	Small (<25mm $\phi$ ) & medium (25-75mm $\phi$ ) deadwood in moderate volumes. Crown density 75-95%. Branch inclusions, some with partial failures. Wounds, various stages of decay. Lopped. Previously failed root plate, now appears stable.	Mature	5-15	Low	Consider for Removal	3.6	2.0	Remove.
14	<i>Cupaniopsis anacardioides</i> (Tuckeroo)	400	5	4	Good	Fair	Small (<25mm $\phi$ ) & medium (25-75mm $\phi$ ) deadwood in low volumes. Wind pruned. Branch inclusions, major. Lopped. Wounds, various stages of decay.	Mature	5-15	Low	Consider for Removal	4.8	2.3	Retain. Major encroachment. Use tree sensitive methods.
