17 October 2022

Arboricultural Impact Assessment Report regarding four (4) trees located within the vicinity of the proposed new eastern deck at St Luke's Grammar School, 1977 Pittwater Road, Bayview

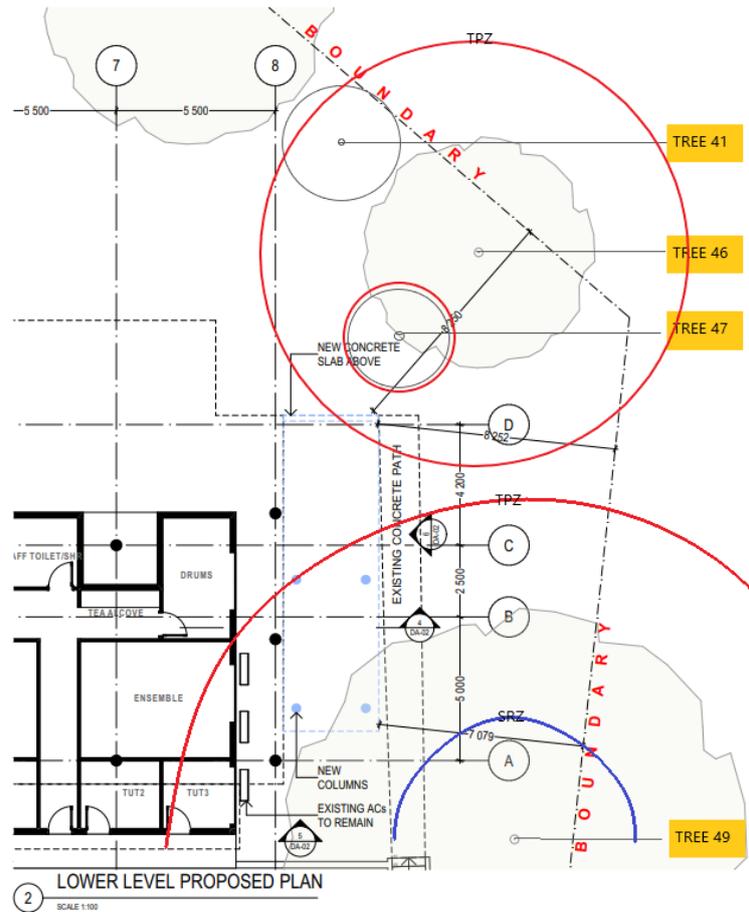
- 6.2.11 Excavation to facilitate post holes (refer Figure 4 below) for the columns to support the deck are located 6.6m, 8.68m, 10.38m and 11.8m respectively from the tree, outside of the SRZ. In its entirety, excavation is less than 10% of the TPZ area, constituting a minor encroachment under the Australian Standard (AS 4970–2009). It is therefore considered the tree can be retained with minimal long-term negative effects if specific protection requirements as outlined in Section 7.2 are followed during development.

Figure 4. A markup of the DA Development Application (Dwg. No. DA-02, Rev. 01) illustrating TPZs (red) and the SRZ for Tree 49 (blue). (ArborSafe, October 2022).

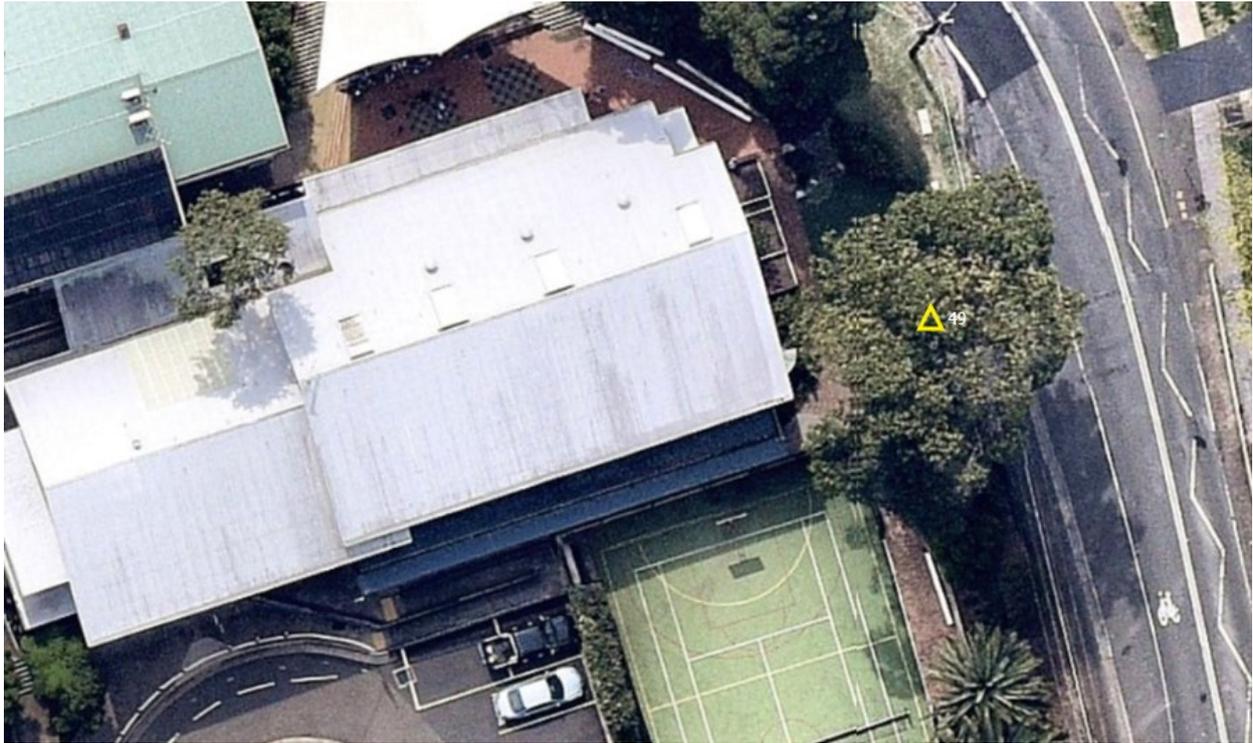
Figure 5. Site map showing tree requiring specific protection measures. (ArborSite, October 2022).

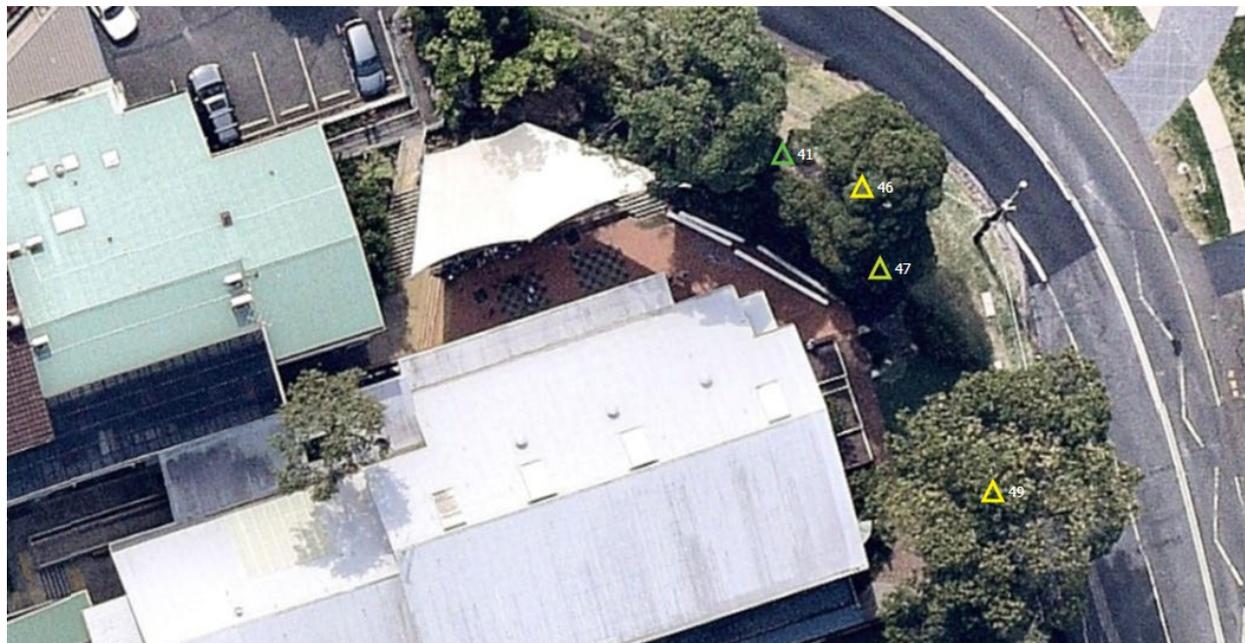
Figure 6. Site map showing trees requiring generic protection measures. (ArborSite, October 2022).

7.4.1 All retained trees require generic protection measure (Figure 6). Refer to Section 7.4–7.7 for further detail.

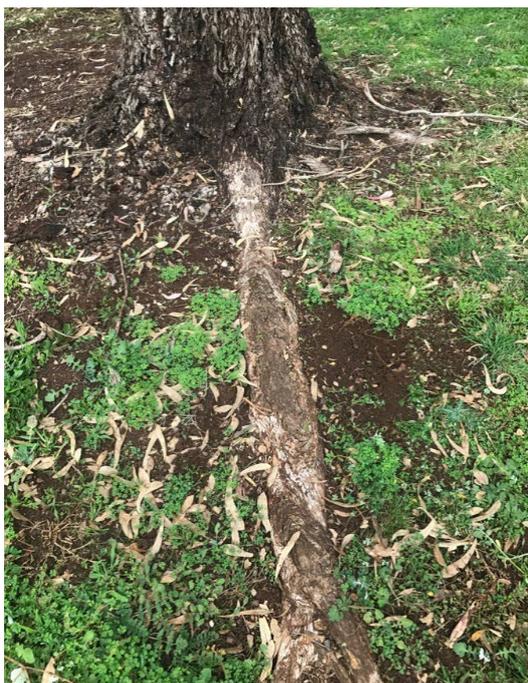
Figure 12. An example of damage to tree roots caused via mowing. (Luke Dawson, June 2017).

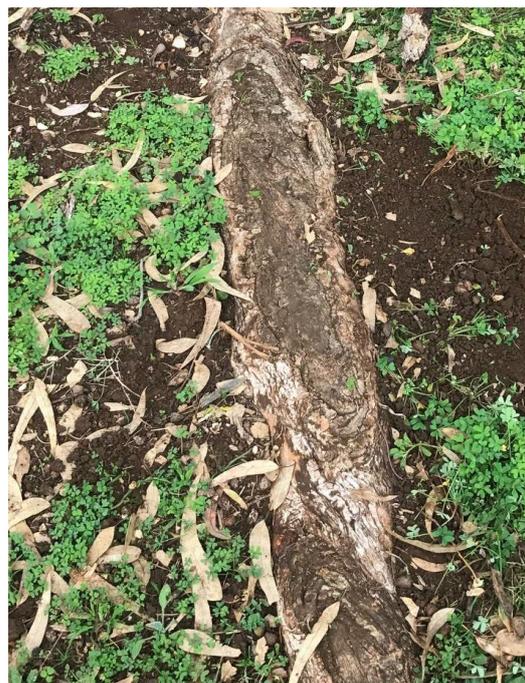
Figure 13. Image showing wound caused to upper portion of surface root by mower. (Luke Dawson, June 2017).
