17 January 2023

9 Horning Parade, Manly Vale

Arbor Impact Assessment
Version 1.0
Client: Tom & Jeni Daven

Luke Smart
AQF V Consulting Arborist (AHC50510)

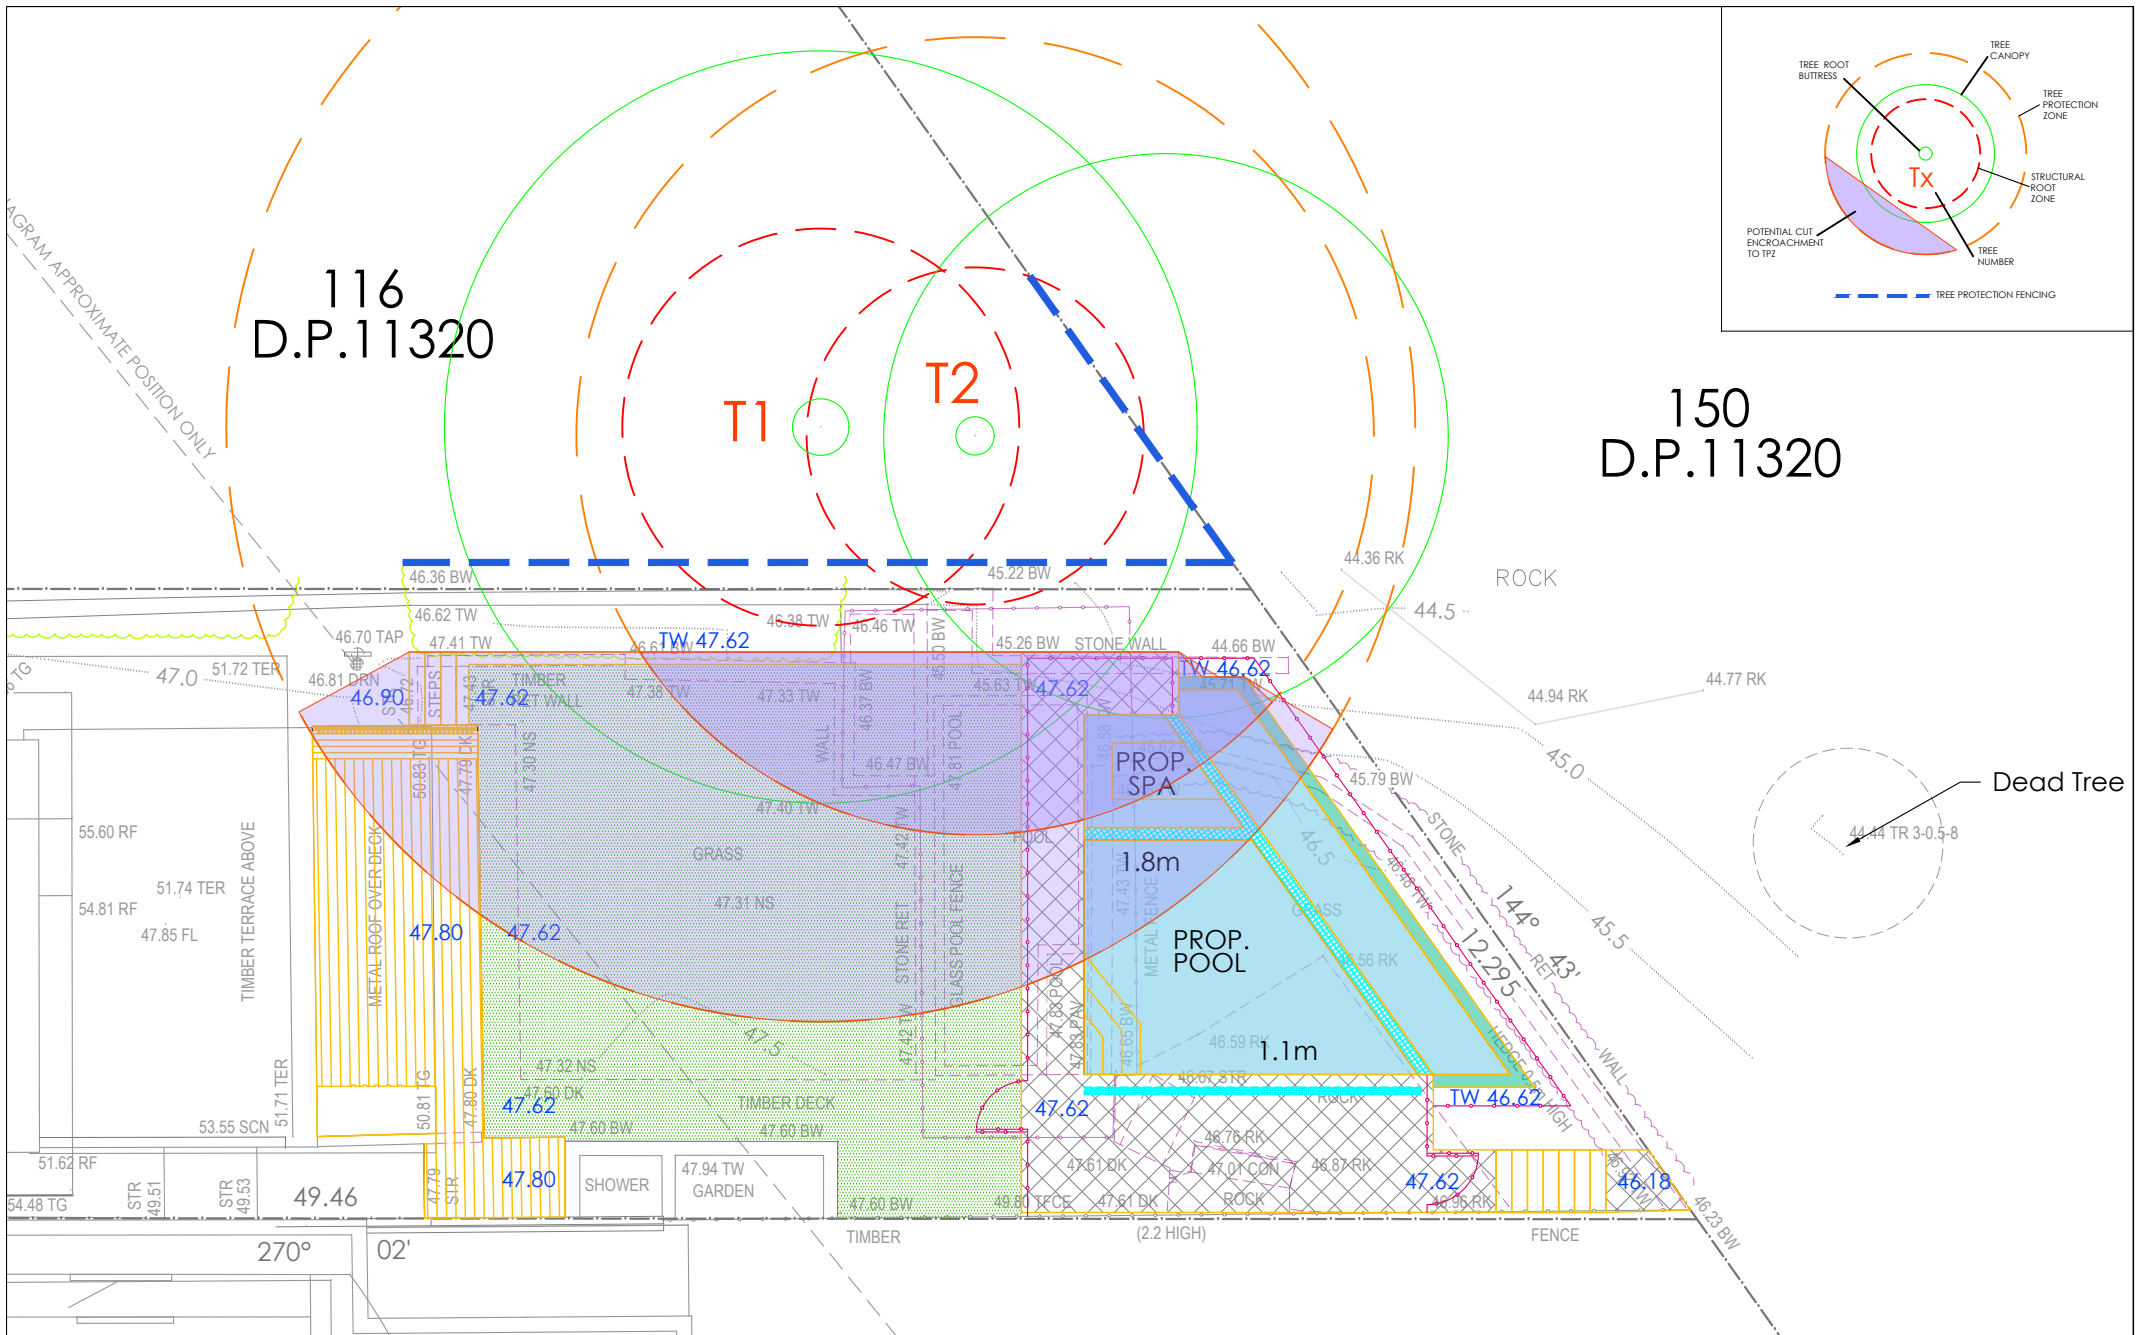
PROJECT: LANDSCAPE & SWIMMING POOL		
DRAWING: TREE LOCATION & IMPACT PLAN		
SCALE: NTS @ A4	ISSUE: V1.0	DRAWN BY: LS
SHEET NUMBER: TLP-S1	DATE: 28.07.22	REVISION: A

- Tree 2 is a Bangalay (*Eucalyptus botryoides*), located in the rear yard of No. 7 Horning Parade and is 3.5m from a proposed replacement retaining wall along the northern edge of the development, providing a 17% encroachment within the Tree Protection Zone. This tree is considered as having a Medium STARS© Significance rating and is suitable for retention.

- Tree 1 is a Bangalay (*Eucalyptus botryoides*), located in the rear yard of No. 7 Horning Parade and is 3.6m from a proposed replacement retaining wall along the northern edge of the development, providing a 26% encroachment within the Tree Protection Zone. This tree is considered as having a Medium-High STARS© Significance rating and is suitable for retention.

A fenced exclusion zone must be implemented in order to protect as much of the measured TPZ as feasible, while providing a reasonable offset from the property boundary to allow clear access for construction activities (as indicated in the **TREE LOCATION & IMPACT PLAN**, page 15).

The same recommended courses of action apply to this tree over the development process including supervision of excavation within the TPZ by a Project Arborist with a minimum AQF5 level qualification; as well as the implementation of a fenced exclusion zone providing a reasonable offset from the property boundary to allow clear access for construction activities (as indicated in the **TREE LOCATION & IMPACT PLAN**, page 15).

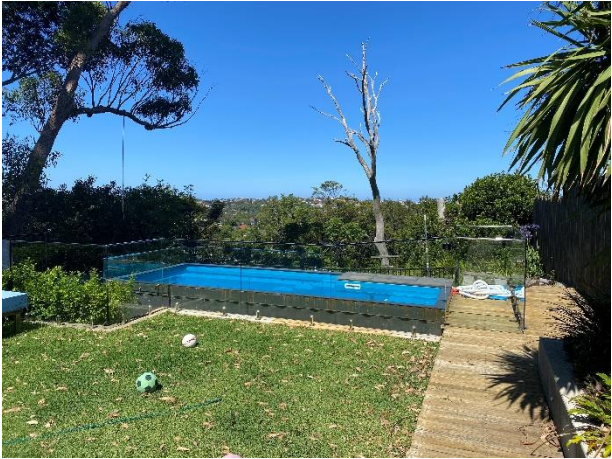
- A tree surveyed on the Site Plan & Site Analysis by Space Landscape Designs located to the rear of the property was noted as dead at the time of inspection and was not assessed as part of this report.

Area of Development (dead tree at rear)

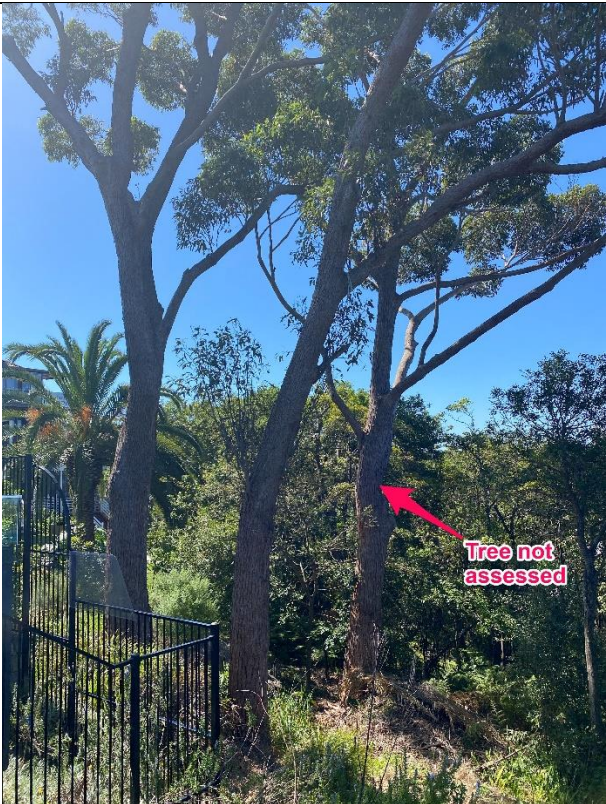
- A Bangalay located directly behind Tree No.'s 1 & 2 was not included on the survey, however all recommendations provided in this report will assist in the retention and protection of this tree. No data was taken from this tree at the time of inspection.
- Shrubs located in the front yard of the property did not match minimum prescribed tree criteria as per the Warringah Development Control Plan and are not included in this report. However, care should be taken when transporting equipment from the front of the property to the construction zone to avoid unnecessary damage to retained shrub crowns or compaction to soil adjacent to these shrubs.

Tree not assessed

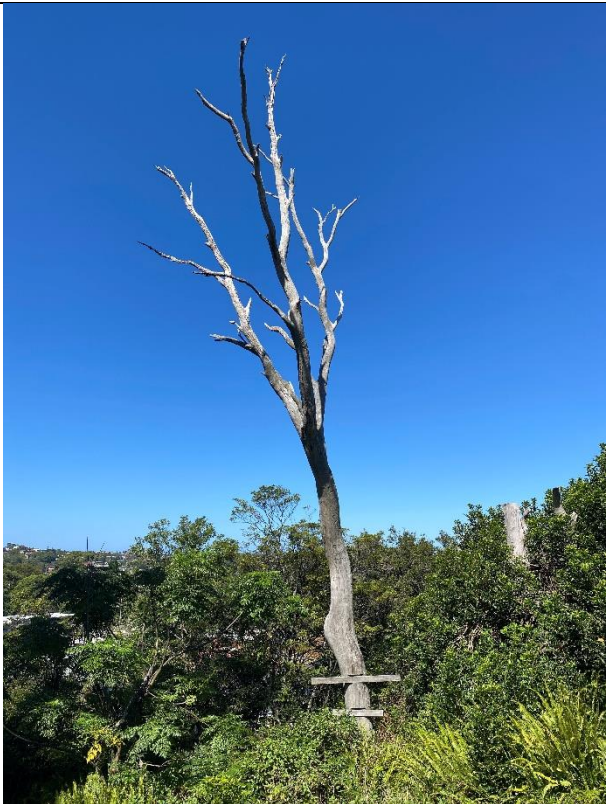
Dead tree in rear bushland

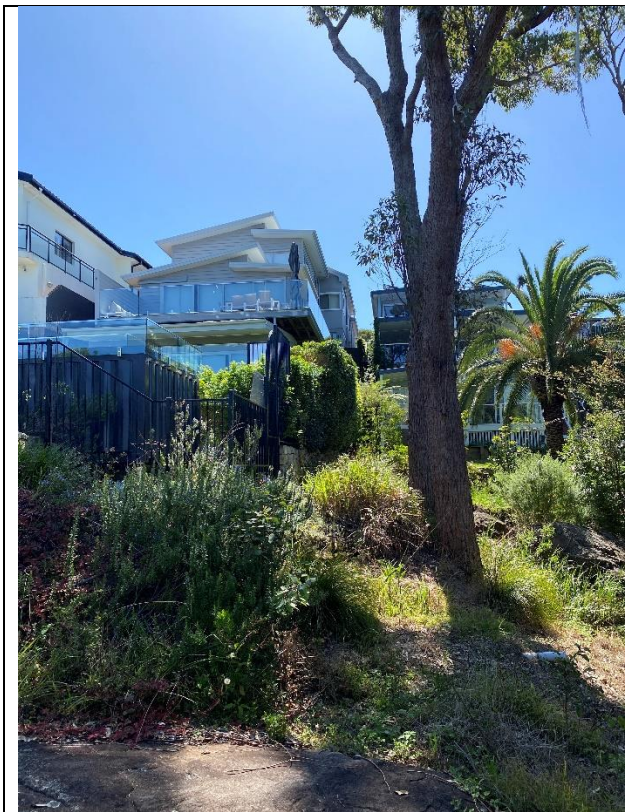
The proposed new 'reconfigured' retaining wall is the same line of wall that poses an encroachment to Tree 2, and the installation of the wall's footing would require a line of excavation on an uphill slope to the location of this tree, and outside the structural root zone. This tree also appears to be growing between sections of rock that form an outcrop at the rear of the properties and the root system spread may be less predictable due to availability of soil in the localised area. The measured encroachment's impact may not necessarily apply due to the differentiation in levels between the installed footing and the location of the tree's root buttress.

Proximity of Trees 1 & 2 to development area

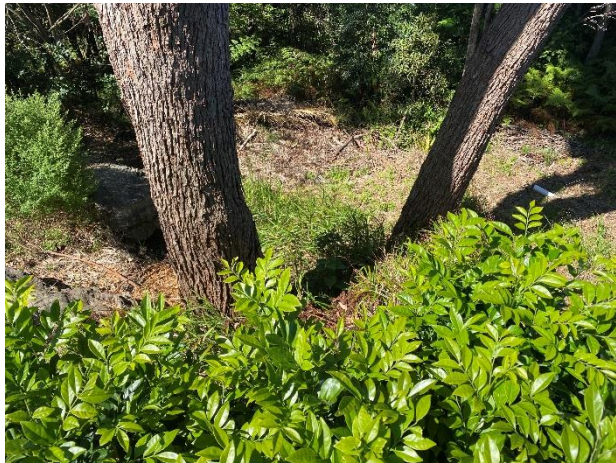
While the installation of this footing would require some excavation, the proposed line of this excavation is on an uphill slope to the location of this tree, and outside the structural root zone. The tree appears to be growing between sections of rock that form an outcrop at the rear of the properties and the root system spread may be less predictable due to availability of soil in the localised area.

Root buttresses lower than property level
