## **GEOTECHNICAL INVESTIGATION:**

### **New Lift at 16 Cabarita Road, Avalon**

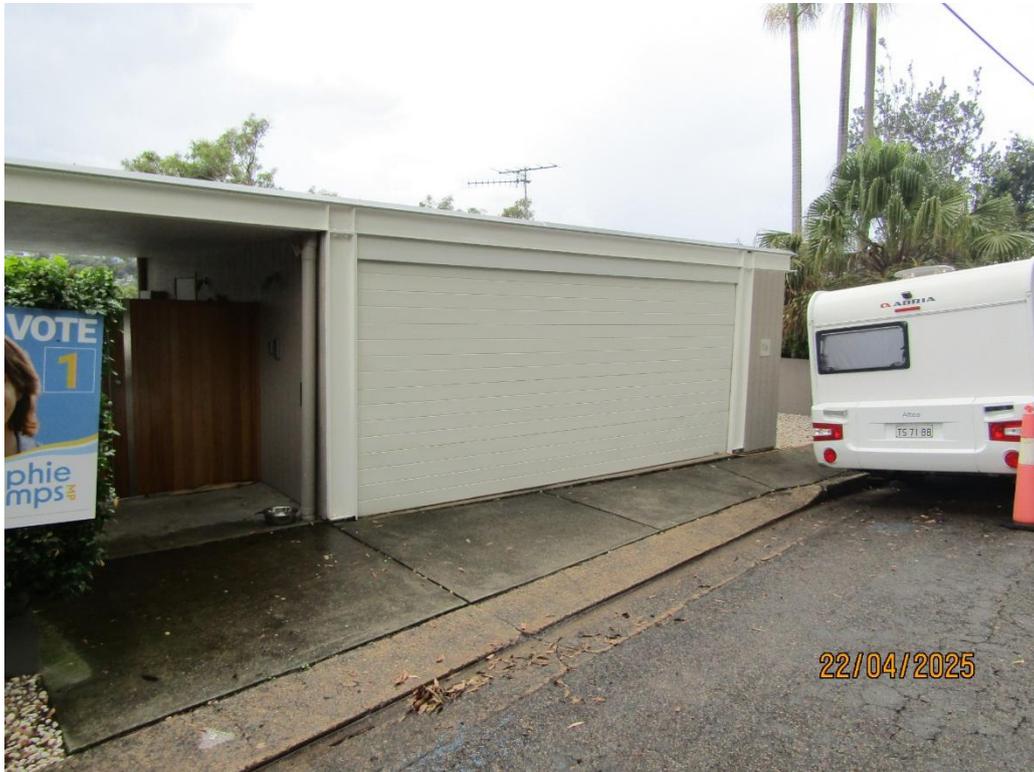
Photo 1

- 2.3** At the road frontage, a concrete driveway runs to a stable garage along the upper boundary of the property (Photo 1). On the downhill side of the garage, an excavation has been made into the slope for a level lawn above the house (Photo 2). The excavation is supported by rendered masonry retaining walls that appear well constructed (Photo 3). The one and two storey clad house displays no significant signs of movement in the external supporting walls (Photo 4). The slope between the downhill side of the house and the waterfront is terraced with a series of stable stack rock retaining walls reaching ~0.8m high (Photo 5). A cut at the waterfront is supported by a stable ~1.8m high sandstone block retaining wall

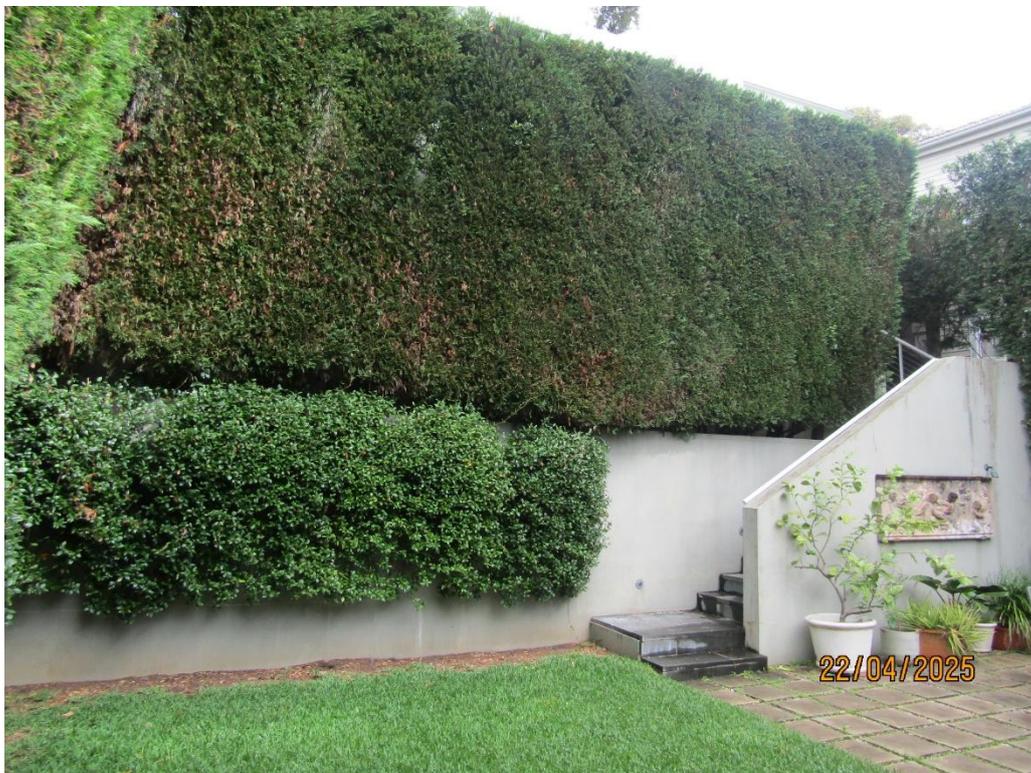
Photo 3

An opening will be cut through the masonry retaining wall immediately downslope of the garage (Photo 3). The boundaries of the wall to be removed are to be cut with saws before

the wall is dismantled from the top down. This work is to be conducted in an orderly manner so no damage occurs to the portions of the wall that are to remain. As the wall is lowered, any fill behind the wall is to be lowered simultaneously and battered at no steeper than 30° until the permanent retaining walls can be constructed.

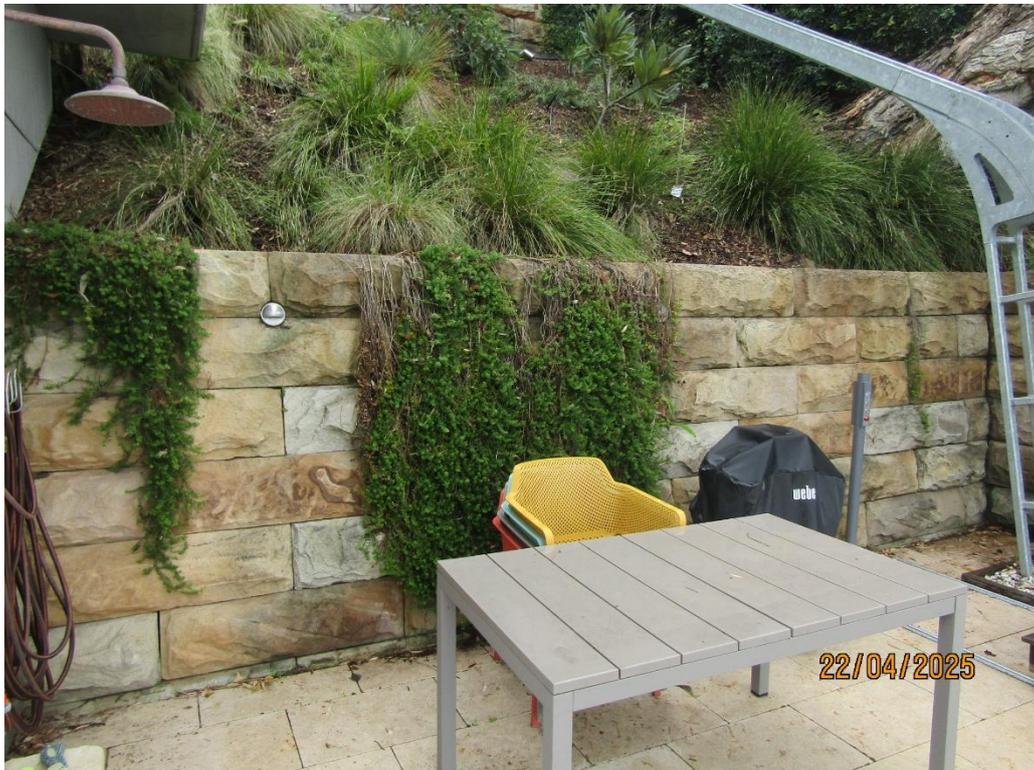
Photo 6

(Photo 6). A boatshed and pool at the waterfront are cut into the slope and appear stable (Photos 7 & 8). The fill around the pool is supported by a stable ~1.8m high sandstone block seawall (Photo 9). Below the property, a jetty extends into Pittwater (Photo 10).

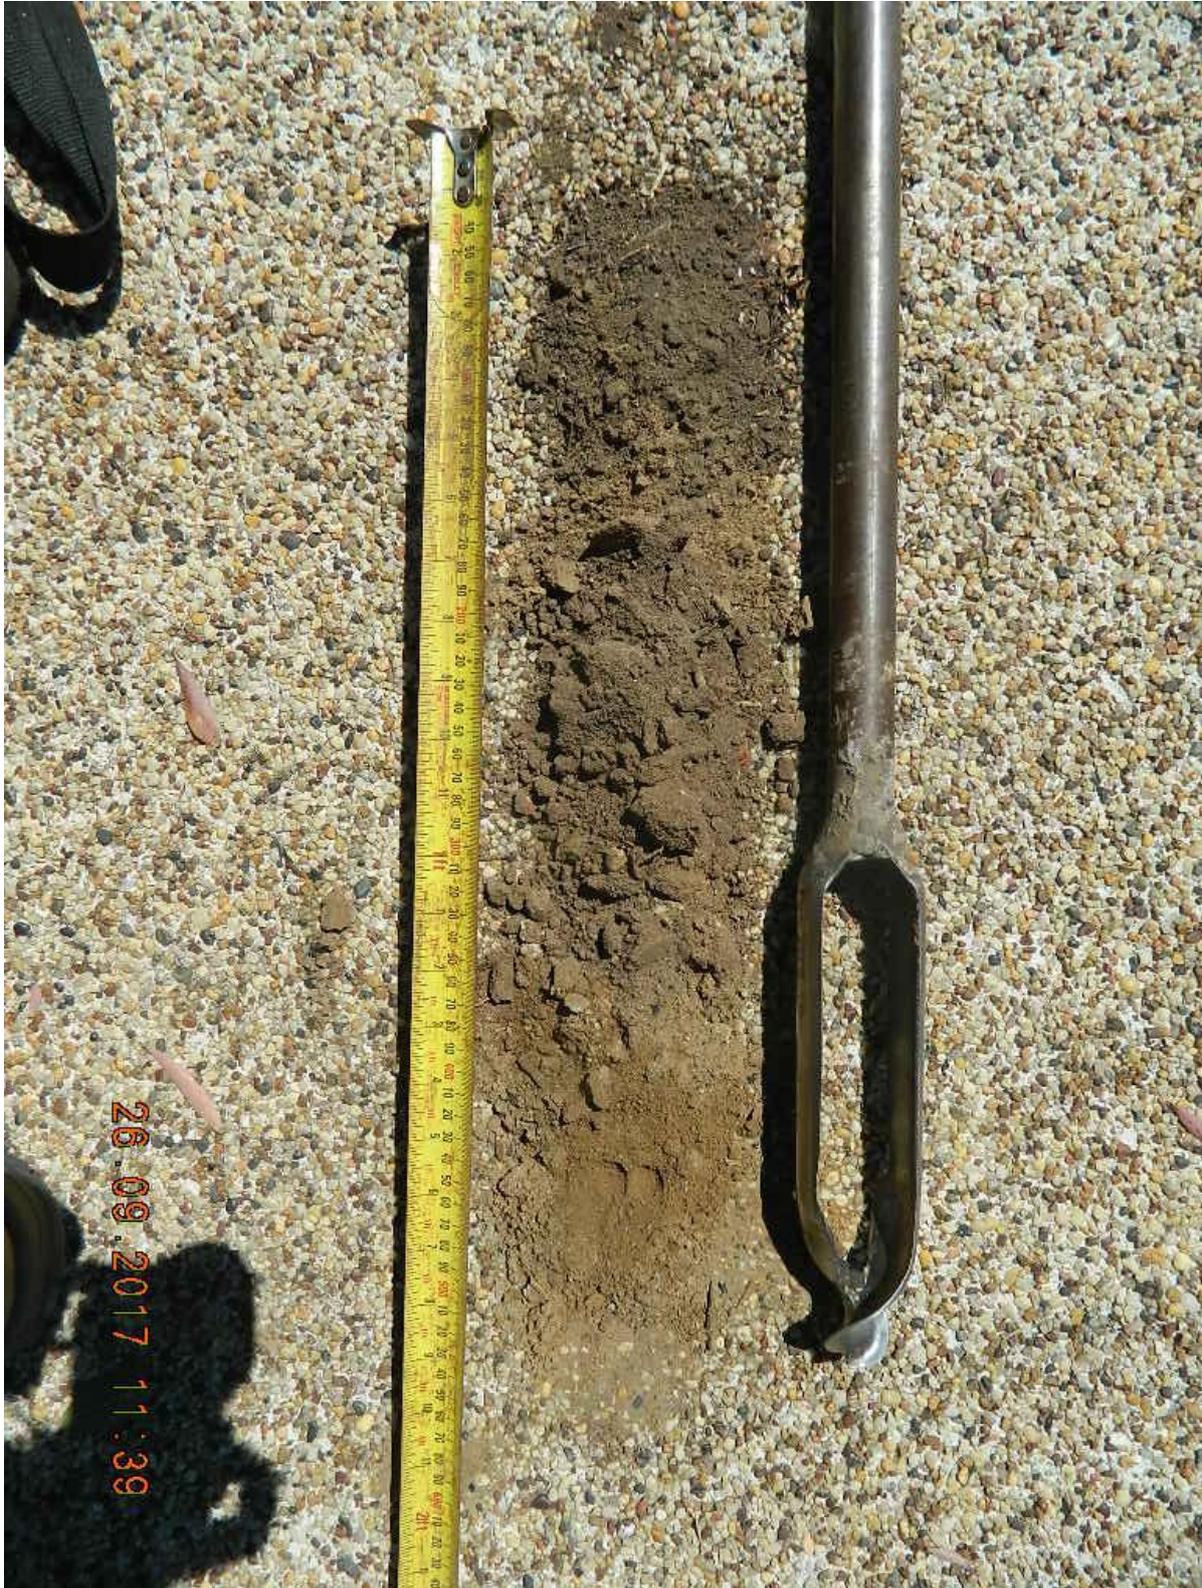
#### AUGER HOLE 1 (~RL3.0) – AH1 (Photo 11)

| Depth (m) | Material Encountered |
|---|---|
| 0.0 to 0.2 | <b>TOPSOIL</b> , black/dark brown, loose, dry. |
| 0.2 to 0.5 | <b>CLAYEY SAND</b> , dark brown, medium dense, dry. |

Refusal on rock @ 0.5m. Estimated to be a sandstone floater. No water table encountered.

Photo 11: AH1 – Downhole is from top to bottom

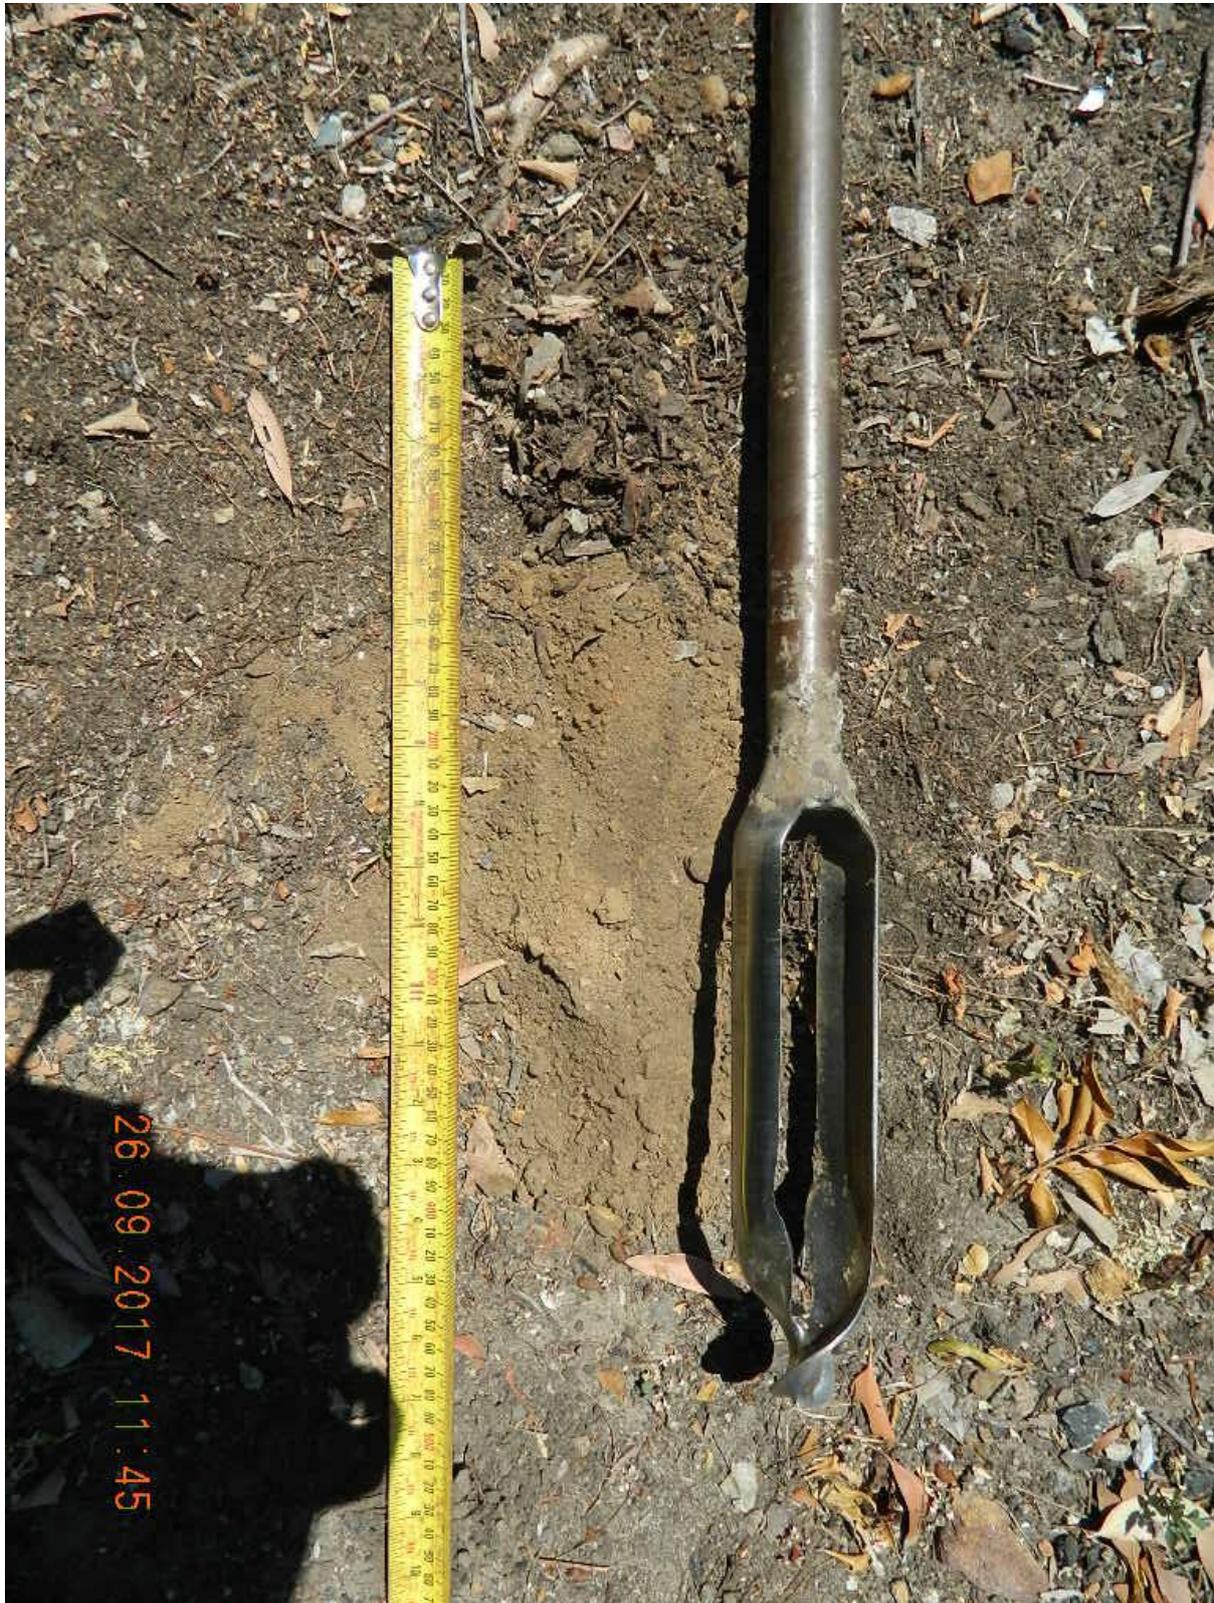
## AUGER HOLE 2 (~RL5.0) – AH2 (Photo 12)

| Depth (m) | Material Encountered |
|---|---|
| 0.0 to 0.1 | <b>MULCH</b> , woodchips, dry. |
| 0.1 to 0.4 | <b>CLAYEY SAND</b> , dark brown, medium dense, dry. |

Refusal on rock @ 0.4m. Estimated to be a sandstone floater. No water table encountered.

Photo 12: AH2 – Downhole is from top to bottom
