8 Bower Street, Manly

Geotechnical Comments for Section 4.55

GEOTECHNICAL INVESTIGATION:

Alterations and Additions, New Pool, and New Outbuilding at **8 Bower Street, Manly**

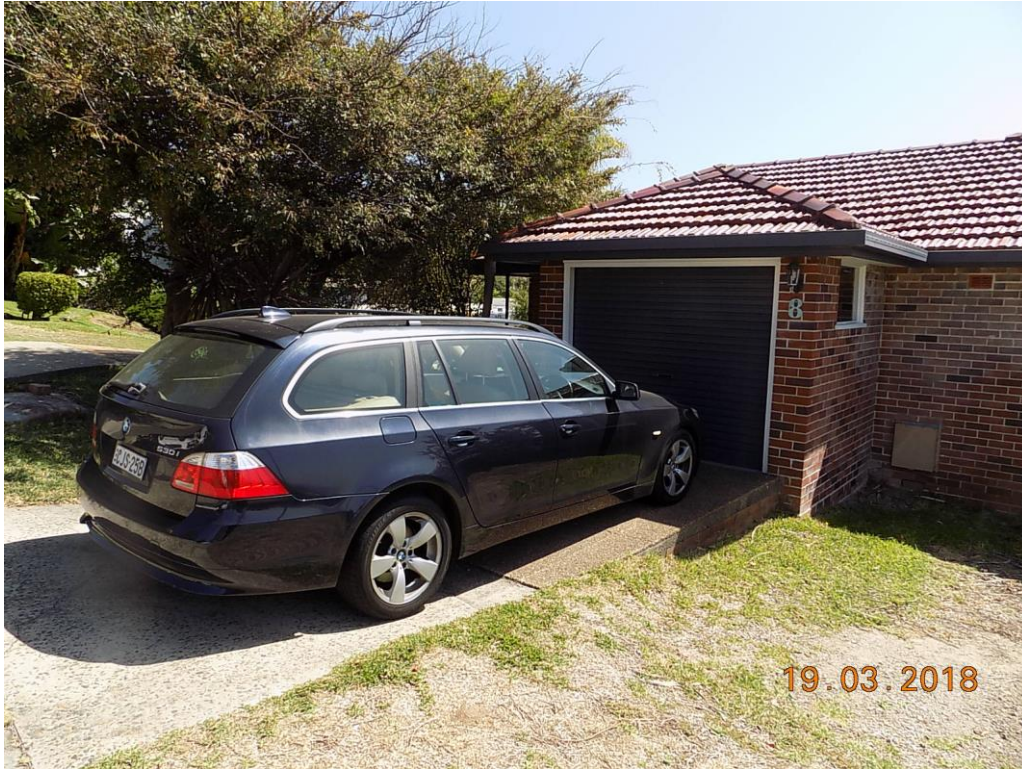
Photo 1

2.3 At the road frontage, a concrete driveway runs to a garage on the ground floor of the house (Photo 1). The part two-storey brick house is supported on brick walls and brick piers (Photo 2). No signs of movement were observed in its external supporting brick walls and the supporting brick piers stand vertical. Some of the supporting brick piers and portions of the supporting brick walls were observed to be supported directly on competent Medium Strength Sandstone (Photo 3). A fill has been placed on the downhill side of the house for a level patio area. The fill batter is lined with rocks and is considered stable (Photo 4). A gentle to moderately sloping lawn falls below the fill batter. Competent Medium Strength Sandstone outcrops through the upper portion of the lawn (Photo 5). A timber framed and clad outbuilding has been constructed near the lower boundary (Photo 6). The outbuilding will be demolished as part of the proposed works. A fill has been placed at the lower boundary. The fill is supported by a rough but stable stack rock retaining wall reaching $\sim 1.0\text{m}$ high that lines the lower boundary (Photo 7). A creek flows down the slope below the lower boundary (Photo 8). Medium Strength Sandstone outcrops through the creek bed.

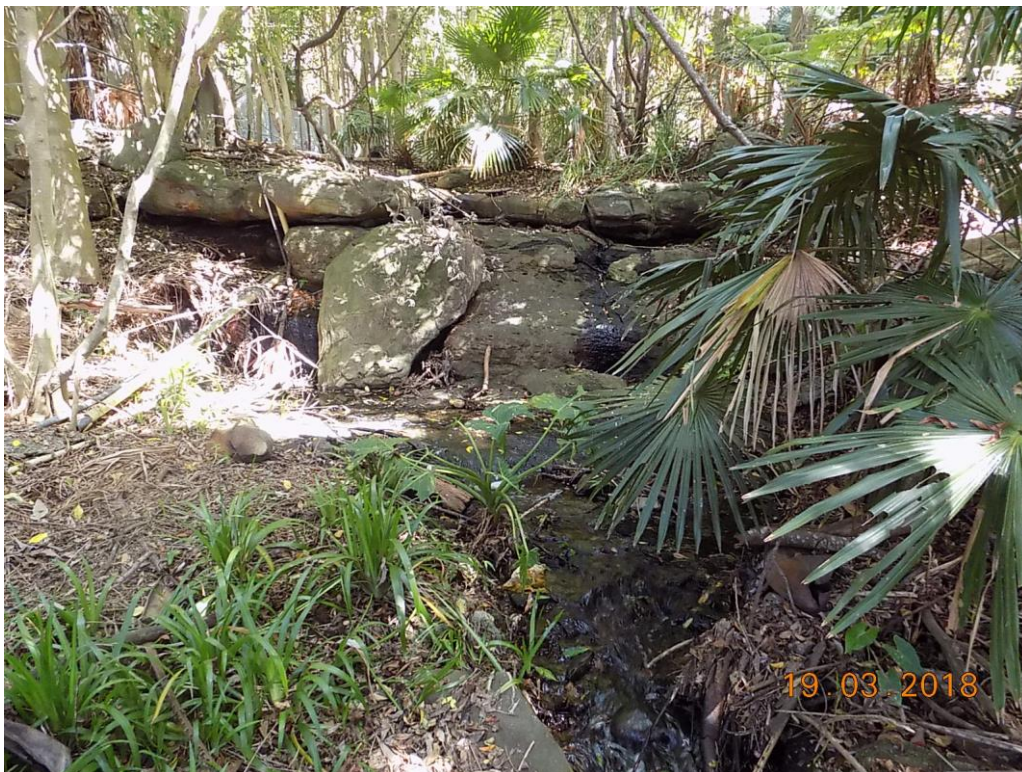
Photo 8

There is fall to the creek below the property (Photo 8). Roof water from the development is to be piped to the creek through any tanks that may be required by the regulating authorities.

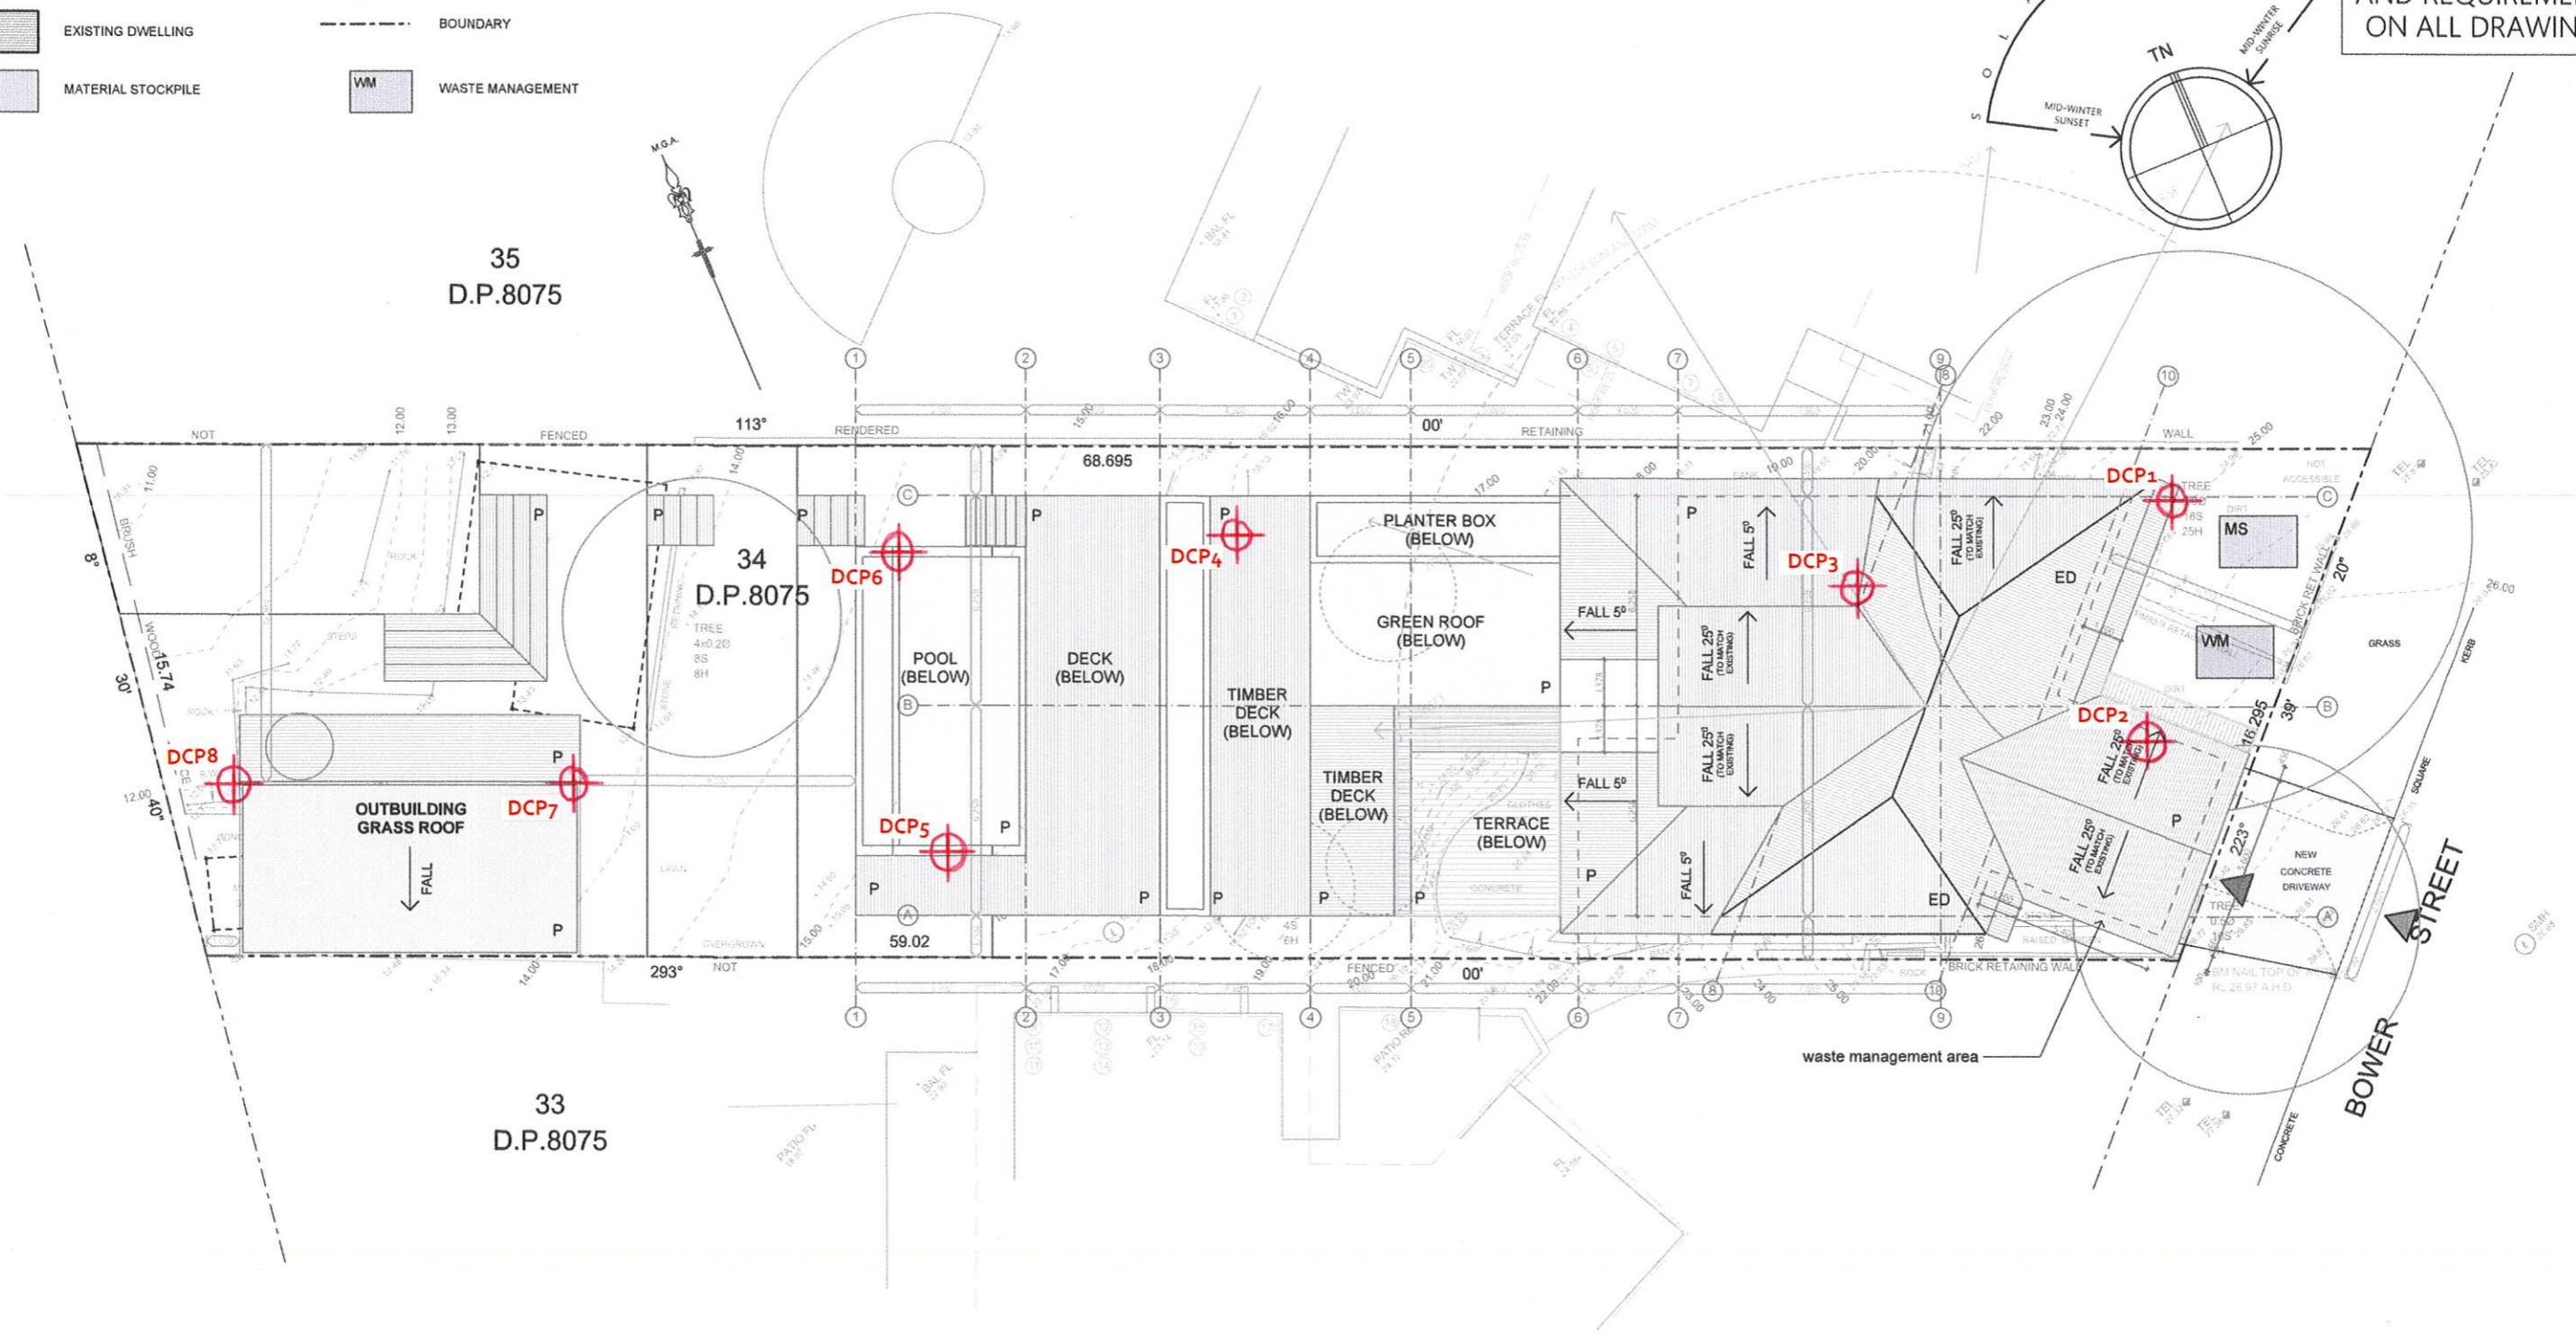
SITE PLAN – showing test locations

Eight Dynamic Cone Penetrometer (DCP) tests were put down to determine the relative density of the overlying soil and the depth to bedrock. The locations of the tests are shown

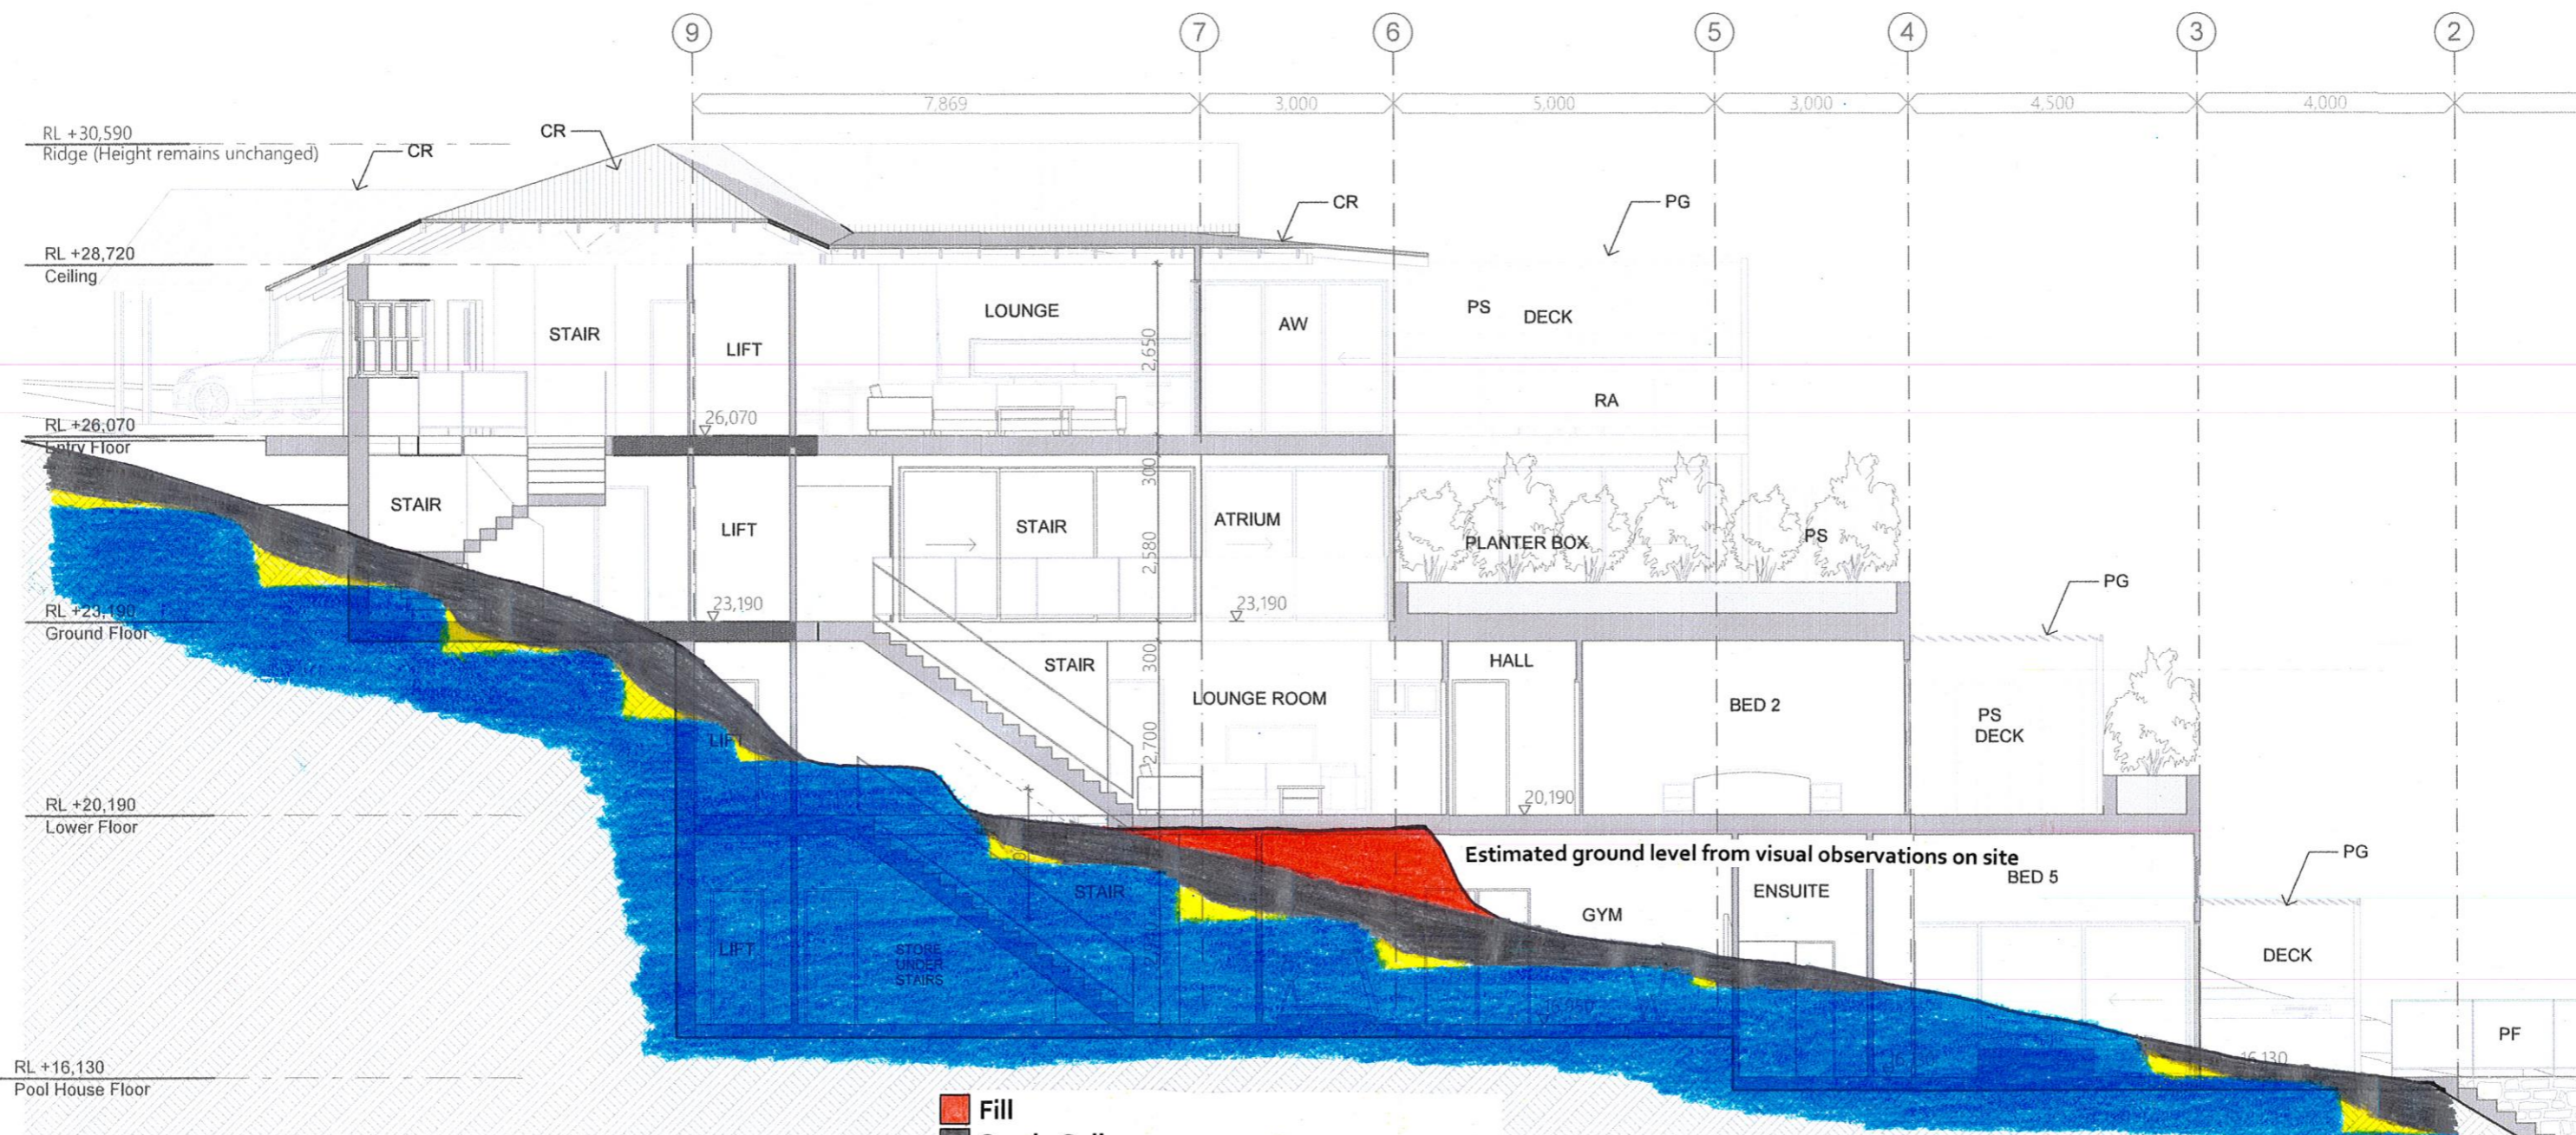
TYPE SECTION – Diagrammatical Interpretation of expected Ground Materials

The surface features of the block are controlled by the outcropping and underlying sandstone bedrock that steps down the property forming sub-horizontal benches between the steps. Where the grade is steeper, the steps are larger and the benches, narrower. Where the slope eases, the opposite is true. Where the rock is not exposed, it is overlain by sandy soils and sandy clays that fill the bench step formation. Filling has been placed across the downhill side of the property for landscaping purposes. In the test locations, the depth to rock ranged between 0.4 to 1.1m below the current surface, being slightly deeper where filling has been used for landscaping and due to the stepped nature of the underlying bedrock. Given all the other tests encountered rock at shallow depths, it is likely DCP1 was over a joint (crack) in the rock as it reached a depth of 1.8m. The outcropping sandstone on the property is estimated to be medium strength or better and similar strength rock is expected to underlie the entire site. See Type Section attached for a diagrammatical representation of the expected ground materials.
