131a Seaforth Crescent, Seaforth

Arbor Impact Assessment
Version 1.0

Client: Xiaochang Zhang
c/- Corona Projects Pty Ltd

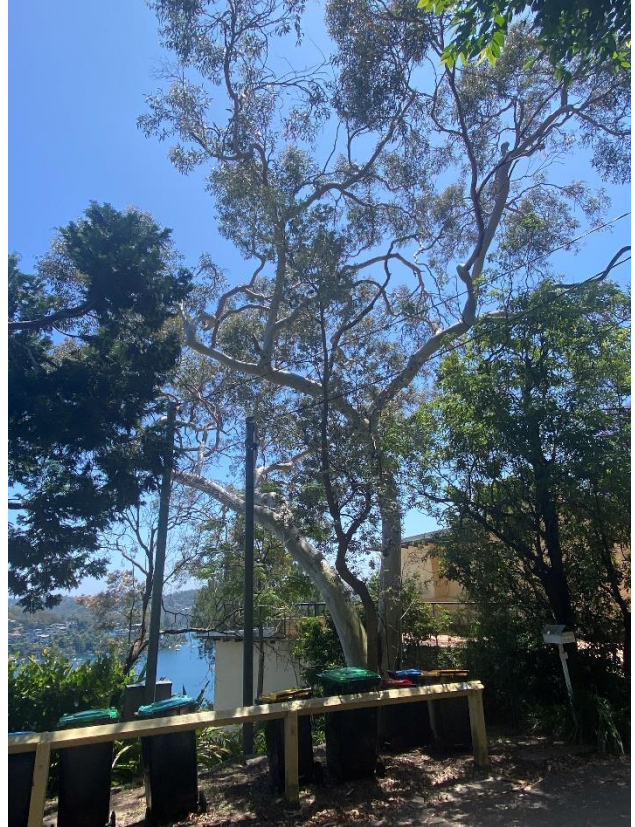
- Tree 2 has a significant area of impact posed to the measured Tree Protection Zone, however the tree may be sustainably retained if all construction works are completed as a suspended or post/pier type construction, with tree sensitive construction techniques being utilised, and protection measures must be implemented as prescribed below and in the **DISCUSSION** section of this report (pages 21 & 22).

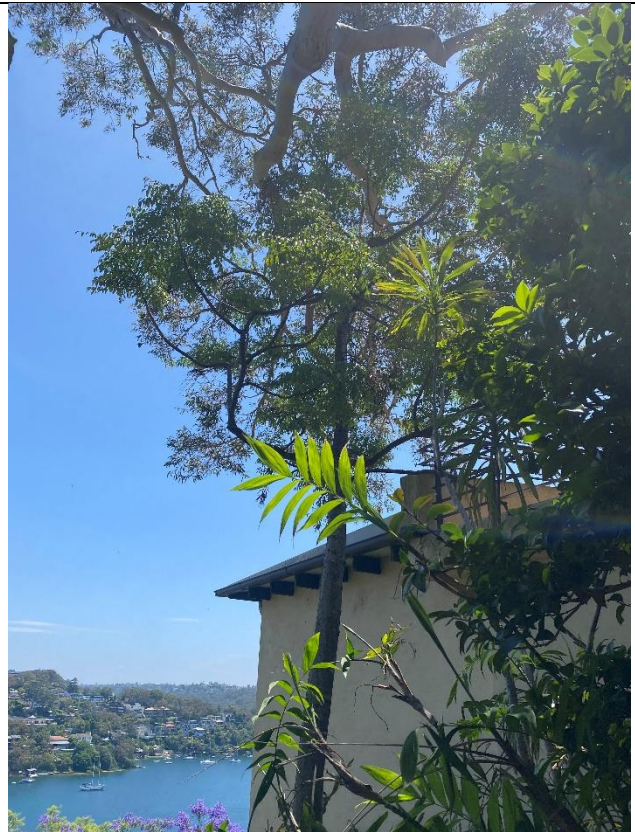
Tree 3

- Tree No.'s 3, 4, 21 & 23 are unsuitable for retention if the proposed development is to proceed due to being located within the footprint of the proposed inclinorail or interfering with the path of travel for the mobile platform. These trees should be removed prior to site establishment.

3	<i>Melia</i>	<i>azedarach</i>	White Cedar	M	Av	U	As, Su	8	3.5	160				160	190	1647	1920	L	Overhanging neighbouring structure.	Tree not on survey	Located within contact of proposed inclinator mobile platform
4	<i>Jacaranda</i>	<i>mimosifolia</i>	Jacaranda	M	F-Av	MS, L	As, Skew	8.5	9	240	240			340	470	2410	4080	L-M	Codominant stems leaning and skewing to N-NW. Only moderate presence of flower. E side of crown with moderate dieback.		Located within footprint of proposed inclinator rail.
5	<i>Pittosporum</i>	<i>undulatum</i>	Native Daphne	M	Av	CD, U	As, Su	7.5	3	180	110			211	300	1996	2532	L	Upright growth habit, suppressed upper crown from T4 overhanging canopy.	Located in neighbouring property to N.	No measurable encroachment
6	<i>Melaleuca</i>	<i>hypericifolia</i>	Hillock Bush	M	G	MS, Shrub	As	3	5	60	70	60	50	121	140	1449	1452	L	Spreading shrub	Located in neighbouring property to N.	No measurable encroachment

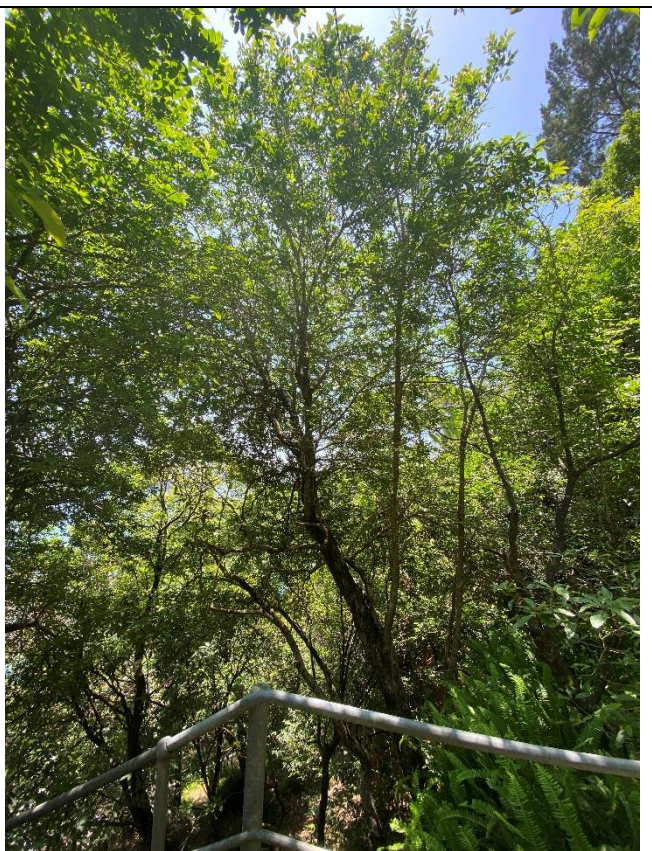
Upper crown of Tree 7

7	<i>Glochidion</i>	<i>ferdinandi</i>	Cheese Tree	M	G	U, Skew	As	11	6	300				300	370	2180	3600	M	Upright forest specimen directly below cliff edge.	Located in neighbouring property to N. Tree not on survey.	Negligible encroachment from inclinator rail installation.
8	<i>Pittosporum</i>	<i>undulatum</i>	Native Daphne	M	Av	L, Photo	As, Emergent	9	7.5 (NW)	250	140	160		329	430	2322	3948	M	Basal sweep to W then leaning phototropic growth habit.	Located in neighbouring property to N.	Negligible encroachment from inclinator rail installation.
9	<i>Glochidion</i>	<i>ferdinandi</i>	Cheese Tree	M	G	CD, U	As	12	7	420				420	510	2494	5040	M	Most dominant crown in surrounds	Located in neighbouring property to N. Tree not on survey.	Located 1.9m from proposed inclinator rail installation posing a 21% discontinuous cut encroachment within the TPZ
10	<i>Ficus</i>	<i>rubiginosa</i>	Port Jackson Fig	M	G	MS, Sp	As	10	17	550				550	860	3106	6600	M	Spreading and dividing root buttress across rocky outcrop above neighbouring property. Suppression of crown to E from T9.	Located in neighbouring property to N. Tree not on survey.	Located 2.8m from proposed inclinator rail installation posing a 20% discontinuous cut encroachment within the TPZ

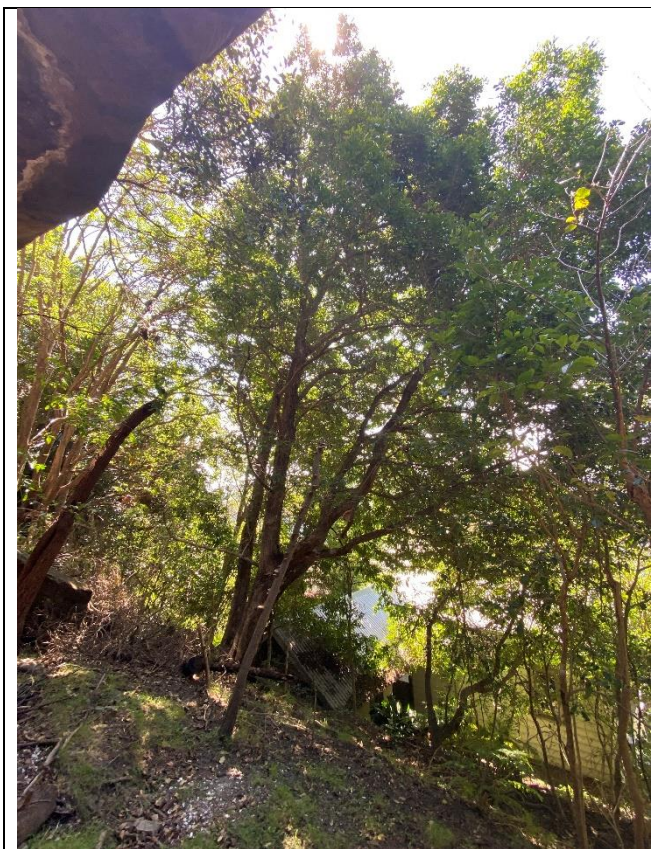
Tree 12

- Potential pruning required on Tree No.'s 12 & 16 to maintain clearance from roof restoration works must be identified during site establishment and brought to the attention of a Project Arborist with a minimum AQF5 level qualification. A pruning specification should be completed by the Project Arborist and submitted to Council prior to commencing any pruning of a retained tree.

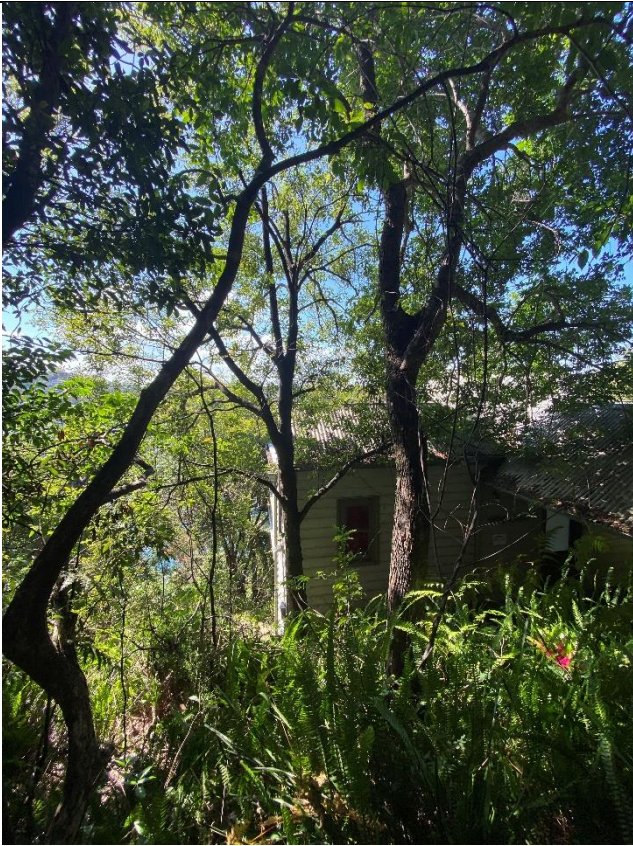
Trees 16 & 17

16	<i>Glochidion</i>	<i>ferdinandi</i>	Cheese Tree	M	G	U	As	7.5	5	230				230	310	2024	2760	L-M	Lower laterals coming into contact with awning roof.		Located 2.8m from proposed roof restoration posing a 10% encroachment within the tree's crown

17	<i>Pittosporum</i>	<i>undulatum</i>	Native Daphne	M	Av	U	As	7	5.5	190		190	250	1849	2280	L	Lower laterals coming into contact with premises roof.	No measurable encroachment
18	<i>Cyathea</i>	<i>cooperi</i>	Lacy Tree Fern	M	G	Pole	S	6	3.5	180		180	N/A	N/A	2750	M	Fronds coming my into contact with premises roof	Located within footprint of proposed roof extension.
19	<i>Glochidion</i>	<i>ferdinandi</i>	Cheese Tree	M	G	L	As, Sp	7.5	8	360		360	460	2388	4320	M	Lean to W.	Located 1.7m from proposed inclinator rail installation posing a 23% discontinuous cut encroachment within the TPZ.
20	<i>Ceratopetalum</i>	<i>gummiferum</i>	NSW Christmas Bush	M	G	U	S	6	3	190		190	210	1718	2280	L-M	Located in neighbouring property to N.	No measurable encroachment
21	<i>Glochidion</i>	<i>ferdinandi</i>	Cheese Tree	M	F-Av	U	As, Sp	7	3.5	250		250	360	2155	3000	L		Located 340mm from proposed inclinator rail installation and directly adjacent to minimum inclinator platform travel clearance posing a 39% discontinuous cut encroachment within the TPZ and a potential impact from moving platform

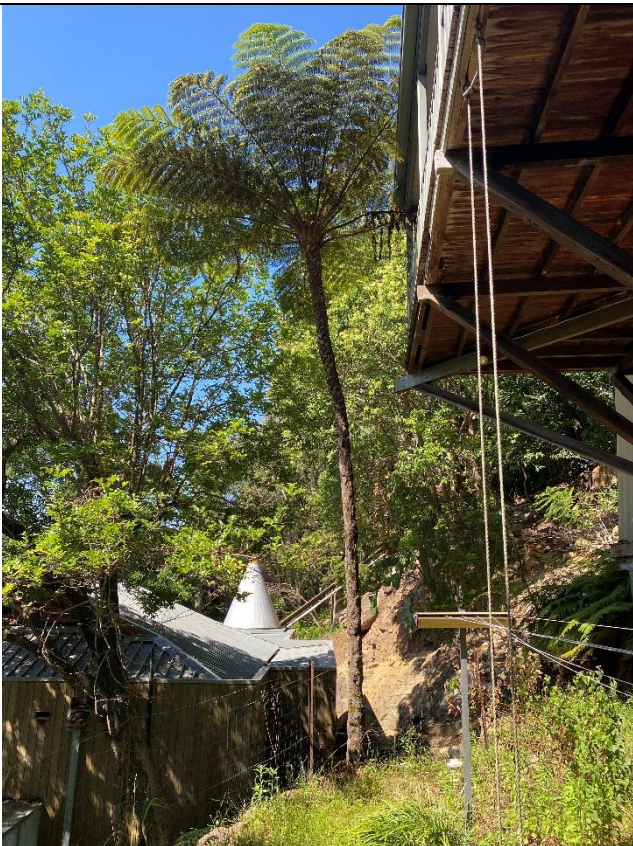
- Tree 18 is unsuitable for retention if the proposed development is to proceed due to being located within the footprint of the proposed roof and deck extension to the premises. This tree should be removed prior to site establishment.

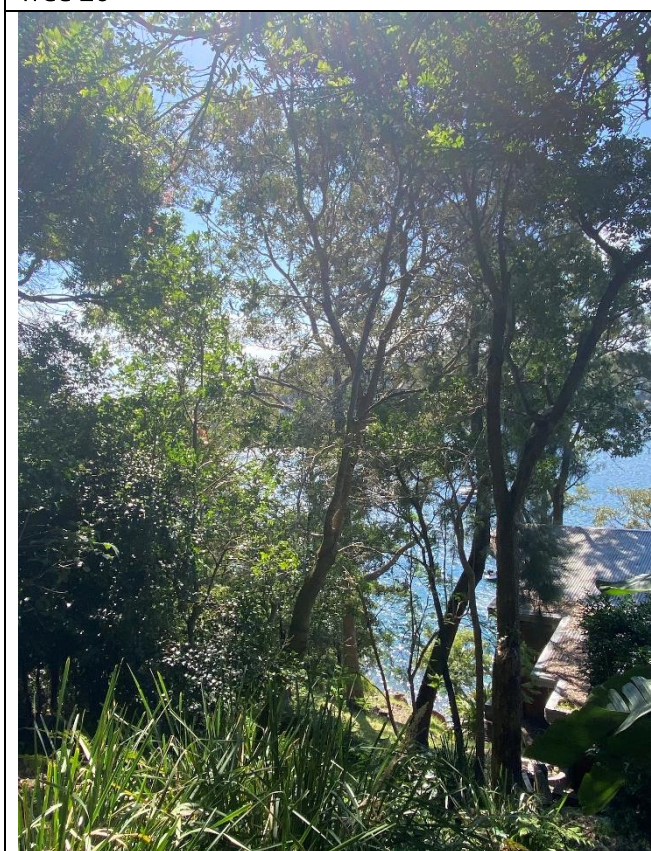
Tree 22

22	<i>Banksia</i>	<i>integrifolia</i>	Coastal Banksia	M	Av	L	As	7.5	4	260		260	350	2129	3120	M		Located 2.2m from proposed inclinator rail installation posing an 8% discontinuous cut encroachment within the TPZ
23	<i>Casuarina</i>	<i>glauca</i>	Swamp She-Oak	M	G	L, Correct	As	17	5	370		370	520	2515	4440	M	Slight lean to W from base, correcting @ 5m.	Located 410mm from proposed inclinator rail installation and directly adjacent to minimum inclinator platform travel clearance posing a 41% discontinuous cut encroachment within the TPZ and a potential impact from moving platform
24	<i>Eucalyptus</i>	<i>botryoides</i>	Bangalay	M	Av	U, B	S	19	13	560		560	770	2965	6720	H	Located on rocky outcrop.	Located 4m from proposed inclinator rail installation posing a 12% discontinuous cut encroachment within the TPZ
25	<i>Pittosporum</i>	<i>undulatum</i>	Native Daphne	M	G	U, Lopped	S	5	4	280		280	300	1996	3360	L	Located near waters edge. Tree previously lopped to 3m.	No measurable encroachment
