87 Alexandra Crescent, Bayview

Comments on Updates to Plans

GEOTECHNICAL INVESTIGATION:

Alterations and Additions at **87 Alexandra Crescent, Bayview.**

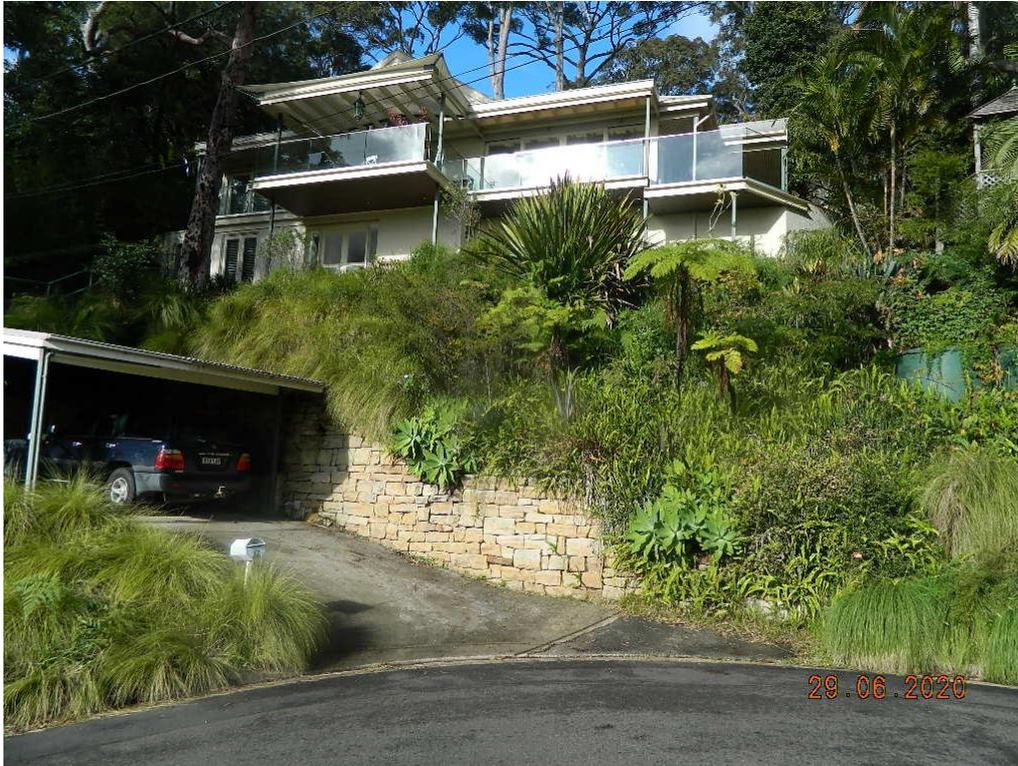
Photo 1

2.3 At the road frontage a concrete driveway runs to a carport cut into the slope (Photo 1). The cut is supported by sandstone block, brick and concrete block retaining walls up to ~3.4m high (Photos 1 to 3). The highest portion of the sandstone block wall is supported by a brick wall in front of the base of the retaining wall (Photo 2). The retaining walls are considered to be stable. Between the carport and the house is a steep and thickly vegetated slope (Photo 1). The part three storey rendered brick and weatherboard clad house is supported by brick walls and brick piers Photos (1 & 4). The supporting walls and piers stand vertical and show no significant signs of movement (Photo 5). Uphill of the house a cut in the slope provides a level platform for the house. The cut is supported by concrete block and sandstone flagging retaining walls up to ~2.7m high. (Photos 6 & 7). The W portion of the concrete block retaining wall is tilting at up to ~4° from vertical. See 'Section 16 Ongoing Maintenance'. A Medium Strength Sandstone bedrock cliff face up to ~7m outcrops above the cut for the house (Photo 8). A portion of the cliff face is undercut by up to ~4.4m (Photo 9). The undercut is considered stable. No geotechnical hazards were observed on the neighbouring properties that could impact on the subject property as seen from the street and subject property.

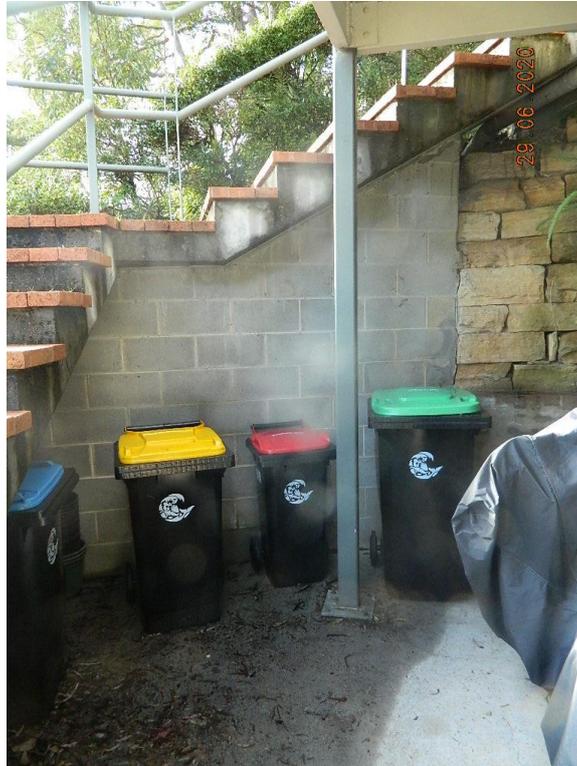
Photo 3

The excavation requires the demolition of part of the existing sandstone block, brick and concrete block retaining walls (Photo 3).

The existing retaining walls (Photo 3) are to be demolished from the top down as the excavation is progressed.

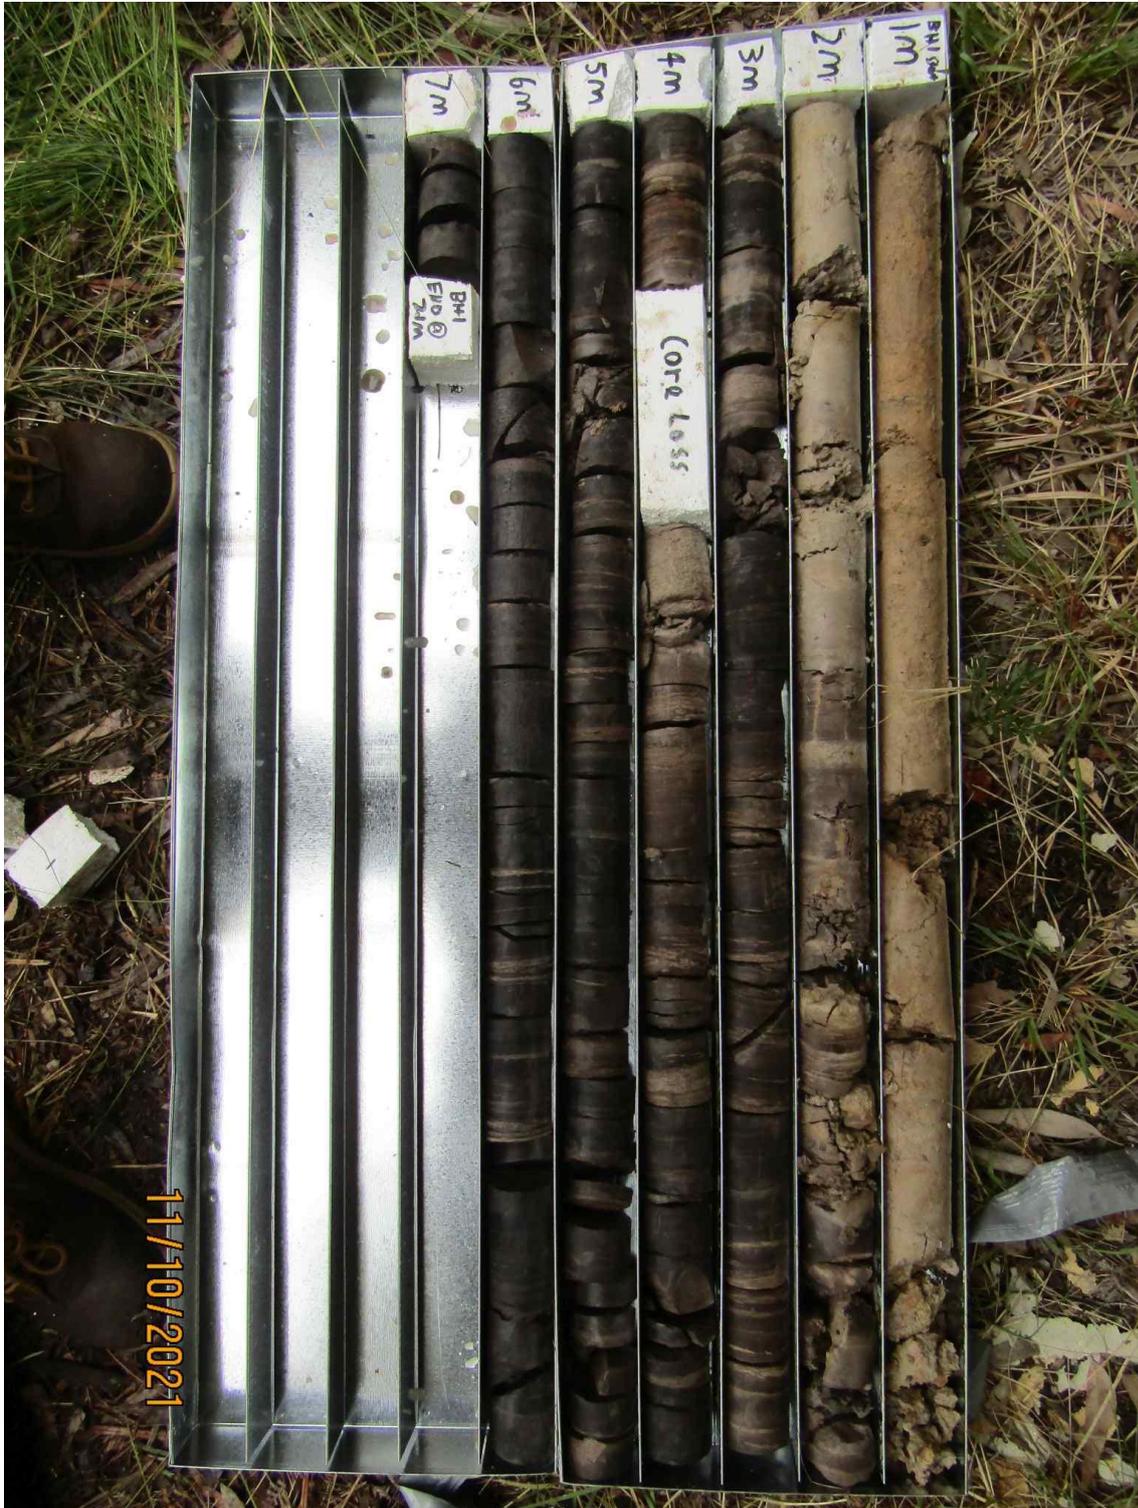
Photo 11: BH1

BORE HOLE 1 (~RL72.9) – BH1 (Photo 11)

End of hole @ 7.1m in Low Strength Shale. No watertable encountered.

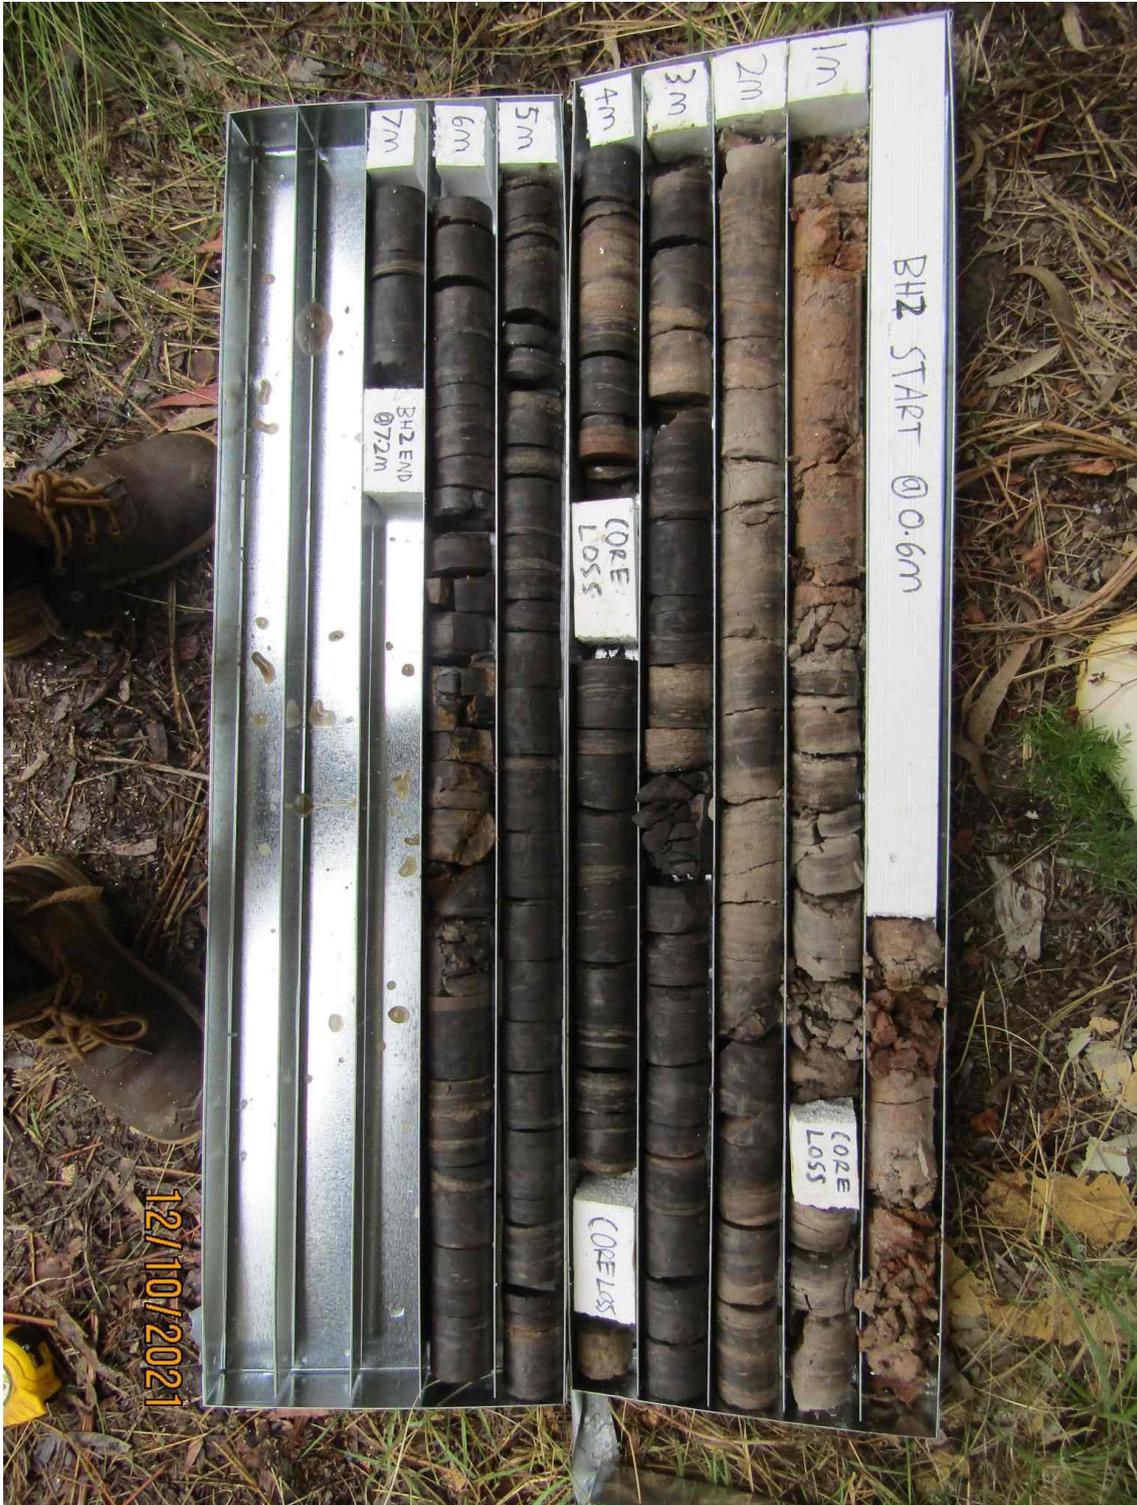
Photo 12: BH2

BORE HOLE 2 (~RL73.0) – BH2 (Photo 12)

End of hole @ 7.2m in Low Strength Shale. No watertable encountered.

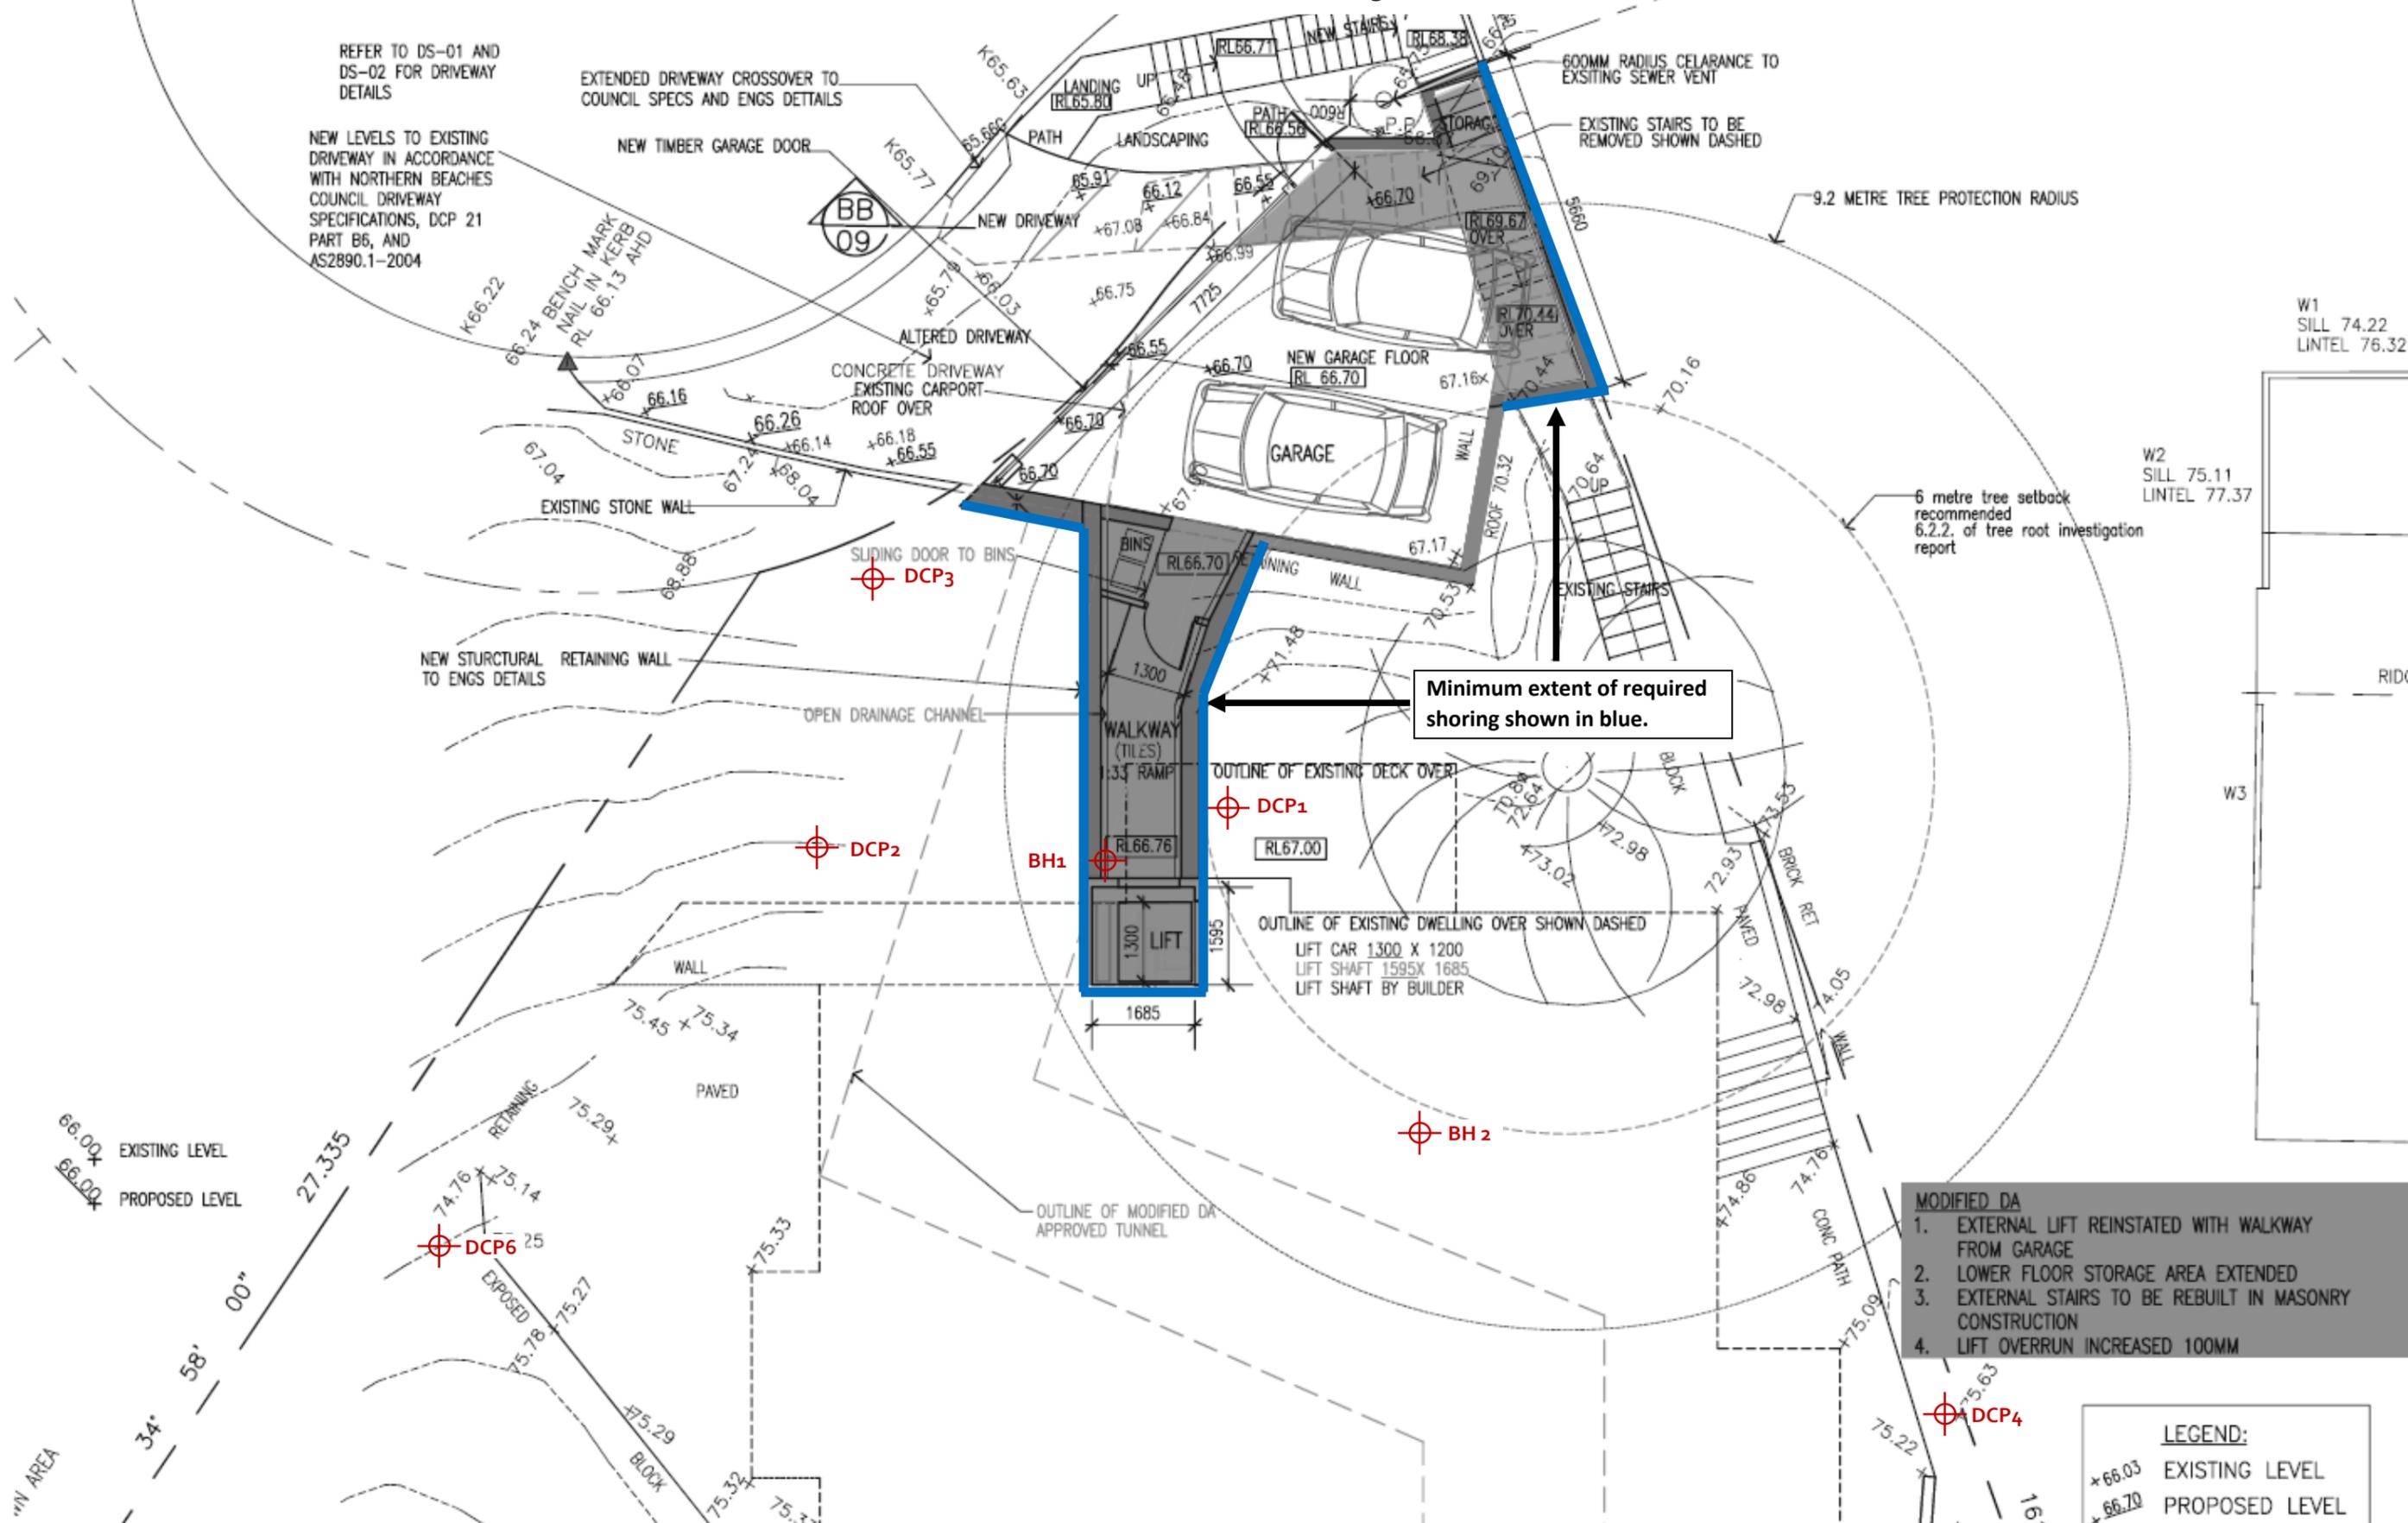
CARPORT PLAN – showing test locations

Minimum extent of required shoring shown in blue.

Due to the depth of the excavation and its proximity to the E common boundary all sides of the excavation will require ground support installed prior to the commencement of the excavation and demolition of the existing retaining walls. See the Carport Plan attached for the minimum extent of the required shoring shown in blue.
