STATEMENT OF WORKS

a. **LAUNDRY REFURBISHMENT**

b. **INTERNAL WALL/DOOR CONFIGURATION.**

c. **INTERNAL STAIR**

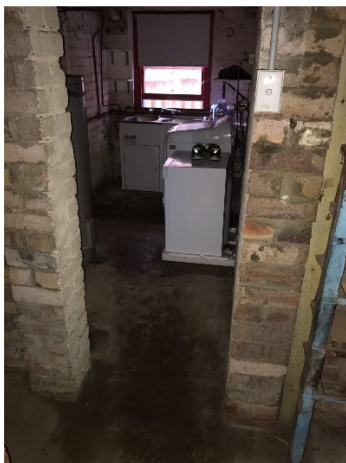
When the owners first purchased the house the basement laundry was in poor condition and in need of refurbishment and this was included in the DA 0163/2017. The plumbing work to Ground level impacted the room layout and the refurbishment was not undertaken due to change of circumstances and priorities. The refurbishment was undertaken in 2024 on the understanding that it would be considered as Exempt Development. The refurbishment includes new compliant waterproofing, fixtures, fittings and finishes and retains the original room size.

Photo 01 - Laundry (2017)

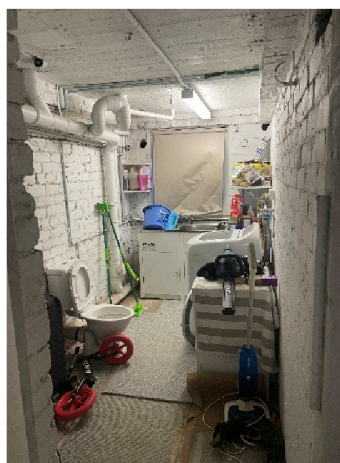
Photo 02 – Laundry (2020)
(when Mod 2020/0441 was issued)

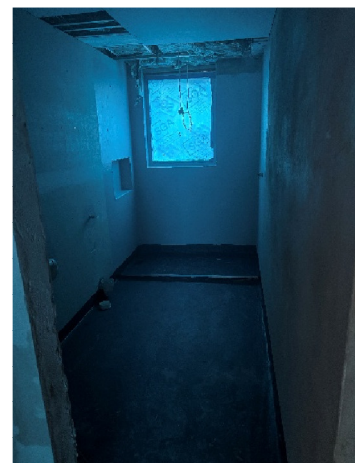
Photo 03 Laundry (2024)

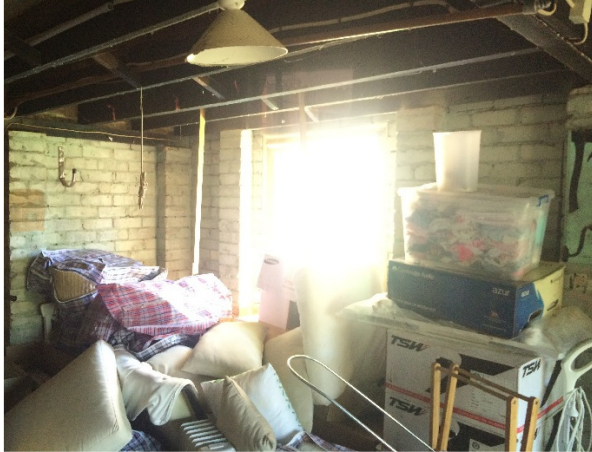
Photo 04 – North wall of basement (Garage) at Grid Line C – (2017). Note access to subfloor restricted by stored goods.

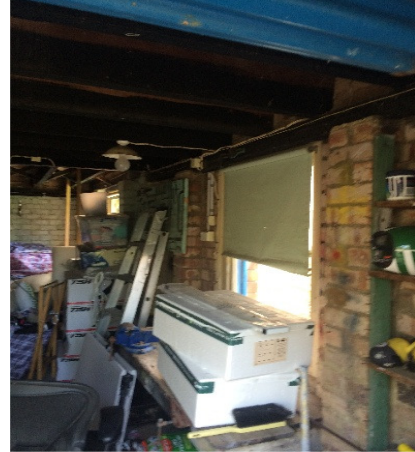
Photo 05 – North wall of at Grid Line D- (2017)

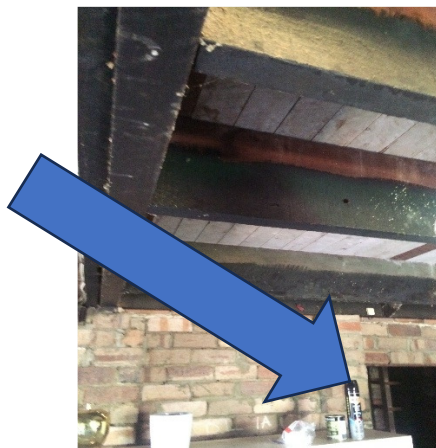
Photo 06- Photo of western end of south wall of Garage wall showing corner of access to other subfloor area (arrow)

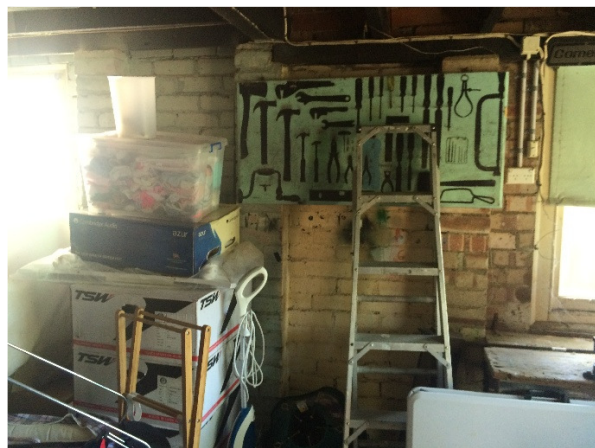
Photo 7 – North wall of basement (garage) area.

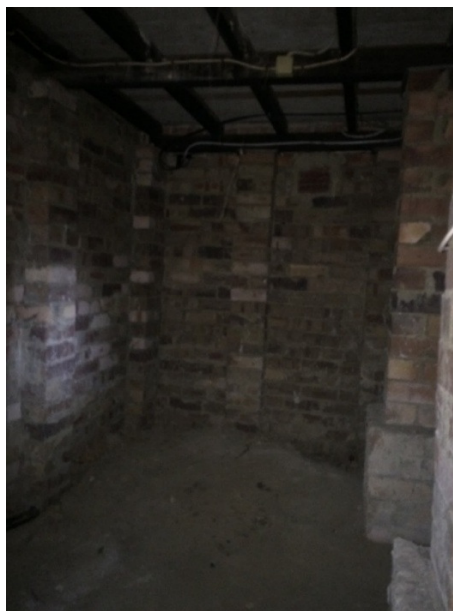
Although not indicated on the plans, these walls existed at Basement Level as shown in below photo. The walls were demolished at Ground Floor Level but left intact at Basement Level

Photo 08 - subfloor area directly under original Sunroom.

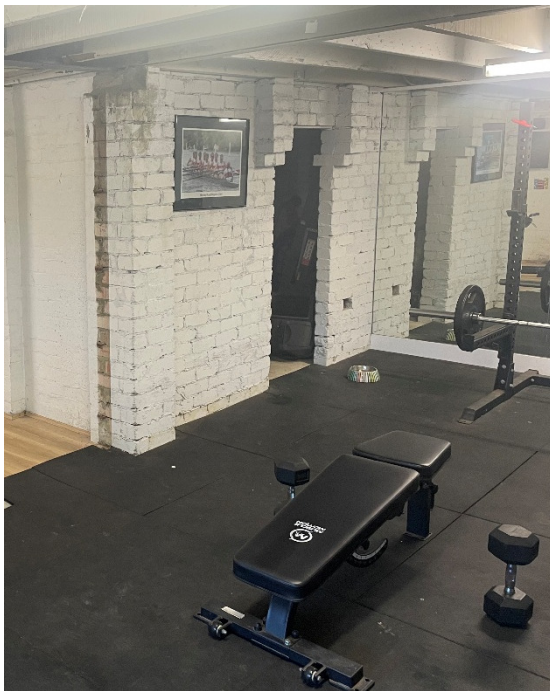
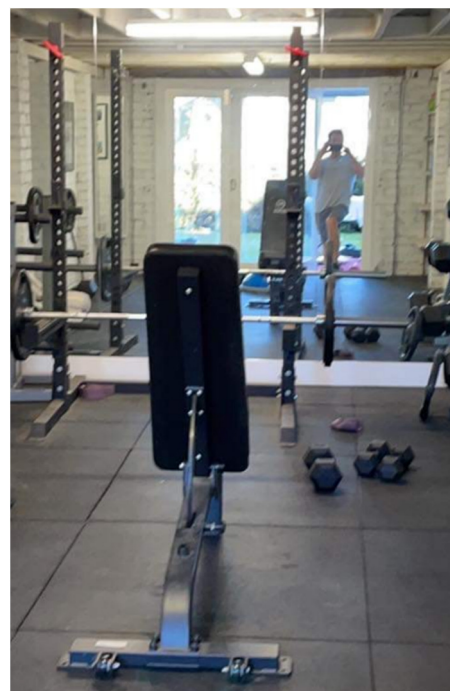
Photos 10 and 11– “Garage” space set up as Gym weight room. Note the owners installed a full width mirror to the west wall to close off remainder of subfloor used for storage and attempt to contain dampness. The remainder of the subfloor area was used for Storage.

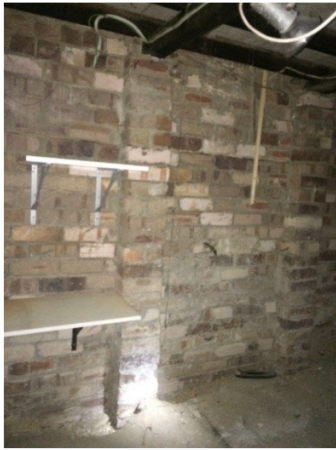
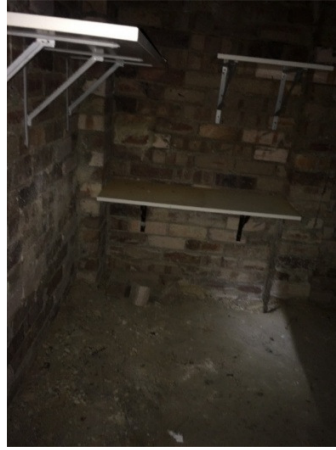
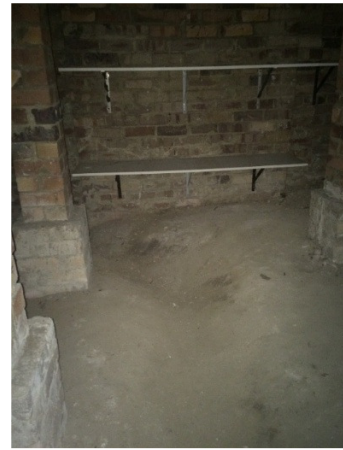
Photos 12, 13 and 14 showing subfloor storage area extending south and west to match footprint of house over

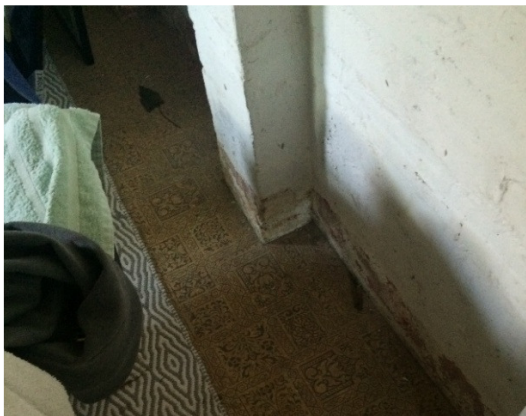
Over time it became apparent that the entire Basement area was damp and prone to flooding at times of significant rainfall due to ground water soaking from the west. In addition, it was noted that the air in the Basement was always musty and humid due to a lack of ventilation. There was concern about damp air from Basement level infiltrating the main house and potentially affecting young children, so a decision was taken **not** to proceed with approved internal stair when works were under way. This was reflected in Modification DA0163 approved in 2020.

Photo 15 – Basement “Study” wall showing signs of rising damp at base of wall. (2017)

In 2024, the Owners opted to construct a swimming pool to the south east of the site, and a decision was taken to address the water ingress issues while access was available. Specialist waterproofing contractors were engaged to provide chemical injection and subsoil drainage, new concrete floor on vapour barriers and new linings for walls and ceilings.

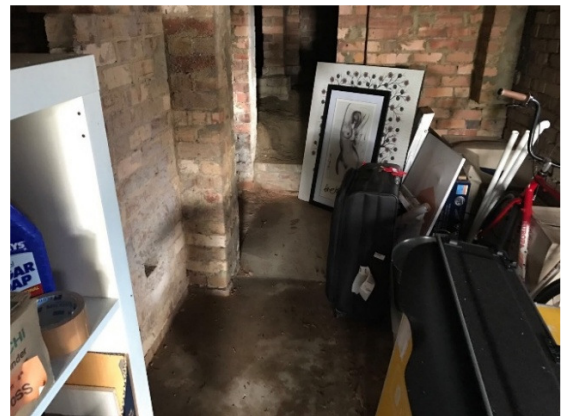
Photo 16 - Subfloor storage area showing evidence of water ingress on floor (2017)

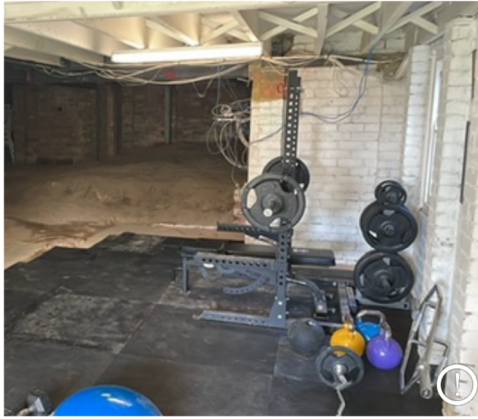
Photo 17 – View toward Grid Line C approx. (2020).- i.e. when Mod 2020/0441 was issued. Note water ingress at floor level and framed mirror removed to provide access.

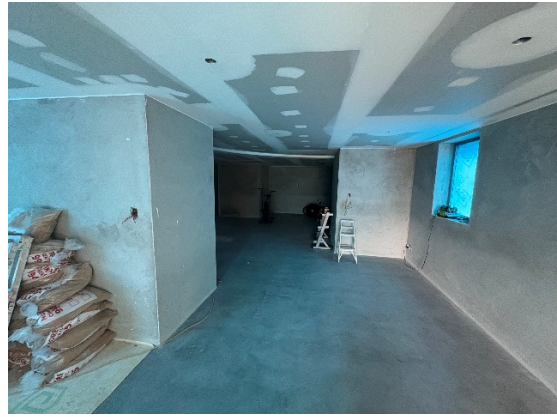
Photo 18 – Similar view to Photo 17 – with walls lined, ceiling installed and slab on moisture barrier installed. (2024)

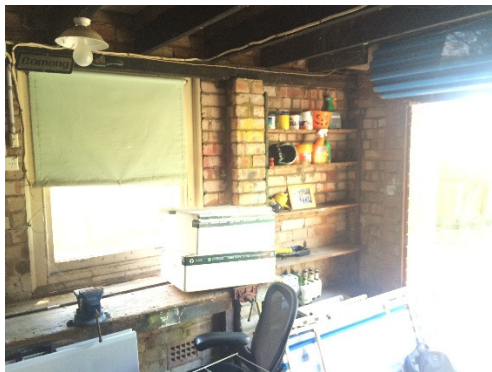
Photo 19 view north east corner of garage – Grid D1 (Feb 2017)

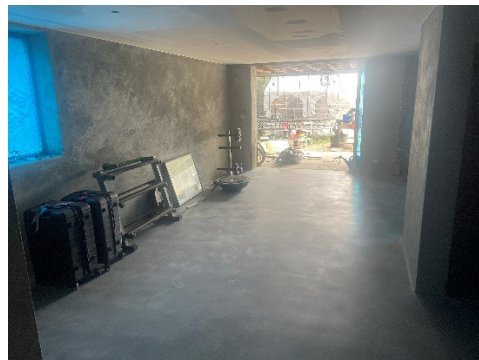
Photo 20– view of north east corner of garage- Grid D1 - with window infilled. (2024)

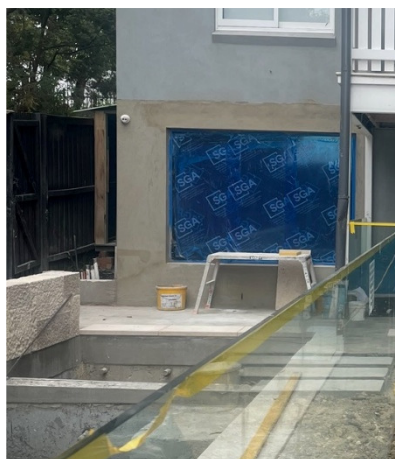
The owners undertook a Complying Development for a Swimming Pool (CDC C240004-01) in 2024. In order to meet pool fence requirements, the window to the east wall of the existing Gym was replaced with a fixed glass opening consistent with the opening shown on DA 0163/2017

Photo 23 – fixed window to east face of house
