# TREE PROTECTION SPECIFICATION

REF: L&Co25006 | 3 September 2025 | v3.1 SITE ADDRESS | 154 Plateau Rd, Bilgola Plateau PREPARED FOR | Asri Halis c/o ERA PREPARED BY | Ms Emma Clark Dr Matthew Laurence BSc. (Hons) BA (Hons) PhD (Plant Pathology) Grad Cert (Arboriculture)

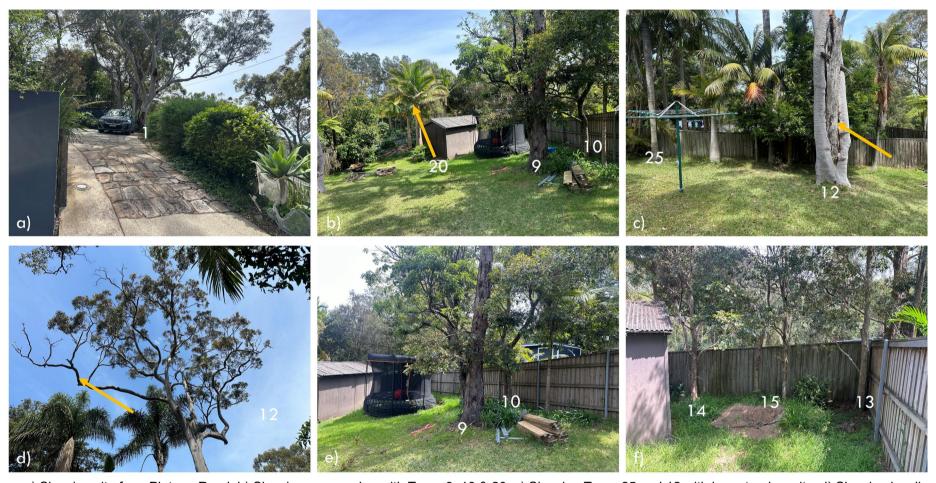
# 14.0 APPENDIX 9 | PLATES

- 4.6.2 The supplied plans show that Tree 12 is within the footprint of the proposed pool and will need to be removed.
- 4.6.1 The Tree was allocated a poor structural rating due to a large cavity on the main trunk (Appendix 9). The column of decay associated with the cavity is likely to extend above and below the opening. However, internal investigations on the extent of the decay column were beyond the scope of this Report.

- 4.6.2 A cavity of this size is unlikely to fully occlude, and the prognosis is for further decay over the medium term
- 4.6.3 Removal and replacement with a healthy advanced size specimen would replace the loss of amenity within a long timeframe.

a) Showing site from Plateau Road. b) Showing rear garden with Trees 9, 10 & 20. c) Showing Trees 25 and 12 with large trunk cavity. d) Showing localised crown death on Tree 12. e) Showing Trees 9 & 10. f) Showing Trees 13-15.
