HUGH
THE ARBORIST

Arboricultural Impact Assessment Report

<u>Client Name:</u>	Stephen Nicol
<u>Site Address:</u>	38 Judith Street Seaforth NSW
<u>Authors Details:</u>	Hugh Millington
<u>Email:</u>	hugh@hughtheArborist.com.au
<u>Phone:</u>	0426 836 701
<u>Date Prepared:</u>	21 st June 2025

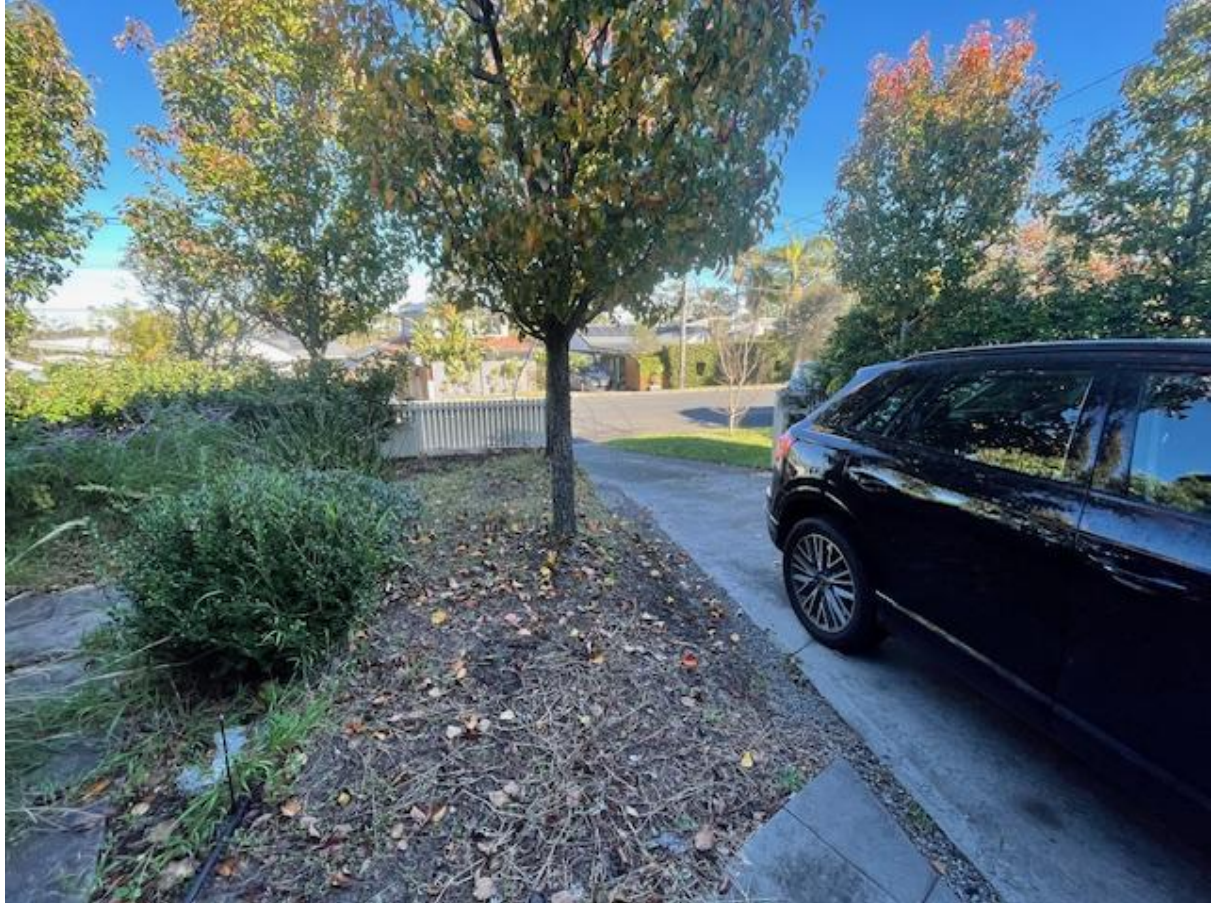
Photo A: Trees within the front setback are proposed to be removed. The trees are planted ornamental Pear species and are considered to be easily replaced.

- 10.2 **Refer to section 8 Table 3 for individual tree identification numbers and values.**
- 10.3 A total of seven category Z trees are proposed to be removed as part of the development works. The trees have been allocated category Z1 ratings as they are considered to be easily replaced in terms of age and species.
