## **Geotechnical Assessment**

**Project:** New Swimming Pool  
1054 Barrenjoey Road, Palm Beach NSW

**Ref:** AG 22162  
4 May 2022

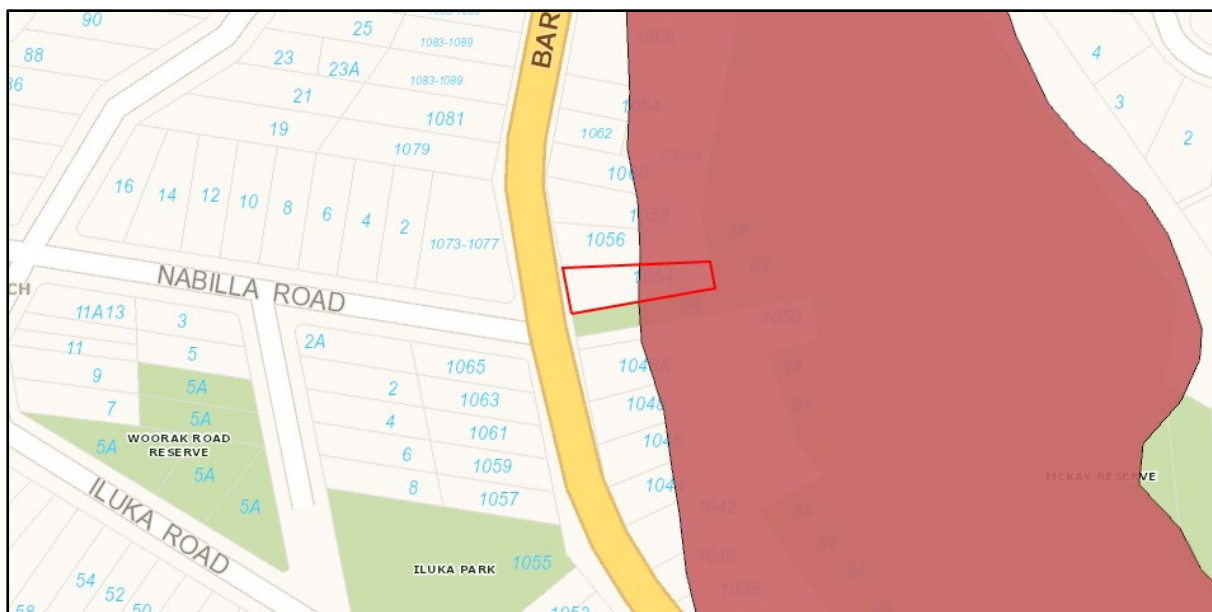
**Image 2.** PLEP Geotechnical Hazard Map  
– 1054 Barrenjoey Road, Palm Beach NSW (NBC Maps)

- No evidence of significant soil creep, tension cracks or landslip instability were identified across the site or on adjacent properties as viewed from the subject site at the time of our inspection.
- Based on reference to the plan entitled "Geotechnical Hazard Mapping" (Ref. P21DCP-BC-MDCP2002, dated 2007) prepared by GHD LONGMAC on behalf of Pittwater Council, the site is mapped as a **Geotechnical Hazard H1** zone.

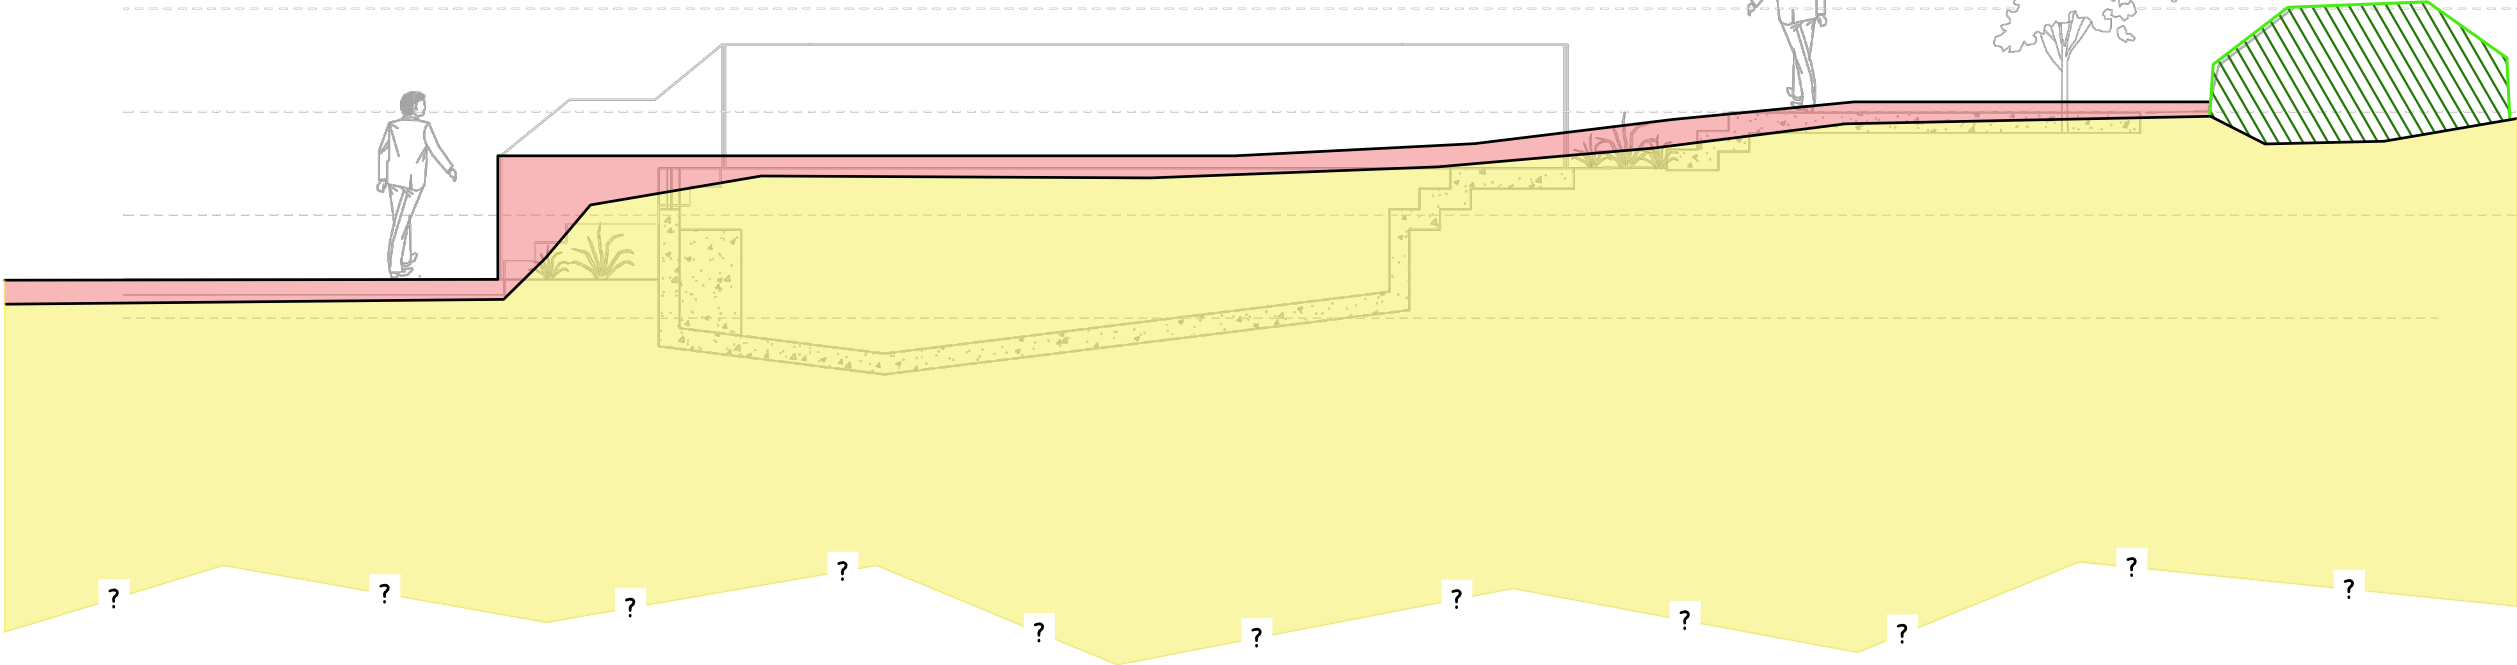
# INFERRED GEOLOGICAL SECTION

INTERPRETED SUBSURFACE SECTION ONLY.  
ACTUAL GROUND CONDITIONS MAY VARY.

| | DEPTH TO BEDROCK NOT DETERMINED |
