# Arboricultural Impact Assessment

2 Prince Edward Road, Seaforth  
NSW, 2092  
28F/-/DP16341  
Job No: 240029  
10/10/2024

**Temporal Tree Management Pty Ltd.**

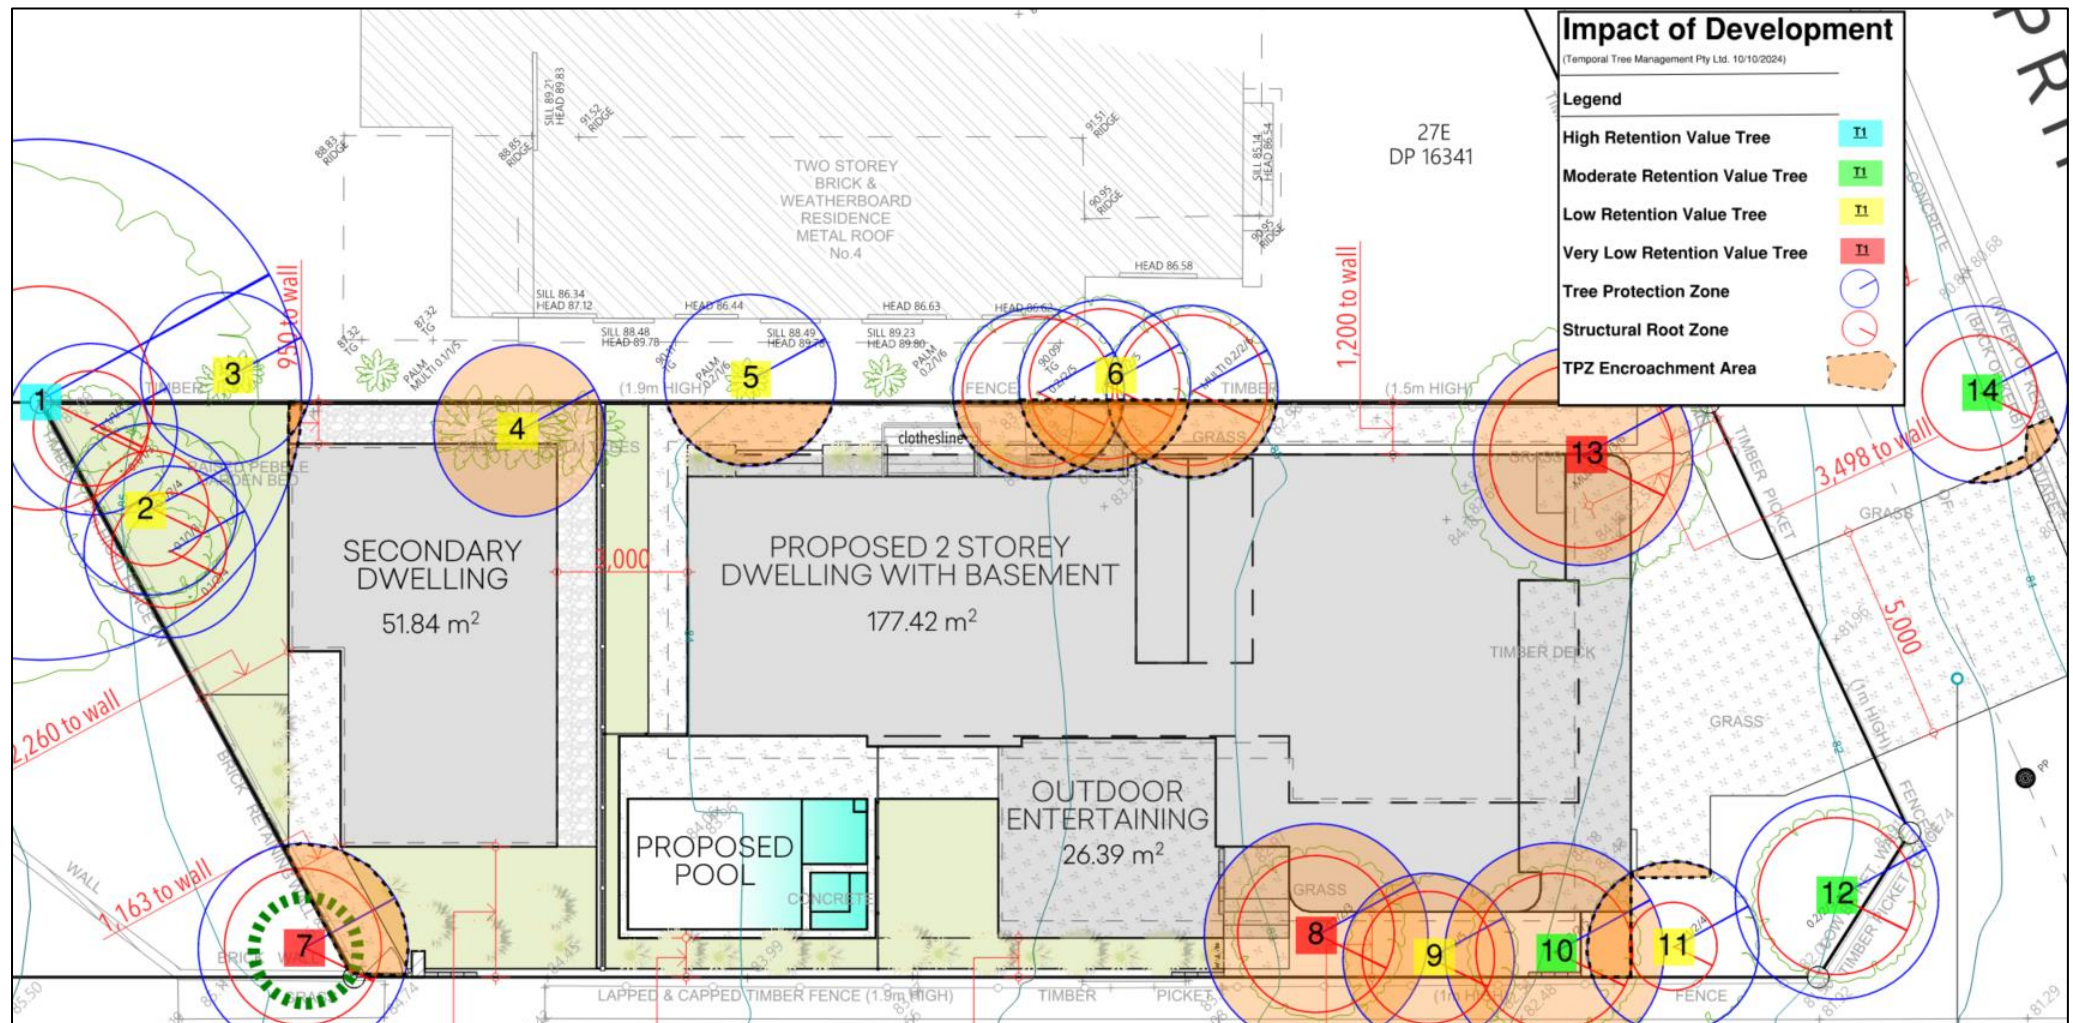
Figure 8. Retention values, TPZs, SRZs and Encroachments for fourteen assessed trees. *Site Plan*, prepared by *New Paradigm Design* (Sheet No: 4 of 19, Rev: D, Drawn: 02/08/2024). Annotated by Temporal Tree Management Pty Ltd. (10/10/2024).

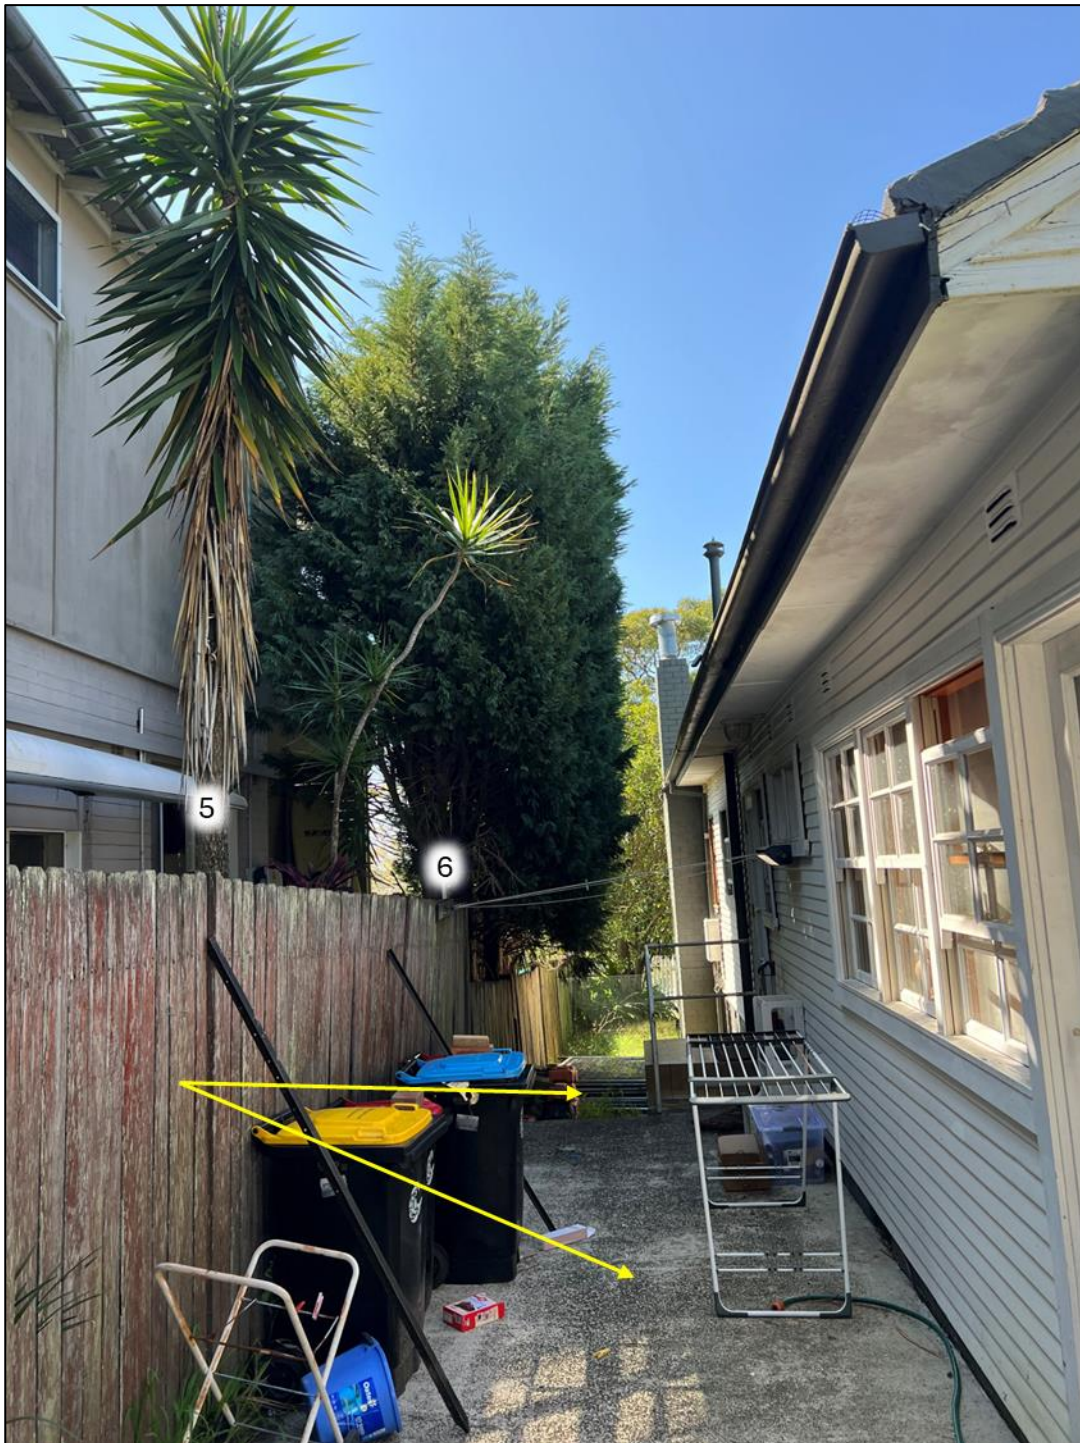
Figure 9. Impact of encroachments sustained by Trees 5 and 6 will be mitigated by the replacement of an existing concrete pathway and the raised their raised position within the neighbouring property.

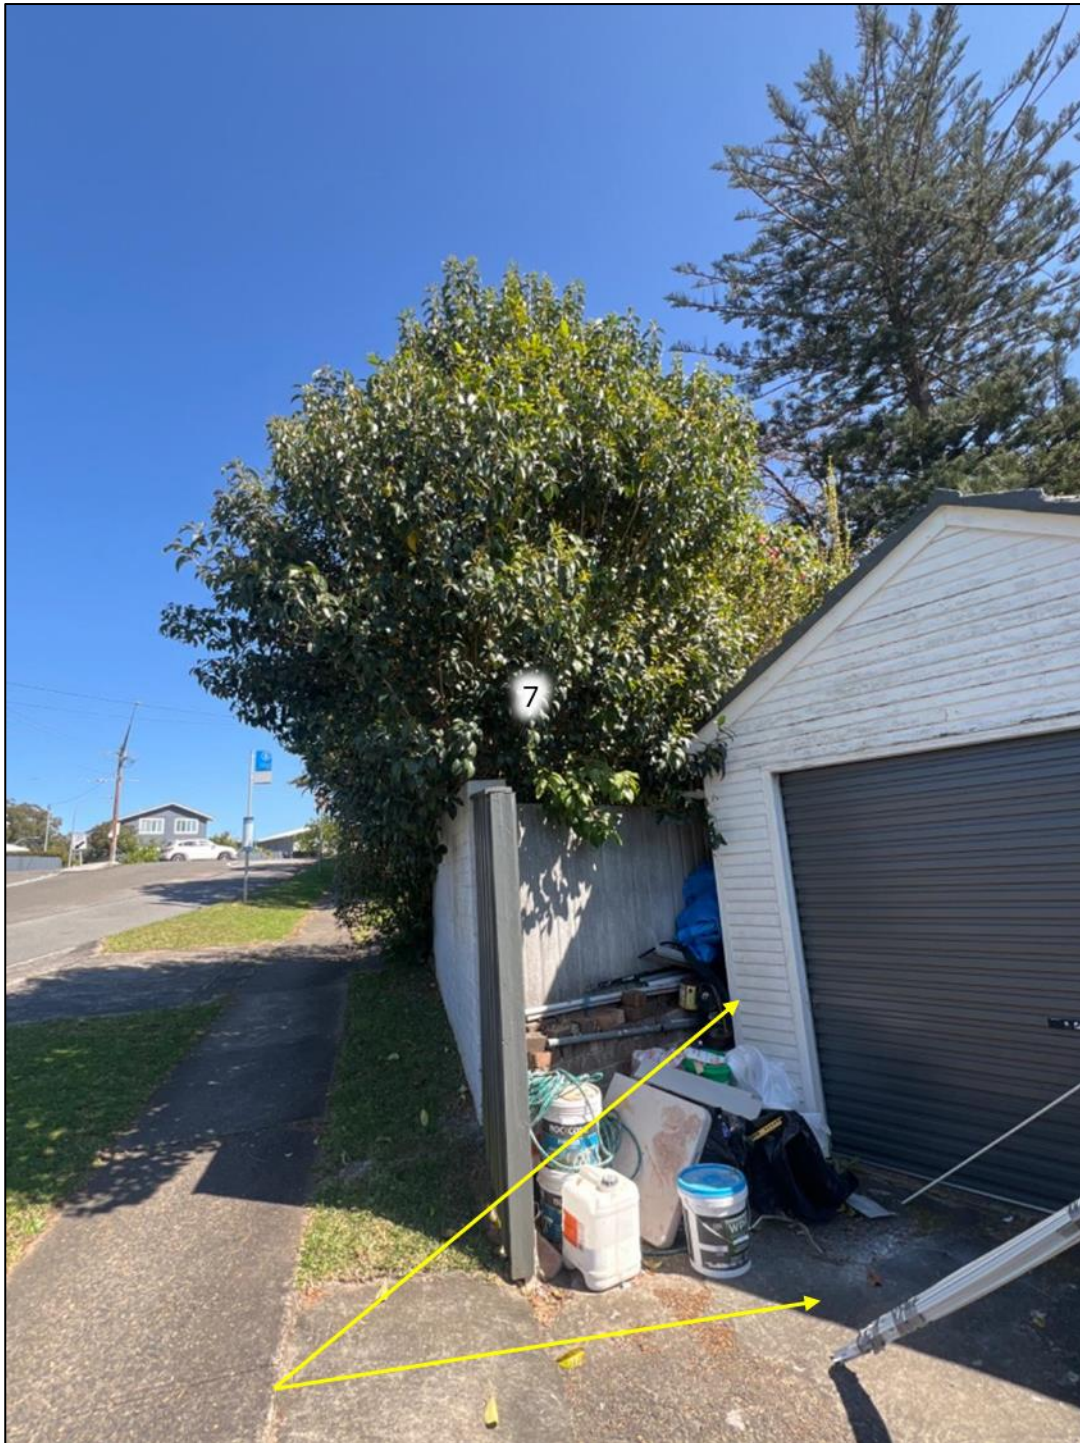
7	Yes	28	High	Small tree will sustain a major encroachment within the eastern portion of its TPZ. Replacement of existing concrete surface and garage within TPZ will significantly mitigate the impact of this encroachment.	<b>Retain.</b> Tree can be suitably retained without the installation of protection measures.
8	Yes	100	Total	Tree is within excavation footprint for proposed basement storage area.	<b>Remove.</b> Tree will require removal to facilitate the proposed development.
9	Yes	100	Total	Tree is within excavation footprint for proposed basement storage area.	<b>Remove.</b> Tree will require removal to facilitate the proposed development.
10	No	100	Total	Tree is within excavation footprint for proposed basement storage area.	<b>Remove.</b> Tree will require removal to facilitate the proposed development.
11	Yes	21	High	Tree will sustain a major TPZ encroachment during the excavation proposed for the basement storage area and proposed driveway.	<b>Remove.</b> Low retention value tree should be removed to facilitate excavation for basement storage area and proposed driveway.

Figure 10. Impact of encroachment sustained by Tree 7 will be mitigated by the replacement of existing concrete and the existing garage.

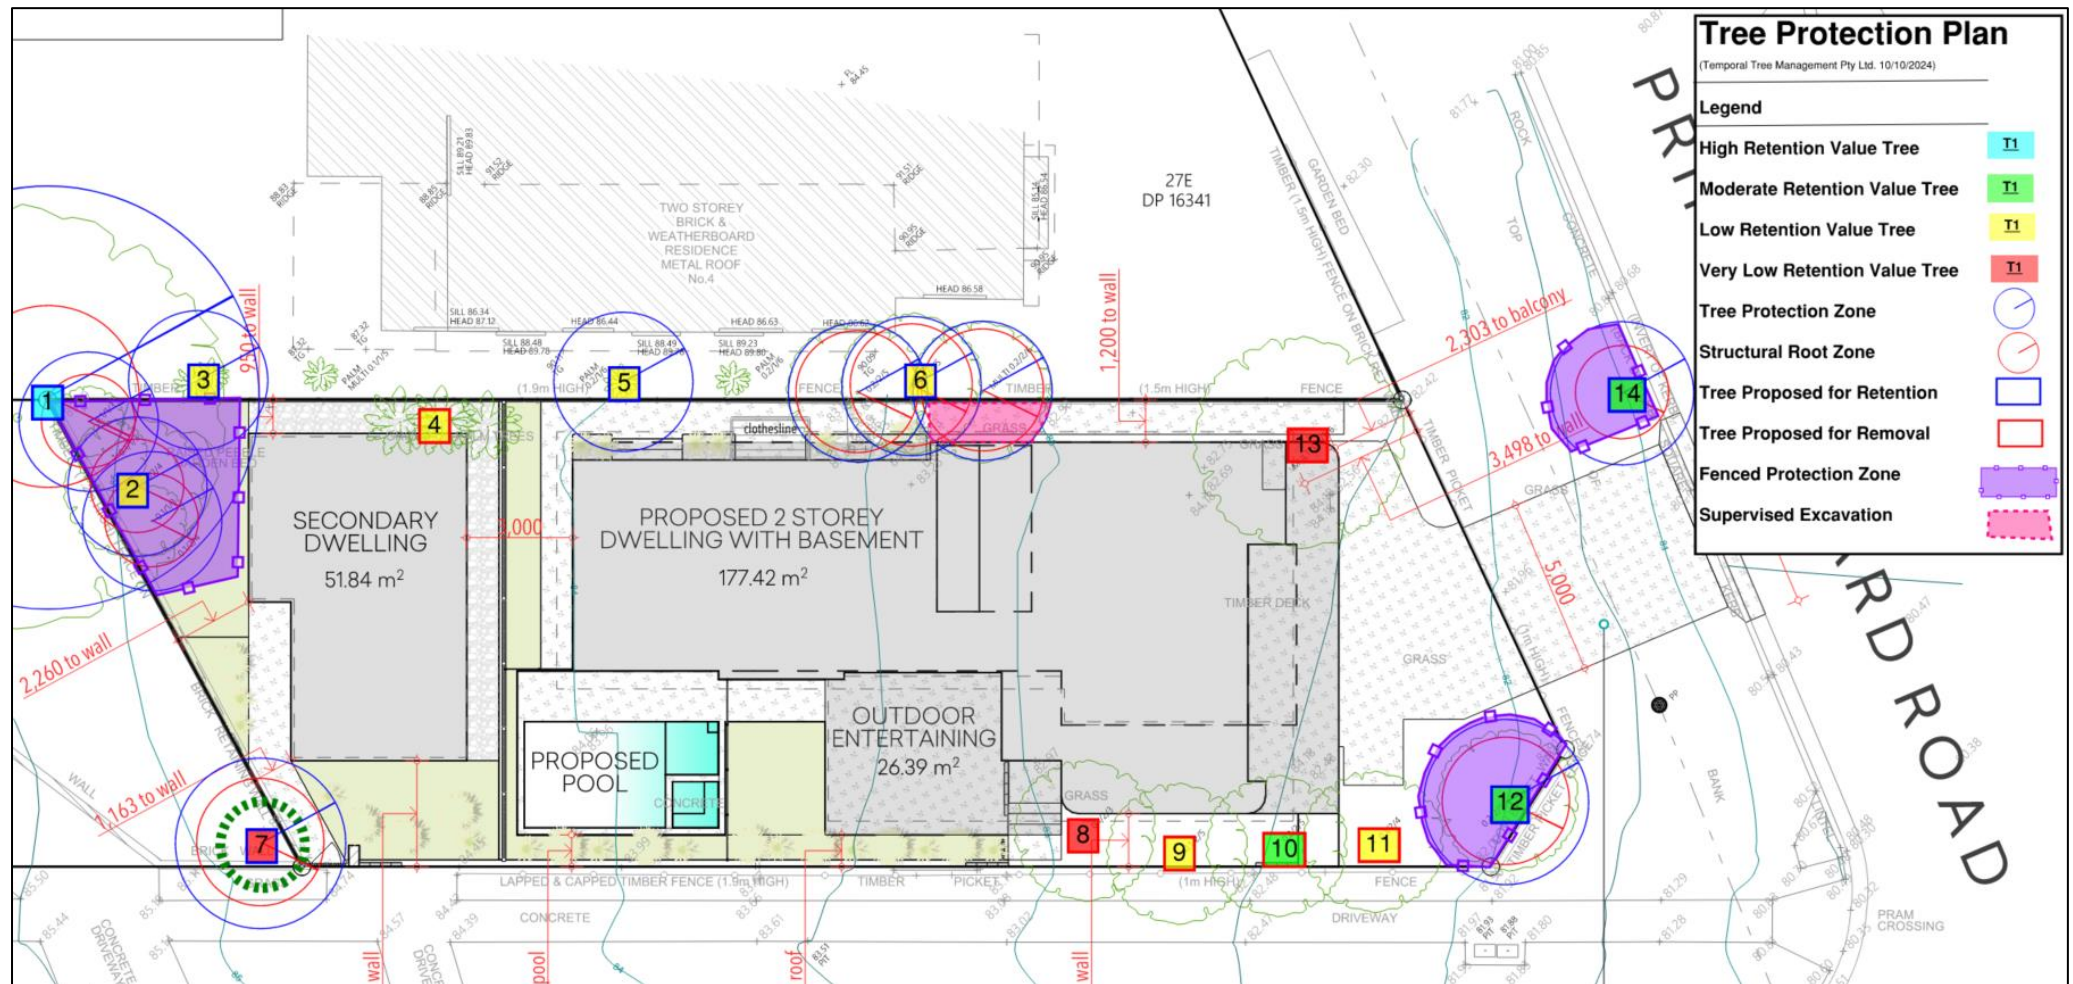
Six assessed trees (Trees 4, 8, 9, 10, 11 and 13) are recommended for removal as part of the proposed development (Figure 14). The stems of three trees (Trees 4, 8, 9, 10 and 13) are within the footprint of proposed excavation within the site. Tree 11 will sustain a major TPZ encroachment during excavation for the proposed vehicle crossing and basement. This unmitigated major encroachment is likely to impact the viability of this small tree.

Figure 14. Tree Protection / Removal Plan for proposed development. *Site Plan*, prepared by *New Paradigm Design* (Sheet No: 4 of 19, Rev: D, Drawn: 02/08/2024). Annotated by Temporal Tree Management Pty Ltd. (10/10/2024).

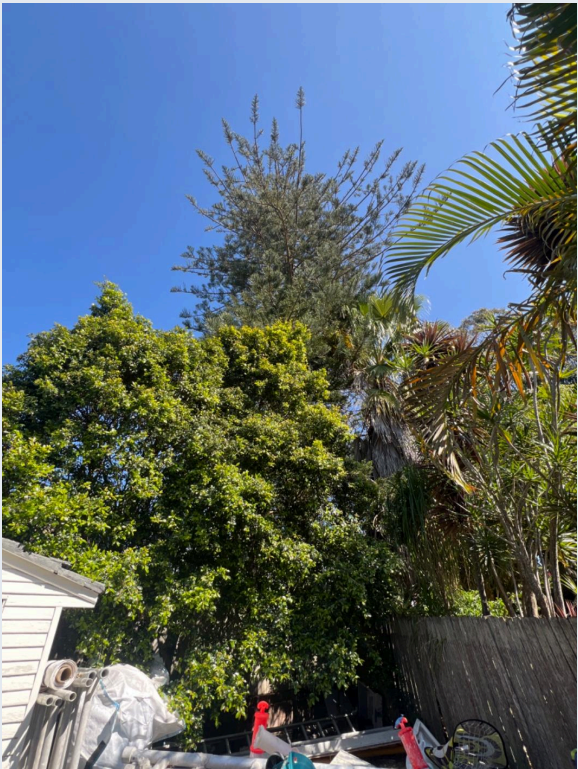
Tree Comments:Large tree of native species value positioned 2 metres outside the northern boundary within the neighbouring property. Canopy shows signs of high vitality. No defects observed. Raised position within neighbouring property and existing brick retaining wall are likely to have somewhat restricted root growth in the subject site,

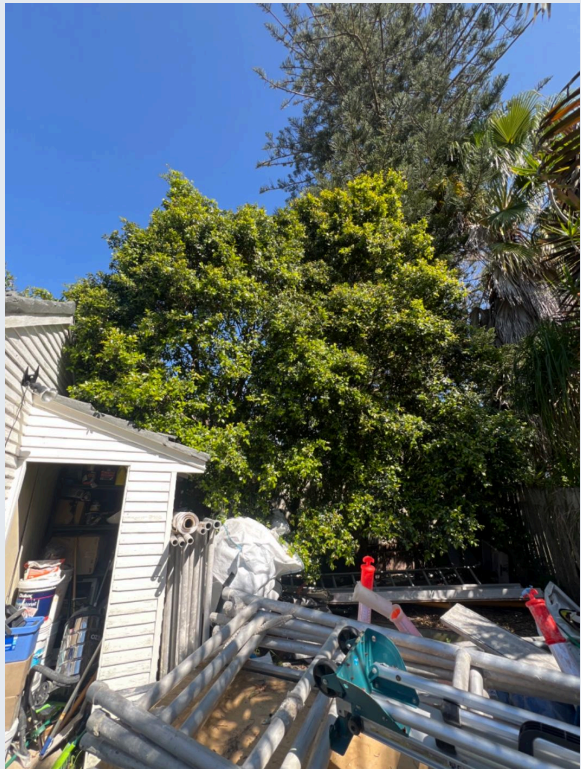
Tree Comments:GROUP of 4 closely positioned trees of the same size and species have been planted as a boundary hedge. Partially suppressed by larger neighbouring tree. Trees of reduced landscape significance due to small size and suitability for replacement.
