# ARBORICULTURAL IMPACT ASSESSMENT

# TREE PROTECTION SPECIFICATION

REF: L&Co25006 | 13 May 2025 | v2 SITE ADDRESS | 154 Plateau Rd, Bilgola Plateau PREPARED FOR | Asri Halis c/o ERA PREPARED BY | Dr Matthew Laurence Ms Emma Clark BSc. (Hons) BA (Hons) PhD (Plant Pathology) Grad Cert (Arboriculture)

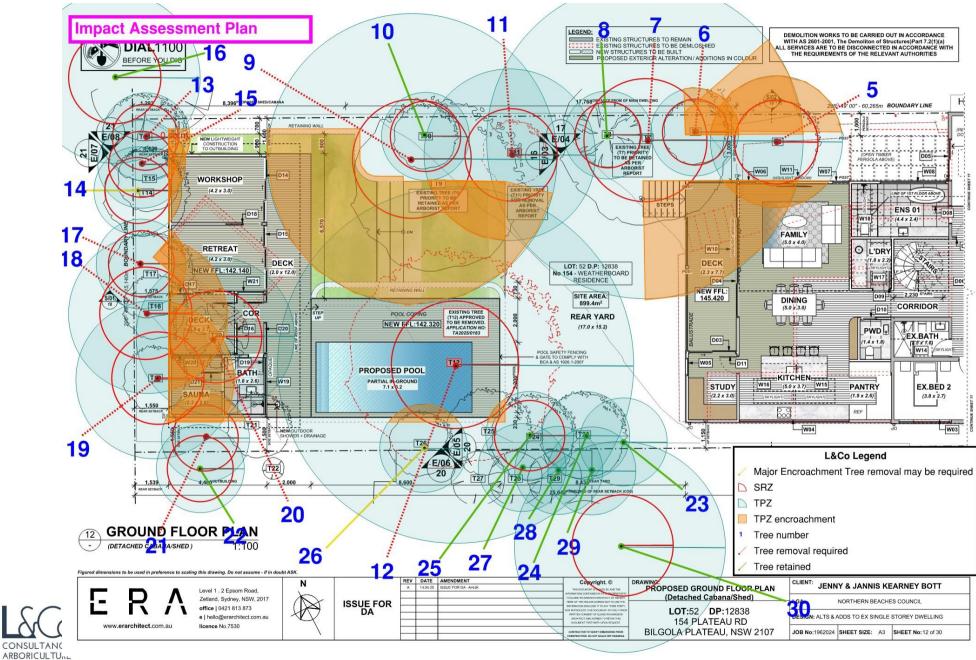
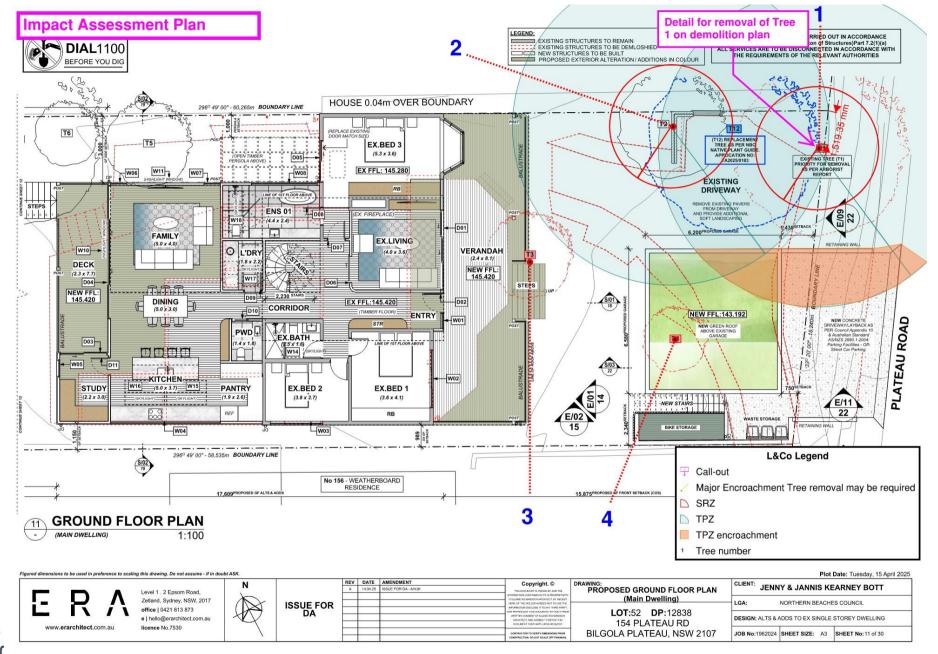
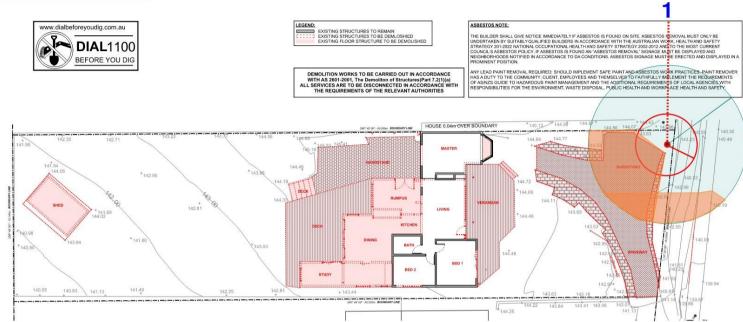
# Impact Assessment Plan

- 1.5 The proposed works are within the SRZs & TPZ's of Trees 1,5,7,9,11,13,14,15,17,18,19,21,25 & 26 and represent a *Major Encroachment* (as defined by AS4970). Trees 14, 25 & 26 can be retained under Clause 3.3.4 of AS4970 if the tree protection measures and tree sensitive construction methods detailed in this report are carefully implemented. Trees 1,5,7,9,11,13,15,17,18,19 & 21 will need to be removed as the TPZ encroachment is too large for their long-term viability, based on a consideration of their health, structure and the size of the encroachment. These trees were all assigned Low to Moderate Landscape Significance Values except for Trees 7 & 9, which were assigned a High Landscape Significance Values.

- 1.6 Trees 2, 3, 4 are within the footprint of demolition and construction of new driveway and garage and will need to be removed. Trees 12 & 20 are within the proposed pool and landscaping footprint and will need to be removed. Trees 12 & 20 were assigned High and Low Landscape Significance Values, respectively.

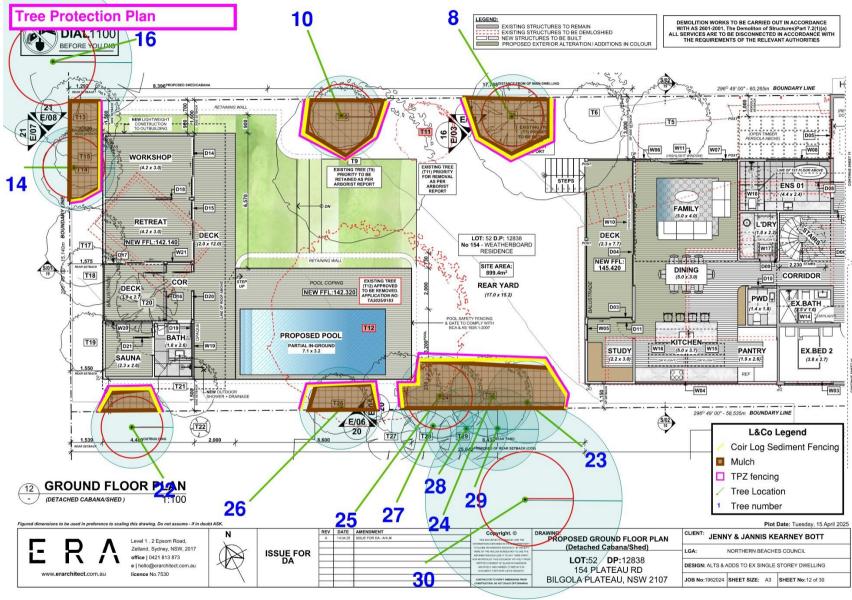
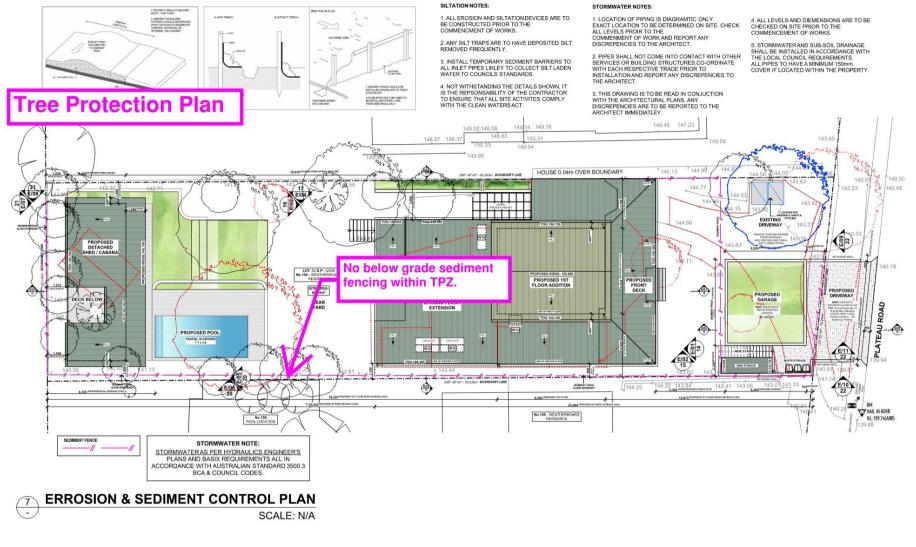
### 11.0 APPENDIX 6 | TREE PROTECTION PLAN

- The supplied plans show no works are proposed within the TPZs of Trees 8, 10,16, 22, 23, 24, 27, 28, 29 & 30. However, the tree protection measures outlined in this report should be implemented to avoid indirect impacts

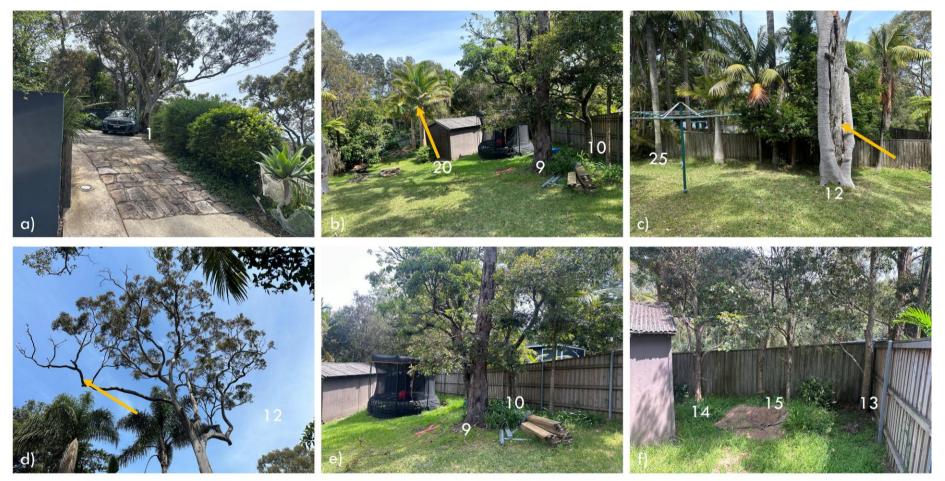
### 14.0 APPENDIX 9 | PLATES

- 4.1.2 Tree 1 was allocated a poor structural rating due to a large cavity at the base of the trunk. The column of decay associated with the cavity is likely to extend above and below the opening. However, internal investigations on the extent of the decay column were beyond the scope of this Report. The main trunk cavity represents a point of structural weakness and given the size of the cavity, poor tree vigour, the species and the likelihood of decay progression, the tree is considered to be structurally compromised and tree removal should be considered from a tree stability and short ULE perspective.

- 4.5.2 The supplied plans show that Tree 12 is within the footprint of the proposed pool and will need to be removed.
- 4.5.1 The Tree was allocated a poor structural rating due to a large cavity on the main trunk (Appendix 9). The column of decay associated with the cavity is likely to extend above and below the opening. However, internal investigations on the extent of the decay column were beyond the scope of this Report.

- 4.5.2 A cavity of this size is unlikely to fully occlude, and the prognosis is for further decay over the medium term.
- 4.5.3 Removal and replacement with a healthy advanced size specimen would replace the loss of amenity within a long timeframe.

a) Showing site from Plateau Road. b) Showing rear garden with Trees 9, 10 & 20. c) Showing Trees 25 and 12 with large trunk cavity. d) Showing localised crown death on Tree 12. e) Showing Trees 9 & 10. f) Showing Trees 13-15.
