## **56 CRESCENT ROAD**

**NEWPORT, NSW**

# **ARBORICULTURAL ASSESSMENT & DEVELOPMENT IMPACT REPORT**

*Report Ref No- RTC-19618*

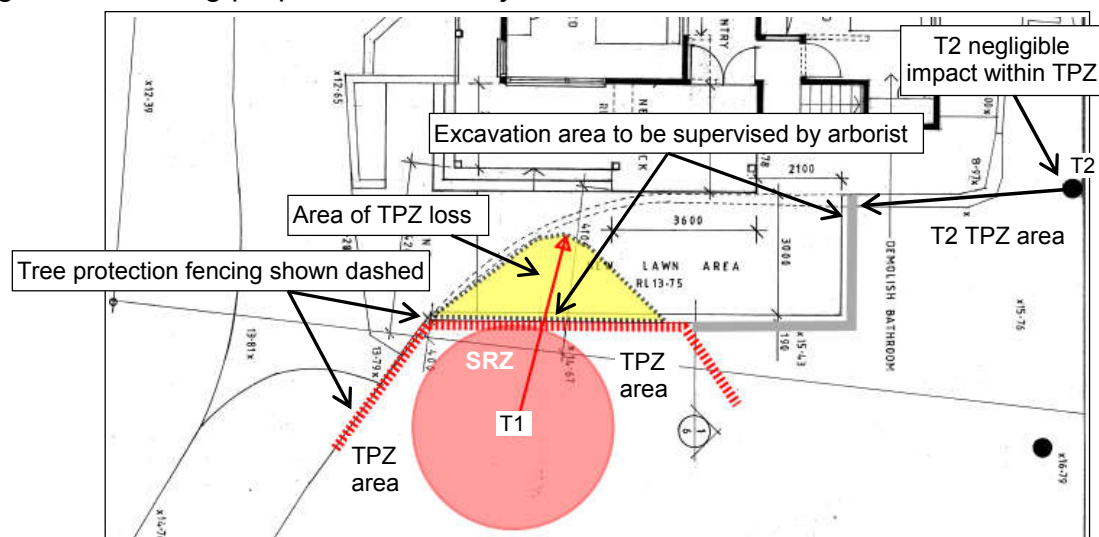
Figure 2, showing proposed works adjacent T1 & 2, *not to scale*

1.3.1 Tree 1. Proposed works adjacent the tree consist of excavating a cut face to accommodate a new entry access area, verandah and timber decking. Works are located just outside of the 2.4m SRZ with the overall encroachment within the TPZ considered a Medium level (<20%) of encroachment within the tree protection zone (TPZ). The level of impact is considered manageable as the TPZ is not radial due to the existing cut within the notional TPZ and recent loss of an adjacent tree which has reduced soil moisture competition. To ensure the tree is adequately managed the following recommendations are provided as a guide for the minimising of impacts during work activities:

1. Given the height of the tree there is to be no excavation within 2.6m from the tree to accommodate the proposed block retaining wall.
2. Prior to works occurring Tree Protection Fencing (TPF) is to be installed and certified by an appointed project arborist as indicated within Figure 2 below. The fenced area is to be considered a tree protection zone where development access is to be restricted.

3. The extent of excavation within the TPZ is to be supervised by the site project arborist with manual (hand) excavation occurring to a depth of 0.7m (700mm) to ensure all encountered tree roots are appropriately clean cut. Mechanical excavation should then occur to achieve the required RL.

4. The extent of the cut face within the 4.8m TPZ is to be covered with jut-mesh, geotextile fabric or similar product to avoid exposure and drying of the soil profile and root system.

5. Given the cut location adjacent the SRZ and soil loss, the TPZ radius is recommended to be mulched with native leaf mulch and routinely watered to retain soil moisture content and reduce stress during development activities.

6. The site project arborist is to provide certification of tree protection methodology including evidence of appropriate root pruning and photographs of works conducted.

- 1.3.2 Tree 2. Proposed works adjacent the tree consist of excavating a cut face to accommodate a block retaining wall at near 5.2m from the tree. The encroachment within the 5.4m TPZ is considered negligible to low impact (<10%) with the following recommendations provided to ensure the tree is adequately protected during work activities.

1. There should be no excavation within 5m of the tree to accommodate the block retaining wall as shown within construction drawings.
  2. As in tree 1 protection methodology the excavation cut is to be supervised and certified by the site project arborist appropriately treating all encountered tree roots. Given the setback of the excavation line mechanical excavation under the supervision of the arborist is permitted to achieve the required RL.

3. Prior to works occurring timber beam trunk protection is to be installed with the remaining upper natural ground level at RL15.29+ to be considered a Tree Protection Zone (TPZ). No long term storage of building materials should occur within the 5.4m TPZ without prior arborist advice.
