GEOTECHNICAL REPORT

PROPOSED NEW DWELLING

18 HILLCREST AVENUE, MONA VALE NSW

Project No.: 2022-039.2 November 2024

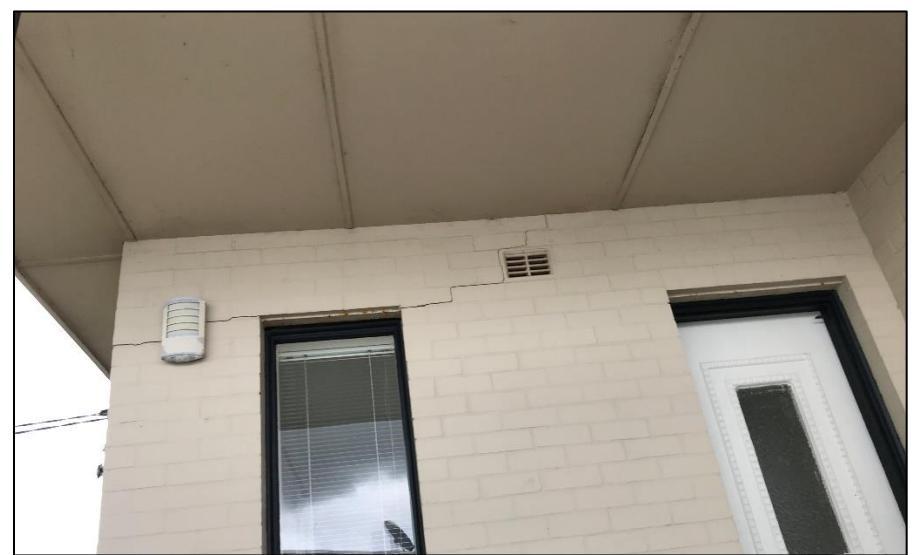
The existing site residence is generally in good condition with the exception of a crack on the external southern wall as shown on Photograph 4. The crack is present near the front of the house and is likely related to settlement of founding strata rather than an indicator of a deep-seated landslip hazard.

Photograph 4: Cracking observed in the external wall.

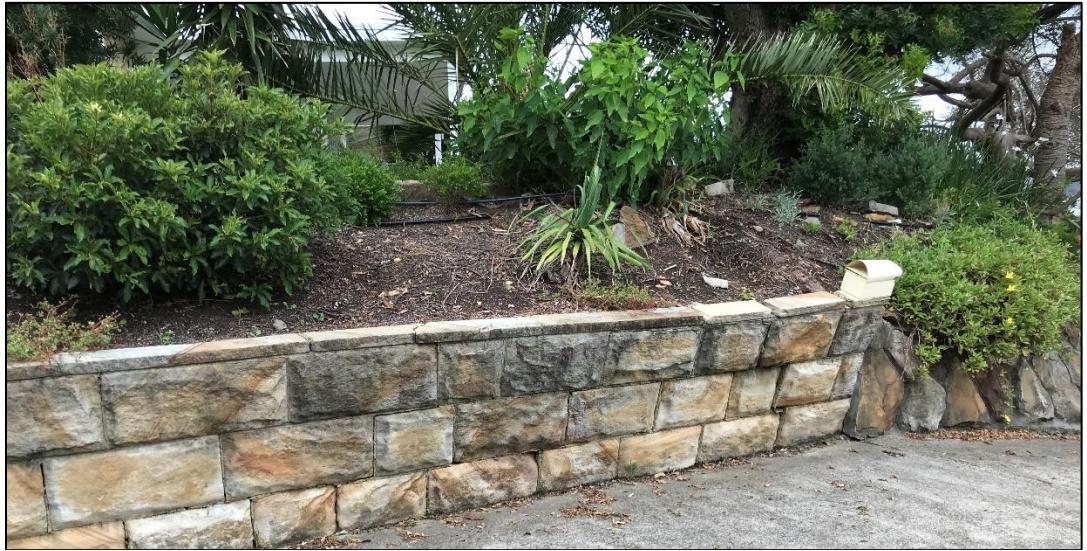
The retaining wall (located adjacent to the site driveway) did display some rotation which may be related to the growth of an adjacent tree or inadequate construction and is considered unlikely to represent a deepseated geotechnical issue.

Photograph 5: View of rotating wall at the front with the site.

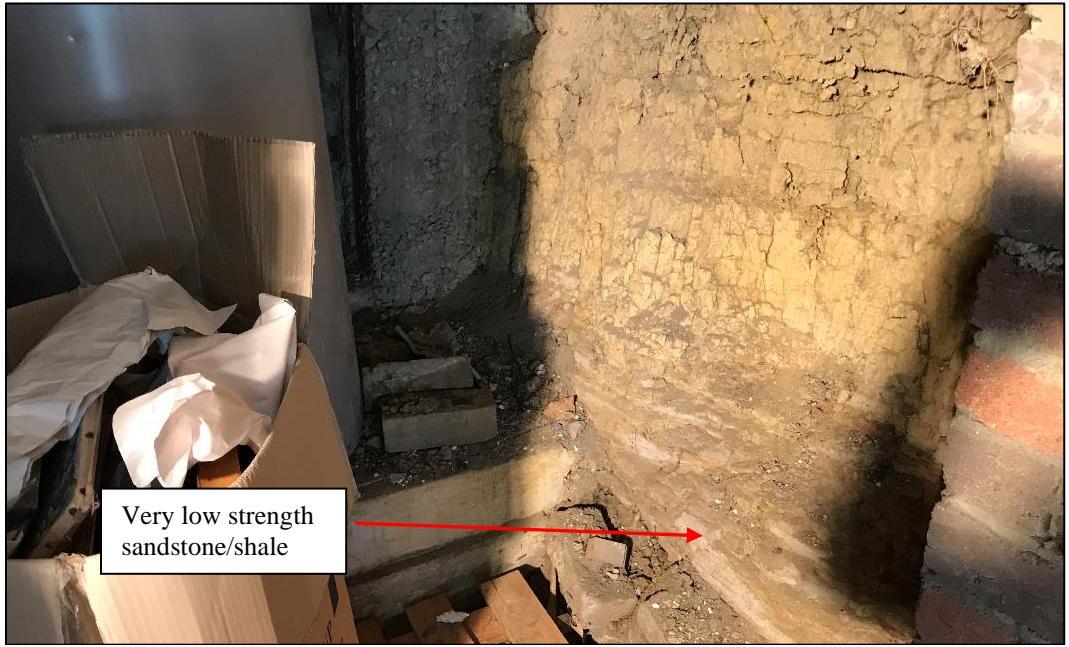
Within the site garage an outcrop of very low strength sandstone interbedded with shale was observed and overlain by approximately 0.8m thickness of residual clay soils (See Photograph 6)

Photograph 6: View of bedrock outcrop in the garage

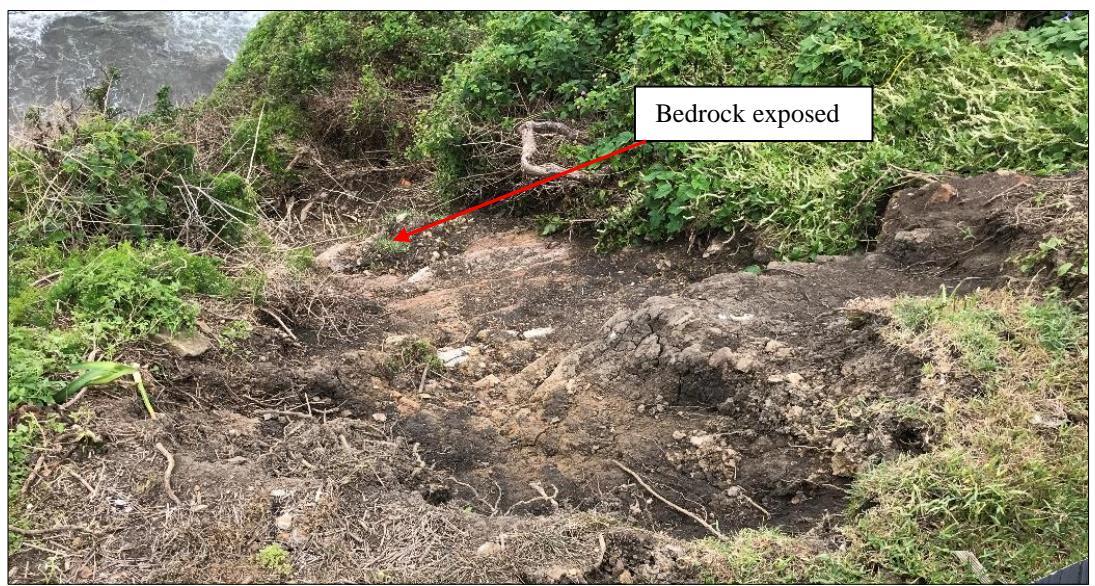
Adjacent to the rear deck of the site dwelling and near the crest of the cliff, recent erosion/landslip of topsoil/residual soils exposed bedrock approximately 1.5-2.0m below the elevation of the garden and is shown in Photograph 7.

Photograph 7: View of bedrock outcrop near crest of the cliff

Significant geotechnical hazards were not observed however erosion/previous landslip was observed near the crest of the cliff adjacent to the site deck during the initial phase of fieldwork. This feature is typical following heavy rainfall which occurred before the initial inspection were completed and represents a

normal cliff process which periodically exposes bedrock and not representative of a significant deep seated landslip hazard.

Apparently stable bedrock was observed within an area of landslip/erosion near the crest of the cliff adjacent to the existing site residence deck however it appears the results of erosion and not representative of a larger or continuing landslip hazard.

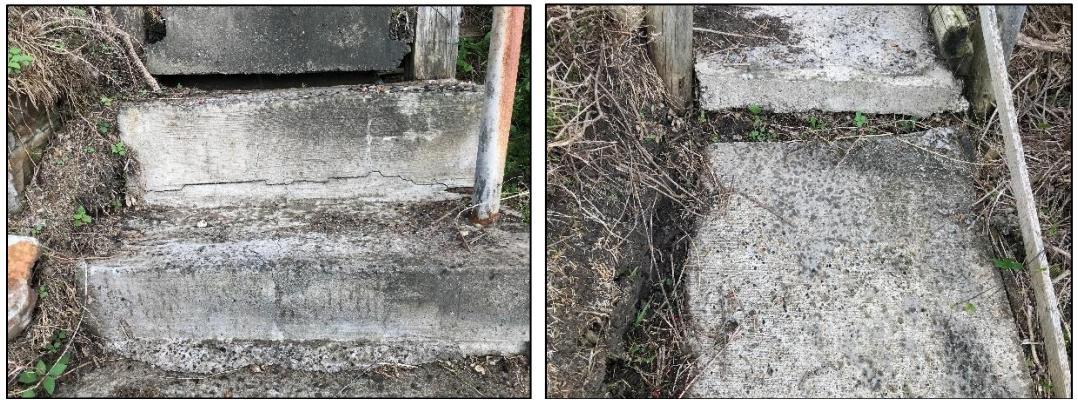
Within the site indications of distress were observed within the access steps which lead down to Bungan Beach to the east and indicated in Photograph 8. The separation/cracking observed is considered to be the result of settlement/creep of colluvial soils and the shallow founding of the path in this material and not an indication of a significant geotechnical issue.

Photographs 8 and 9: View of separation with the beach access steps looking west
