## **ARBORICULTURAL IMPACT ASSESSMENT REPORT**

**28 Goondari Road  
Allambie Heights**

**Synergy Construction Group**

**30<sup>th</sup> November 2021**

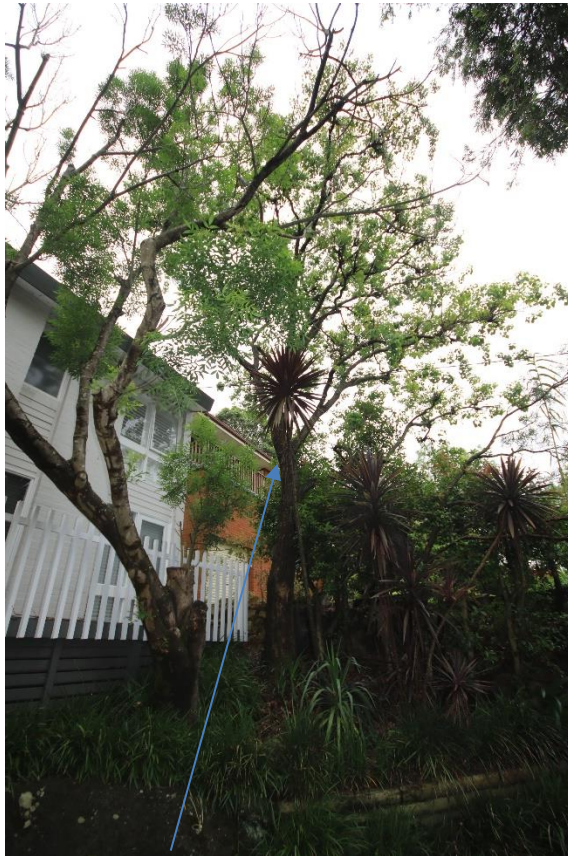
Plate 1: Tree 1

1. Tree 1 *Glochidion ferdinandi* is showing fair condition but with all of its canopy pruned away from the residence – refer plate 1.

This tree is within these structures and will require removal. Its removal is balanced by all the remaining indigenous trees in the rear of the site.

Note this tree for removal in the Tree Management Plan (TMP).

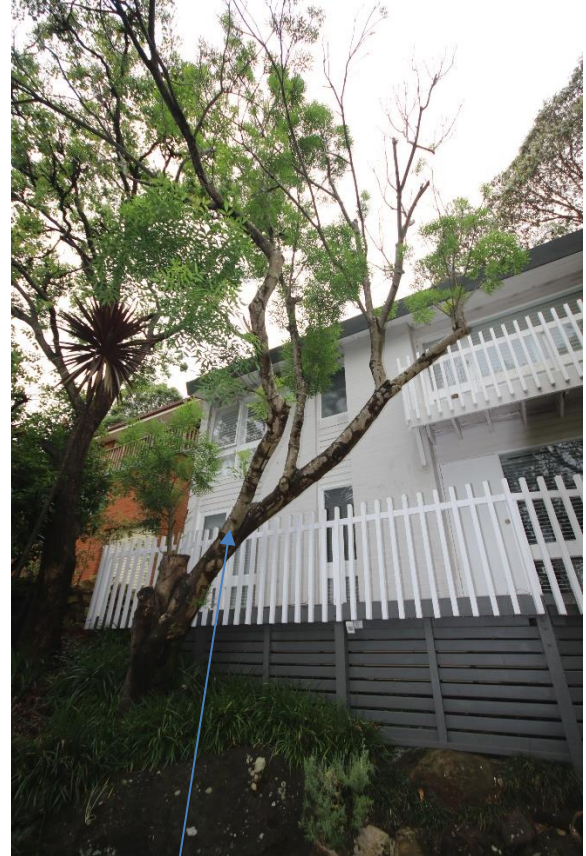
Plate 2: Tree 2

2. Tree 2 *Fraxinus* sp. is ½ dead and has poor condition – refer plate 2.

This tree is also in the proposed renovations and will require removal, however due to its poor condition removal is recommended.

Note this tree for removal in the TMP.

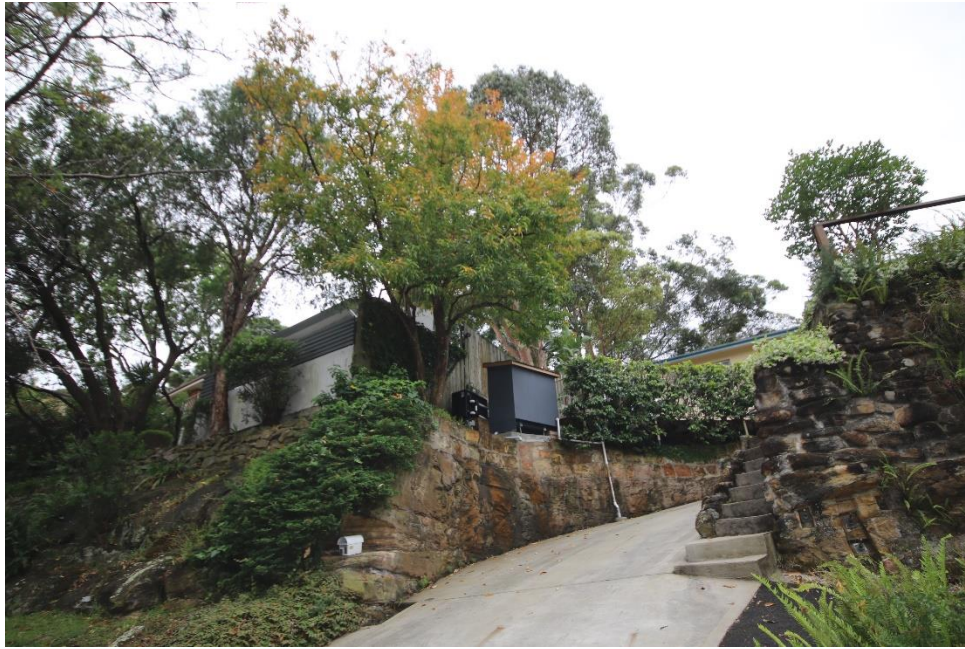
Plate 3: Tree 3.

3. Tree 3 *Citharexylum spinosum* is showing fair condition and is jammed in between the existing garage and the actual boundary line – refer Annexure B & plate 3.

The clients wish to extend the retaining wall to the actual boundary to provide good turning circle to exit the site forwards down a steep driveway (which is not an unreasonable proposition), this resulting in the need to remove this tree.

The Fiddlewood tree is not an indigenous tree (originates from Central America & West Indies) and is therefore considered a low retention value tree. Plus, as noted above there are many local trees being retained on site.

Note this tree for removal in the TMP.

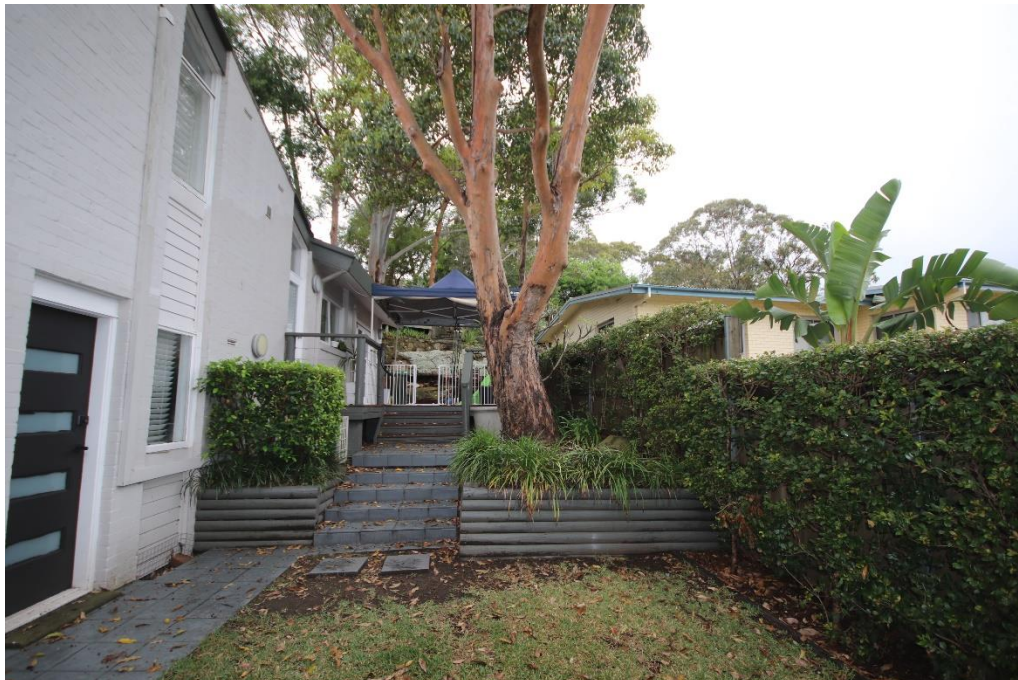
Plate 4: Tree 4 & 5 behind.

4. Trees 4 & 5 *Lophostemon confertus* are showing good and fair condition respectively and have an existing retaining wall (tree 4) and timber deck (tree 5) within their TPZ.

While these trees are showing fair & good condition, they should not be considered to be an impediment to the approval of this application. These trees are found from Port Stephens northwards and are not indigenous to this area, although they have adapted to the Sydney environment.

Removal is recommended to allow the development works to proceed. Note for removal in the TMP.
