ARBORICULTURAL IMPACT REPORT

101 BUNGAN HEAD ROAD NEWPORT BEACH NSW

6 JUNE 2016

PREPARED FOR NORTH SHORE BUILDING DESIGN GROUP

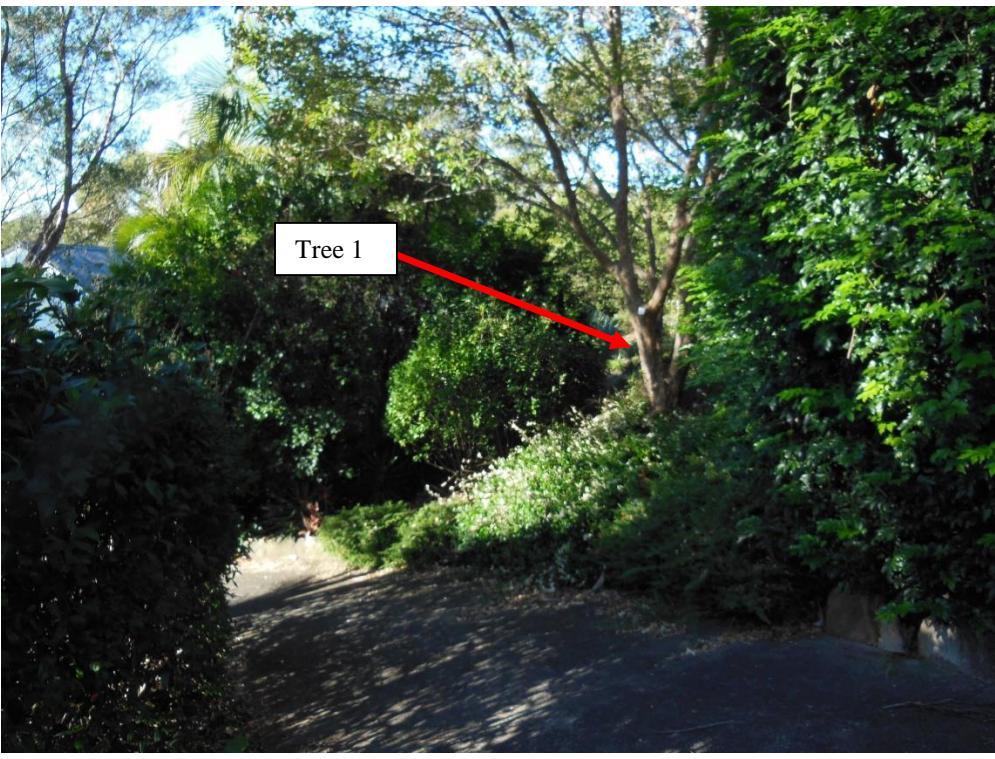
Photograph 1: Tree # 1 – Illustrating the existing driveway layout and the tree.

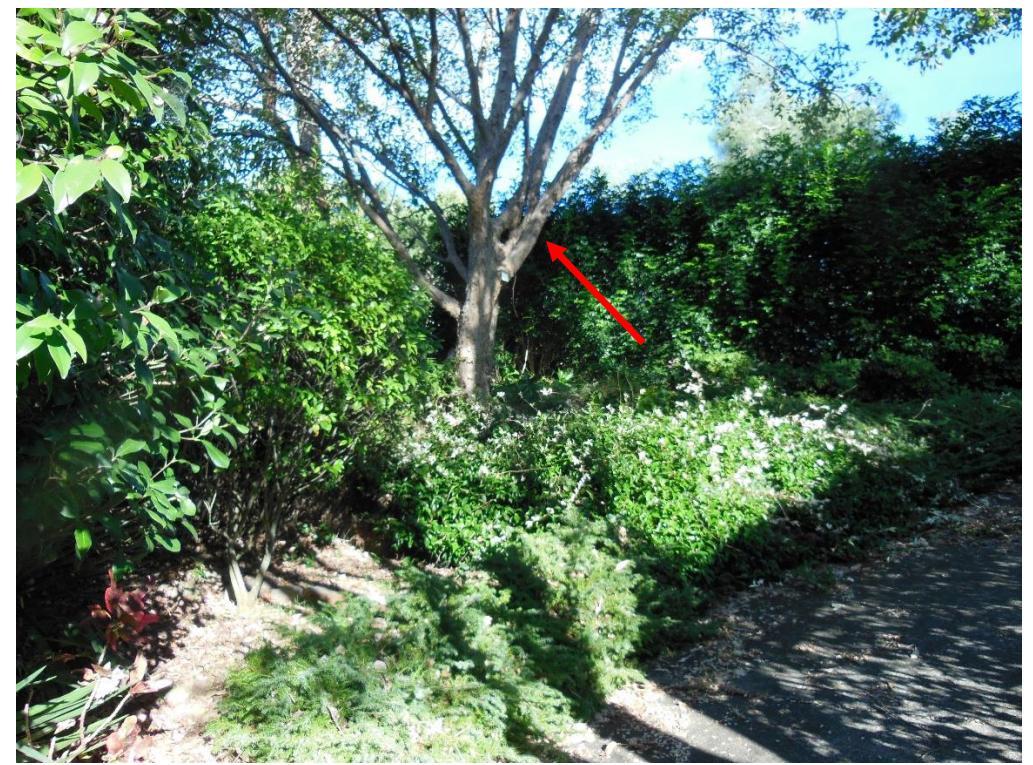
Photograph 2: Tree # 1 – Illustrating the area of past canopy raising that will minimise the need to prune the canopy for the driveway access.

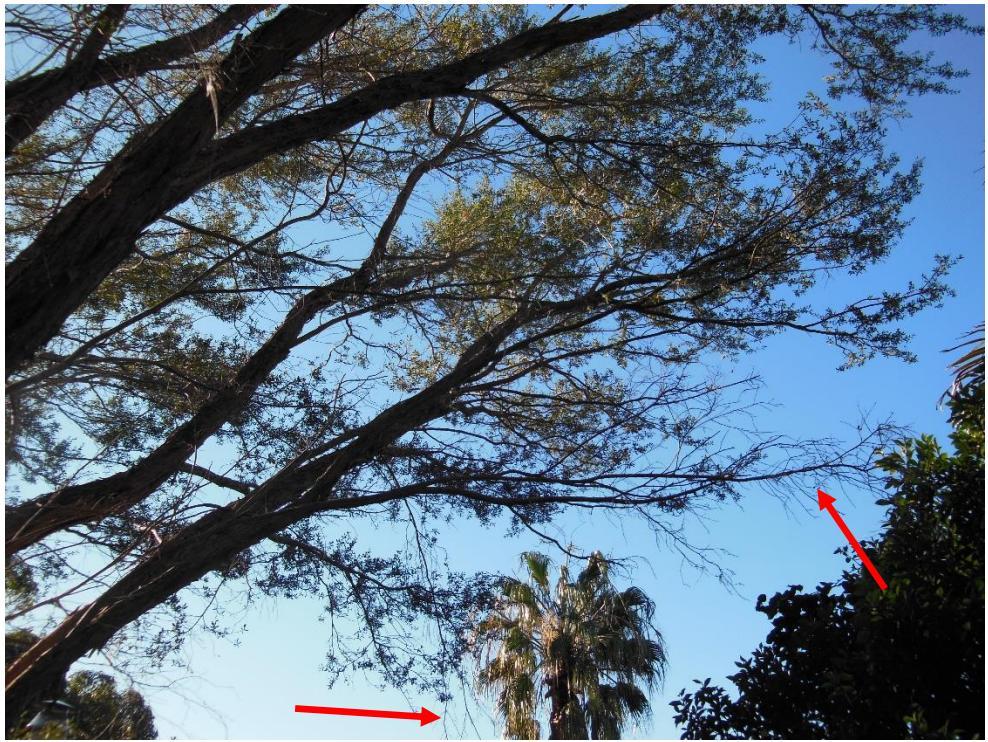
The trees were generally of good health at the time of inspection and did not exhibit any visual evidence of significant pest or disease. However, tree number 2 was of moderate health and fair vigour and exhibited significantly reduced foliage density and moderate to high levels of dieback

Photograph 3: Tree # 2 – Illustrating the reduced foliage density and moderate to high levels of dieback.

- The existing concrete driveway in this area will be converted to soft landscape area; and
- Past pruning of lower branches to around 3 metres will minimise the need to prune the canopy for driveway clearance.
- Taking these factors into consideration it is considered the potential impacts to tree number 1 will be within an acceptable threshold.
- Tree numbers 2 and 3 are proposed to be removed as part of the works.

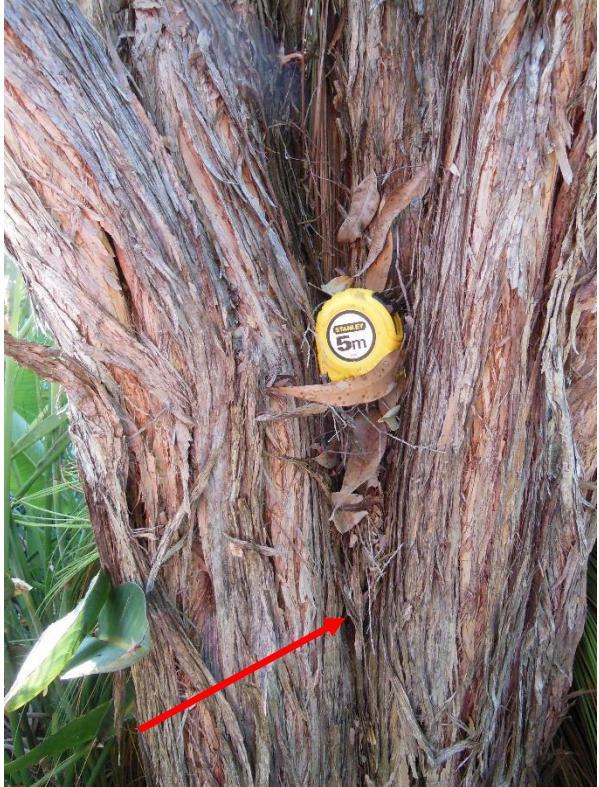
with increased risk of failure. At the time of inspection the tree was of moderate health and fair vigour and exhibited
		significantly reduced foliage density and moderate to high levels of dieback.
3	Michellia figo (Port	A mature, multi trunked specimen approximately 3.5 metres in height with a canopy spread of 3.5 metres and DBH of
	Wine Magnolia)	up to 55mm (160 x 220mm above the root flare). In good health and of low landscape significance.
		The tree's past canopy development has been suppressed.

Photograph 4: Tree # 2 – Illustrating the multiple leaders from 1 metre with evidence of poor attachment at the junction.
